**Castle Peak Road
Improvement Between
Sham Tseng and Ka
Loon Tsuen,
Tsuen Wan
West Contract No.
HY/99/18**

Monthly Environmental
Monitoring and Audit
Report
July 2004

Monthly Environmental Monitoring and Audit Report – July 2004

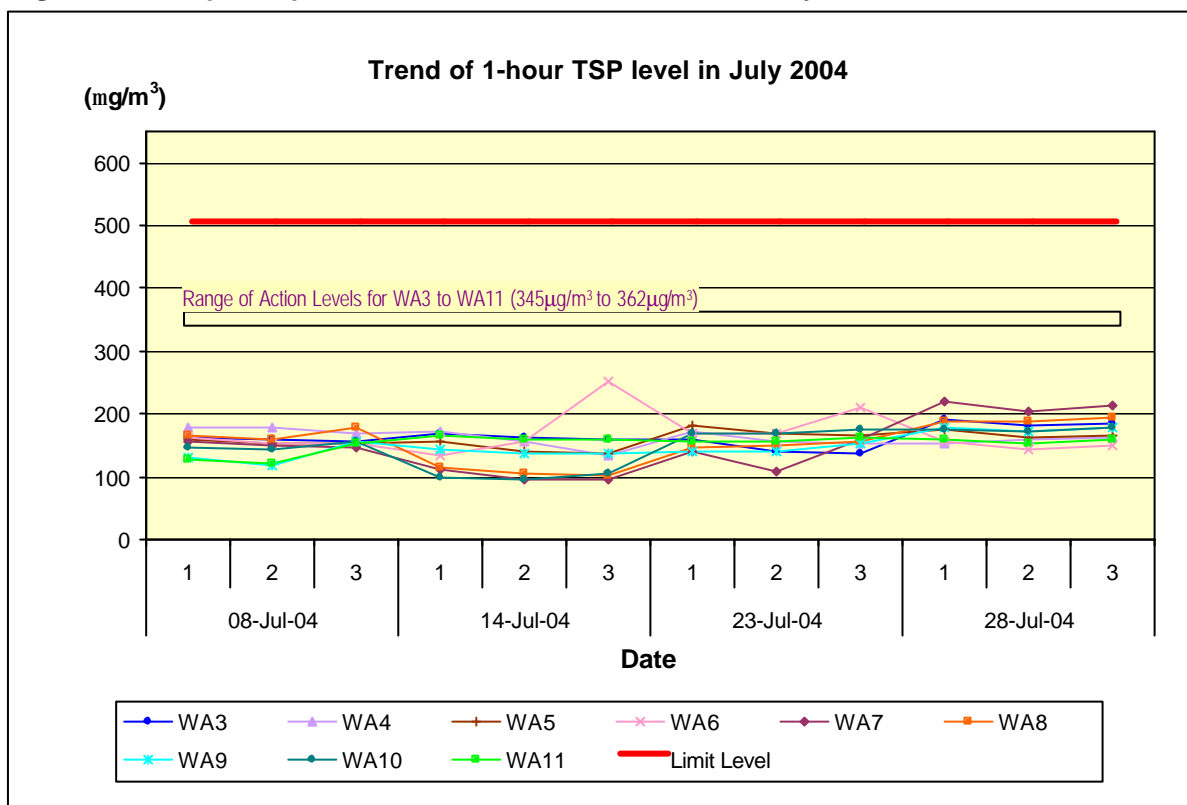
Figure 4-1 Graphical presentation of 1-hour TSP levels for July 2004

The detailed monitoring results of 1-hour TSP are given in Appendix E and the 1-hour TSP level at each monitoring location are plotted and presented in Figure 4-1.

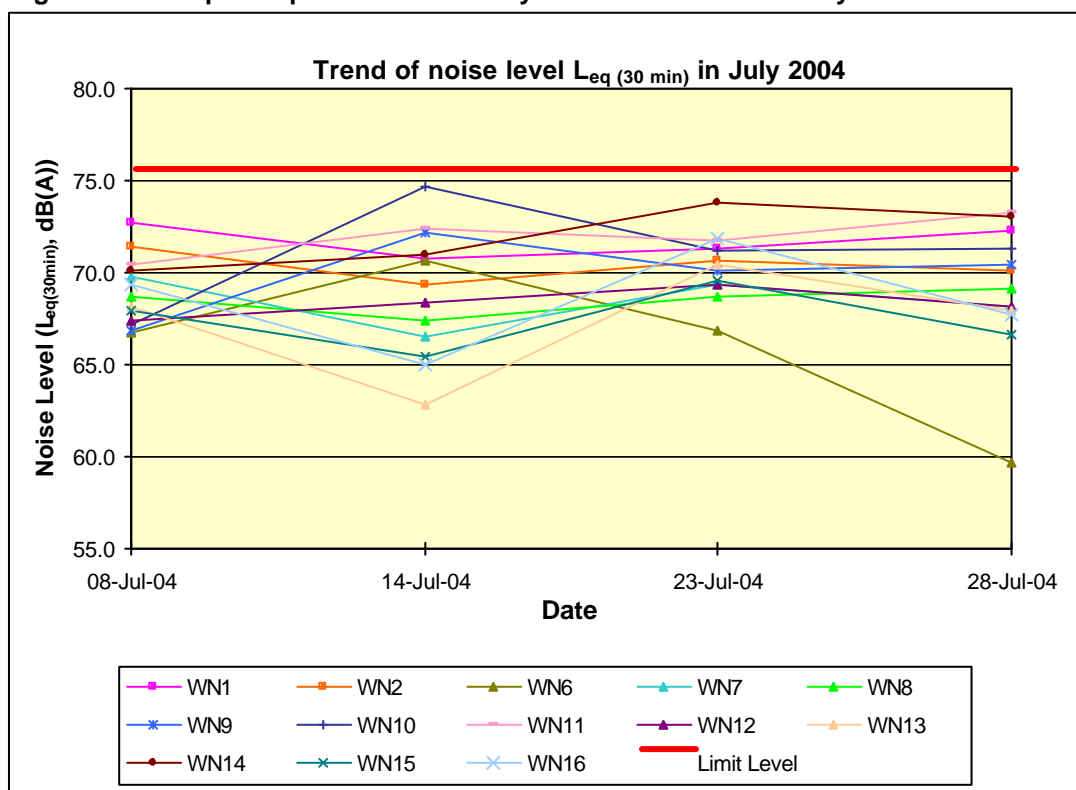
Figure 5-1 Graphical presentation of daytime noise levels for July 2004

The noise levels at each monitoring location are plotted and presented in Figure 5-1.
