**Castle Peak Road  
Improvement Between  
Sham Tseng and Ka  
Loon Tsuen,  
Tsuen Wan  
West Contract No.  
HY/99/18**

Quarterly Environmental  
Monitoring and Audit  
Summary Report  
August 2004 to October  
2004

Quarterly Environmental Monitoring and Audit Summary Report

August 2004 to October 2004

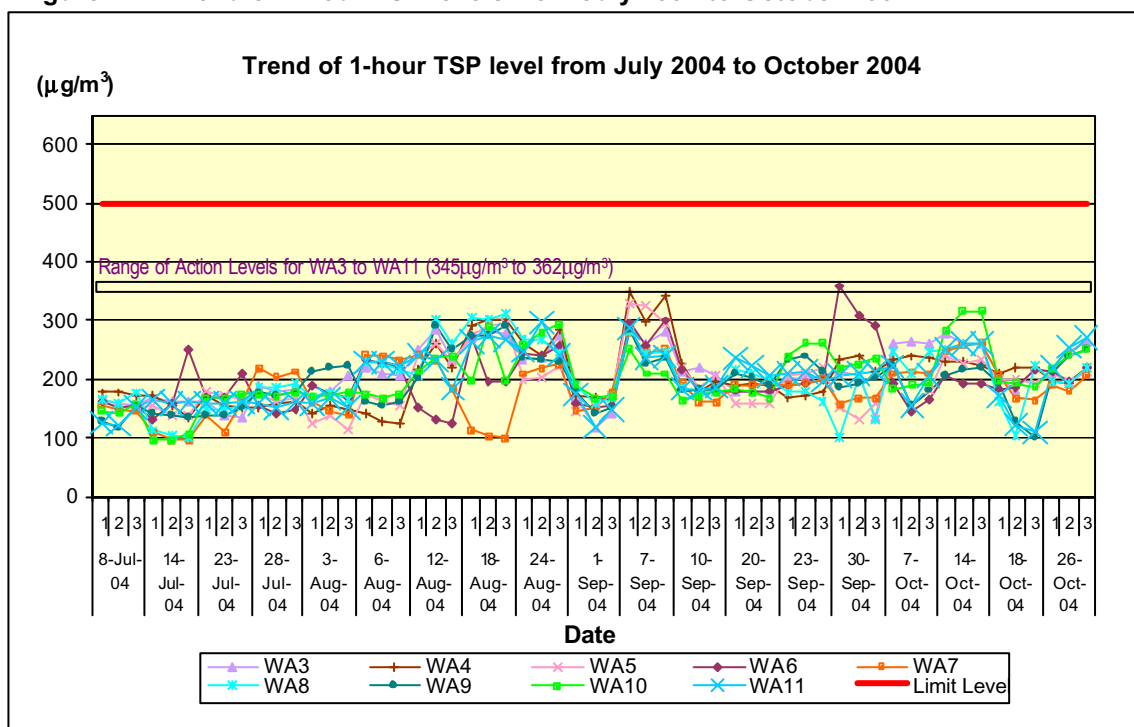
The trend of 1-hour TSP levels at each monitoring location are plotted and presented in Figure 4-1.

**Figure 4-1 Trend of 1-hour TSP levels from July 2004 to October 2004**

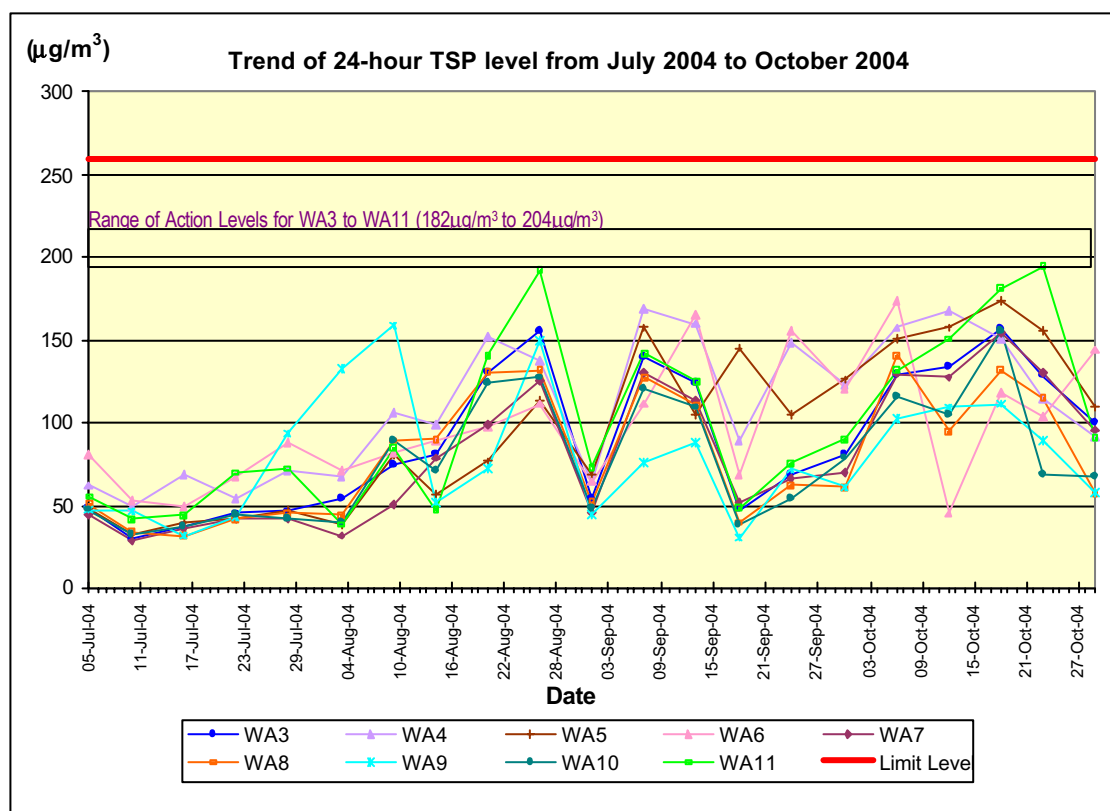
The trend of 24-hour TSP levels at each monitoring location are plotted and presented in Figure 4-2.

**Figure 4-2 Trend of 24-hour TSP level from July 2004 to October 2004**

The highest 24-hour TSP level was  $194.6\mu\text{g}/\text{m}^3$  recorded at G/F, Carpark, Lido Garden (WA11) on 23 October 2004 while the lowest 24-hour TSP level was  $30.4\mu\text{g}/\text{m}^3$  recorded at Car Park of Sea Crest Villa Phase 2 Block 6 (WA9) on 18 September 2004.

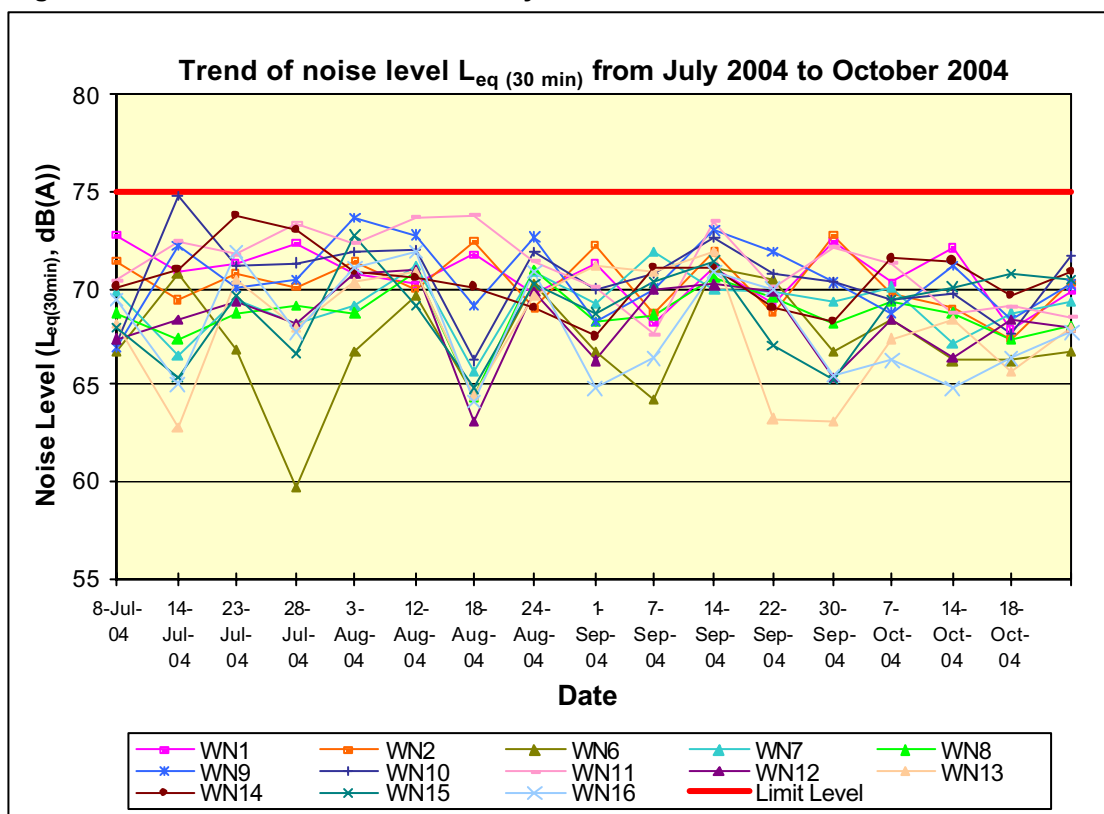
The trend of the noise levels at each monitoring location are plotted and presented in Figure 5-1.

Figure 5-1 Trend of noise level from July 2004 to October 2004

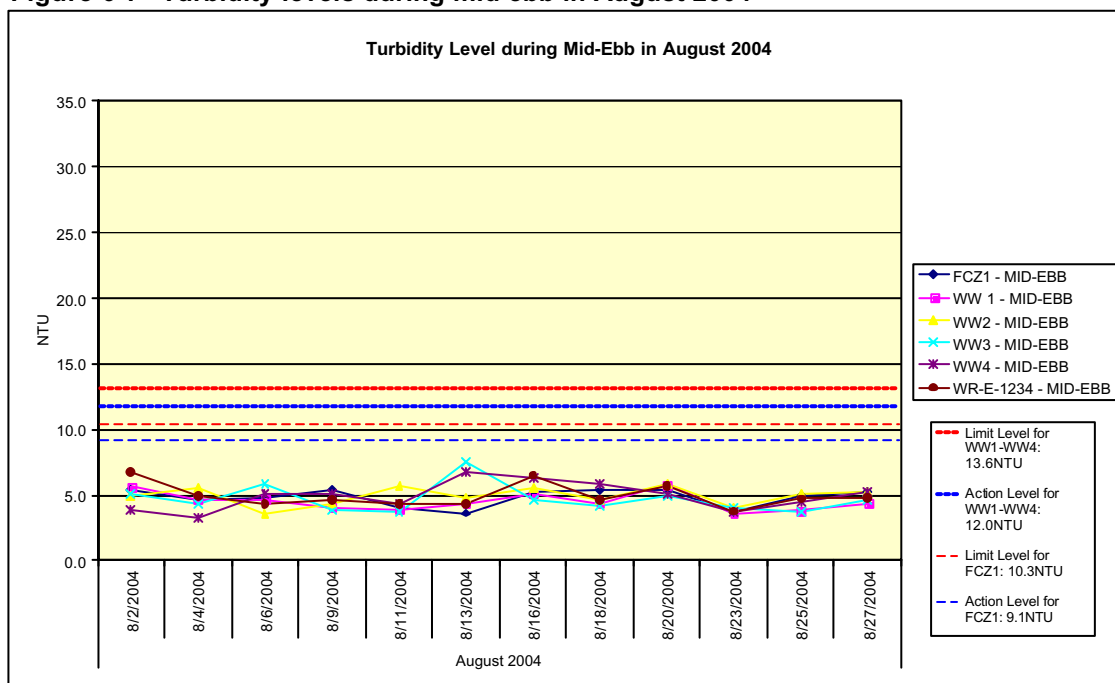
**Figure 6-1 Turbidity levels during mid-ebb in August 2004**

The monitoring results from August 2004 to October 2004 are plotted and presented in Figure 6-1 to Figure 6-8.

There was no exceedance of the Action and Limit Levels for Tby of marine water quality monitoring in the reporting period.

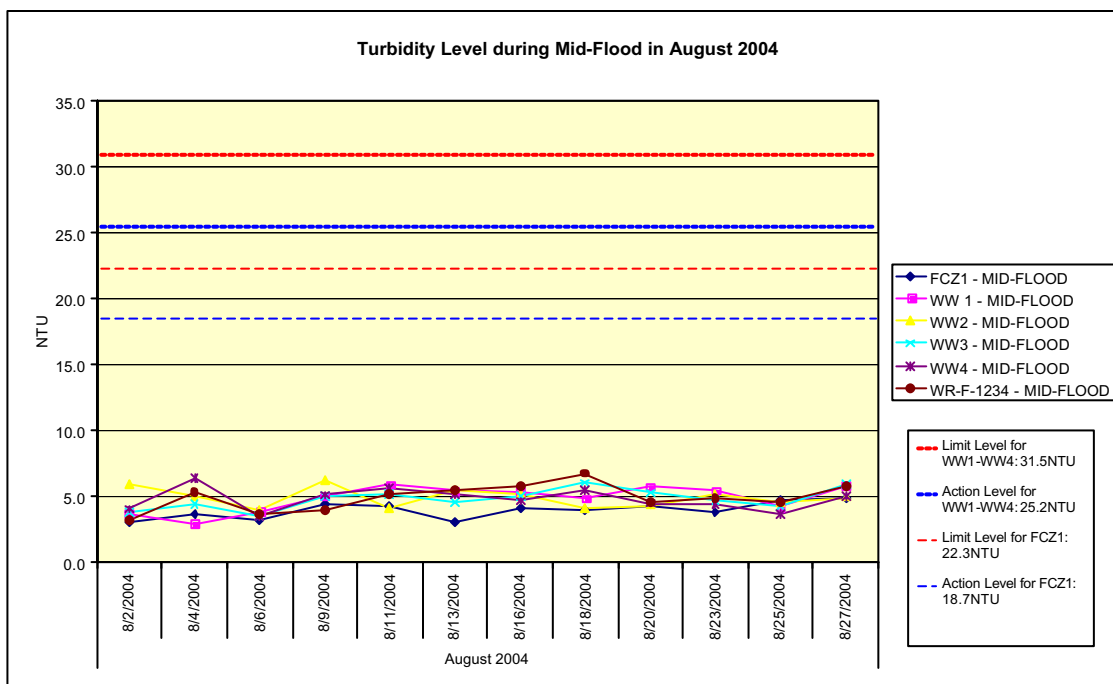
**Figure 6-2 Turbidity levels during mid-flood in August 2004**

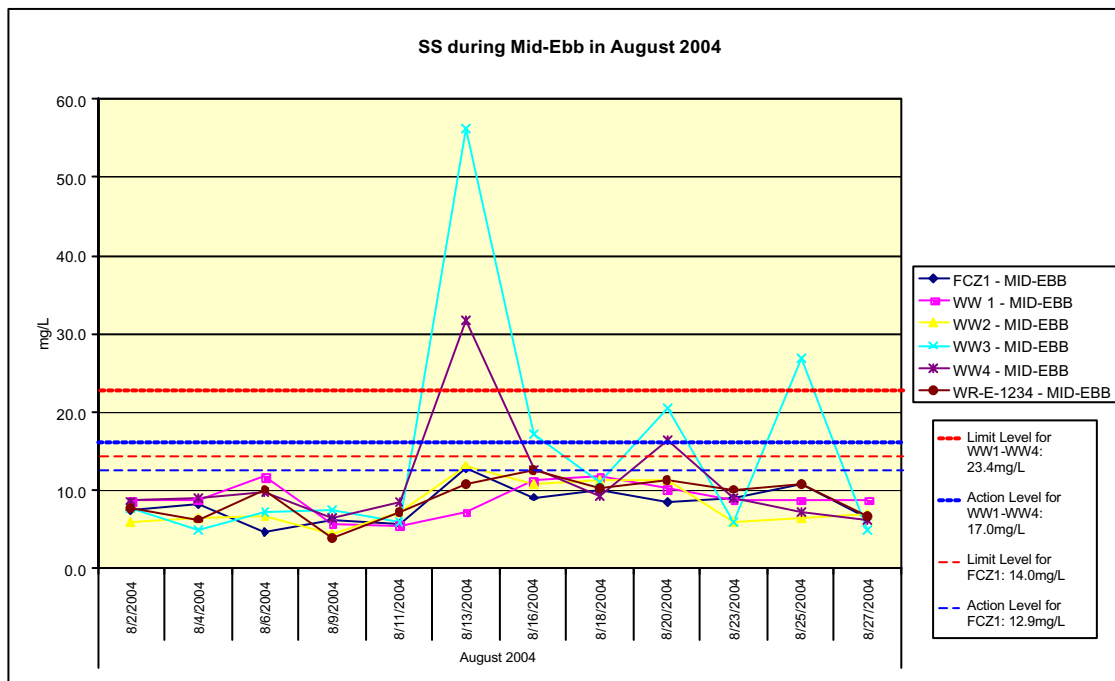
**Figure 6-3 SS during mid-ebb in August 2004**

There were exceedances on A/L Levels of DO and SS of marine water quality monitoring in August 2004. A thorough investigation had been triggered to reveal the causes of exceedances, including the review of Contractor's recent works, identification of other potential pollution sources, complaints, etc.

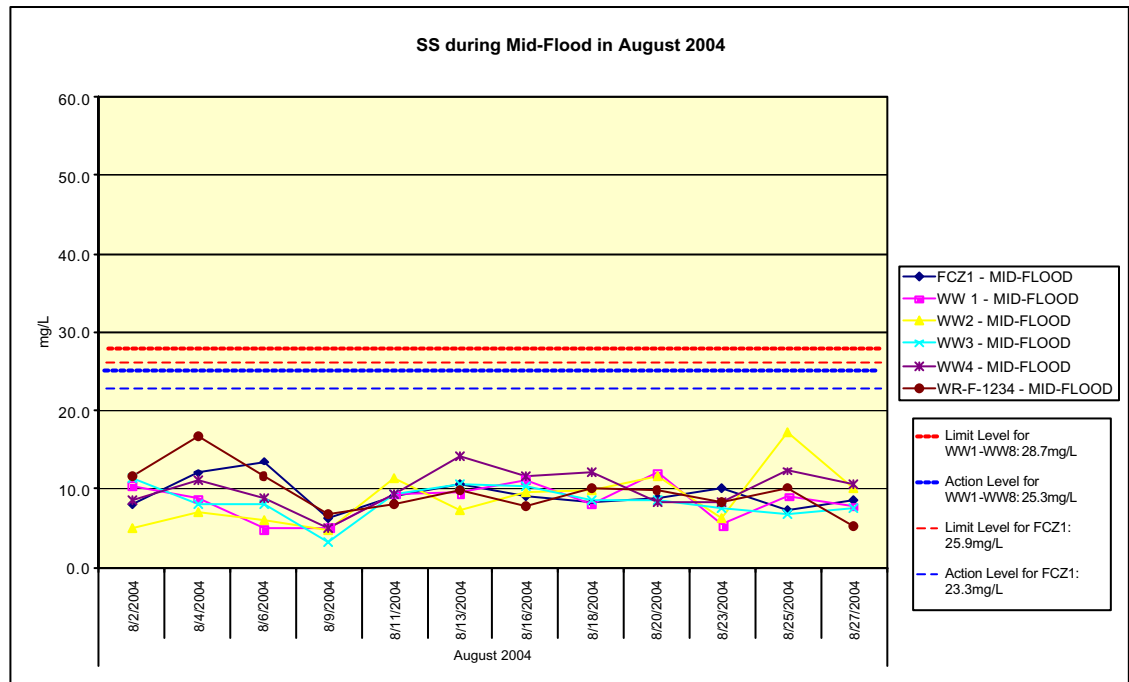
**Figure 6-4 SS during mid-flood in August 2004**

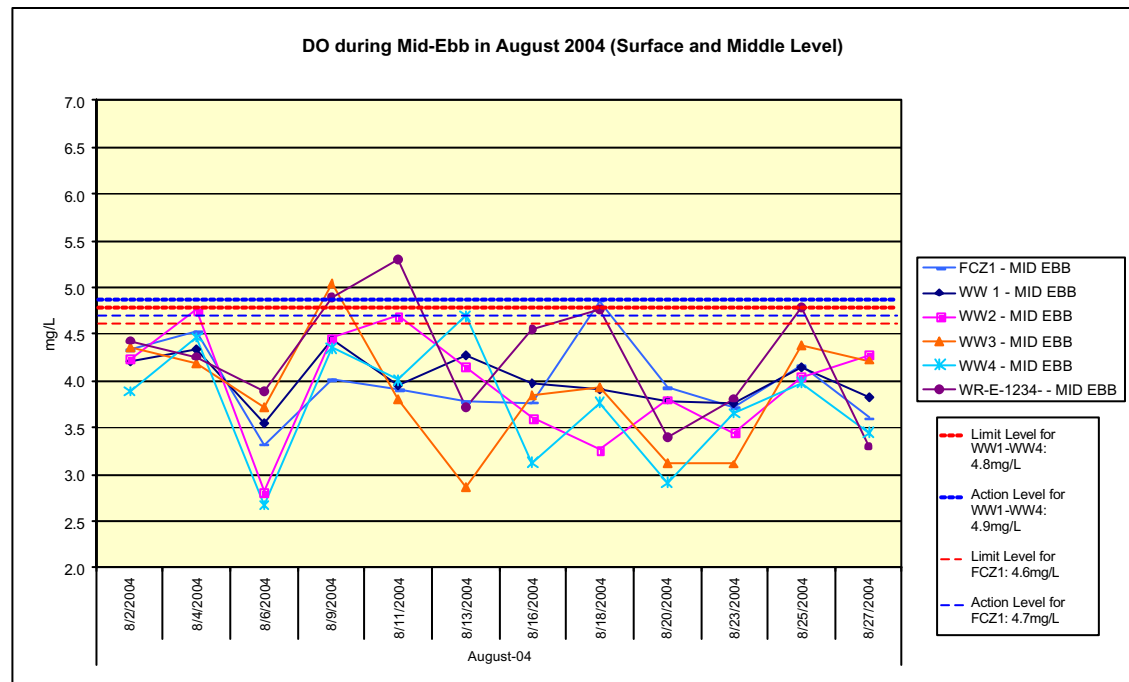
**Figure 6-5 DO at surface and middle level during mid-ebb in August 2004**

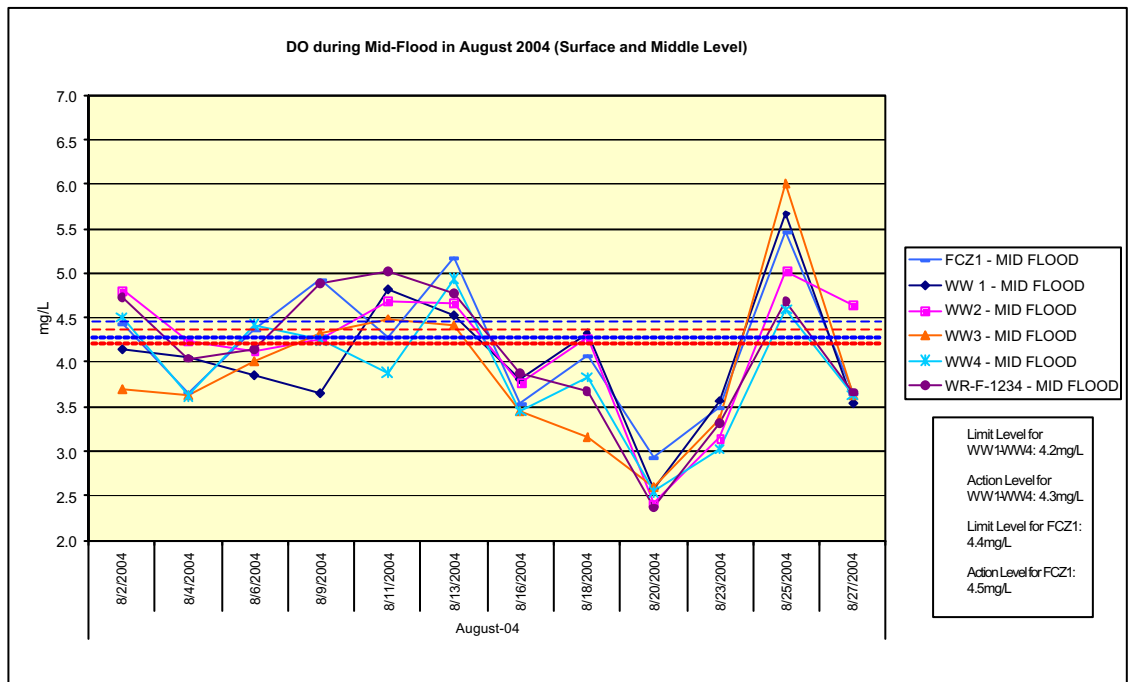
**Figure 6-6 DO at surface and middle level during mid-flood in August 2004**

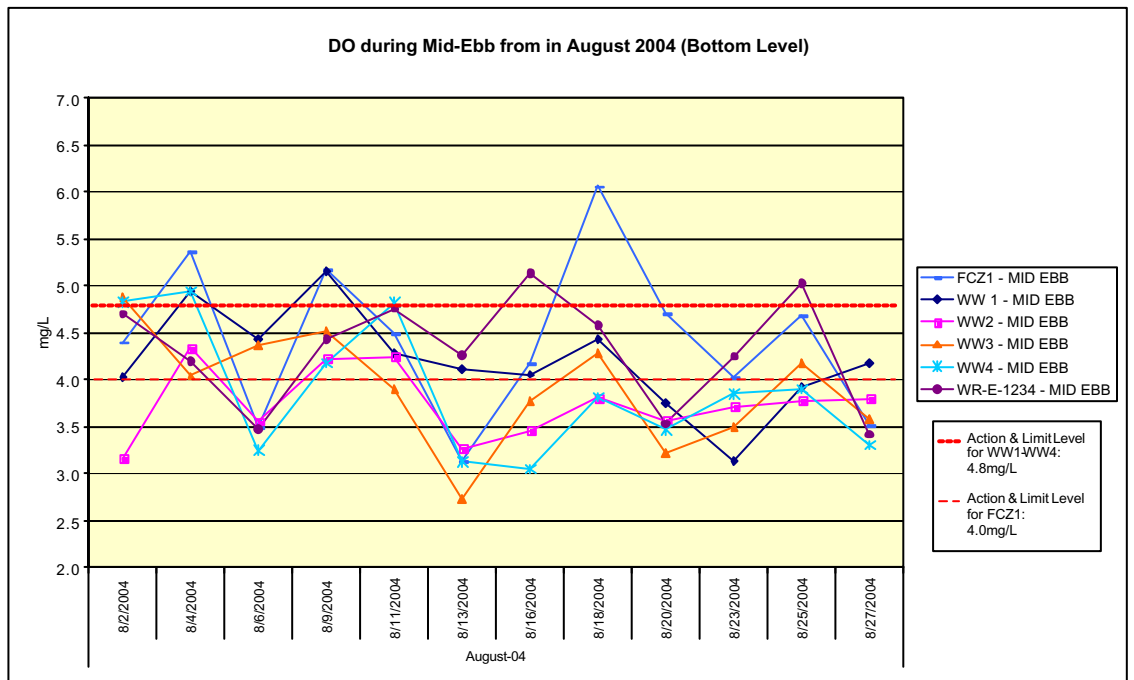
**Figure 6-7 DO at bottom level during mid-ebb in August 2004**

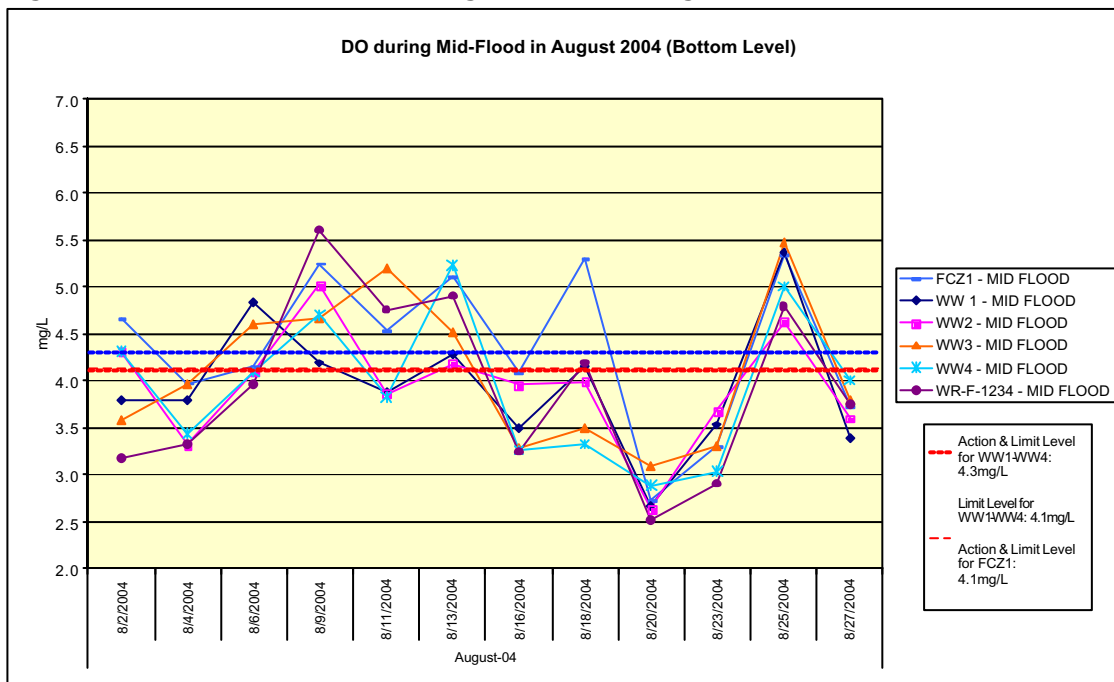
**Figure 6-8 DO at bottom level during mid-flood in August 2004**
