**Castle Peak Road
Improvement between
Sham Tseng and Ka
Loon Tsuen,
Tsuen Wan
West Contract No.
HY/99/18**

Monthly Environmental
Monitoring and Audit
Report
September 2006

Environmental Monitoring and Audit

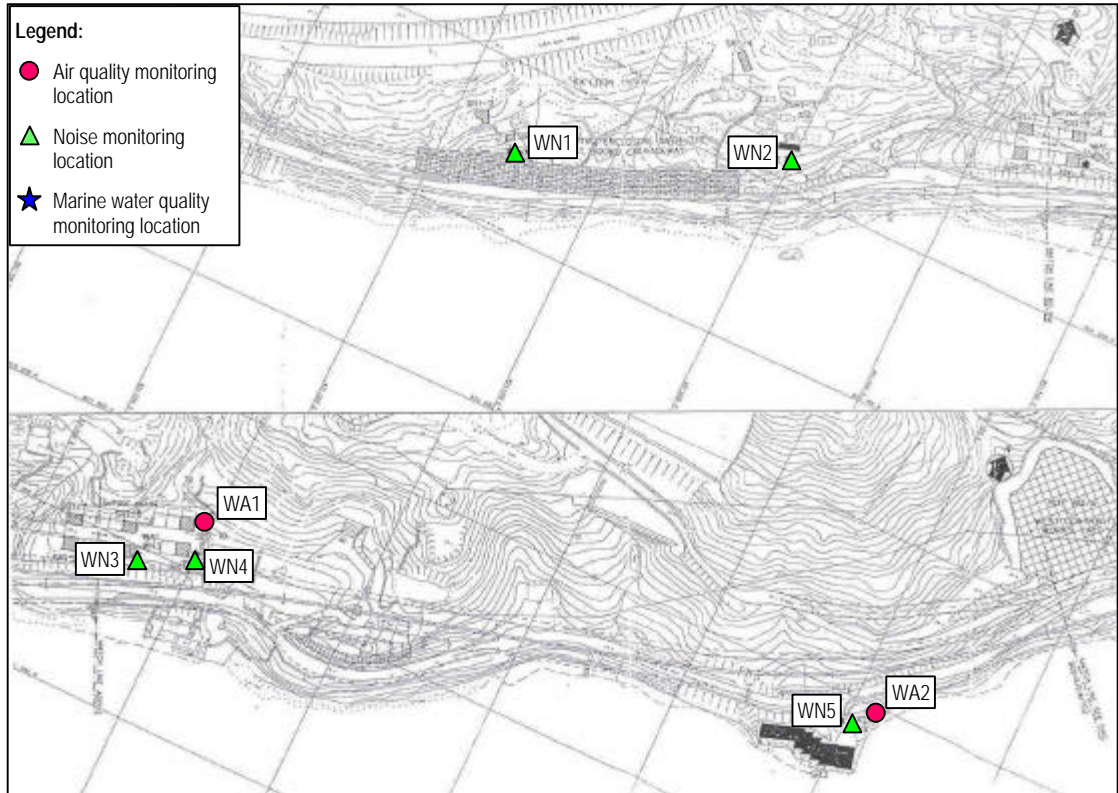
Figure 3-1a Monitoring locations

Figure 3-1b Monitoring locations

Figure 3-1c Monitoring locations

Figure 3-1d Monitoring locations

A total of eleven locations were specified in the EM&A Manual for the air quality monitoring and they are given in Table 3-2 and presented in Figures 3-1a to 3-1d.

A total of sixteen noise monitoring locations were specified in the EM&A Manual. They are presented in Table 3-4 and presented in Figures 3-1a to 3-1d. The measurements were taken at a position 1m from the exterior of building façade and at a position of 1.2m above ground.

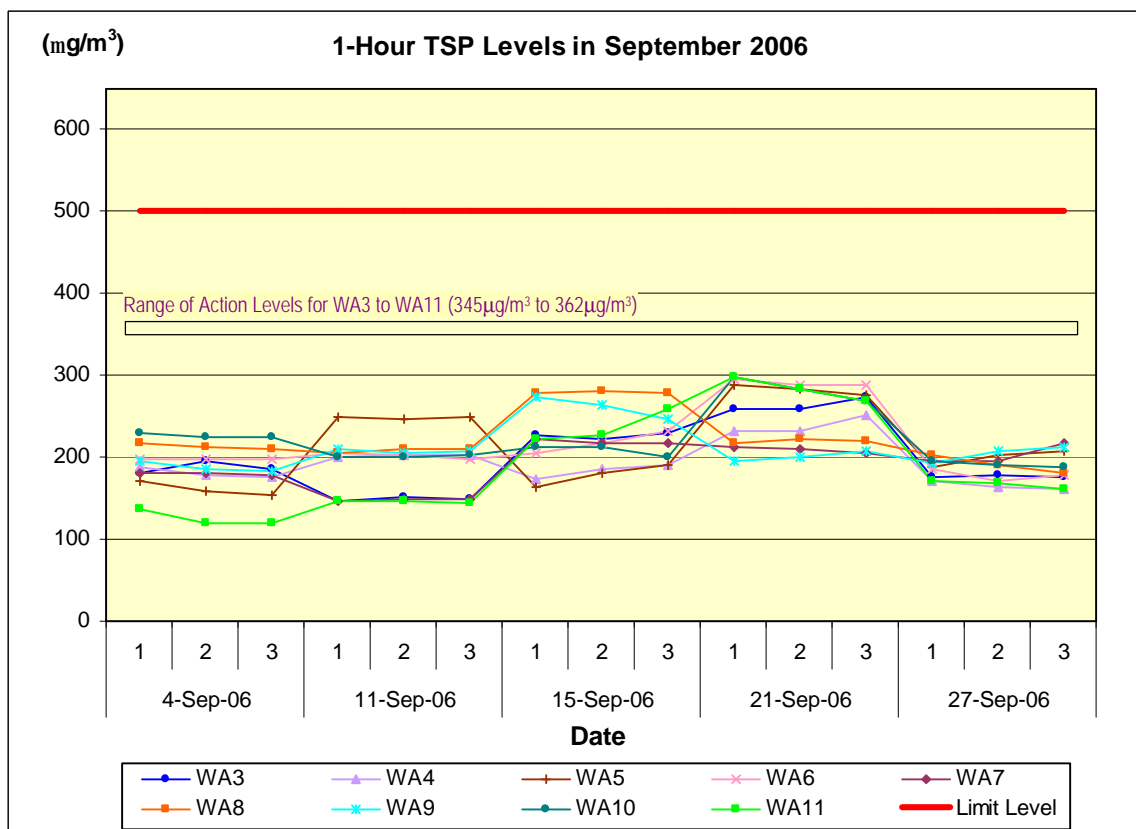
Figure 4-1 Graphical Presentation of 1-Hour TSP Levels for September 2006

Detailed monitoring results of 1-hour TSP are attached in Appendix E and graphical presentation of the 1-hour TSP levels at each monitoring location is illustrated in Figure 4-1.

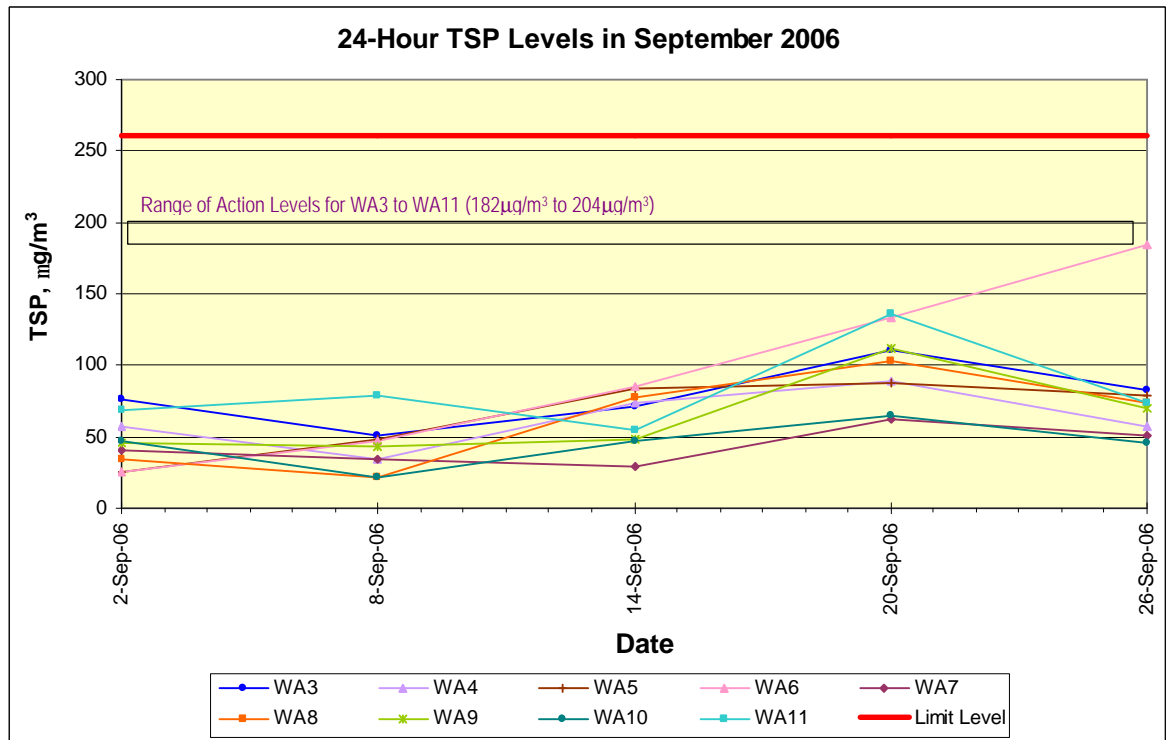
Figure 4-2 Graphical Presentation of 24-Hour TSP Levels in September 2006

Detailed monitoring results of 24-hour TSP are attached in Appendix F and graphical presentation of the 24-hour TSP levels at each monitoring location is illustrated in Figure 4-2.

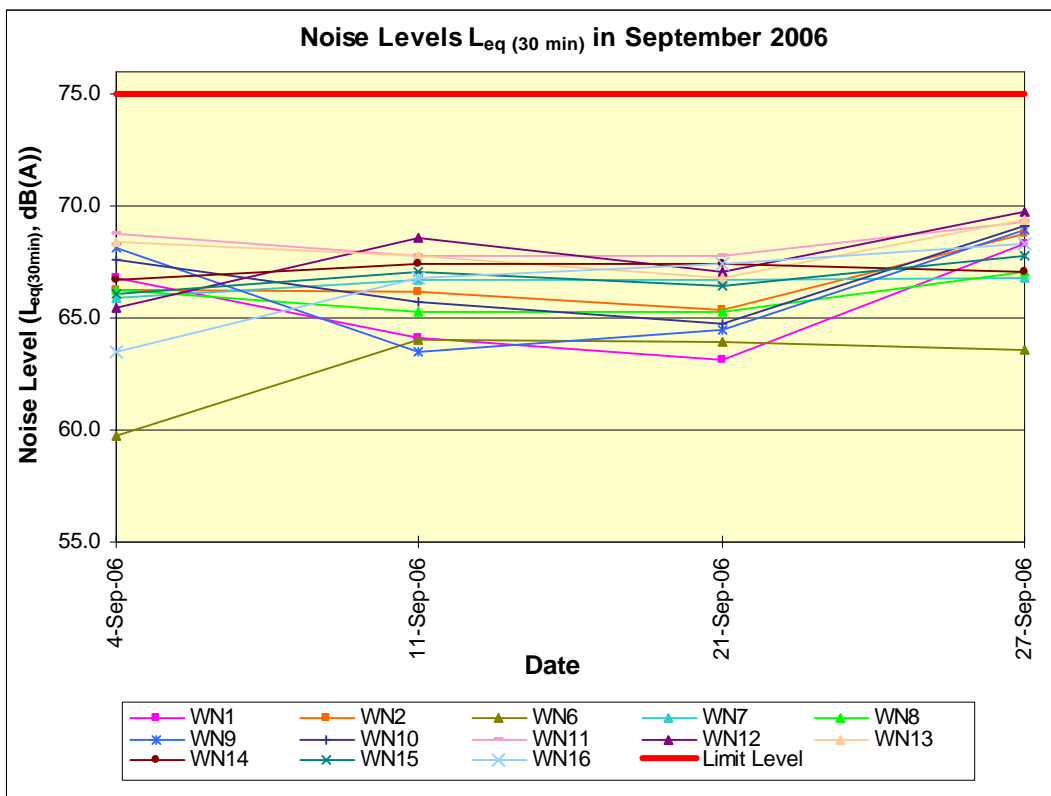
Figure 5-1 Graphical Presentation of Day-time Noise Levels in September 2006

Detailed construction noise monitoring results are attached in Appendix I and graphical presentation of the noise levels at each monitoring location is illustrated in Figure 5-1.

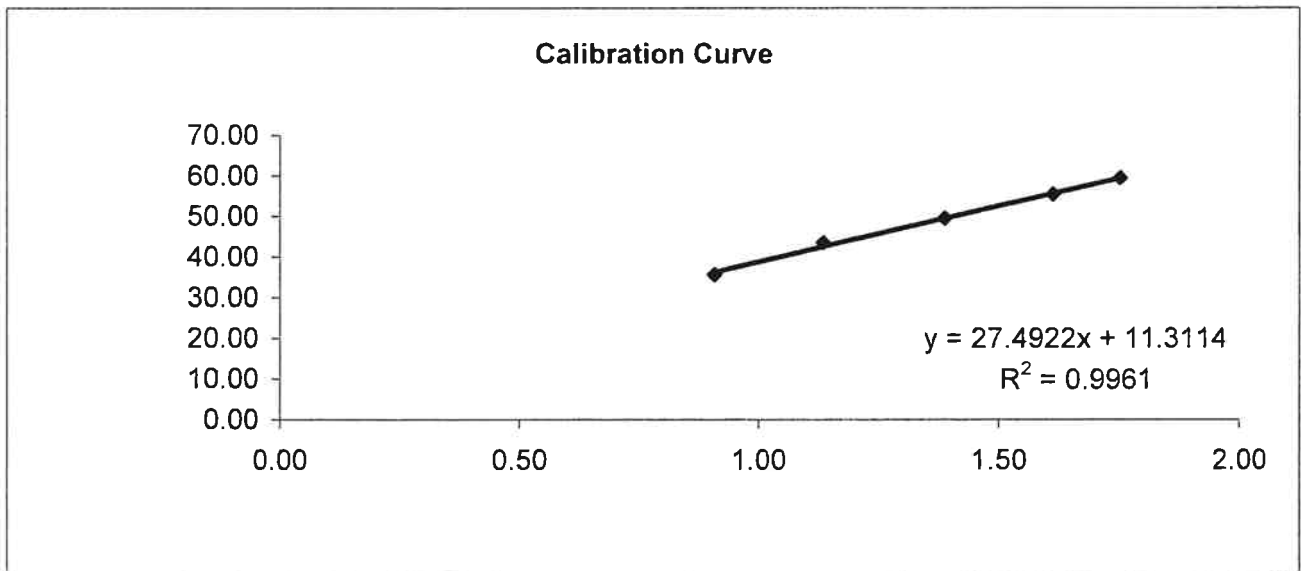
Calibration date	24-Aug-06	Barometric pressure	755 mm Hg
Calibration due date	23-Oct-06	Temperature (°C)	29 °C
Sampler location	WA3 - Hong Kong Garden (Regent Heights)	Temperature (K)	302 K
Sampler model	TE-5170	P _{std}	760 mm Hg
Sampler serial number	0505	T _{std}	298 K
Calibrator model	GMW-2535		
Calibrator serial number	1378		
Slope of the standard curve, m _s	2.00216		
Intercept of the standard curve, b _s	-0.02053

Resistance Plate No.	Manometer Reading (inch H ₂ O)	Flow Recorder Reading (CFM)	Calculated Q _{std} (m ³ /min)	Continuous Flow Recorder Reading IC (CFM)
5	3.30	36.00	0.91	35.64
7	5.20	44.00	1.14	43.56
10	7.80	50.00	1.39	49.50
13	10.50	56.00	1.61	55.44
18	12.40	60.00	1.75	59.40

Sampler slope (m) : **27.4922**
 Sampler intercept (b) : **11.3114**
 Correlation coefficient (R²) : **0.9961**

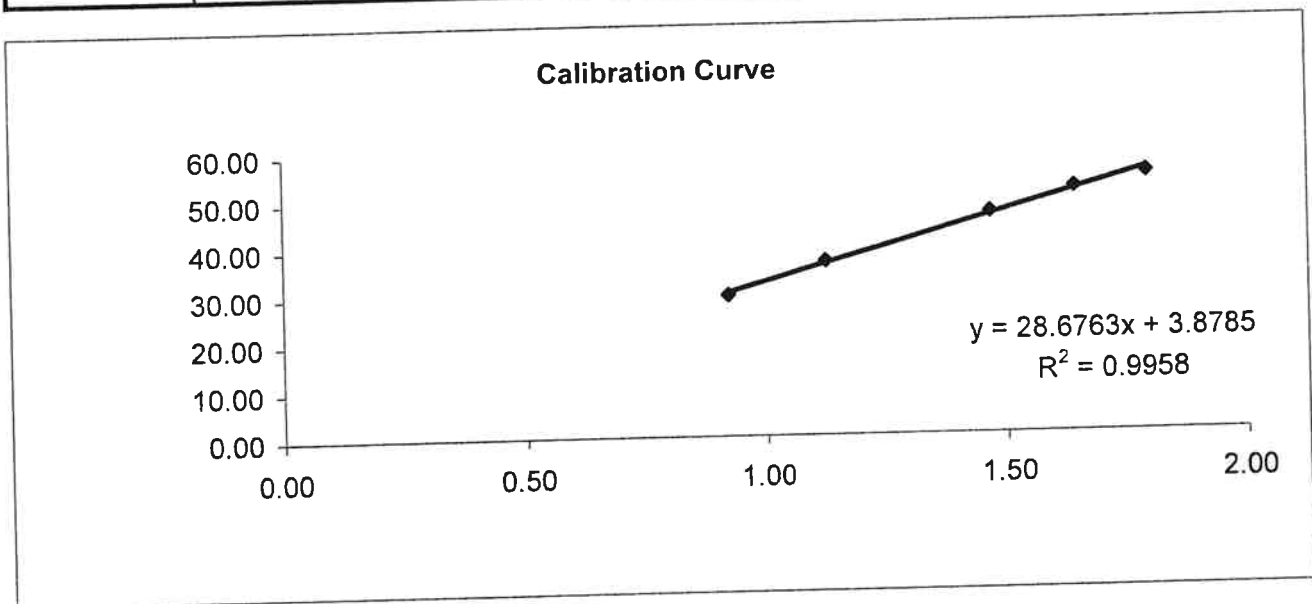
Calibration date	24-Aug-06	Barometric pressure	755 mm Hg
Calibration due date	23-Oct-06	Temperature (°C)	29 °C
Sampler location	WA4 - Hong Kong Garden (Between Blk1 & Blk2)	Temperature (K)	302 K
Sampler model	TE-5170	P _{std}	760 mm Hg
Sampler serial number	0512	T _{std}	298 K
Calibrator model	GMW-2535		
Calibrator serial number	1378		
Slope of the standard curve, m _s	2.00216		
Intercept of the standard curve, b _s	-0.02053

Resistance Plate No.	Manometer Reading (inch H ₂ O)	Flow Recorder Reading (CFM)	Calculated Q _{std} (m ³ /min)	Continuous Flow Recorder Reading IC (CFM)
5	3.40	30.00	0.92	29.70
7	5.10	37.00	1.13	36.63
10	8.70	47.00	1.47	46.53
13	10.90	52.00	1.64	51.48
18	13.00	55.00	1.79	54.45

Sampler slope (m) : **28.6763**
 Sampler intercept (b) : **3.8785**
 Correlation coefficient (R²) : **0.9958**

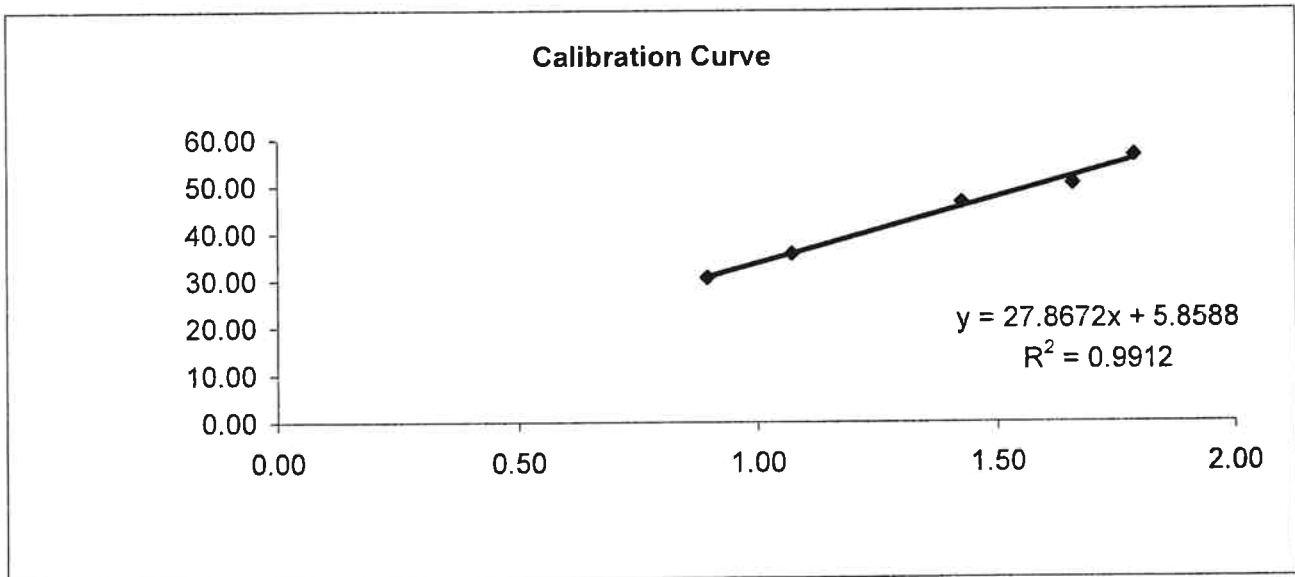
Resistance Plate No.	Manometer Reading (inch H ₂ O)	Flow Recorder Reading (CFM)	Calculated Q _{std} (m ³ /min)	Continuous Flow Recorder Reading IC (CFM)
5	3.20	31.00	0.89	30.69
7	4.60	36.00	1.07	35.64
10	8.20	47.00	1.43	46.53
13	11.10	51.00	1.66	50.49
18	12.90	57.00	1.79	56.43

Sampler slope (m) :	27.8672
Sampler intercept (b) :	5.8588
Correlation coefficient (R ²) :	0.9912

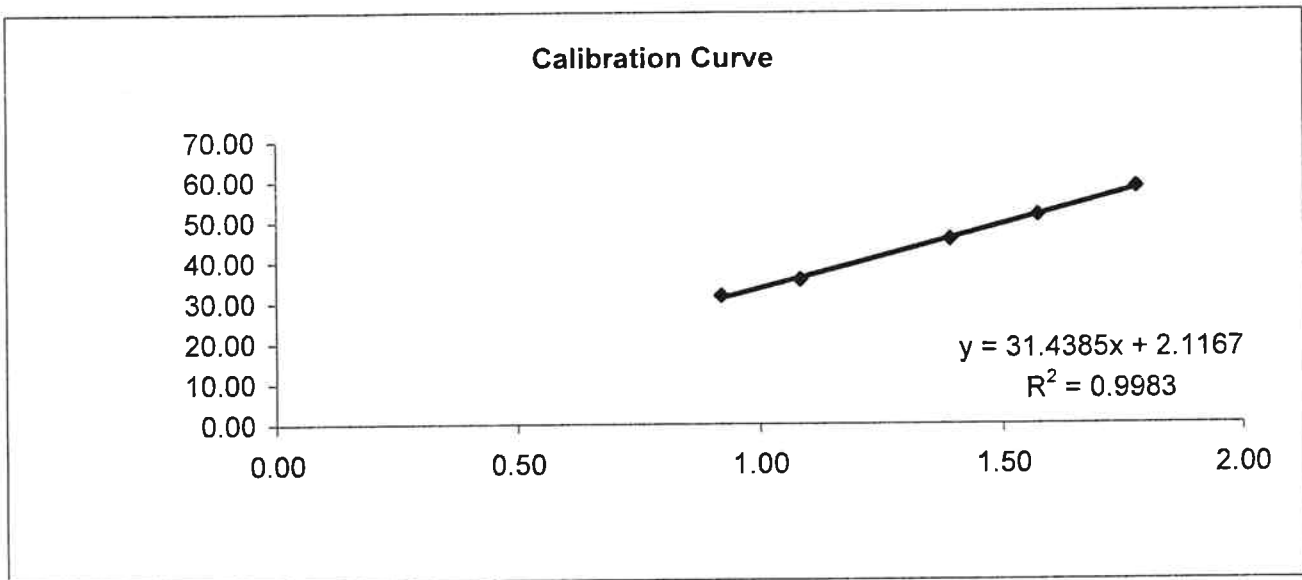
Resistance Plate No.	Manometer Reading (inch H ₂ O)	Flow Recorder Reading (CFM)	Calculated Q _{std} (m ³ /min)	Continuous Flow Recorder Reading IC (CFM)
5	3.40	32.00	0.92	31.68
7	4.70	36.00	1.08	35.64
10	7.80	46.00	1.39	45.54
13	10.00	52.00	1.57	51.48
18	12.80	59.00	1.78	58.41

Sampler slope (m) : **31.4385**
 Sampler intercept (b) : **2.1167**
 Correlation coefficient (R²) : **0.9983**

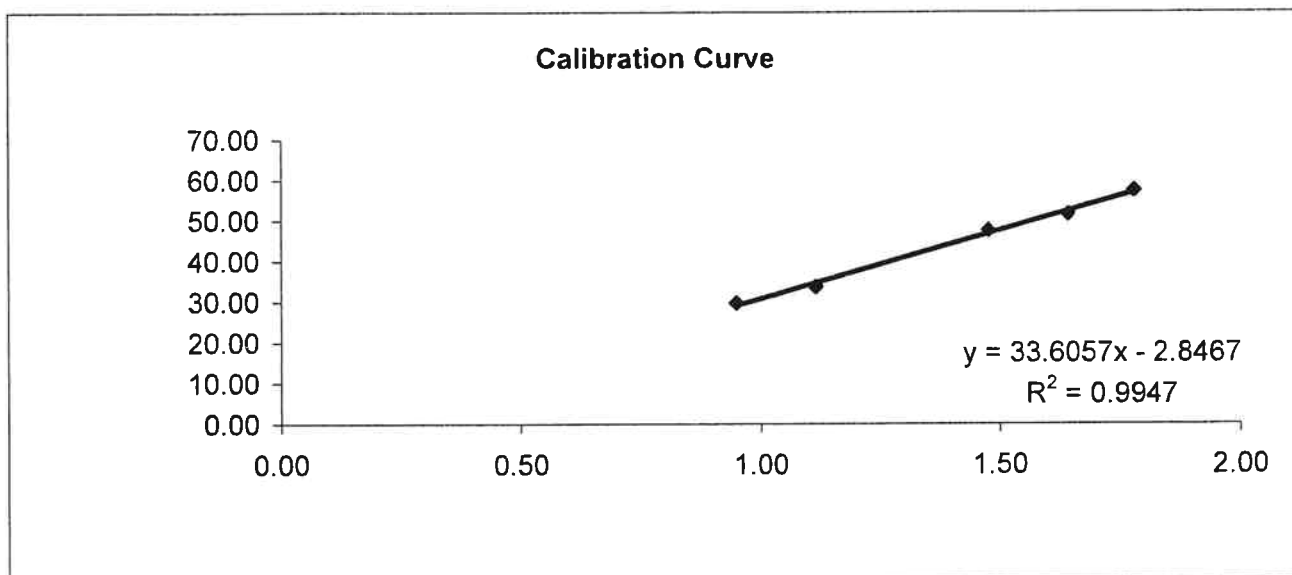
Calibration date	24-Aug-06	Barometric pressure	755 mm Hg
Calibration due date	23-Oct-06	Temperature (°C)	29 °C
Sampler location	WA7 - Sea Crest Villa (Phase 4 Blk 12)	Temperature (K)	302 K
Sampler model	TE-5170	P _{std}	760 mm Hg
Sampler serial number	0517	T _{std}	298 K
Calibrator model		GMW-2535	
Calibrator serial number		1378	
Slope of the standard curve, m _s		2.00216	
Intercept of the standard curve, b _s		-0.02053

Resistance Plate No.	Manometer Reading (inch H ₂ O)	Flow Recorder Reading (CFM)	Calculated Q _{std} (m ³ /min)	Continuous Flow Recorder Reading IC (CFM)
5	3.60	30.00	0.95	29.70
7	5.00	34.00	1.12	33.66
10	8.80	48.00	1.48	47.52
13	10.90	52.00	1.64	51.48
18	12.80	58.00	1.78	57.42

Sampler slope (m) : **33.6057**
 Sampler intercept (b) : **-2.8467**
 Correlation coefficient (R²) : **0.9947**

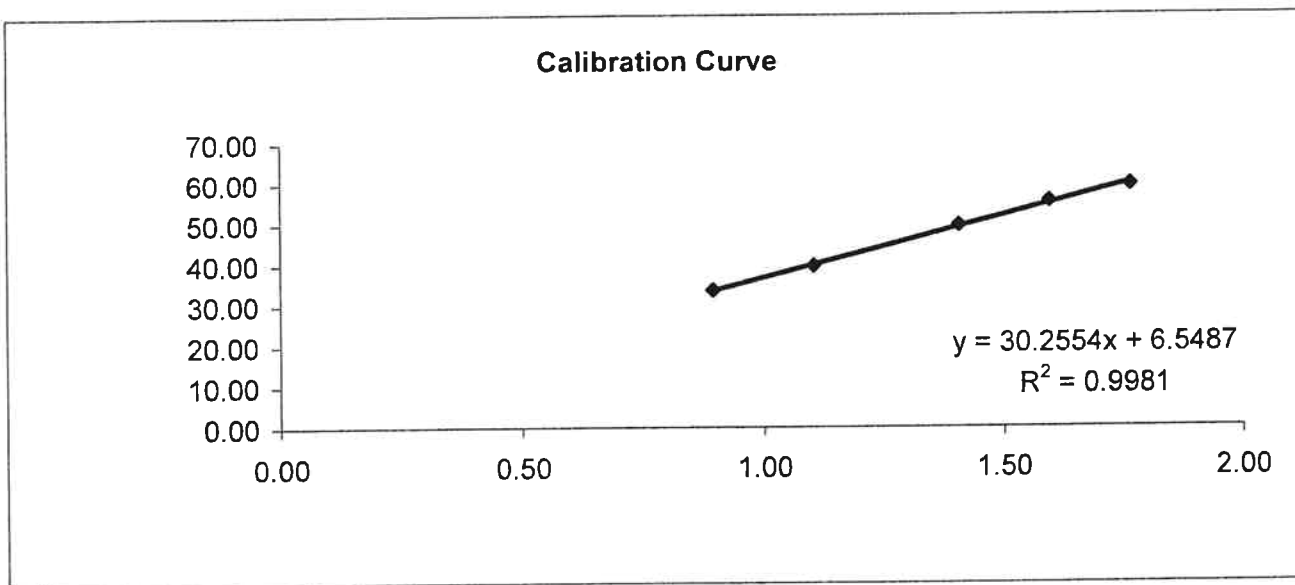
Calibration date	24-Aug-06	Barometric pressure	755 mm Hg
Calibration due date	23-Oct-06	Temperature (°C)	29 °C
Sampler location	WA8 - Sea Crest Villa (Phase 3 Block 8)	Temperature (K)	302 K
Sampler model	TE-5170	P _{std}	760 mm Hg
Sampler serial number	0526	T _{std}	298 K
Calibrator model	GMW-2535		
Calibrator serial number	1378		
Slope of the standard curve, m _s	2.00216		
Intercept of the standard curve, b _s	-0.02053

Resistance Plate No.	Manometer Reading (inch H ₂ O)	Flow Recorder Reading (CFM)	Calculated Q _{std} (m ³ /min)	Continuous Flow Recorder Reading IC (CFM)
5	3.20	34.00	0.89	33.66
7	4.90	40.00	1.10	39.60
10	8.00	50.00	1.41	49.50
13	10.30	56.00	1.60	55.44
18	12.60	60.00	1.77	59.40

Sampler slope (m) : **30.2554**
 Sampler intercept (b) : **6.5487**
 Correlation coefficient (R²) : **0.9981**

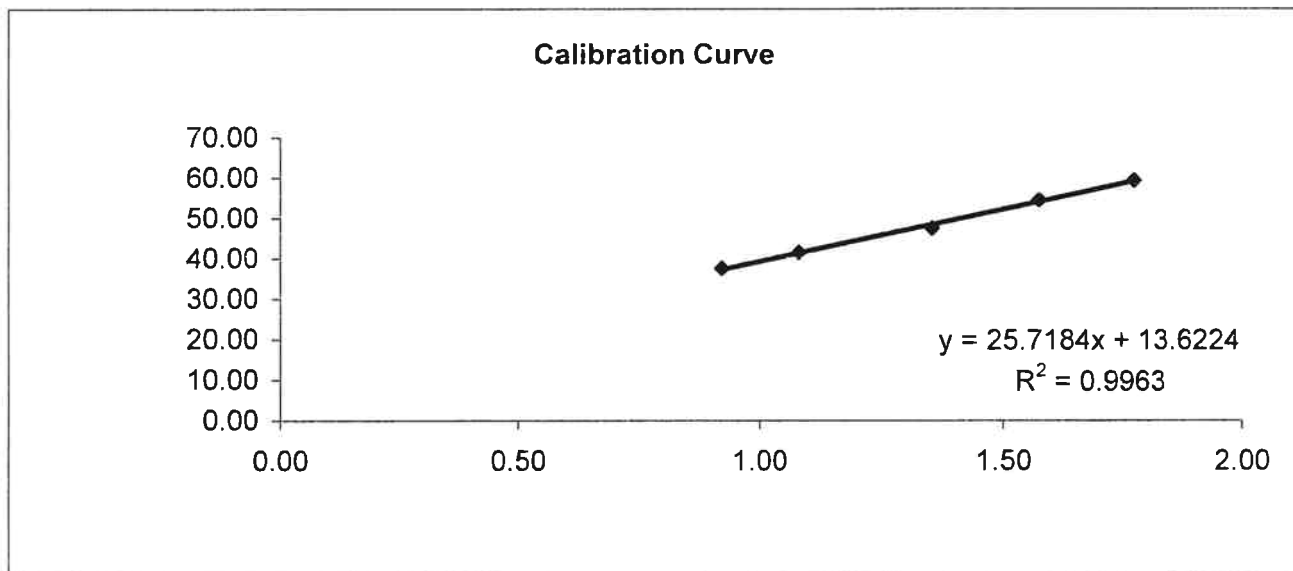
Calibration date	24-Aug-06	Barometric pressure	755 mm Hg
Calibration due date	23-Oct-06	Temperature (°C)	29 °C
Sampler location	WA9 - Sea Crest Villa (Phase 2 Blk 6)	Temperature (K)	302 K
Sampler model	TE-5170	P _{std}	760 mm Hg
Sampler serial number	0523	T _{std}	298 K
Calibrator model	GMW-2535		
Calibrator serial number	1378		
Slope of the standard curve, m _s	2.00216		
Intercept of the standard curve, b _s	-0.02053

Resistance Plate No.	Manometer Reading (inch H ₂ O)	Flow Recorder Reading (CFM)	Calculated Q _{std} (m ³ /min)	Continuous Flow Recorder Reading IC (CFM)
5	3.40	38.00	0.92	37.62
7	4.70	42.00	1.08	41.58
10	7.40	48.00	1.36	47.52
13	10.00	55.00	1.57	54.45
18	12.70	60.00	1.77	59.40

Sampler slope (m) : **25.7184**
 Sampler intercept (b) : **13.6224**
 Correlation coefficient (R²) : **0.9963**

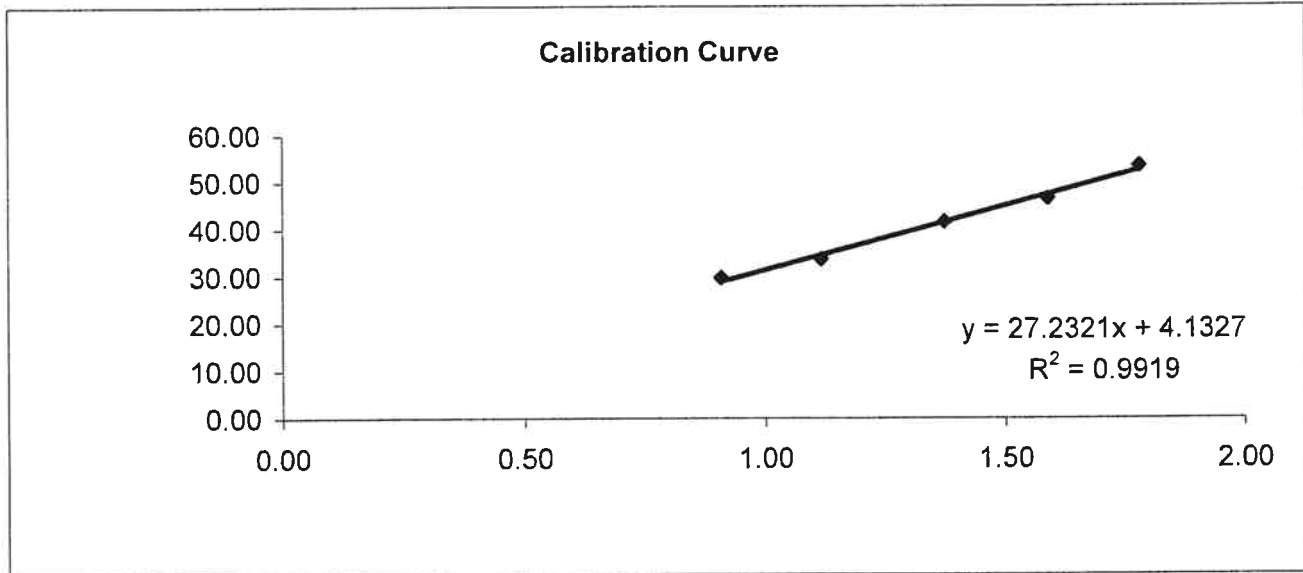
Calibration date	24-Aug-06	Barometric pressure	755 mm Hg
Calibration due date	23-Oct-06	Temperature (°C)	29 °C
Sampler location	WA10 - Sea Crest Villa (Phase 1 Blk 1)	Temperature (K)	302 K
Sampler model	TE-5170	P _{std}	760 mm Hg
Sampler serial number	0507	T _{std}	298 K
Calibrator model	GMW-2535		
Calibrator serial number	1378		
Slope of the standard curve, m _s	2.00216		
Intercept of the standard curve, b _s	-0.02053

Resistance Plate No.	Manometer Reading (inch H ₂ O)	Flow Recorder Reading (CFM)	Calculated Q _{std} (m ³ /min)	Continuous Flow Recorder Reading IC (CFM)
5	3.30	30.00	0.91	29.70
7	5.00	34.00	1.12	33.66
10	7.60	42.00	1.37	41.58
13	10.20	47.00	1.59	46.53
18	12.80	54.00	1.78	53.46

Sampler slope (m) : **27.2321**
 Sampler intercept (b) : **4.1327**
 Correlation coefficient (R²) : **0.9919**

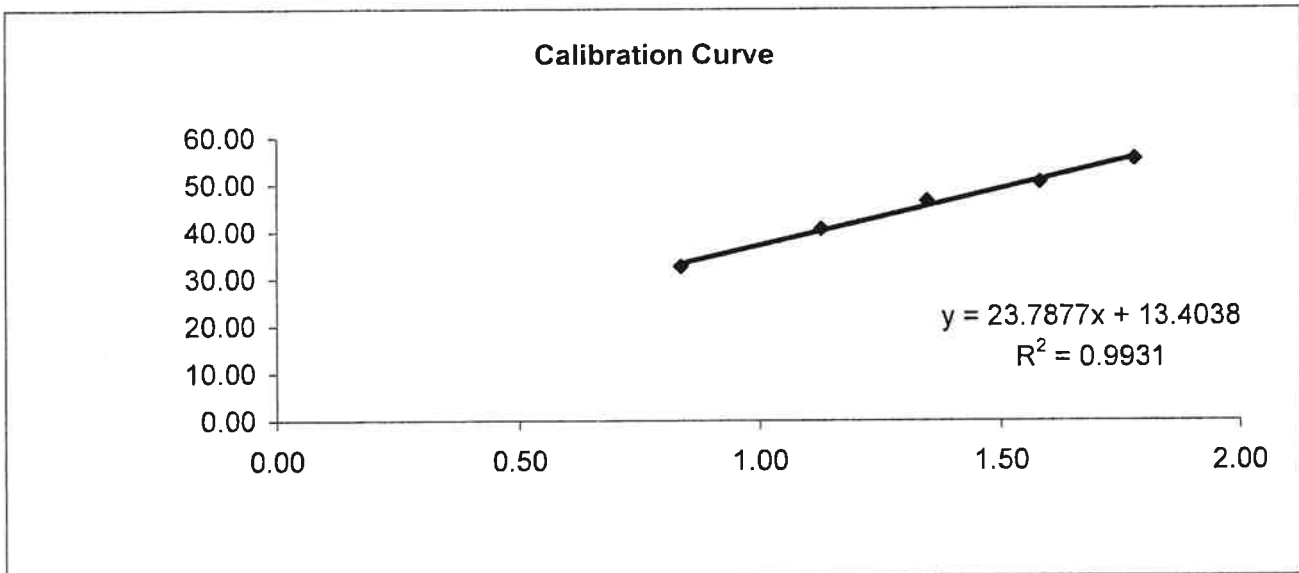
Calibrator model	GMW-2535
Calibrator serial number	1378
Slope of the standard curve, m _s	2.00216
Intercept of the standard curve, b _s	-0.02053

Resistance Plate No.	Manometer Reading (inch H ₂ O)	Flow Recorder Reading (CFM)	Calculated Q _{std} (m ³ /min)	Continuous Flow Recorder Reading IC (CFM)
5	2.80	33.00	0.84	32.67
7	5.10	41.00	1.13	40.59
10	7.30	47.00	1.35	46.53
13	10.10	51.00	1.58	50.49
18	12.80	56.00	1.78	55.44

Linear Regression

Sampler slope (m) : **23.7877**
 Sampler intercept (b) : **13.4038**
 Correlation coefficient (R²) : **0.9931**
