**Castle Peak Road  
Improvement Between  
Sham Tseng and Ka  
Loon Tsuen,  
Tsuen Wan  
West Contract No.  
HY/99/18**

Monthly Environmental  
Monitoring and Audit  
Report  
November 2003

**West Contract No. HY/99/18  
Castle Peak Road Improvement Between  
Sham Tseng and Ka Loon Tsuen, Tsuen Wan**

Monthly Environmental Monitoring and Audit Report - November 2003

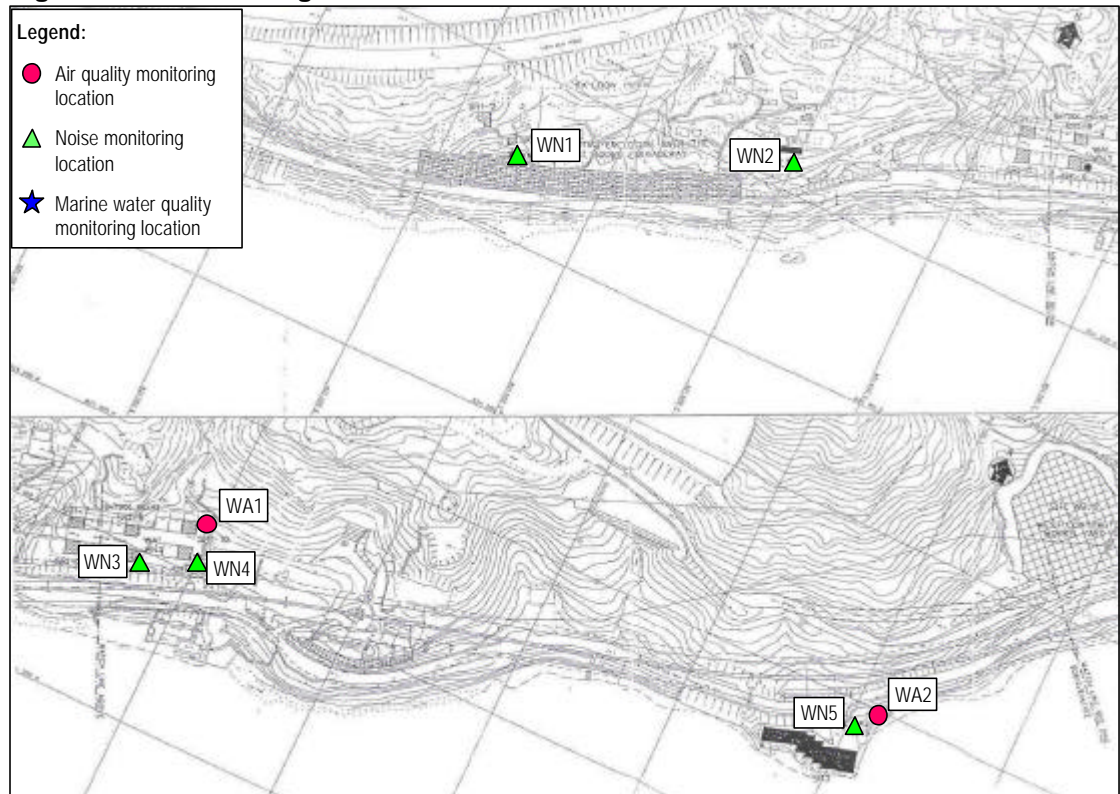
**Figure 3-1a Monitoring locations**

**Figure 3-1b Monitoring locations**

**Figure 3-1c Monitoring locations**

**Figure 3-1d Monitoring locations**

**Figure 3-1e Monitoring locations**

A total of eleven locations had been specified for the air quality monitoring and they are given in Table 3-2 and presented in Figures 3-1a to 3-1d.

A total of sixteen noise monitoring locations had been specified. They are given in Table 3-4 and presented in Figures 3-1a to 3-1d. The measurements were taken at a position 1m from the exterior of building façade and at a position of 1.2m above ground.

A total of sixteen locations, 9 for impact and 7 for control were originally selected for marine water quality monitoring and the locations are given in Table 3-5a and presented in Figure 3-1b to 3-1e.

The new marine water quality monitoring programme was commenced on 12 February 2003 as agreed by the IC(E) and EPD. A total of twelve locations, 8 for impact and 4 for control were selected for the new marine water quality monitoring programme and the locations are given in Table 3-5b and presented in Figure 3-1b to Figure 3-1e.

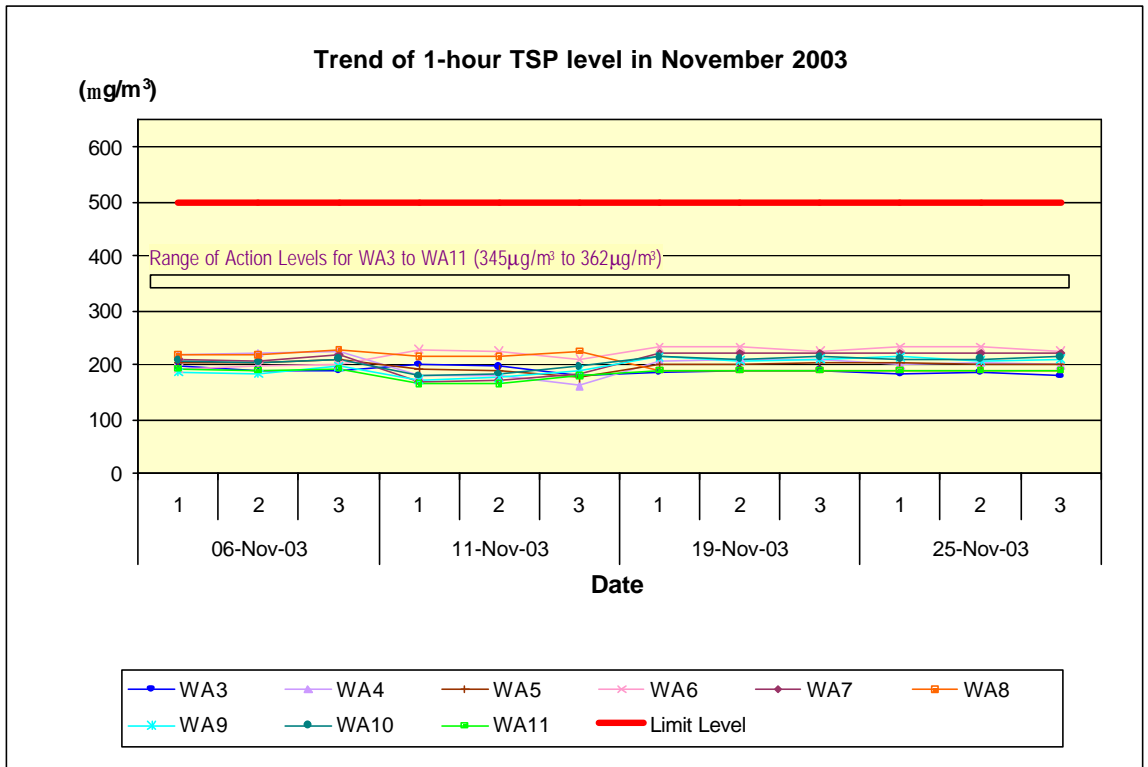
**Figure 4-1 Graphical presentation of 1-hour TSP levels for November 2003**

The detailed monitoring results of 1-hour TSP are given in Appendix F and the 1-hour TSP level at each monitoring location are plotted and presented in Figure 4-1.

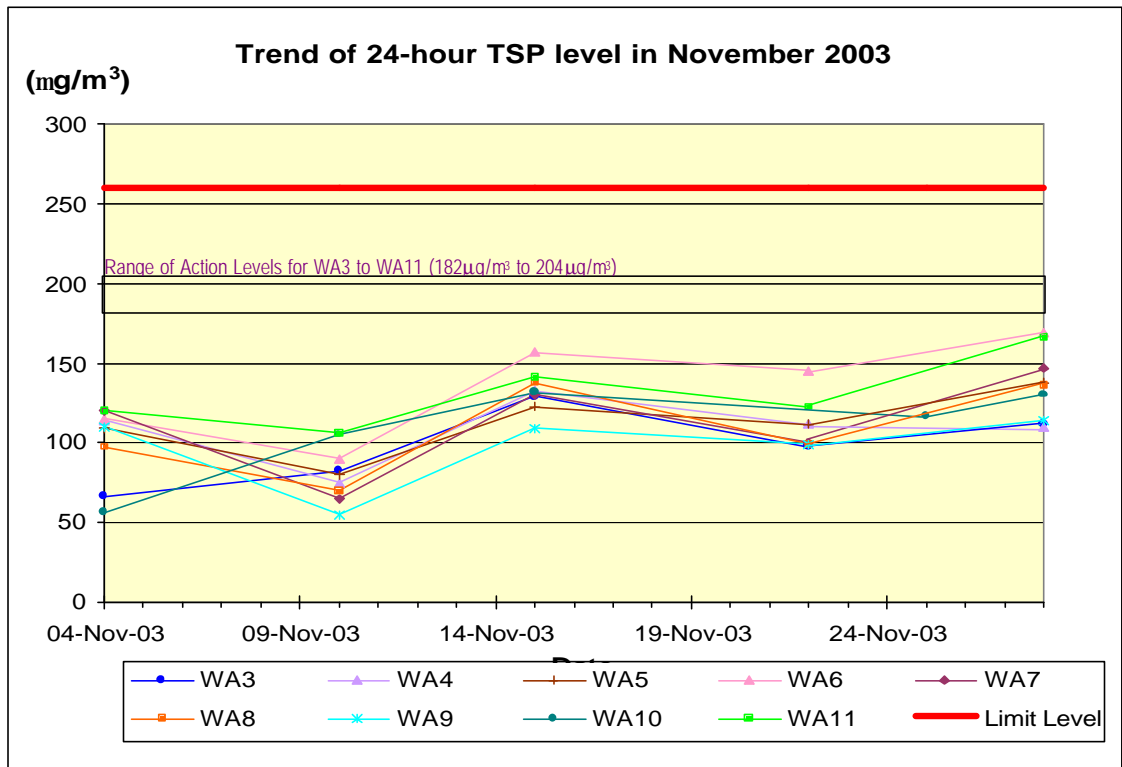
**Figure 4-2 Graphical presentation of 24-hour TSP levels for November 2003**

A total of 5 sets of 24-hour TSP measurement had been taken on 4<sup>th</sup>, 10<sup>th</sup>, 15<sup>th</sup>, 22<sup>nd</sup> (except for WA10 due to power shortage), 25<sup>th</sup> (for WA 10 only) and 28<sup>th</sup> November 2003.

The detailed monitoring results of 24-hour TSP are given in Appendix G and the 24-hour TSP level at each monitoring location are plotted and presented in Figure 4-2.
