**Castle Peak Road
Improvement Between
Sham Tseng and Ka
Loon Tsuen,
Tsuen Wan
West Contract No.
HY/99/18**

Monthly Environmental
Monitoring and Audit
Report
January 2004

Monthly Environmental Monitoring and Audit Report – January 2004

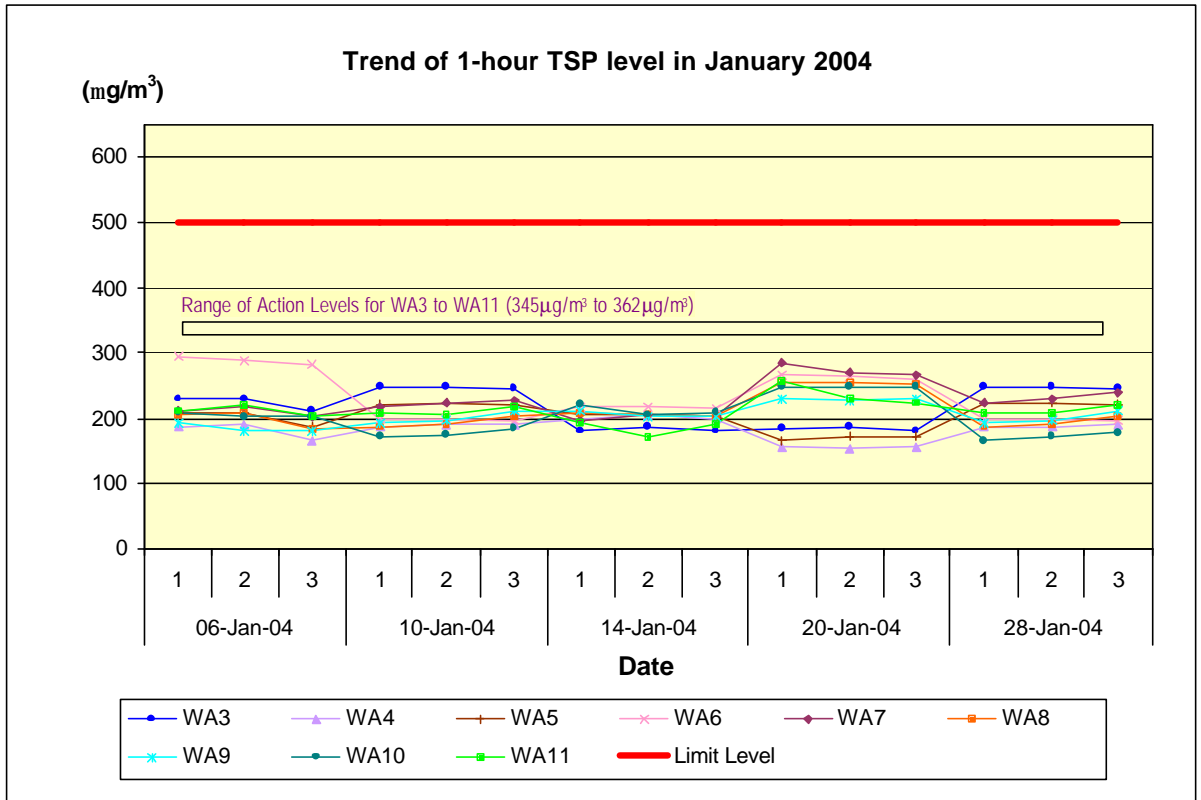
Figure 4-1 Graphical presentation of 1-hour TSP levels for January 2004

The detailed monitoring results of 1-hour TSP are given in Appendix F and the 1-hour TSP level at each monitoring location are plotted and presented in Figure 4-1.

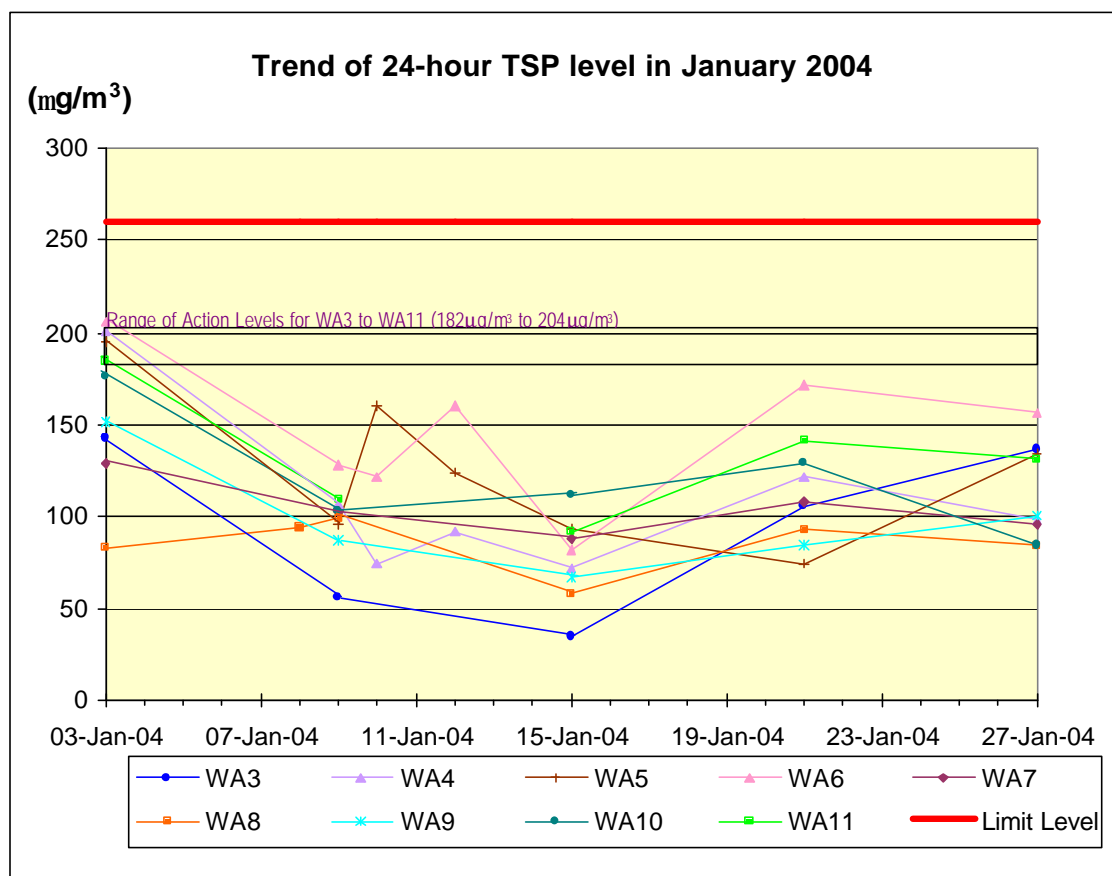
Figure 4-2 Graphical presentation of 24-hour TSP levels for January 2004

The detailed monitoring results of 24-hour TSP are given in Appendix G and the 24-hour TSP level at each monitoring location are plotted and presented in Figure 4-2.

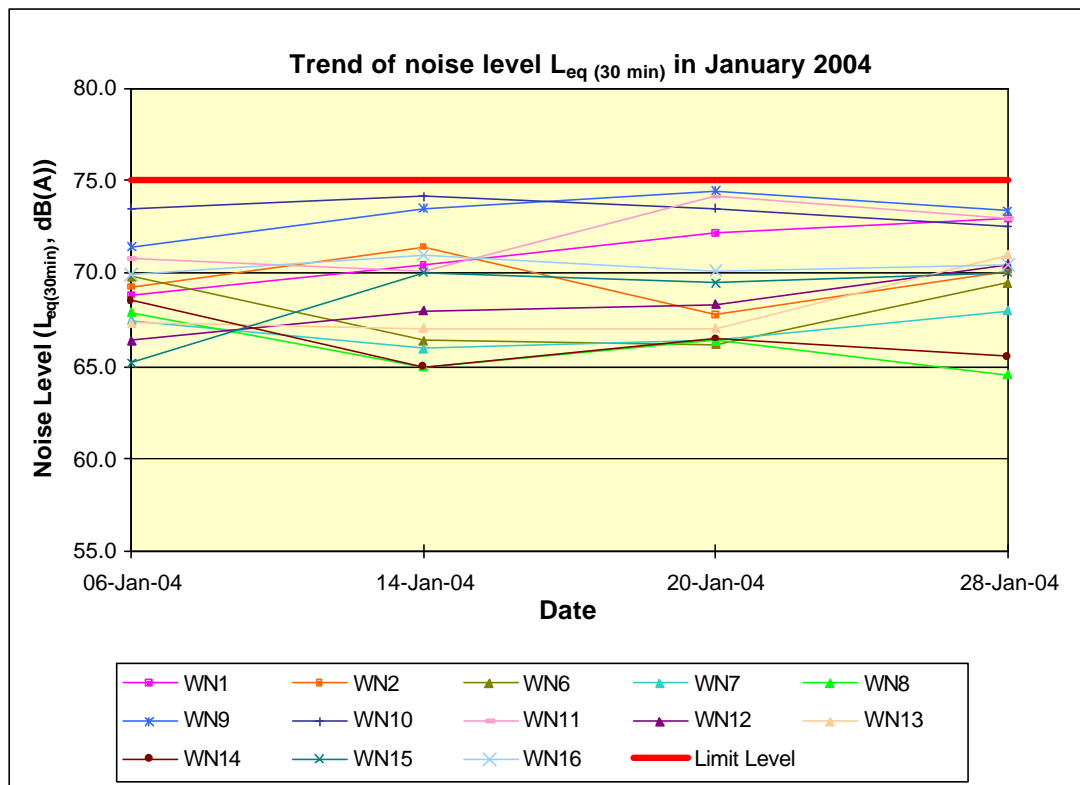
Figure 5-1 Graphical presentation of daytime noise levels for January 2004

The noise levels at each monitoring location are plotted and presented in Figure 5-1.
