**Castle Peak Road
Improvement Between
Sham Tseng and Ka
Loon Tsuen,
Tsuen Wan
West Contract No.
HY/99/18**

Monthly Environmental
Monitoring and Audit
Report
February 2004

Monthly Environmental Monitoring and Audit Report – February 2004

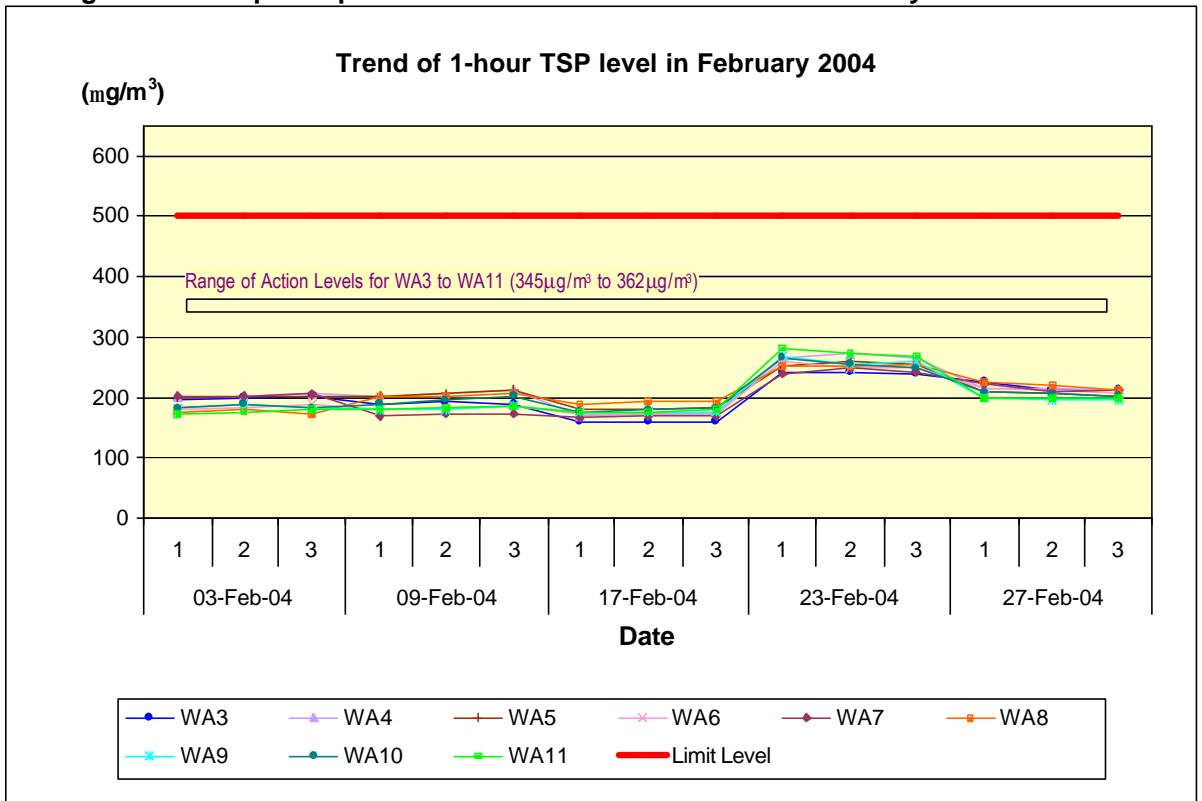
Figure 4-1 Graphical presentation of 1-hour TSP levels for February 2004

The detailed monitoring results of 1-hour TSP are given in Appendix F and the 1-hour TSP level at each monitoring location are plotted and presented in Figure 4-1.

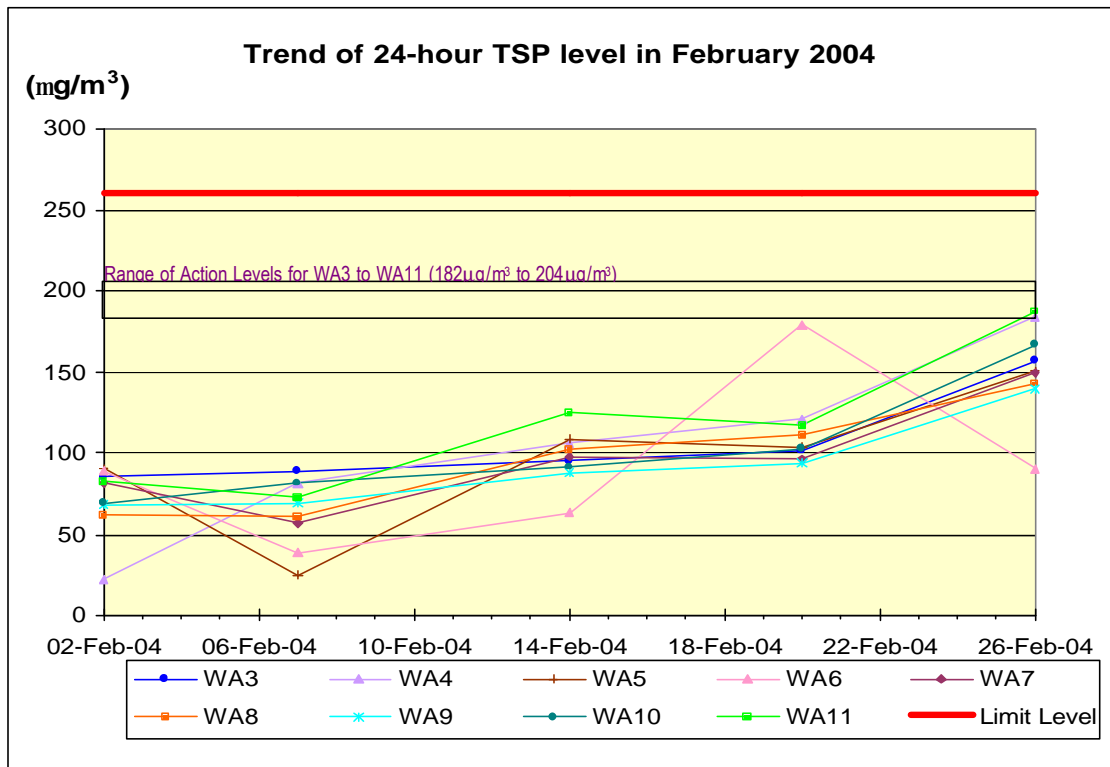
Figure 4-2 Graphical presentation of 24-hour TSP levels for February 2004

A total of 5 sets of 24-hour TSP measurement had been taken on 2nd, 7th, 14th, 20th and 26th February 2004.

The detailed monitoring results of 24-hour TSP are given in Appendix G and the 24-hour TSP level at each monitoring location are plotted and presented in Figure 4-2.

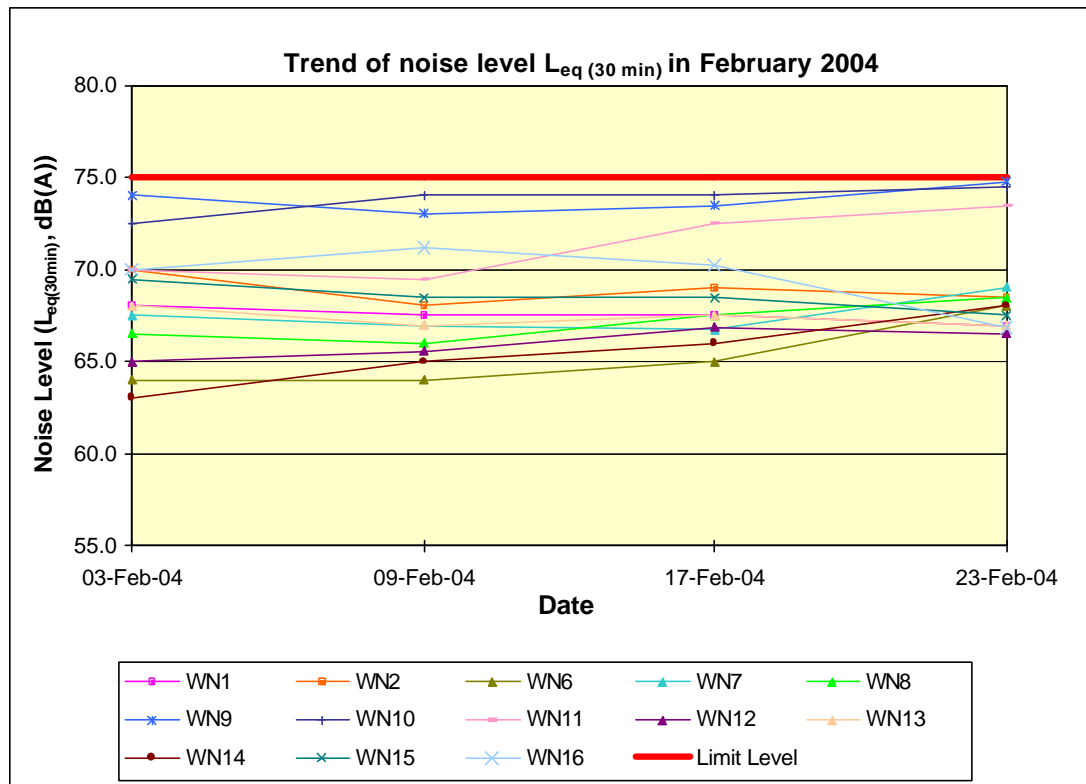
Figure 5-1 Graphical presentation of daytime noise levels for February 2004

The noise levels at each monitoring location are plotted and presented in Figure 5-1.
