**Castle Peak Road
Improvement Between
Sham Tseng and Ka
Loon Tsuen,
Tsuen Wan
West Contract No.
HY/99/18**

Monthly Environmental
Monitoring and Audit
Report
March 2004

Monthly Environmental Monitoring and Audit Report – March 2004

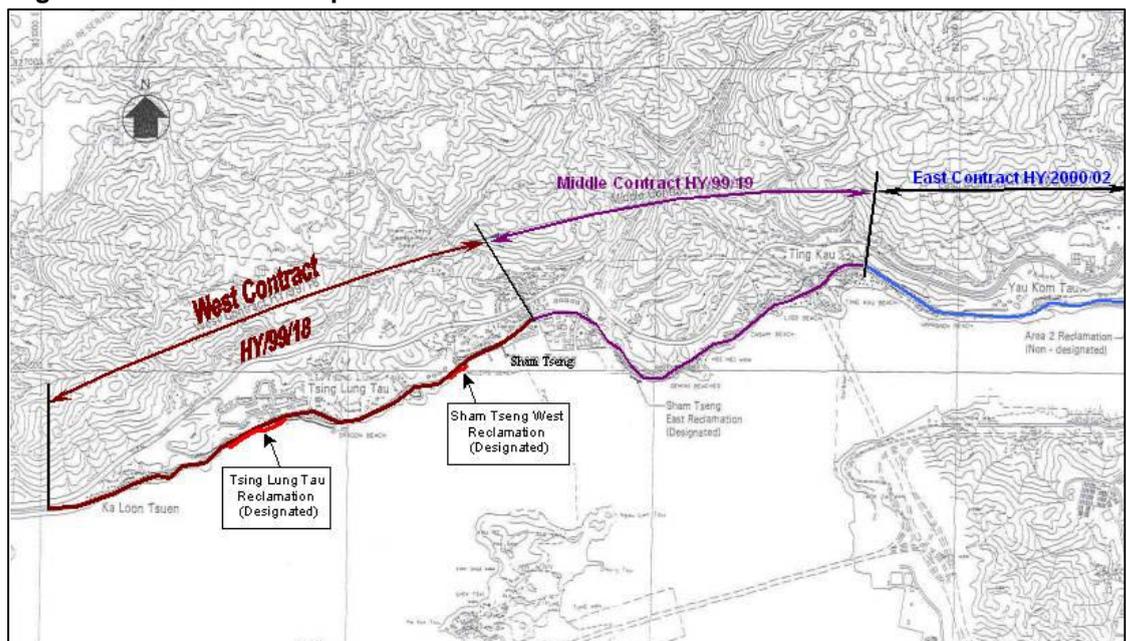
Figure 1-1 Site location plan

The Castle Peak Road improvements works consists of upgrading the existing Castle Peak Road to provide a dual two-lane carriageway of “Rural Road A” classification between Area 2, Tsuen Wan and Ka Loon Tsuen, and all associated utility, junction and pedestrian facilities. The Castle Peak Improvement project is divided into three contracts. This Environmental Monitoring and Audit (EM&A) exercise only concerns the West Contract No. HY/99/18 between Sham Tseng and Ka Loon Tsuen, Tsuen Wan. Figure 1-1 shows the site location plan and the detailed site layout plans are provided in Appendix A.

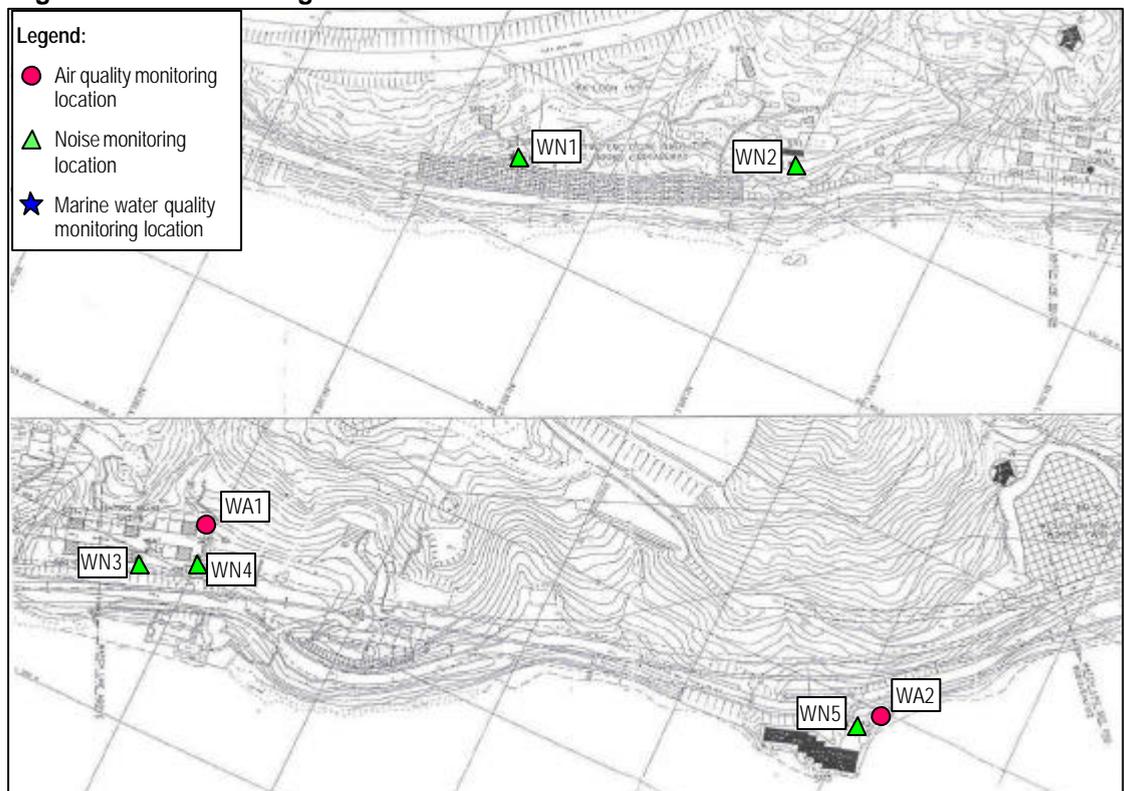
Figure 3-1a Monitoring locations

A total of eleven locations had been specified for the air quality monitoring and they are given in Table 3-2 and presented in Figures 3-1a to 3-1d.

A total of sixteen noise monitoring locations had been specified. They are given in Table 3-4 and presented in Figures 3-1a to 3-1d. The measurements were taken at a position 1m from the exterior of building façade and at a position of 1.2m above ground.

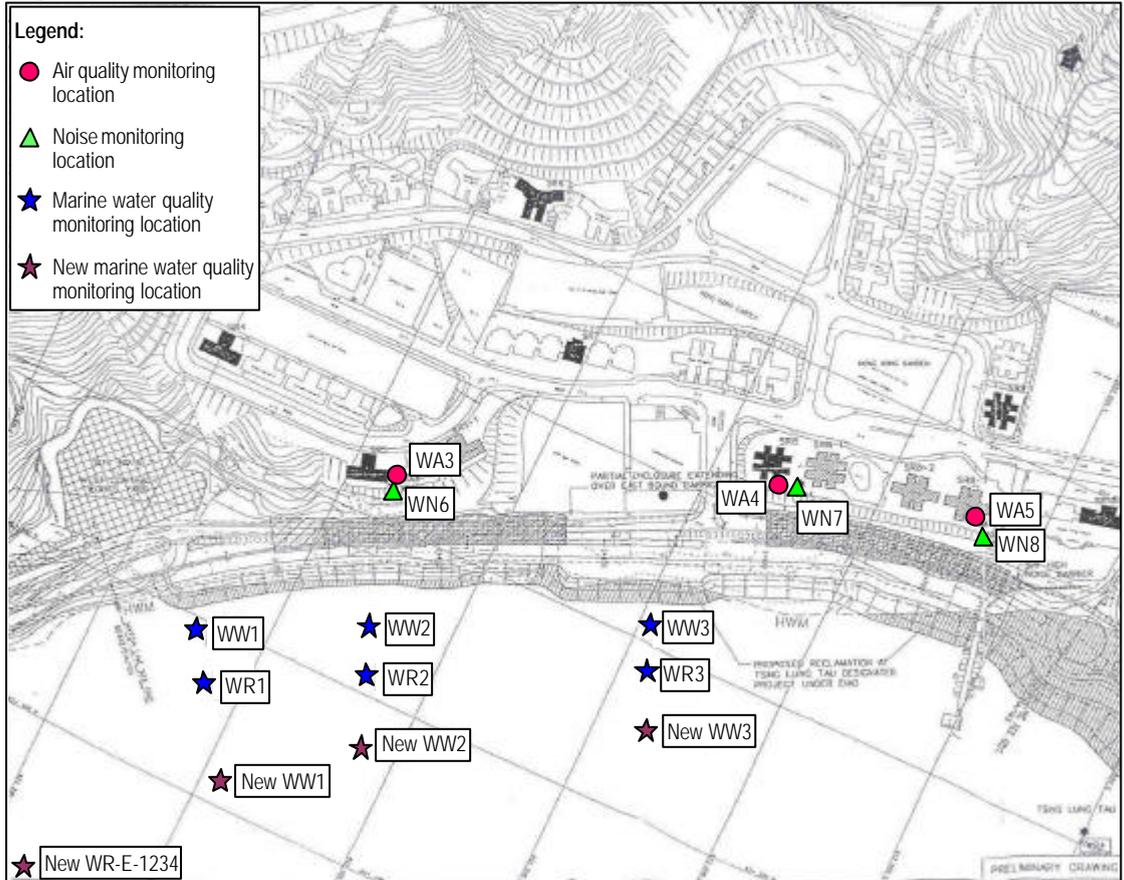
Figure 3-1b Monitoring locations

A total of sixteen locations, 9 for impact and 7 for control were originally selected for marine water quality monitoring and the locations are given in Table 3-5a and presented in Figure 3-1b to 3-1e.

The new marine water quality monitoring programme, was commenced on 12 February 2003 and suspended on 10 October 2003, as agreed by the IC(E) and EPD. A total of twelve locations, 8 for impact and 4 for control were selected for the new marine water quality monitoring programme and the locations are given in Table 3-5b and presented in Figure 3-1b to Figure 3-1e.

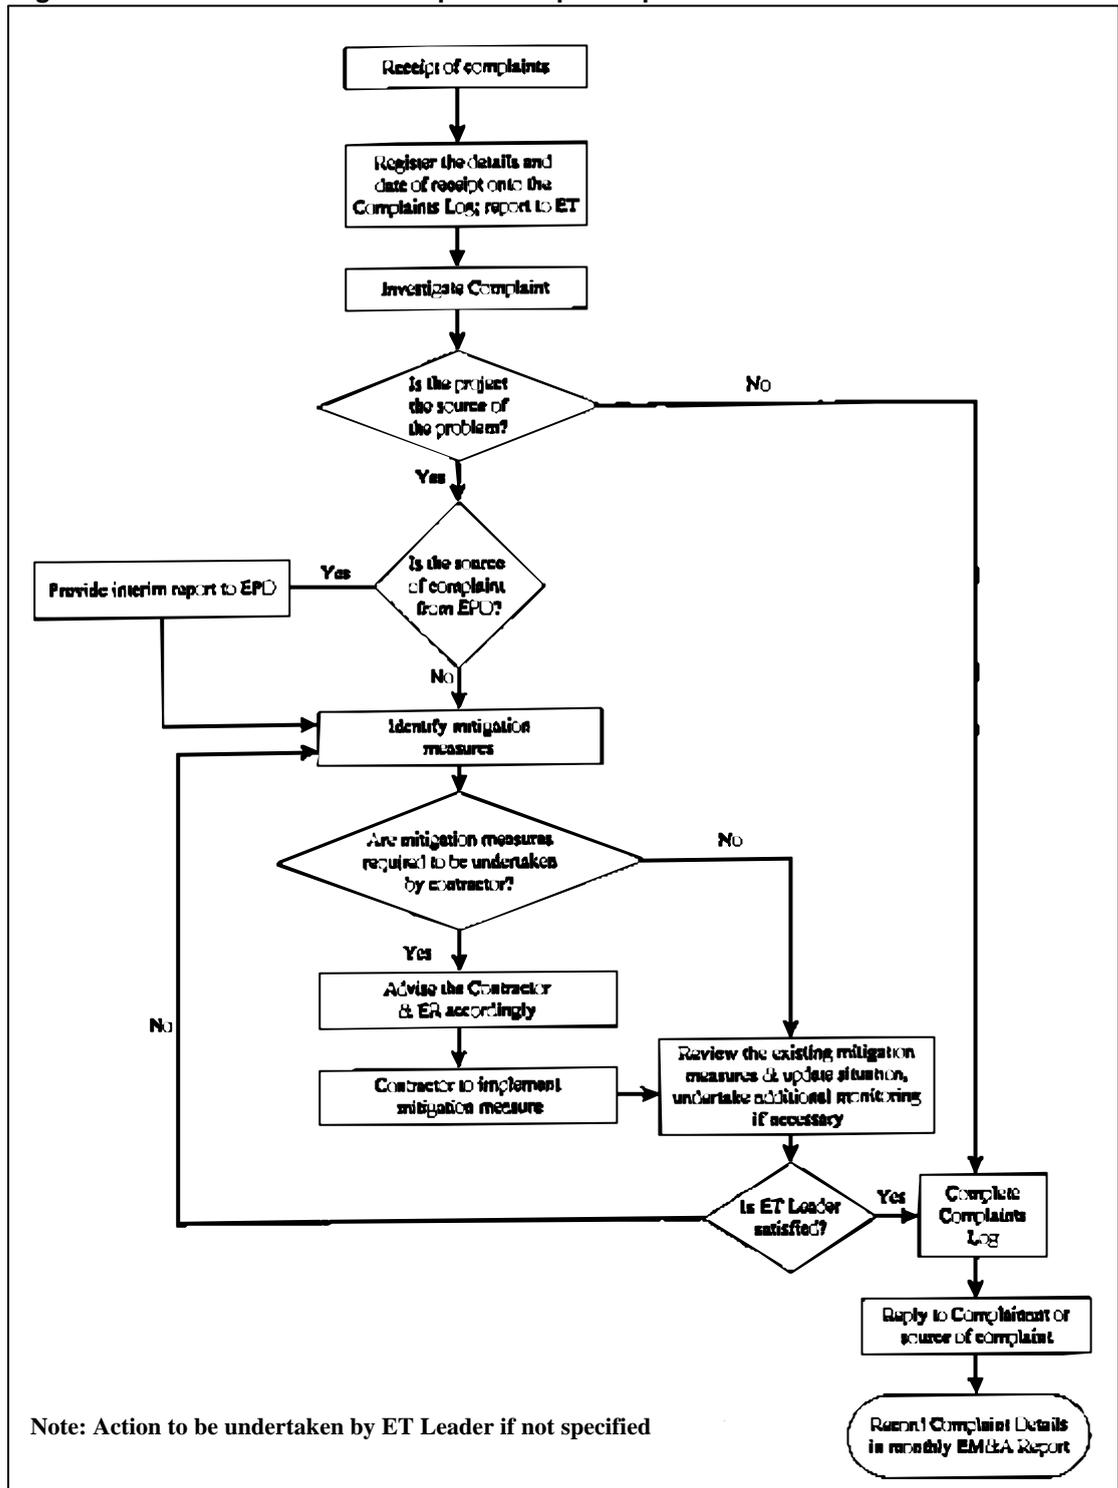
Figure 3-2 Flow chart of the complaint response procedure

A flow chart of the complaint response procedures is shown in Figure 3-2 for reference.

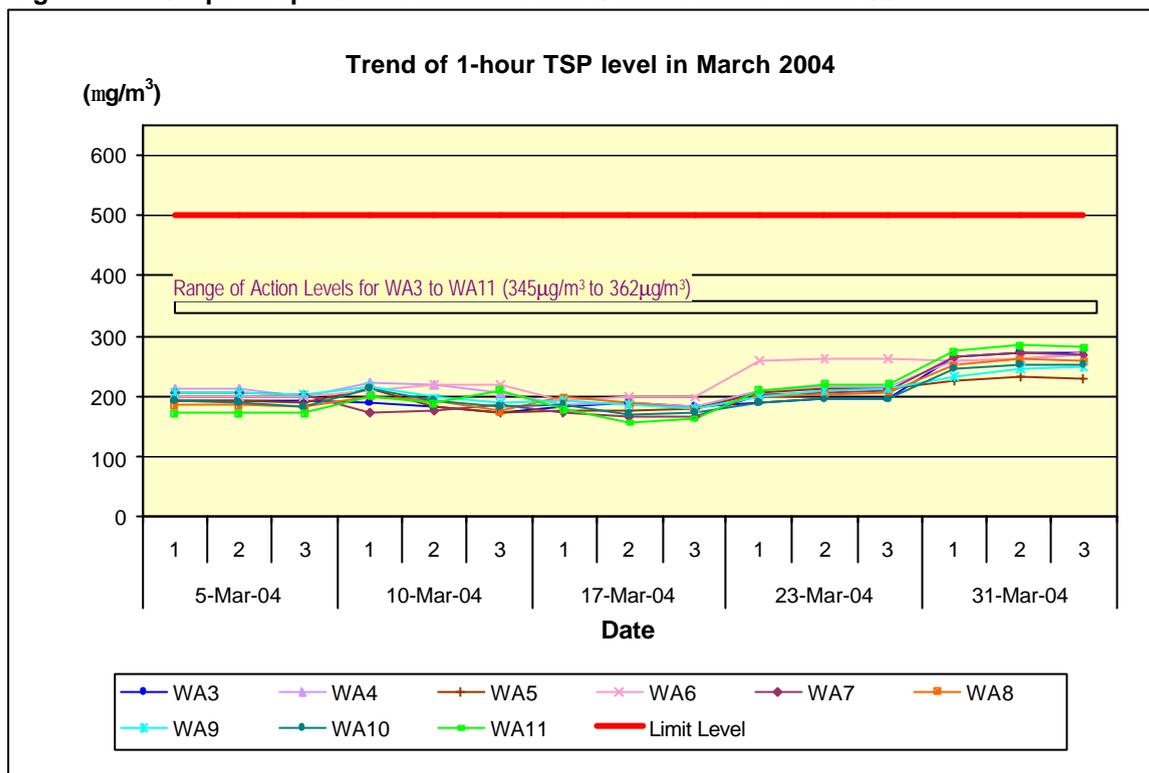
Figure 4-1 Graphical presentation of 1-hour TSP levels for March 2004

The detailed monitoring results of 1-hour TSP are given in Appendix F and the 1-hour TSP level at each monitoring location are plotted and presented in Figure 4-1.

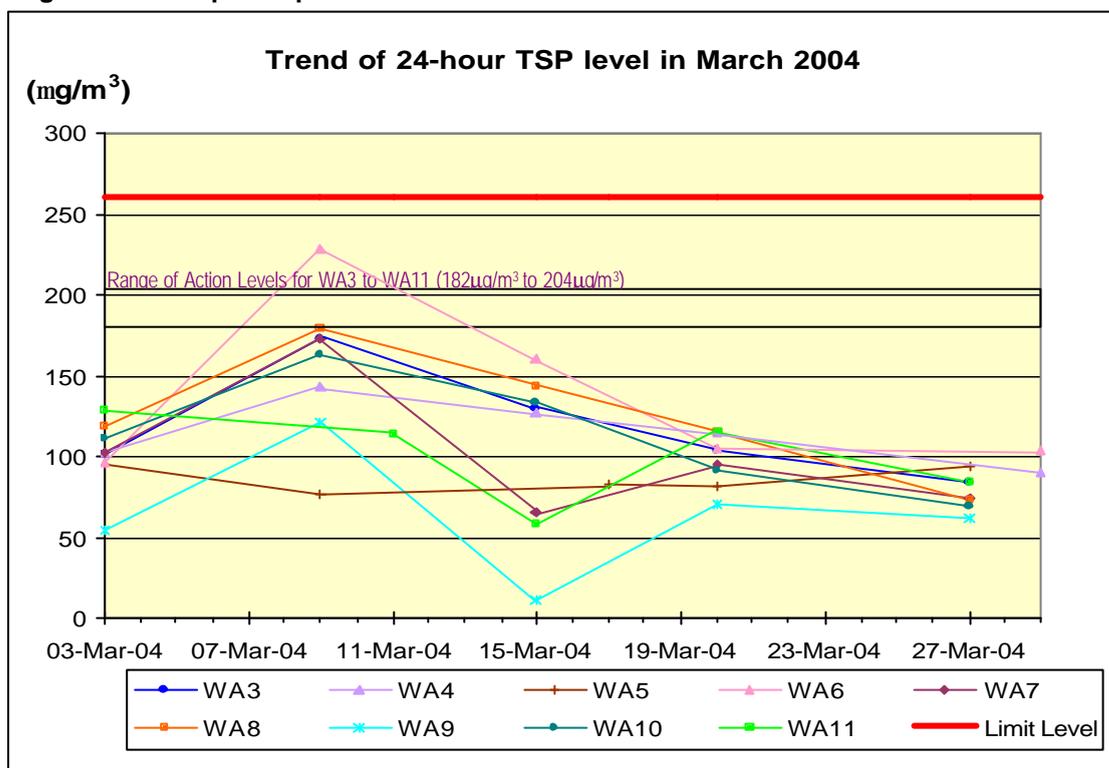
Figure 4-2 Graphical presentation of 24-hour TSP levels for March 2004

A total of 5 sets of 24-hour TSP measurement had been taken on 3, 9 (except for WA11 due to power shortage), 11 (for WA11 only), 15 (except for WA5 due to power shortage), 17 (for WA5 only), 20, 27 (except for WA4 and WA6 due to exhaust of carbon brush) and 29(WA4 and WA6 only) March 2004.

The detailed monitoring results of 24-hour TSP are given in Appendix G and the 24-hour TSP level at each monitoring location are plotted and presented in Figure 4-2.

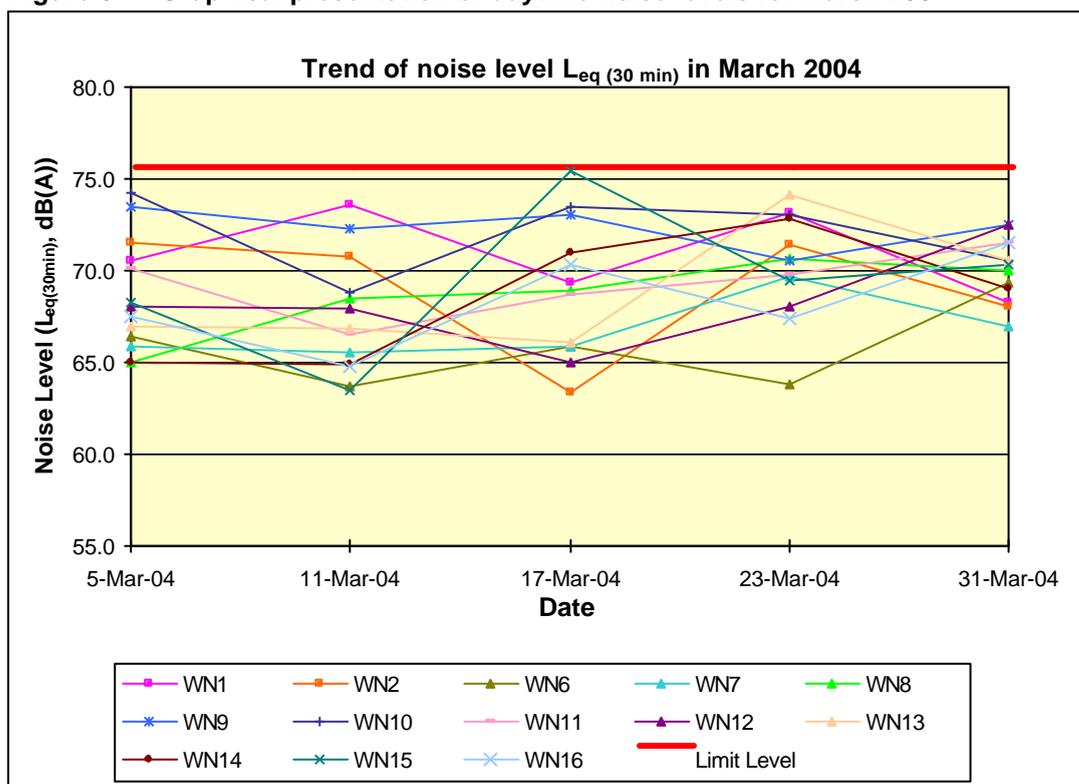
Figure 5-1 Graphical presentation of daytime noise levels for March 2004

The noise levels at each monitoring location are plotted and presented in Figure 5-1.
