**Castle Peak Road
Improvement Between
Sham Tseng and Ka
Loon Tsuen,
Tsuen Wan
West Contract No.
HY/99/18**

Monthly Environmental
Monitoring and Audit
Report
April 2004

Monthly Environmental Monitoring and Audit Report – April 2004

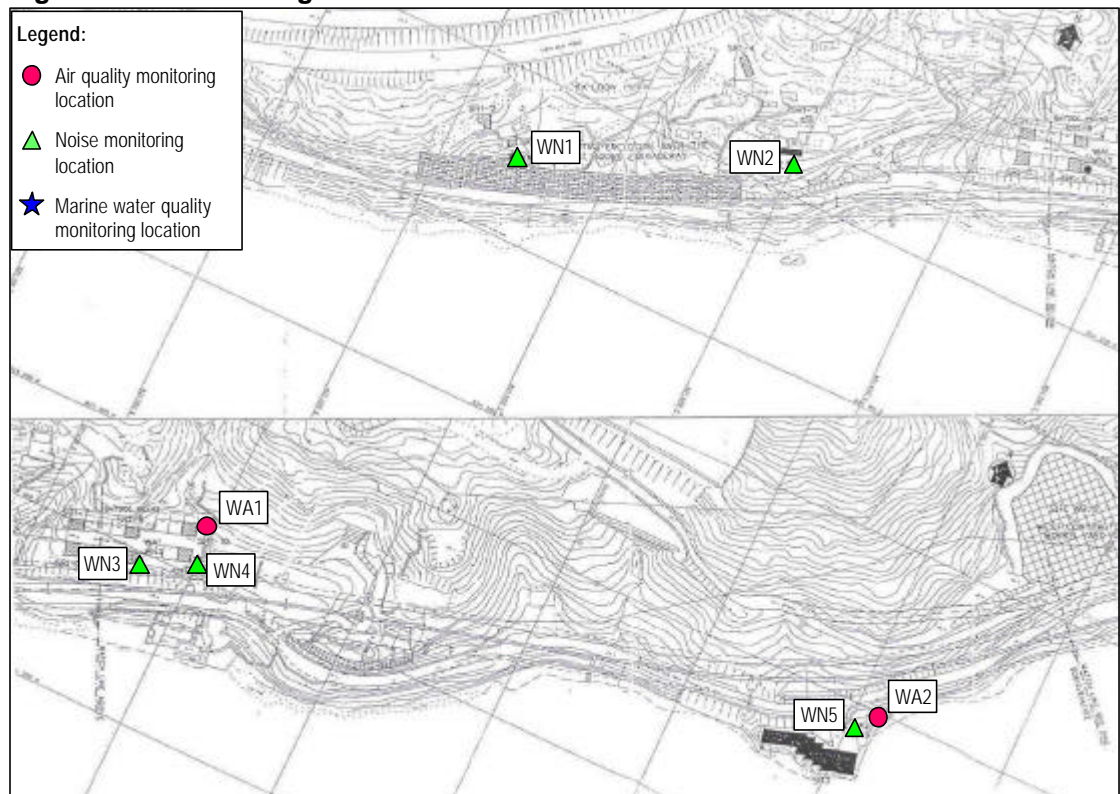
Figure 3-1a Monitoring locations

A total of eleven locations had been specified for the air quality monitoring and they are given in Table 3-2 and presented in Figures 3-1a to 3-1d.

A total of sixteen noise monitoring locations had been specified. They are given in Table 3-4 and presented in Figures 3-1a to 3-1d. The measurements were taken at a position 1m from the exterior of building façade and at a position of 1.2m above ground.

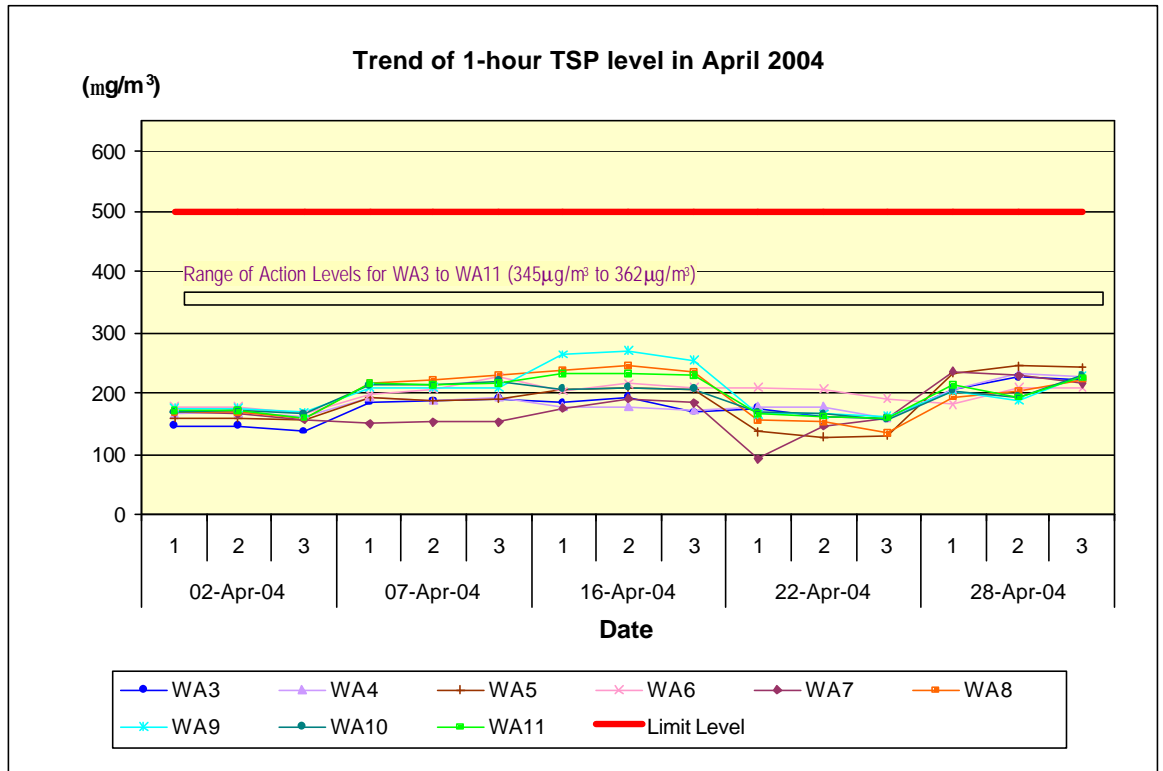
Figure 4-1 Graphical presentation of 1-hour TSP levels for April 2004

The detailed monitoring results of 1-hour TSP are given in Appendix F and the 1-hour TSP level at each monitoring location are plotted and presented in Figure 4-1.

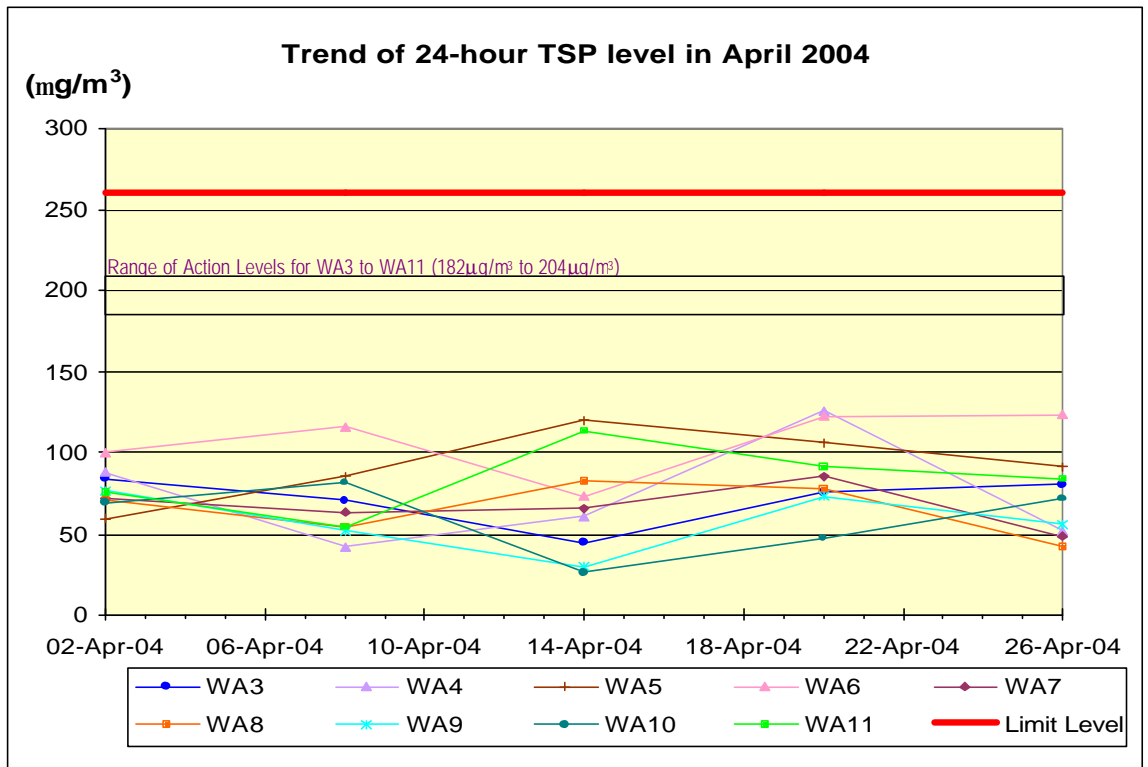
Figure 4-2 Graphical presentation of 24-hour TSP levels for April 2004

A total of 5 sets of 24-hour TSP measurement had been taken on 2, 8, 14, 20 and 26 April 2004.

The detailed monitoring results of 24-hour TSP are given in Appendix G and the 24-hour TSP level at each monitoring location are plotted and presented in Figure 4-2.

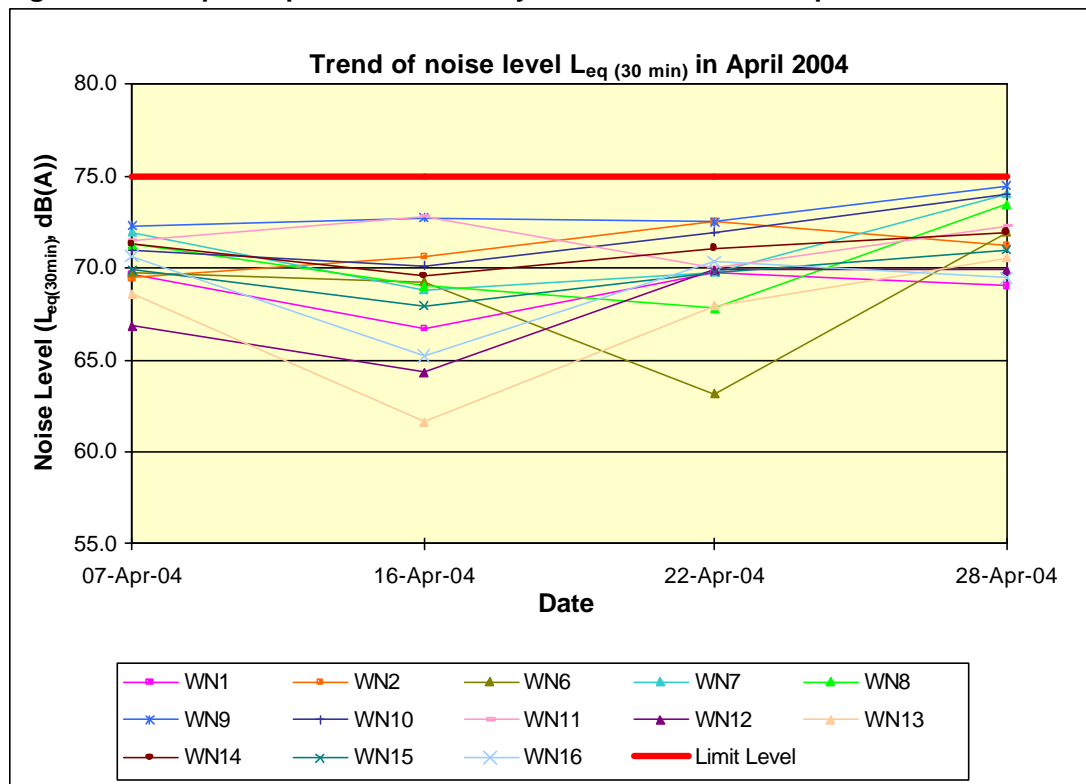
Figure 5-1 Graphical presentation of daytime noise levels for April 2004

The noise levels at each monitoring location are plotted and presented in Figure 5-1.
