Castle Peak Road Improvement Between Sham Tseng and Ka Loon Tsuen, Tsuen Wan West Contract No. HY/99/18

Monthly Environmental Monitoring and Audit Report March 2005

Monthly Environmental Monitoring and Audit Report - March 2005

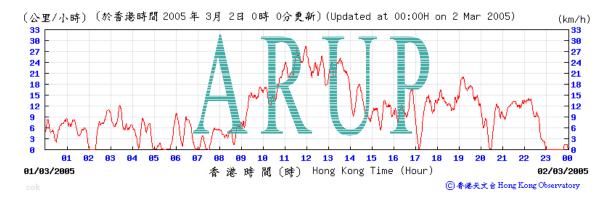
Wind Monitoring Data – Wind Speed during air quality monitoring in March 2005

Detailed wind monitoring data for the air quality monitoring period
