Castle Peak Road Improvement Between Sham Tseng and Ka Loon Tsuen, Tsuen Wan West Contract No. HY/99/18

Quarterly Environmental Monitoring and Audit Summary Report August 2003 to October 2003

Quarterly Environmental Monitoring and Audit Summary Report

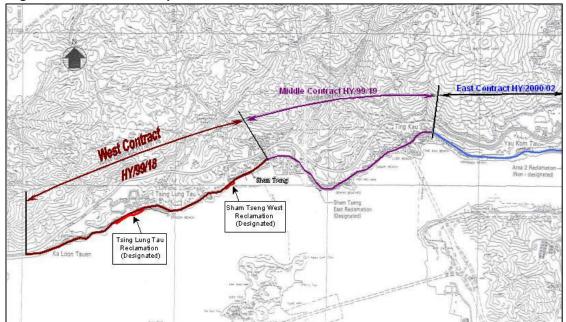
Figure 1-1 Site location plan

The Castle Peak Road improvements works consists of upgrading the existing Castle Peak Road to provide a dual two-lane carriageway of "Rural Road A" classification between Area 2, Tsuen Wan and Ka Loon Tsuen, and all associated utility, junction and pedestrian facilities. The Castle Peak Improvement project is divided into three contracts. This Environmental Monitoring and Audit (EM&A) exercise only concerns the West Contract No. HY/99/18 between Sham Tseng and Ka Loon Tsuen, Tsuen Wan. Figure 1-1 shows the site location plan.

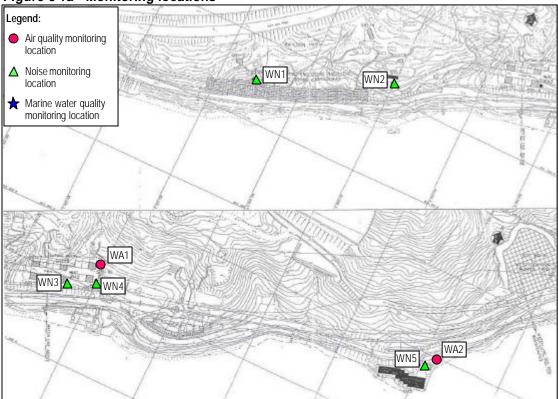
Figure 3-1a Monitoring locations

A total of eleven locations were specified for the air quality monitoring and they are given in Table 3-2 and presented in Figures 3-1a to 3-1d.

A total of sixteen noise monitoring locations were specified. They are given in Table 3-4 and presented in Figures 3-1a to 3-1d. The measurements shall be taken at a position 1m from the exterior of building façade and at a position of 1.2m above ground.

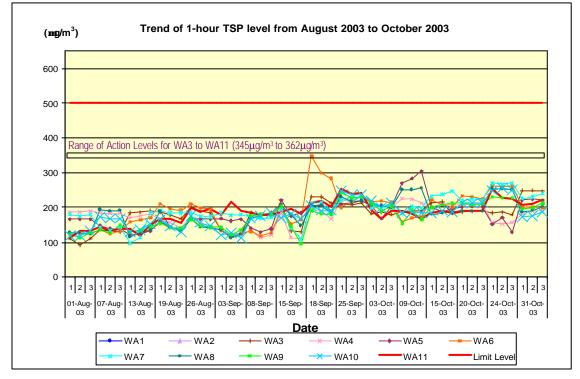
Figure 4-1 Trend of 1-hour TSP levels from August 2003 to October 2003

The trend of 1-hour TSP levels at each monitoring location are plotted and presented in Figure 4-1.

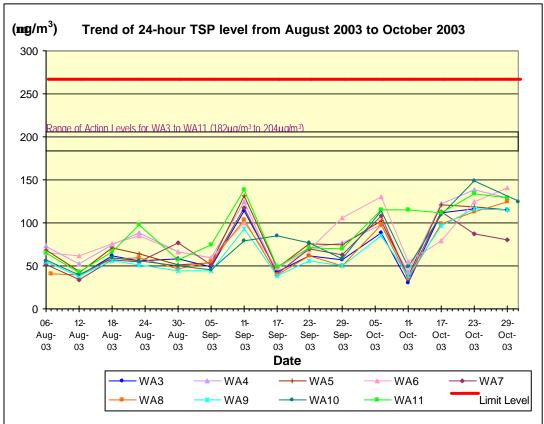
Figure 4-2 Trend of 24-hour TSP level from August 2003 to October 2003

The trend of 24-hour TSP levels at each monitoring location are plotted and presented in Figure 4-2.

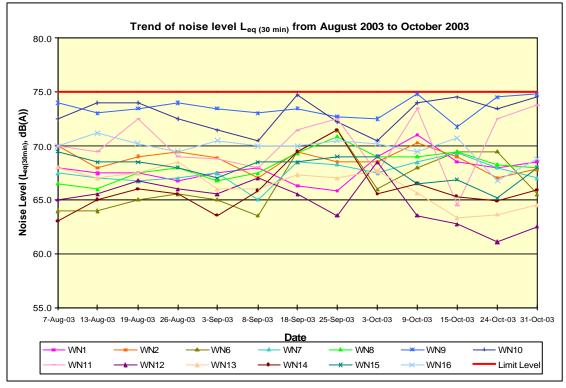
Figure 5-1 Trend of noise level from August 2003 to October 2003

The trend of the noise levels at each monitoring location are plotted and presented in Figure 5-1.

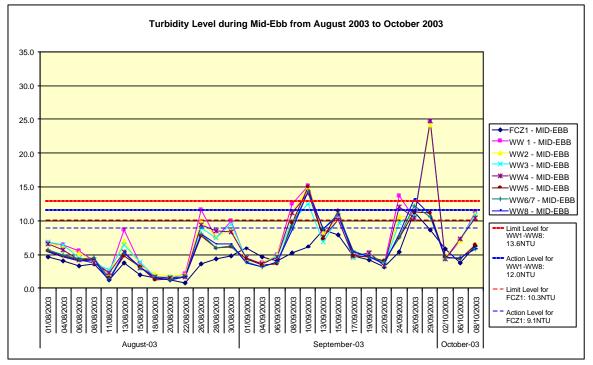
Figure 6-1 Turbidity levels during mid-ebb from August 2003 to October 2003

The monitoring results from August 2003 to October 2003 are plotted and presented in Figure 6-1 to Figure 6-8.

There were occasional "Reaching of Trigger Value" of Dissolved Oxygen (DO), Turbidity (Tby) and Suspended Solids (SS) of marine water quality monitoring in the reporting period. However, all "Reaching of Trigger Value" of DO, Tby and SS in the reporting period were caused by the natural variation of the marine water quality rather than by the construction activities.
