Contract No HY/2005/06
Castle Peak Road
Improvement – West of
Tsing Lung Tau

Final Environmental
Monitoring and Audit
Review Report

July 2009

Ove Arup & Partners Hong Kong Ltd

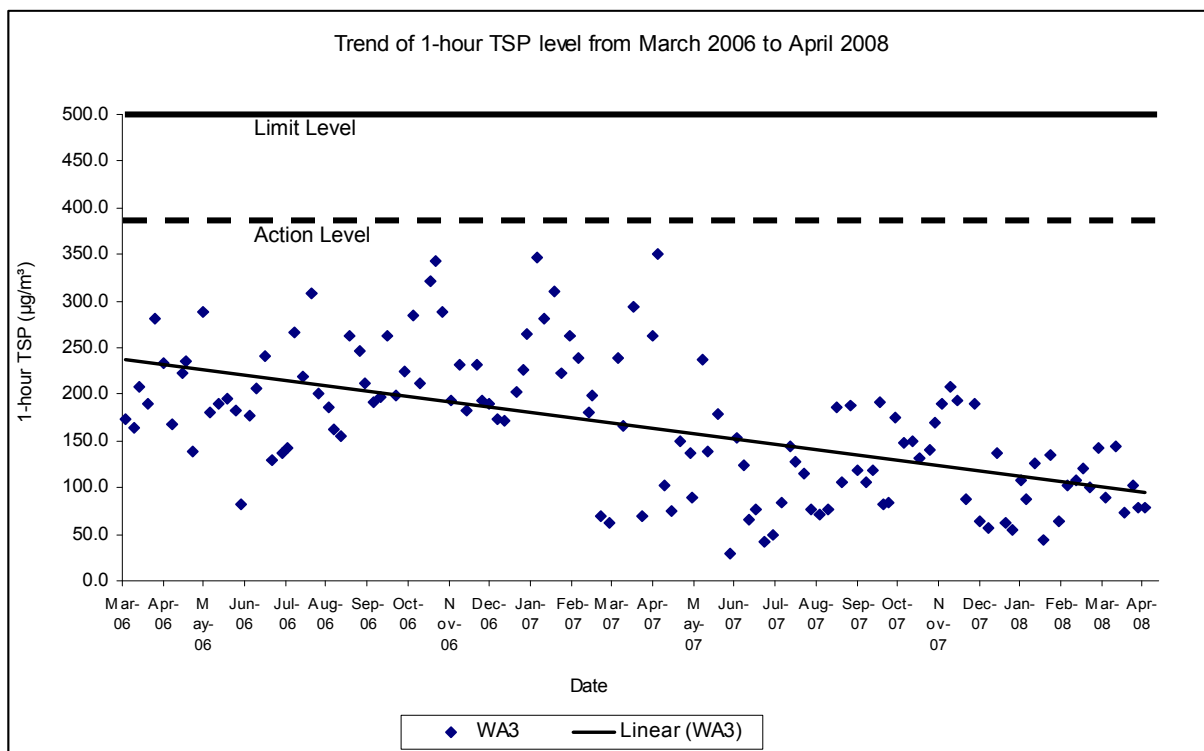
The trend of 1-hour TSP levels at the monitoring location (WA3) is plotted and presented in Figure 4-1.

- Figure 4-1: Trend of 1-hour TSP levels from March 2006 to April 2008
- Figure 4-2: Trend of 24-Hour TSP Levels from March 2006 to April 2008
- Figure 5-1: Trend of day-time noise levels from March 2006 to April 2008

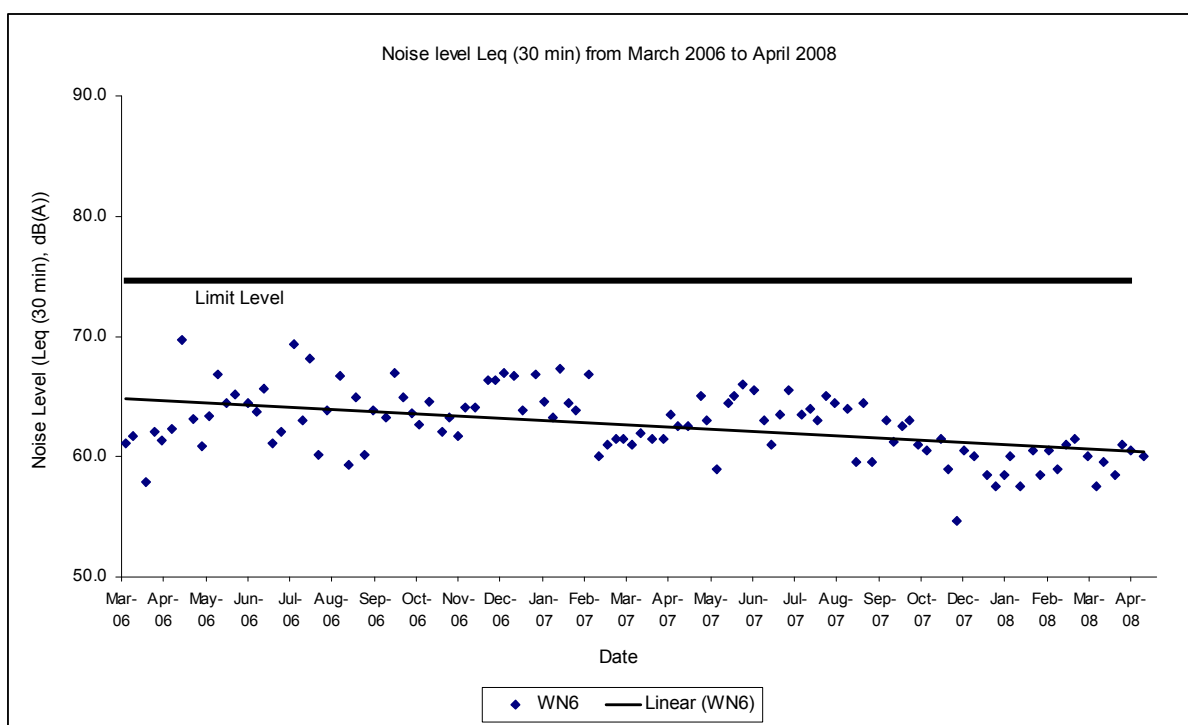
Figure 5-1: Trend of day-time noise levels from March 2006 to April 2008

The trend of day-time noise levels at the monitoring location (WN6) is plotted and presented in **Figure 5-1**.
