SkyCity Golf Course EM&A

Monthly Impact Report

October 2006

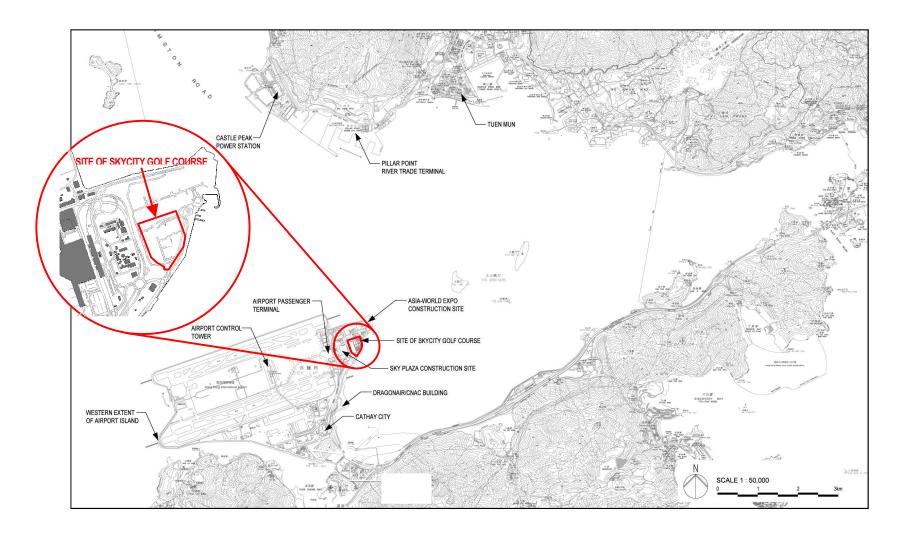
Figure 1-1 Location of SkyCity Golf Course on the Airport Island

The purpose of this Project is to construct and operate a 9-hole Golf Course at the east side of the North Commercial District (NCD) on the Airport Island as an interim arrangement prior to the area's future development as a business park (see Figure 1-1). The proposed interim golf facility, known as "SkyCity Golf Course" is intended to serve airport passengers, overseas visitors and airport workers until August 2013.

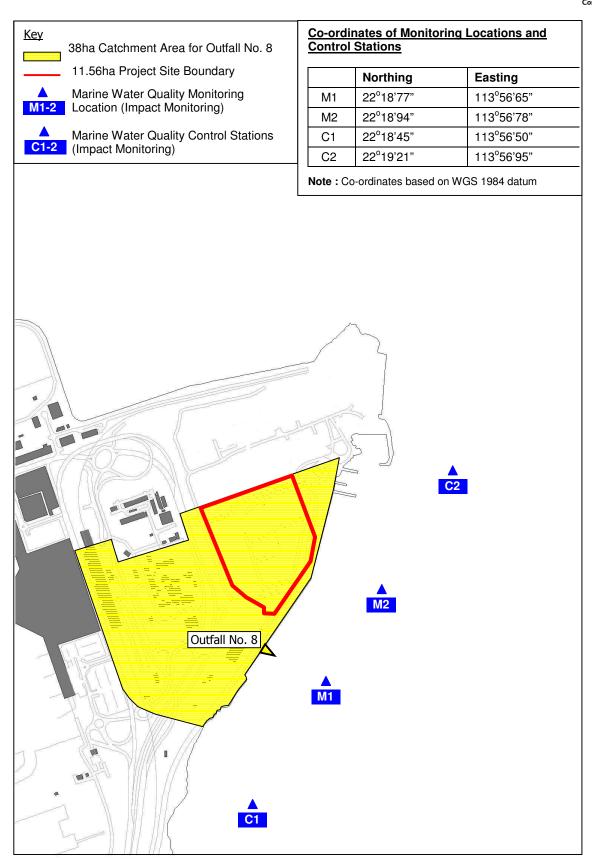
Figure 3-2 Location of Impact Monitoring Stations

Monitoring locations together with grid references are shown in Figure 3-2. Control Stations are designated C1 and C2 and Monitoring Stations are designated M1 and M2.
