# SkyCity Golf Course EM&A

## Monthly Impact Report

November 2006

Report no: 01332R0121

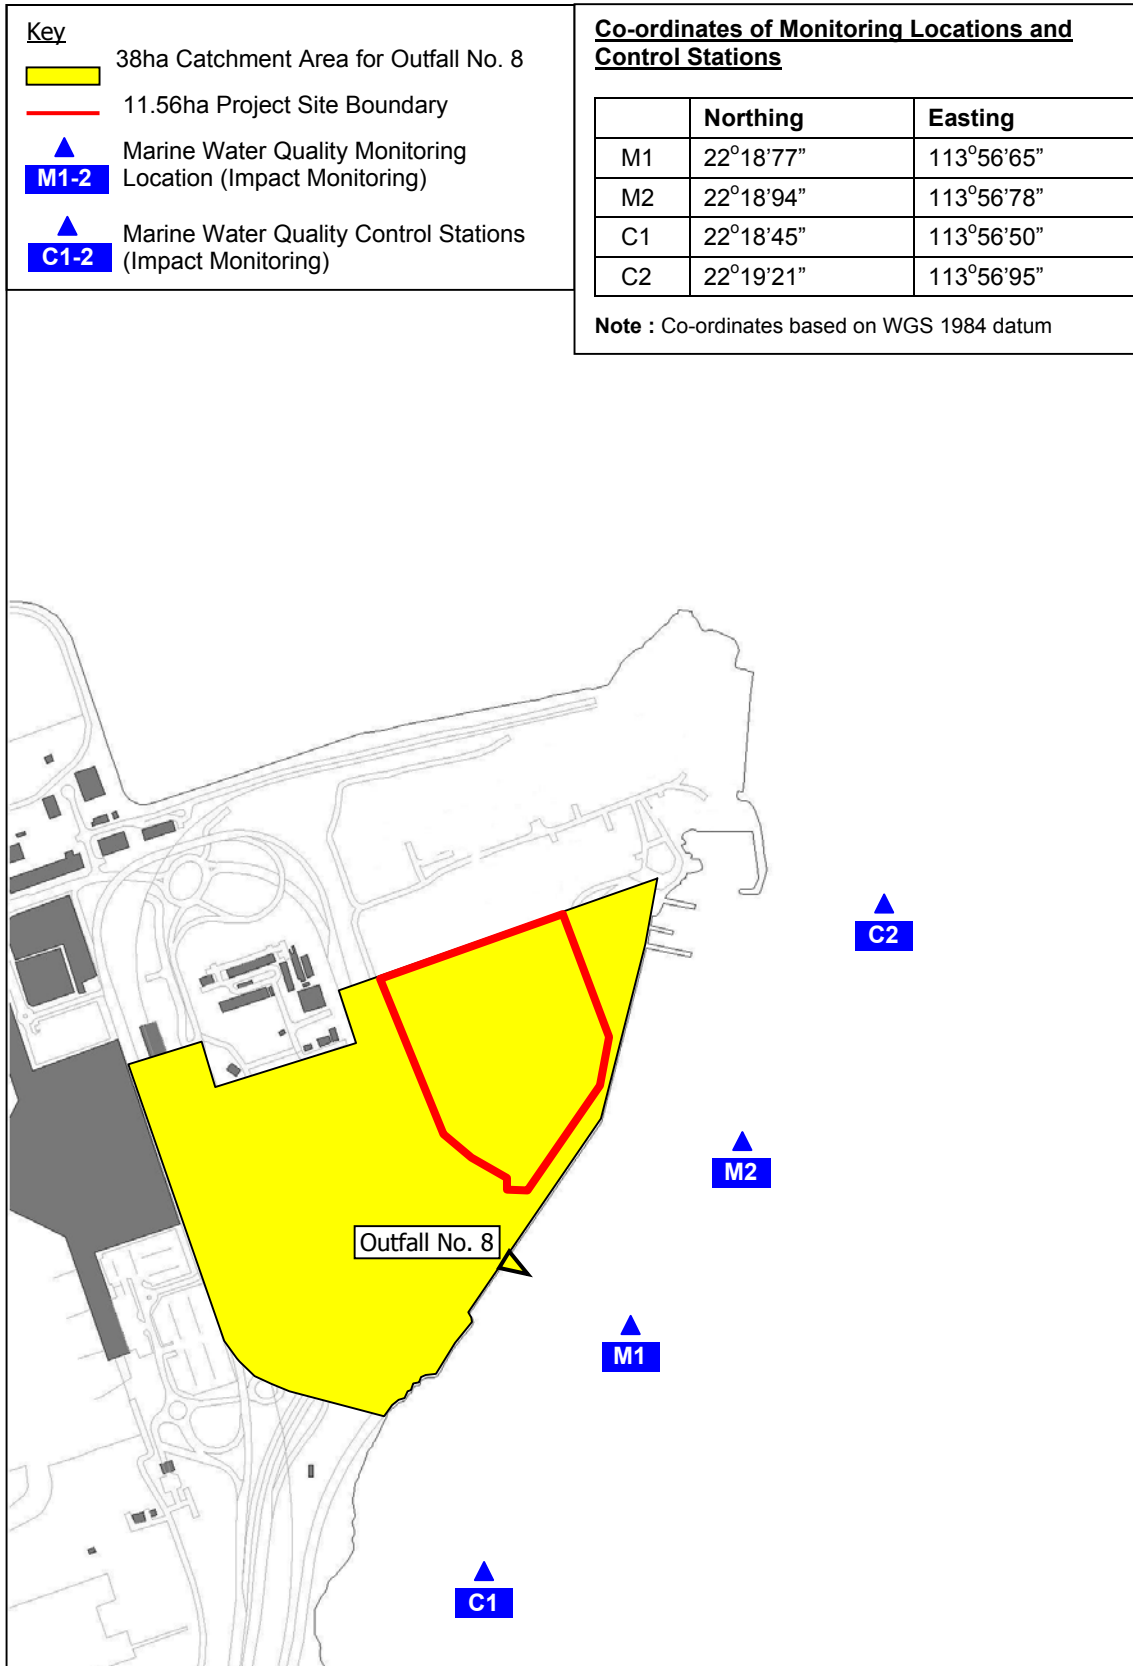
**Figure 3-2** Location of Impact Monitoring Stations

Monitoring locations together with grid references are shown in Figure 3-2. Control Stations are designated C1 and C2 and Monitoring Stations are designated M1 and M2.
