PROJECT No.: TCS/00408/08

DSD CONTRACT NO. DC/2007/17
DRAINAGE IMPROVEMENT WORKS IN
CHEUNG PO, MA ON KONG, YUEN KONG SAN TSUEN
AND TIN SAM TSUEN OF YUEN LONG DISTRICT AND
SEWERAGE AT TSENG TAU CHUNG TSUEN, TUEN MUN

MONTHLY EM&A REPORT FOR KT13
(SEPTEMBER 2009)

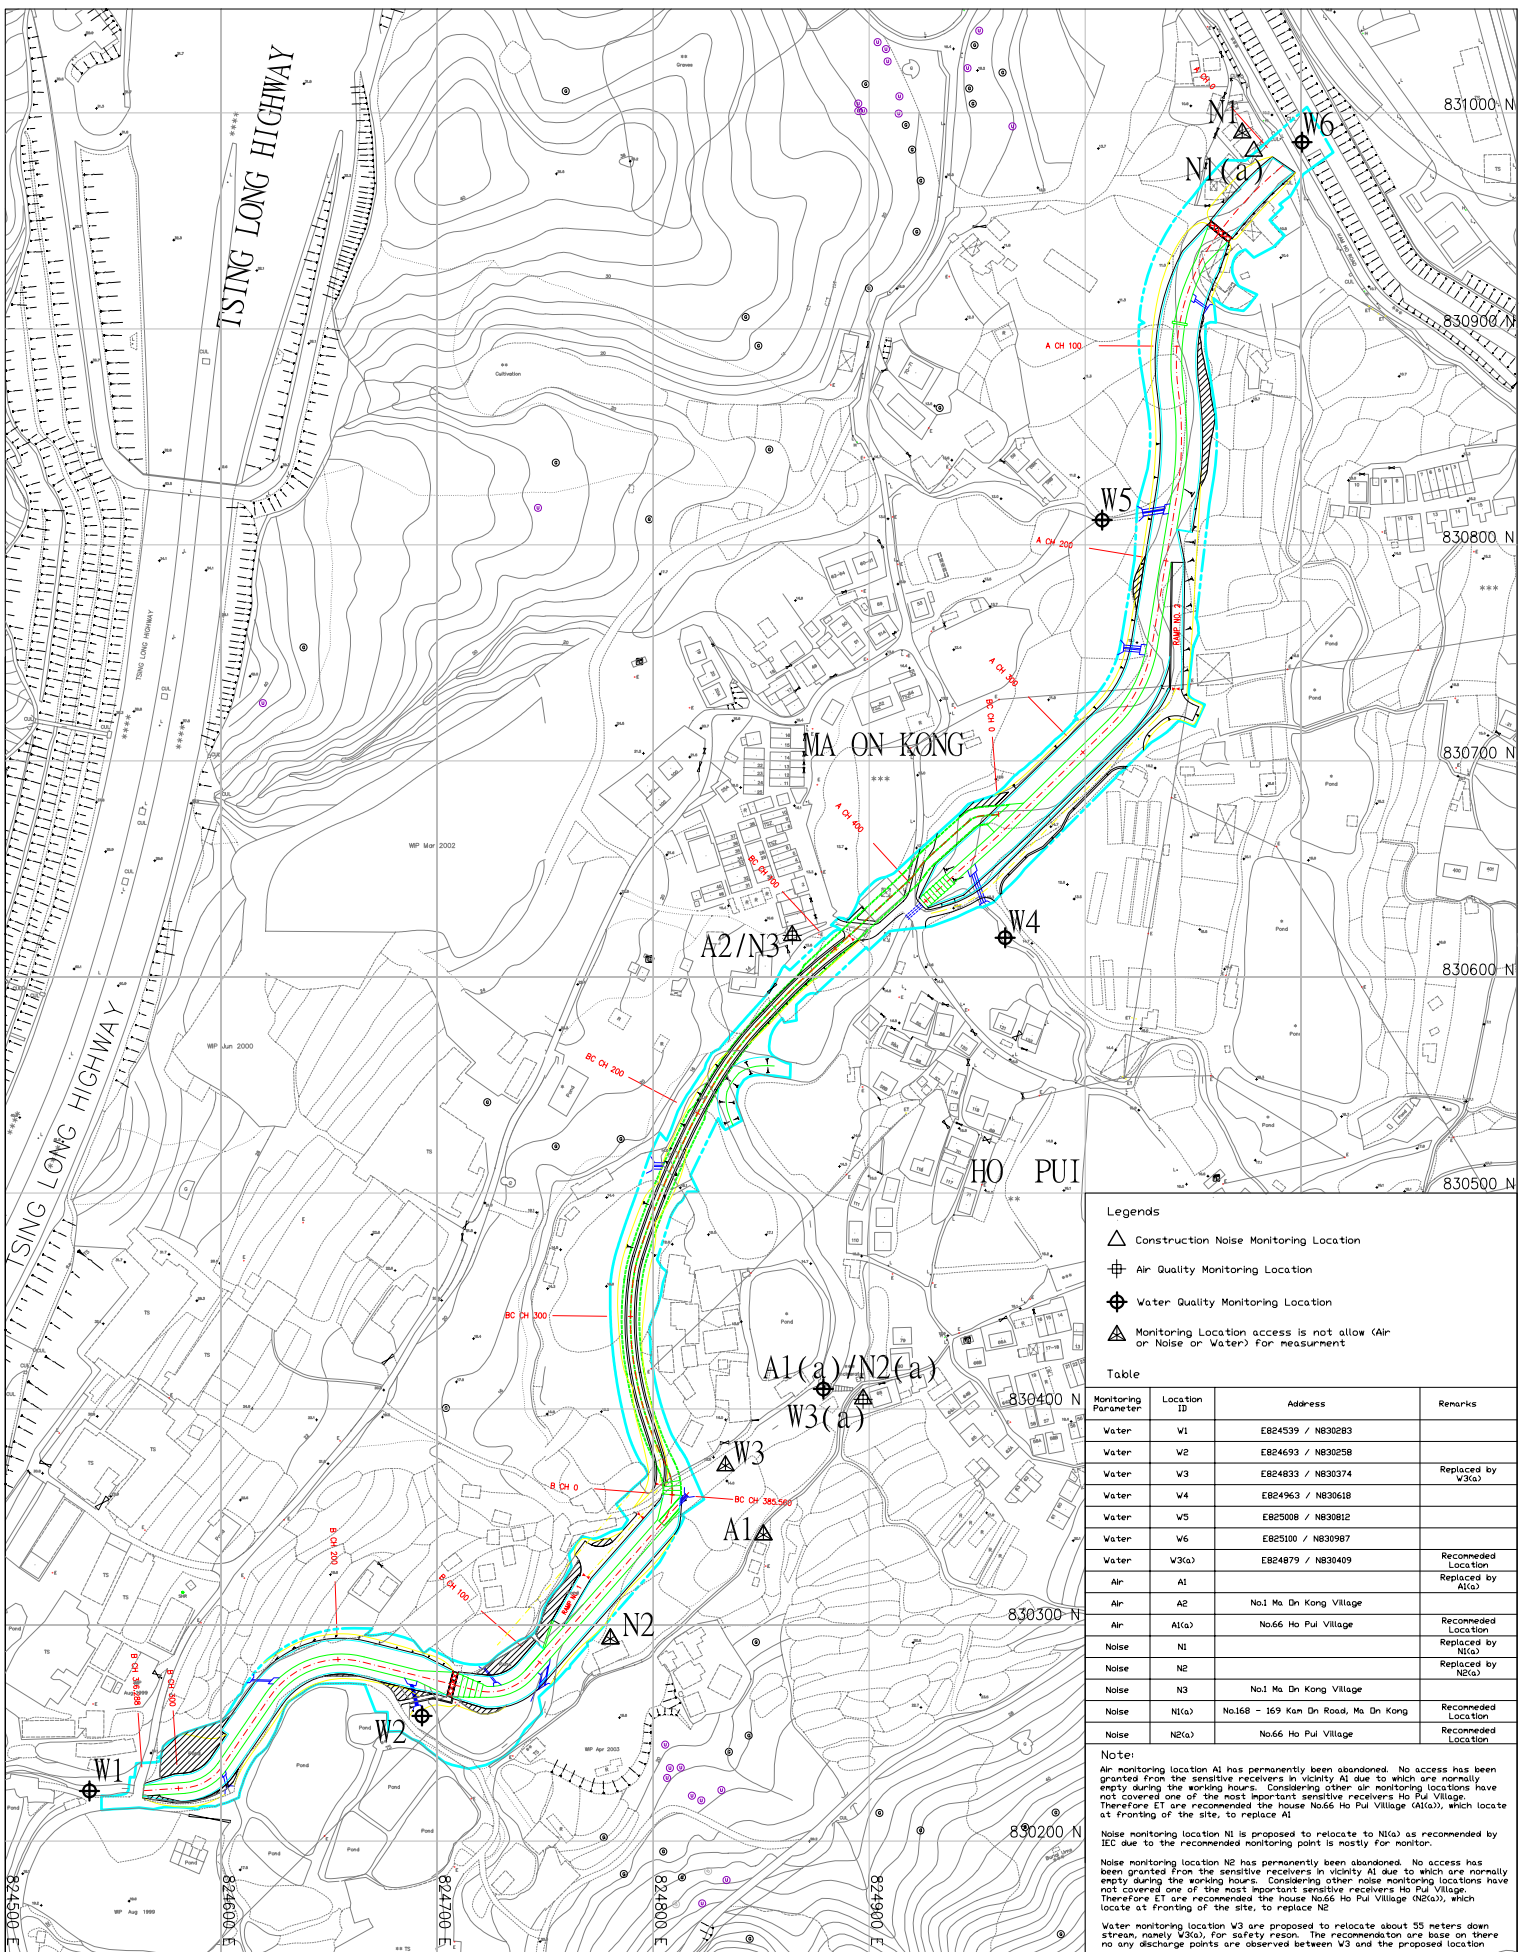
Appendix A
Location Plan and
Environmental Monitoring Locations
Under the Project

- Legends**
- △ Construction Noise Monitoring Location
 - ⊕ Air Quality Monitoring Location
 - ⊗ Water Quality Monitoring Location
 - ⚠ Monitoring Location access is not allow (Air or Noise or Water) for measurement

Air monitoring location A1 has permanently been abandoned. No access has been granted from the sensitive receivers in vicinity A1 due to which are normally empty during the working hours. Considering other air monitoring locations have not covered one of the most important sensitive receivers Ho Pul Village. Therefore ET are recommended the house No.66 Ho Pul Village (A1(a)), which locate at fronting of the site, to replace A1

Noise monitoring location N1 is proposed to relocate to NI(a) as recommended by IEC due to the recommended monitoring point is mostly for monitor.

Noise monitoring location N2 has permanently been abandoned. No access has been granted from the sensitive receivers in vicinity N2 due to which are normally empty during the working hours. Considering other noise monitoring locations have not covered one of the most important sensitive receivers Ho Pul Village. Therefore ET are recommended the house No.66 Ho Pul Village (N2(a)), which locate at fronting of the site, to replace N2

Water monitoring location W3 are proposed to relocate about 55 meters down stream, namely W3(a), for safety reason. The recommendation are base on there no any discharge points are observed between W3 and the proposed location

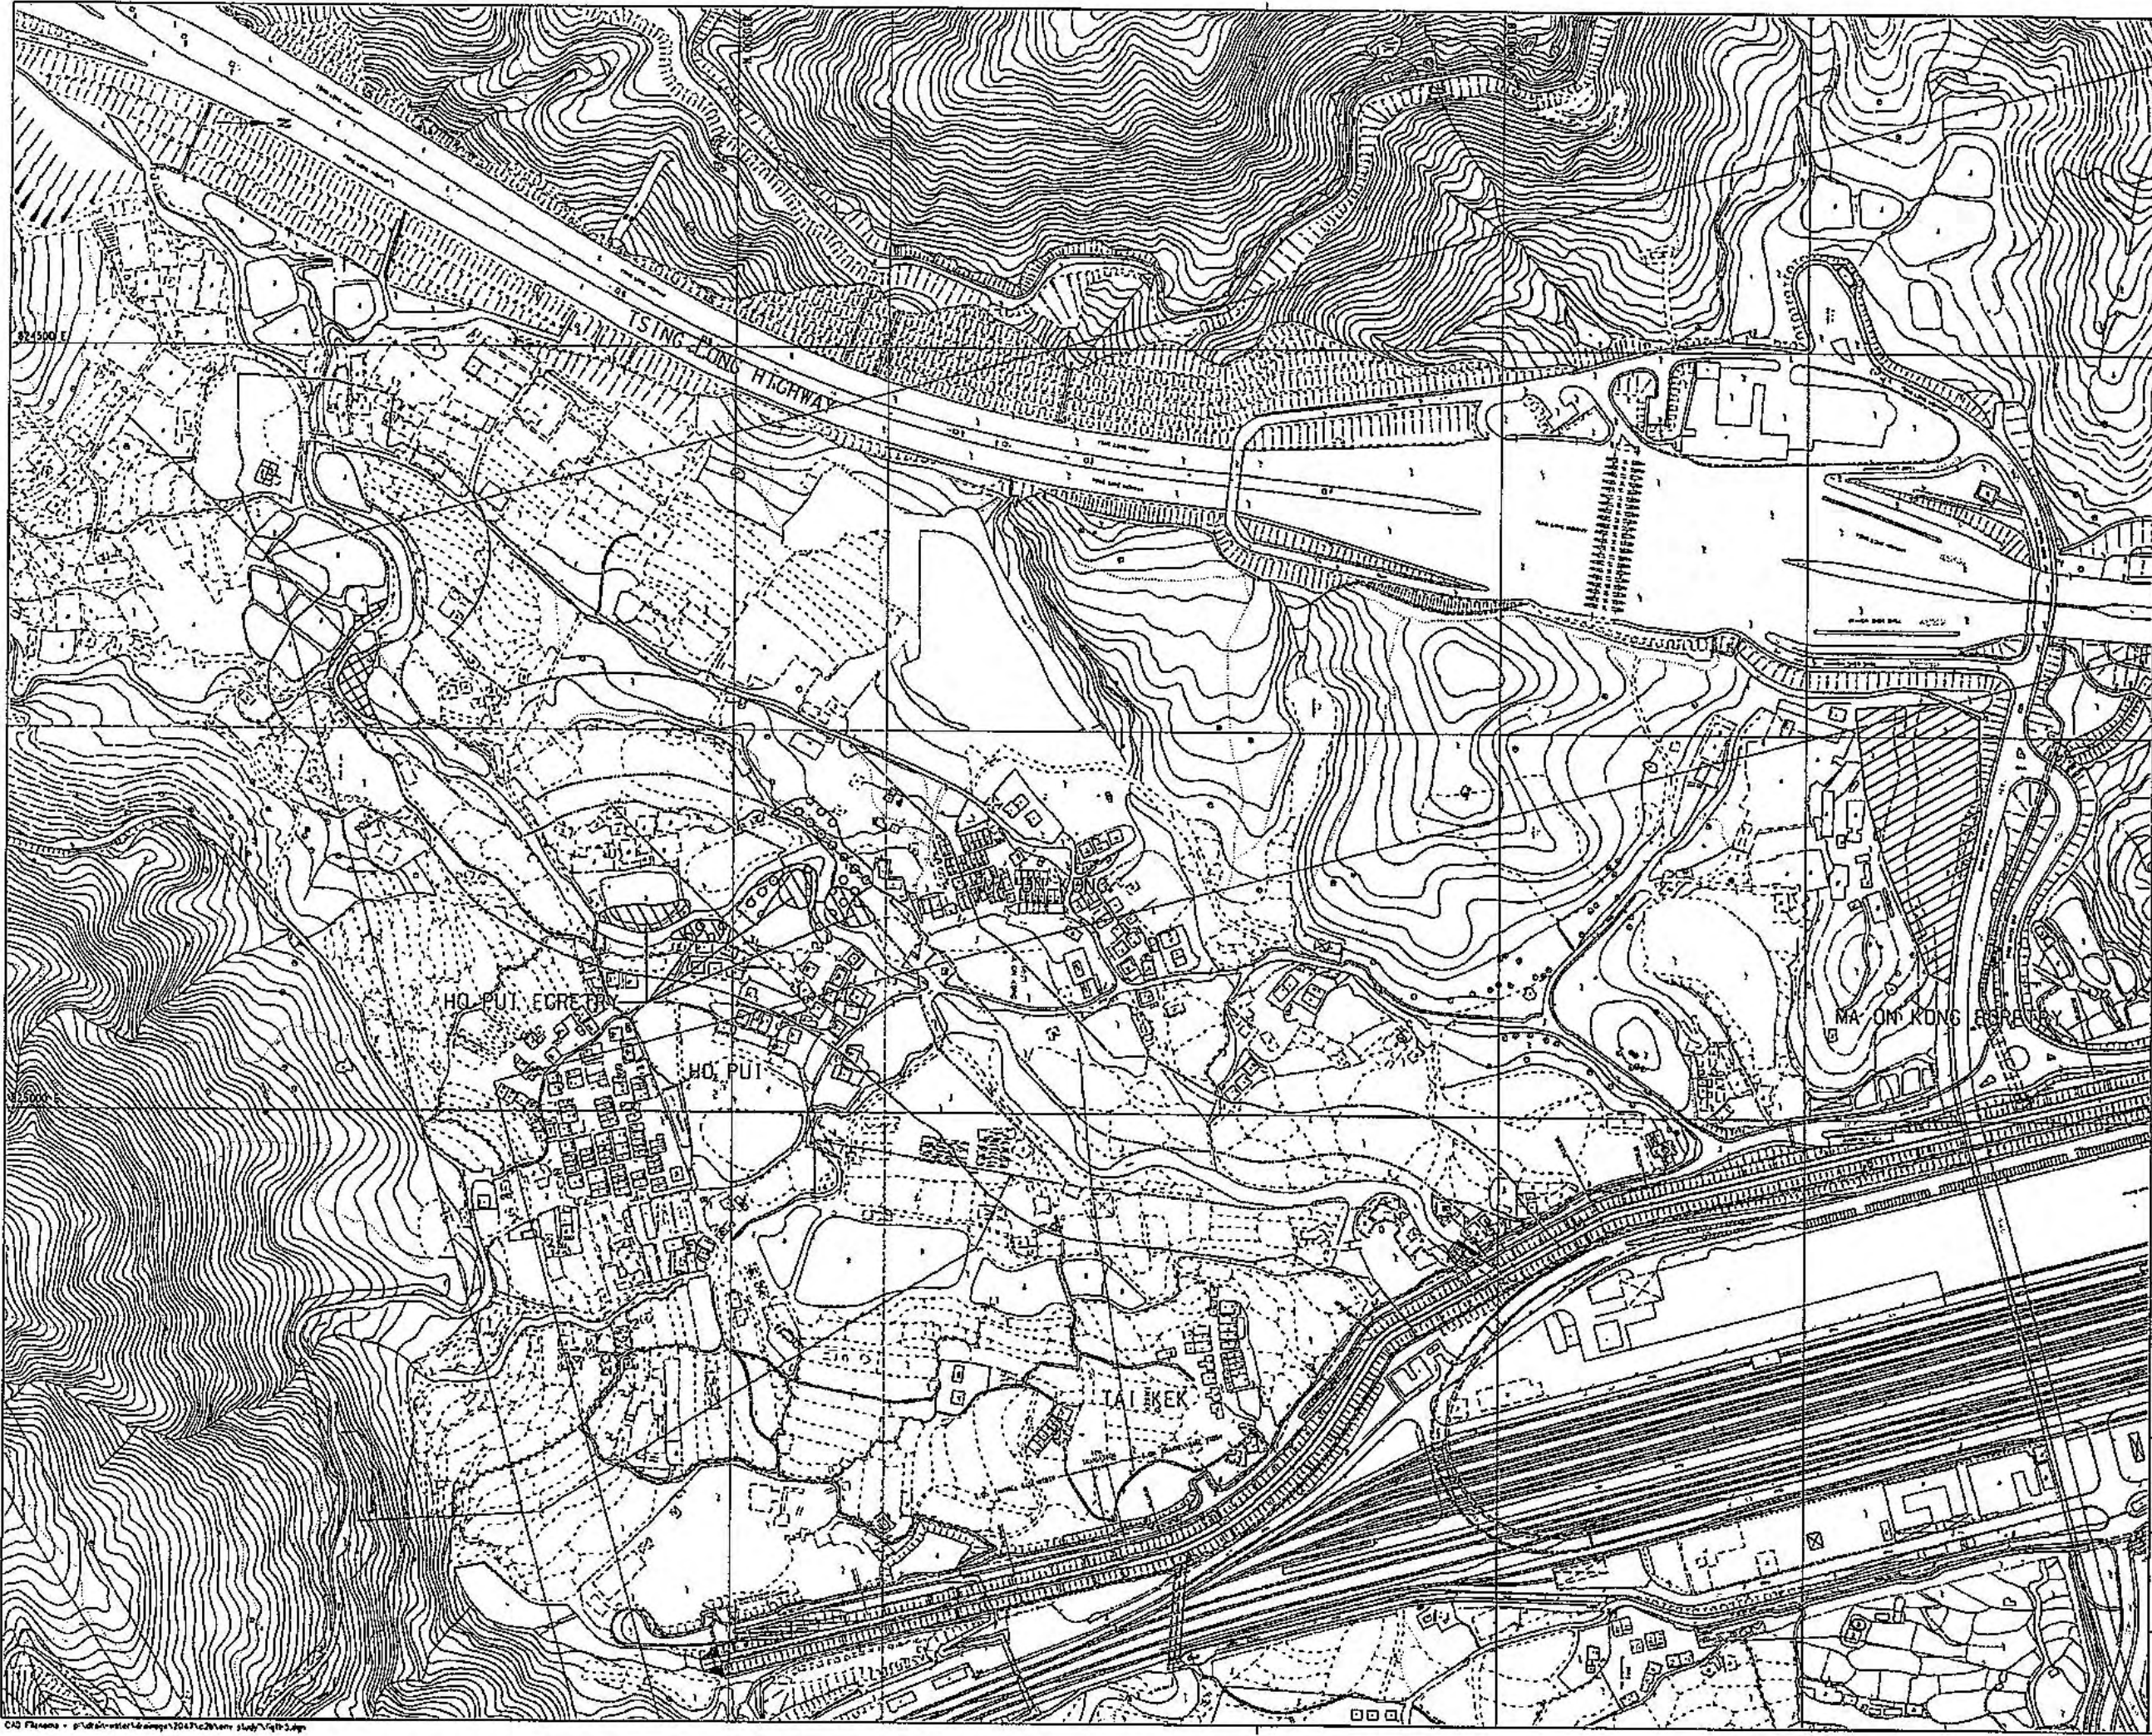
Drawing title
ECOLOGY MONITORING AREAS
RECOMMENDED FOR
CONSTRUCTION PHASE AND
OPERATION PHASE

NOTES:
1. GRID LINES ARE HONG KONG METRIC GRID 1980.

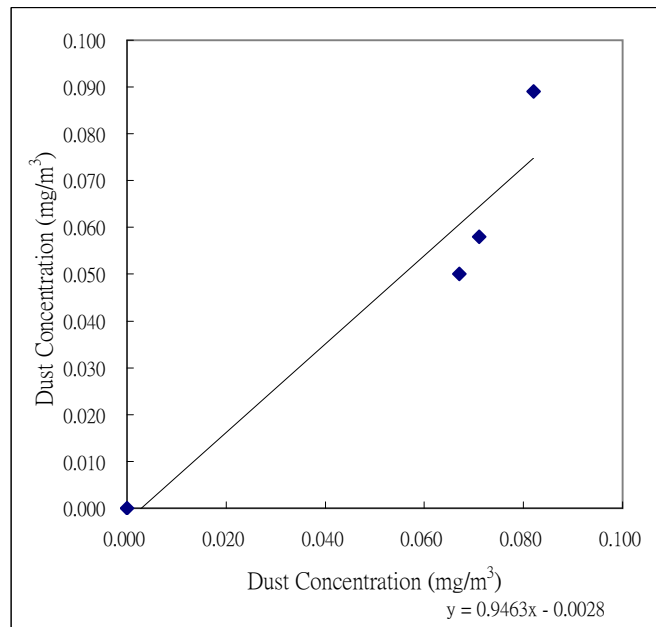
Linear Regression of Y or X

Slope: 0.0198
 Correlation Coefficient 0.9545
 Validity of Calibration Record 18-Jun-10

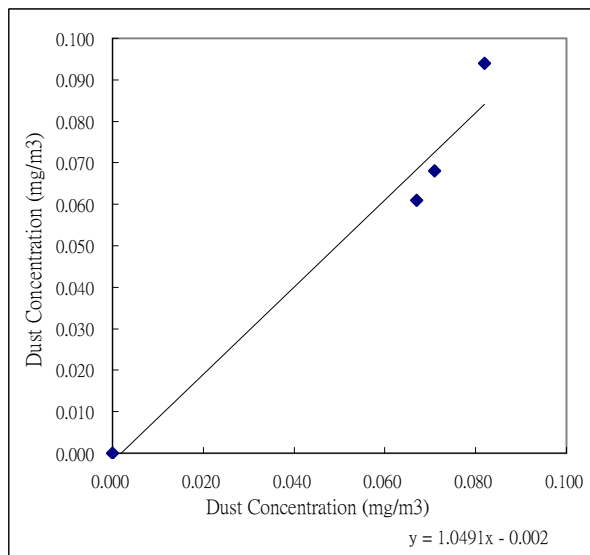
Linear Regression of Y or X

Slope: 0.0167
 Correlation Coefficient 0.9812
 Validity of Calibration Record 18-Jun-10

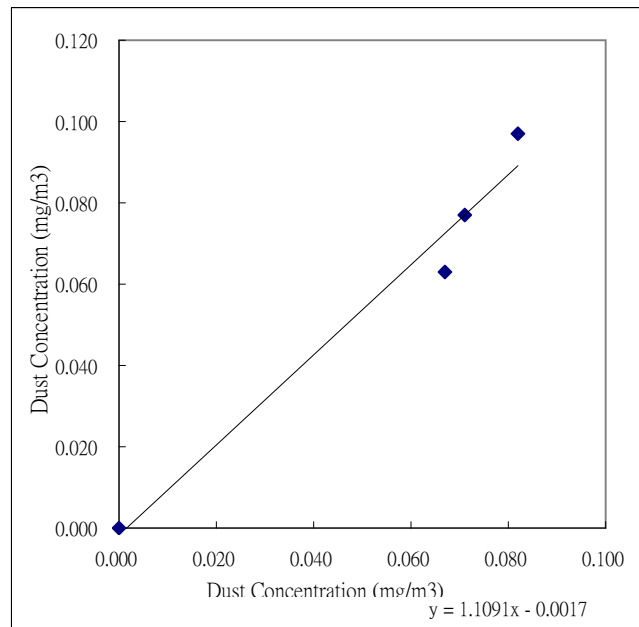
Linear Regression of Y or X

Slope: 0.0162
 Correlation Coefficient: 0.9851
 Validity of Calibration Record: 18-Jun-10

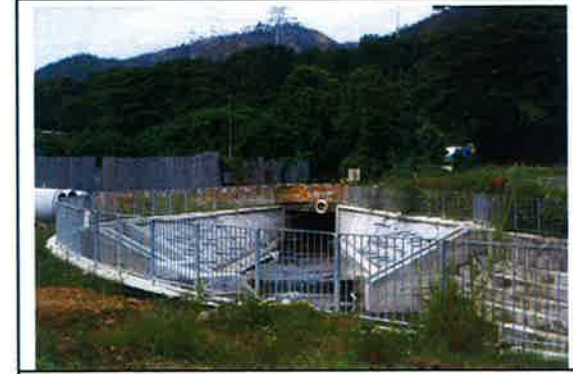
Photo No. A6 – LR2.1

Fish Pond within site boundary

10.7.4	LR2.1 (Fish Pond) within site boundary LR2.2 (Fish Pond) outside site boundary	A6 A7	There are 4 numbers of fallowed fish ponds at the upstream of the Ma On Kong Channel. A chain of fish ponds near downstream but distant from the Channel is noted. The fish ponds cover area of in total 23,000 m ² . Most of them are heavily colonized by aquatic plants, which attribute to their low visual quality as a water landscape element. They have low landscape value and sensitive to change.	Minor change due to construction of structures within site boundary. A soil platform was

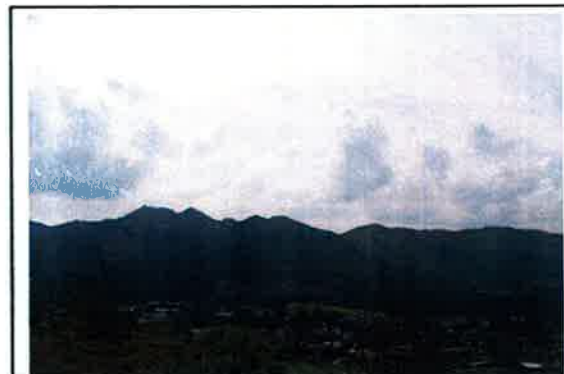
Photo No. A7 – LR2.2

River/Stream

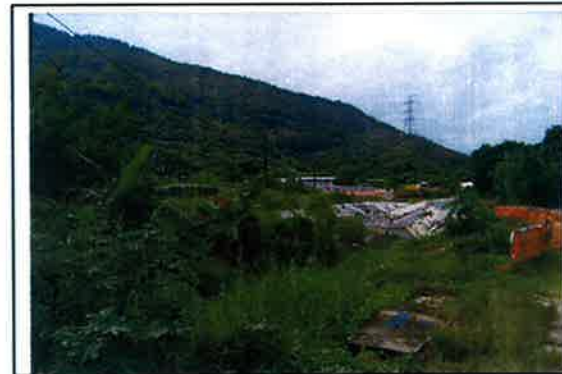
Photo No. A8 – LR3

River/Stream

created outside site boundary due to other project was noted.
Marsh				
10.7.5	LR3 (Marsh)	A8	It comprises 2 marshes at the upstream channel of the Channel. They are inundated lowland heavily colonized with wetland aquatic plants. They have low landscape value and sensitive to change.	Remain the same as the baseline
Vegetation
