PROJECT No.: TCS/00408/08

DSD CONTRACT NO. DC/2007/17
DRAINAGE IMPROVEMENT WORKS IN
CHEUNG PO, MA ON KONG, YUEN KONG SAN TSUEN
AND TIN SAM TSUEN OF YUEN LONG DISTRICT AND
SEWERAGE AT TSENG TAU CHUNG TSUEN, TUEN MUN

MONTHLY EM&A REPORT FOR KT13
(SEPTEMBER 2010)

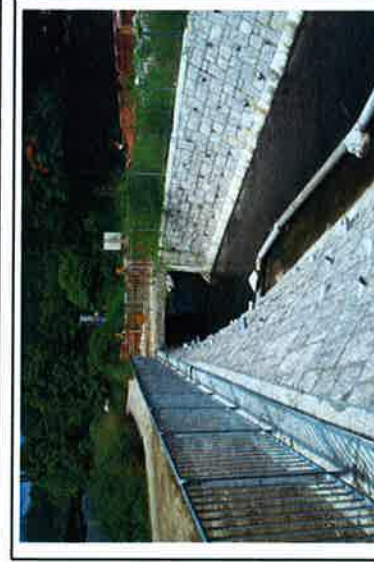
Photo No. A6 – LR2.1

Fish Pond within site boundary

10.7.4	LR2.1 (Fish Pond) within site boundary LR2.2 (Fish Pond) outside site boundary	A6 A7	There are 4 numbers of fallowed fish ponds at the upstream of the Ma On Kong Channel. A chain of fish ponds near downstream but distant from the Channel is noted. The fish ponds cover area of in total 23,000 m2. Most of them are heavily colonized by aquatic plants, which attribute to their low visual quality as a water landscape element. They have low landscape value and sensitive to change.	Minor change due to construction of structures within site boundary. A soil platform was

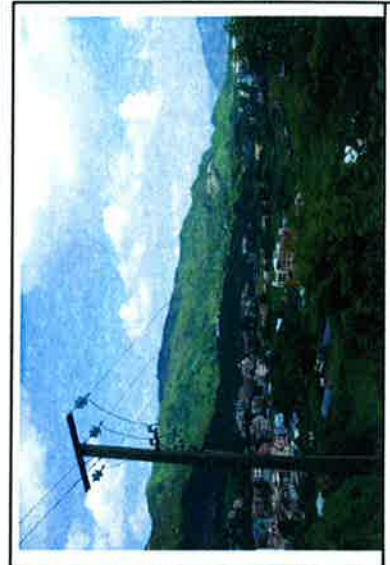
Photo No. A7 – LR2.2

River/Stream
