## Contract No. EP/SP/58/08

## **Sludge Treatment Facilities**

# Quarterly Environmental Monitoring and Audit Report For

September 2011 to November 2011

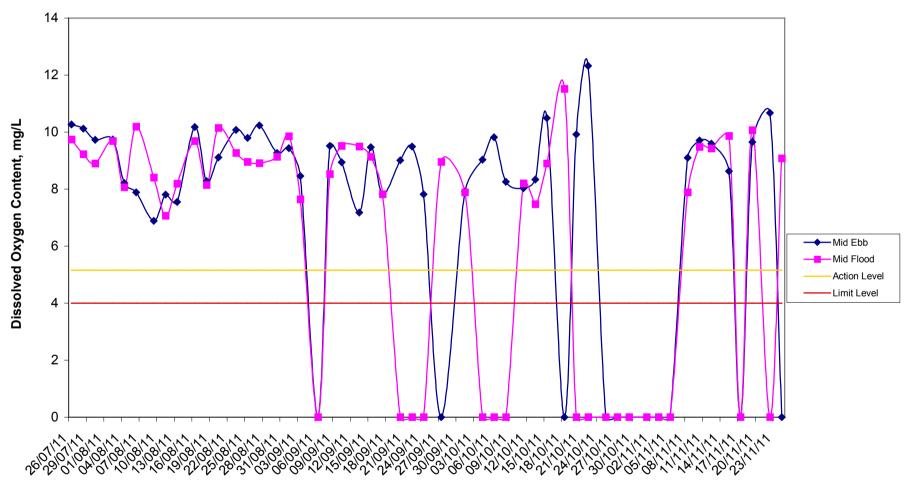
## **C1 - Dissolved Oxygen Content**

Remark: No water at C1 occasionally after 17/02/2011. Zero values are shown in the graph

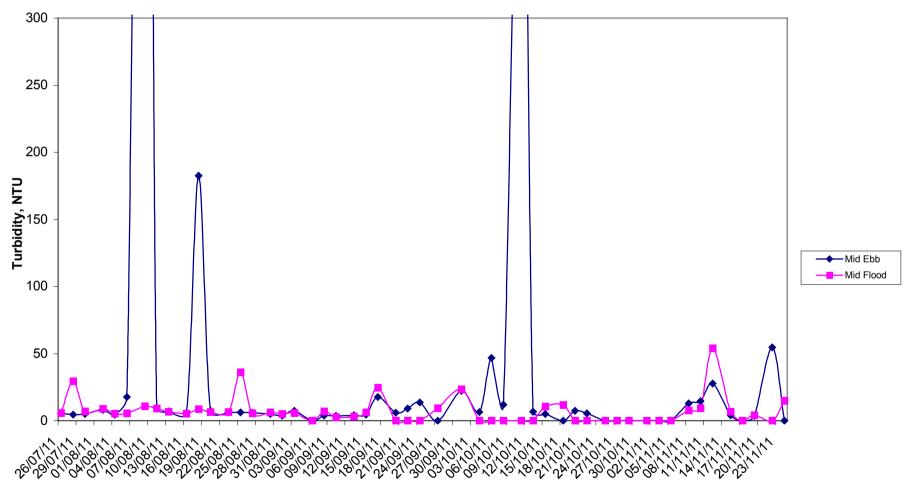
## C1 - Turbidity

Remark: No water at C1 occasionally after 17/02/2011. Zero values are shown in the graph
