**RELOCATION OF SHA TIN SEWAGE TREATMENT WORKS
TO CAVERNS**

Landscape & Visual Mitigation Plan and Tree Preservation Plan (Issue 8.3)
(Under Condition 2.18, Environmental Permit No. EP-533/2017)

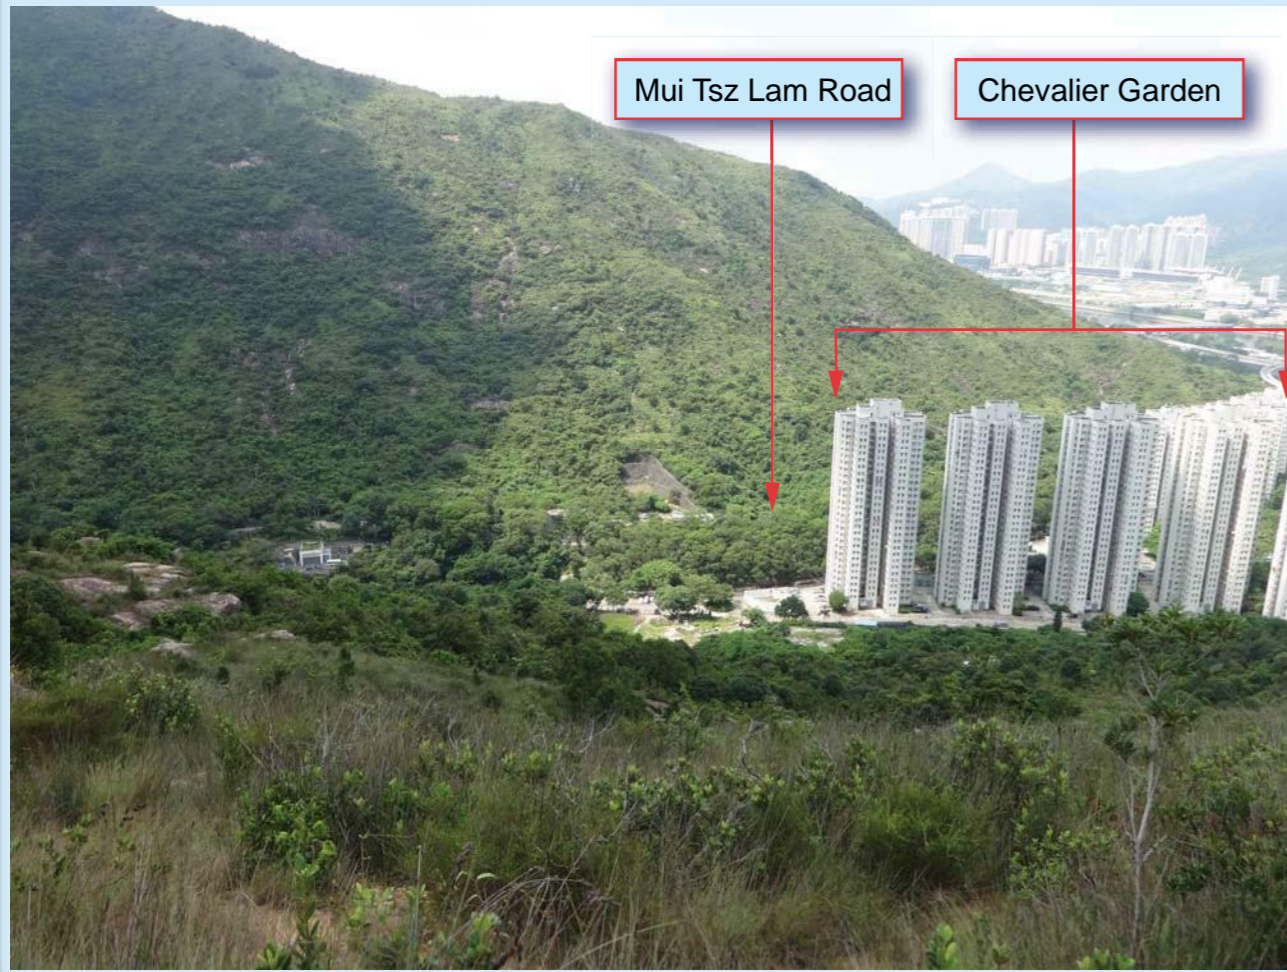
Existing Condition

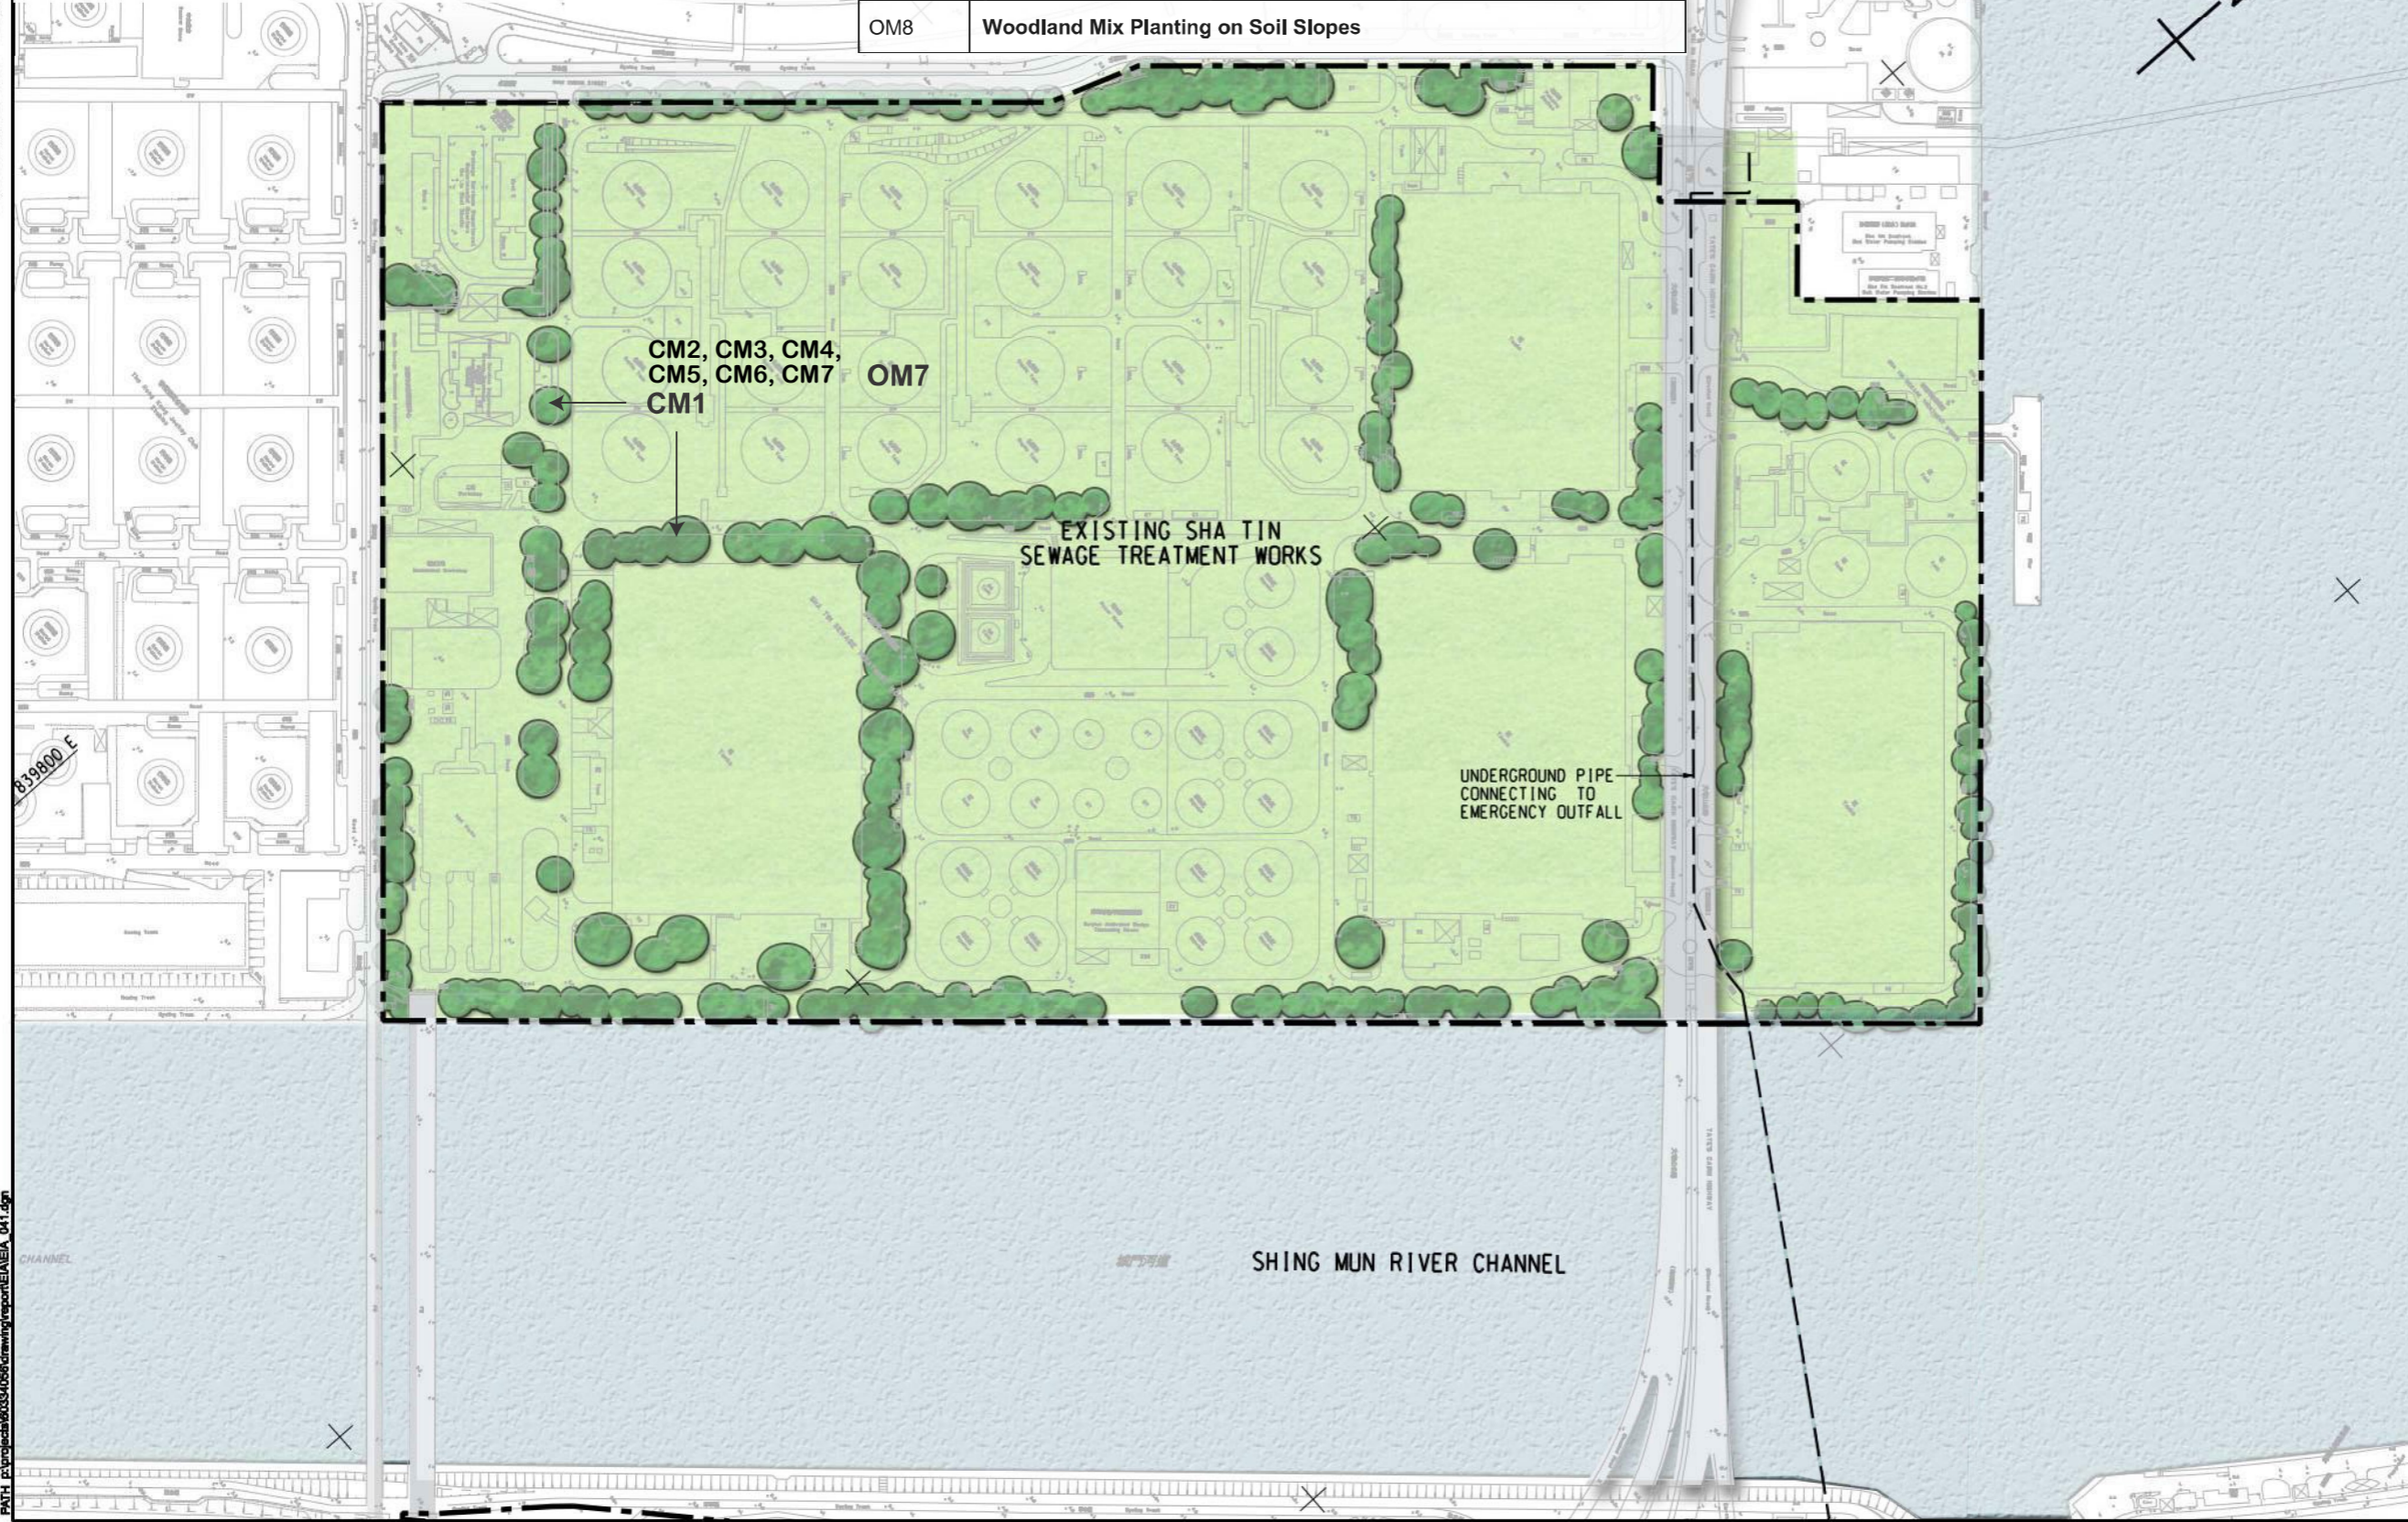
ID No.	Landscape and Visual Mitigation Measures for Construction Phase
CM1	Preservation of Existing Vegetation
CM2	Transplanting of Affected Trees
CM3	Compensatory Tree Planting
CM4	Control of Night-time Lighting Glare
CM5	Erection of Decorative Screen Hoarding
CM6	Management of Construction Activities and Facilities
CM7	Reinstatement of Temporarily Disturbed Landscape Areas

ID No.	Landscape and Visual Mitigation Measures for Operation Phase
OM1	Tree and Shrub Planting at the Temporary Project Magazine Site after Completion of Engineering Works
OM2	Aesthetically pleasing design of Aboveground Structures
OM3	Aesthetically pleasing design of Highways Structures
OM4	Reprovision of Cycle Track
OM5	Provision of Green Roof
OM6	Provision of Buffer Planting
OM7	Hydroseeding on the Disturbed Ground Surface after Demolition Works prior to Future Redevelopment of the Existing STSTW
OM8	Woodland Mix Planting on Soil Slopes

The general layout on the implementation of CMs and OMs, as recommended in Figure 10.41 – 10.46 of the AEIAR are presented in **Appendix E** to provide an overview on implementation of landscape and visual mitigation measures. The mitigation measures, implementation schedule as well as maintenance and management schedule are listed in Table 2.5.1 and Table 2.5.2. Implementation schedule of CMs and OMs with respect to the tentative works programme of each contract is listed in Table 2.5.3 and the implementation schedule of CMs and OMs with respect to LRs and LCAs is listed in Table 2.5.4. The key mitigation measure implementation schedule and programme is summarized in **Appendix L**. All recommended measures as set out in the approved Landscape & Visual Mitigation and Tree Preservation Plan shall be properly implemented and maintained for the Project. The implementation of the recommended measures shall be certified by the Register Landscape Architect and ET Leader, verified by the IEC and reported in the EM&A programme required in the EM&A Manual in the following month of the measure(s) implemented. **As-built drawings of landscape & visual mitigation measures" should be submitted for record before the commencement of operation of the Project.**

In accordance with EIA report, recommended mitigation measures are described in details in Table 2.6.1 and Table 2.6.2, a general layout on the implementation of CMs and OMs is illustrated in **Appendix E**. Relevant drawings and plans of each measure are supplemented in corresponding appendix.

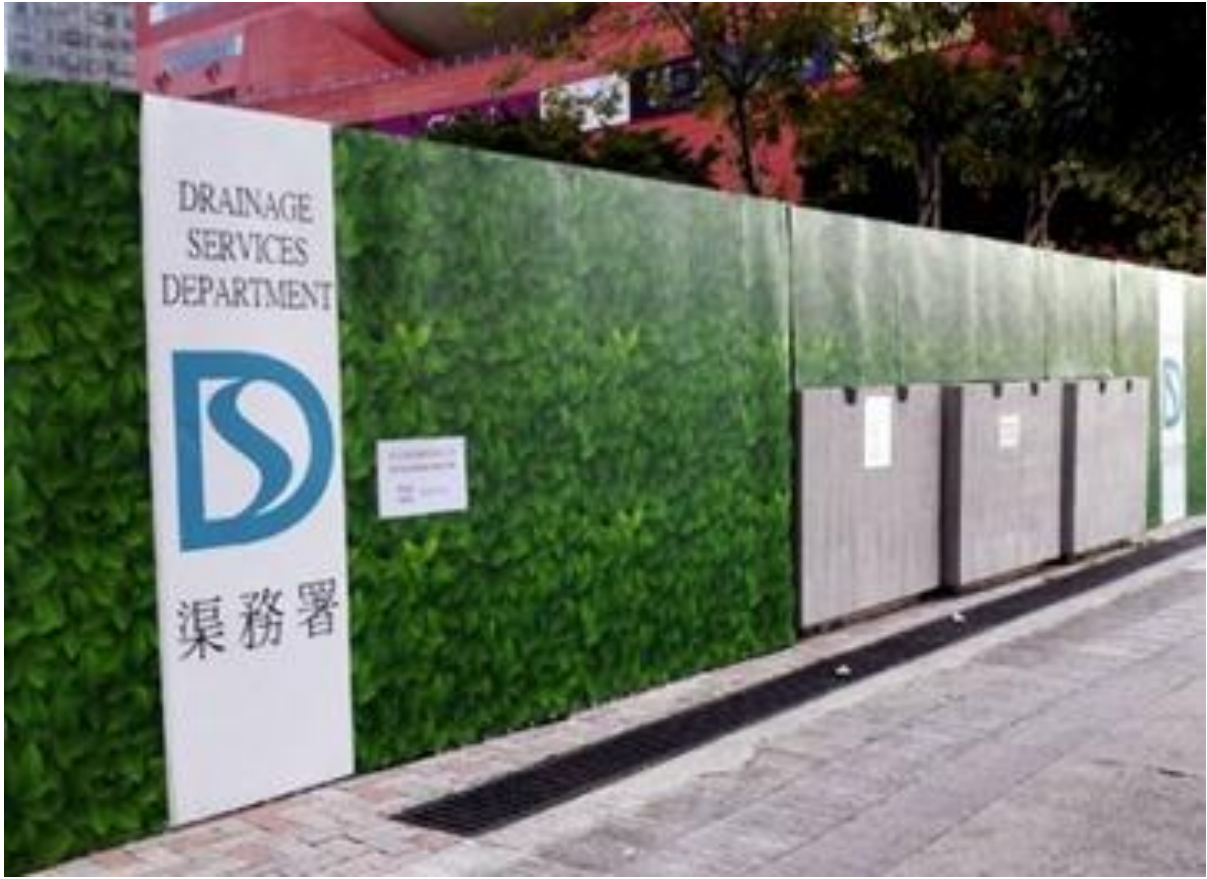
Tentative Hoarding Design

APPENDIX K – TENTATIVE DESIGN ON DECORATIVE HOARDING
