Intermodal Transfer Terminal – Bonded Vehicular Bridge and Associated Roads

Monthly EM&A Report for October 2022

This Submission of Construction Phase Monthly Environmental Monitoring and Audit (EM&A) Report for October 2022

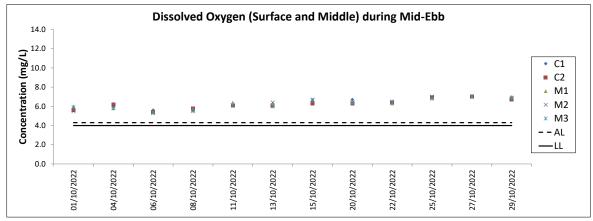
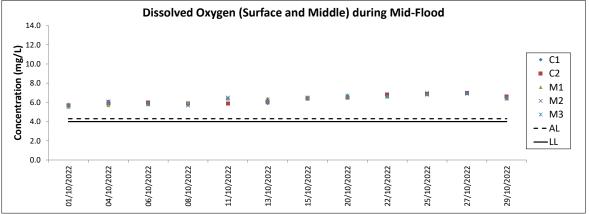
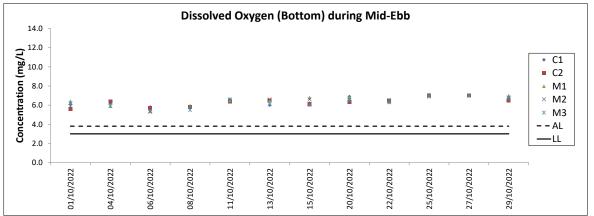
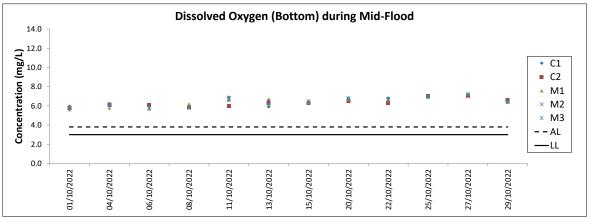
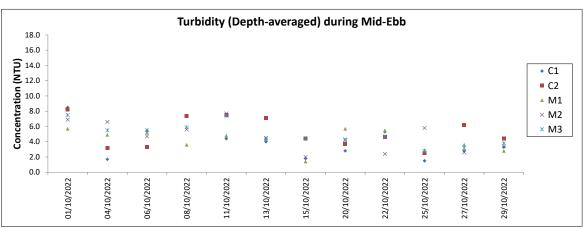
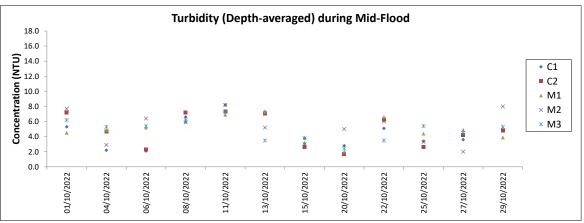
Note: The Action and Limit Level of turbidity can be referred to Table 2.3 of the monthly EM&A report.

Weather conditions during monitoring are presented in the data tables above.

QA/QC requirements as stipulated in the EM&A Manual were carried out during measurement.
