Intermodal Transfer Terminal – Bonded Vehicular Bridge and Associated Roads

Monthly EM&A Report for January 2023

Airport Authority Hong Kong

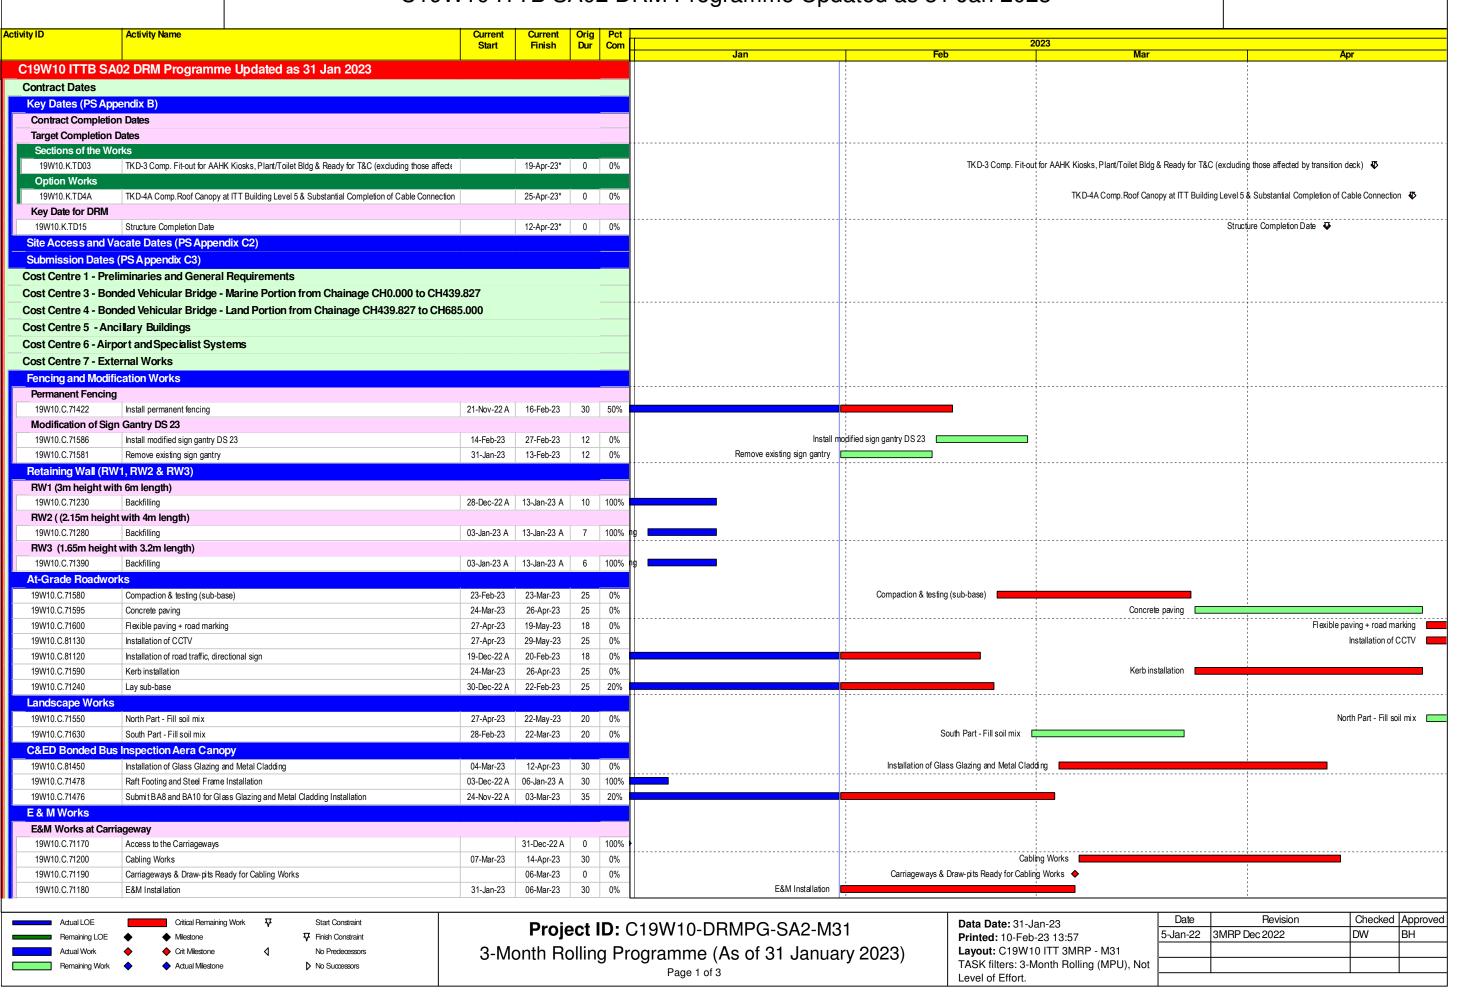
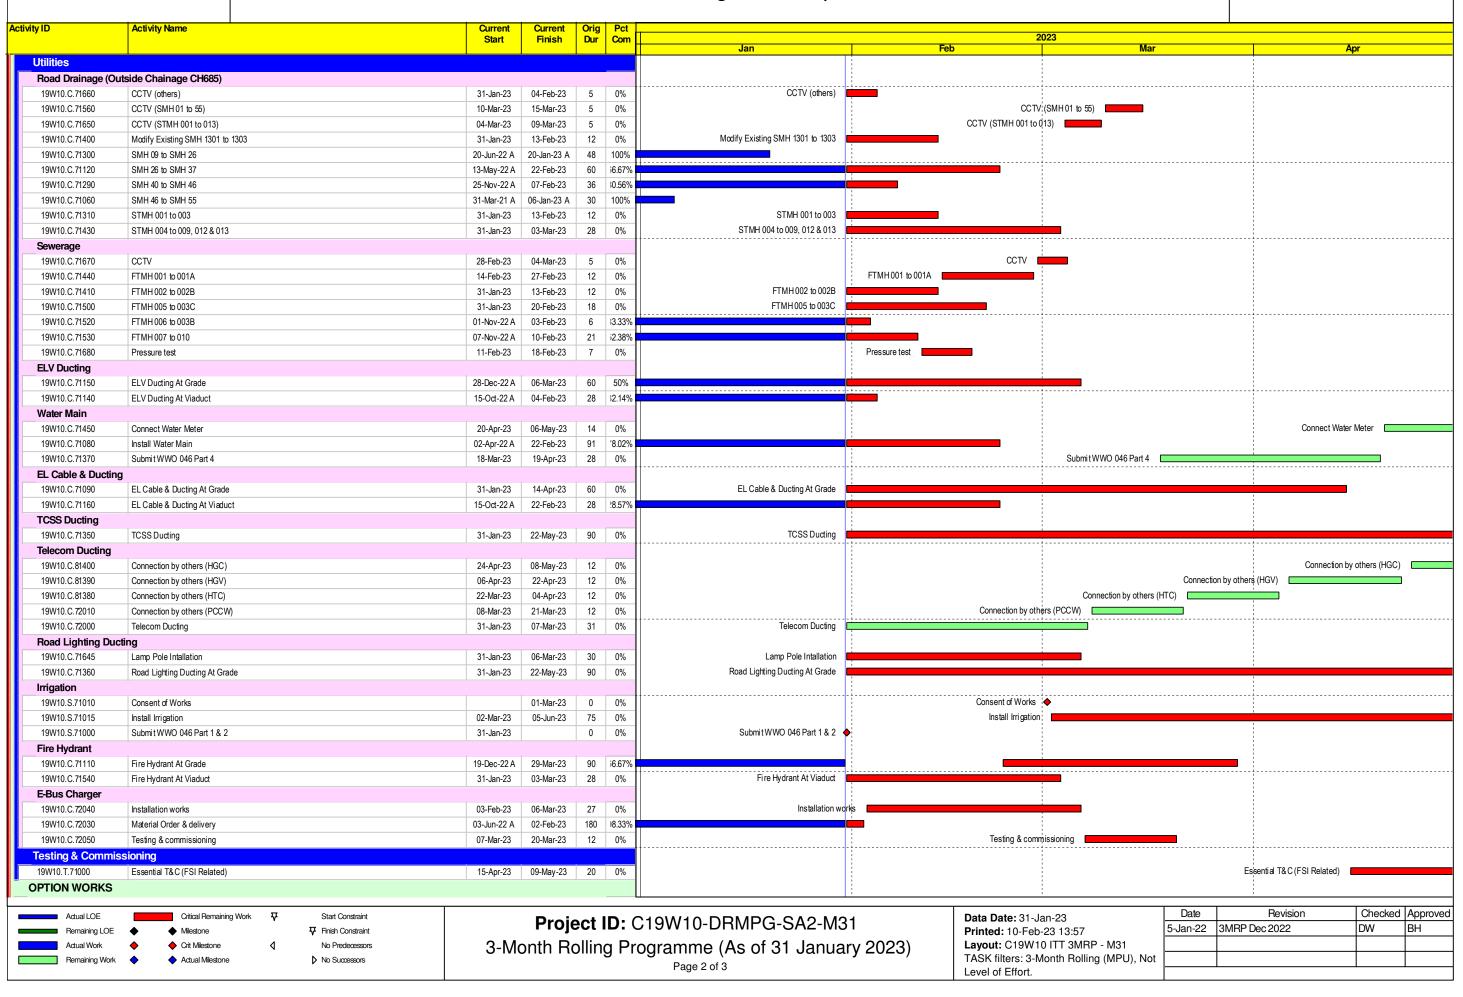
C19W10 ITTB SA02 DRM Programme Updated as 31 Jan 2023

Appendix B. Construction Works Programme

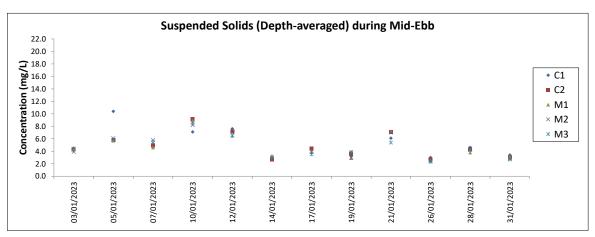
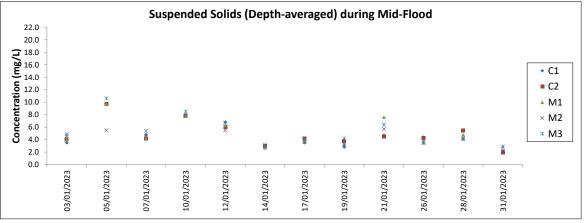
Note: The Action and Limit Level of suspended solids can be referred to Table 2.3 of the monthly EM&A report.
