# **Airport City Link**

Monthly EM&A Report for October 2022

# This Submission of Construction Phase Monthly Environmental Monitoring and Audit (EM&A) Report for October 2022

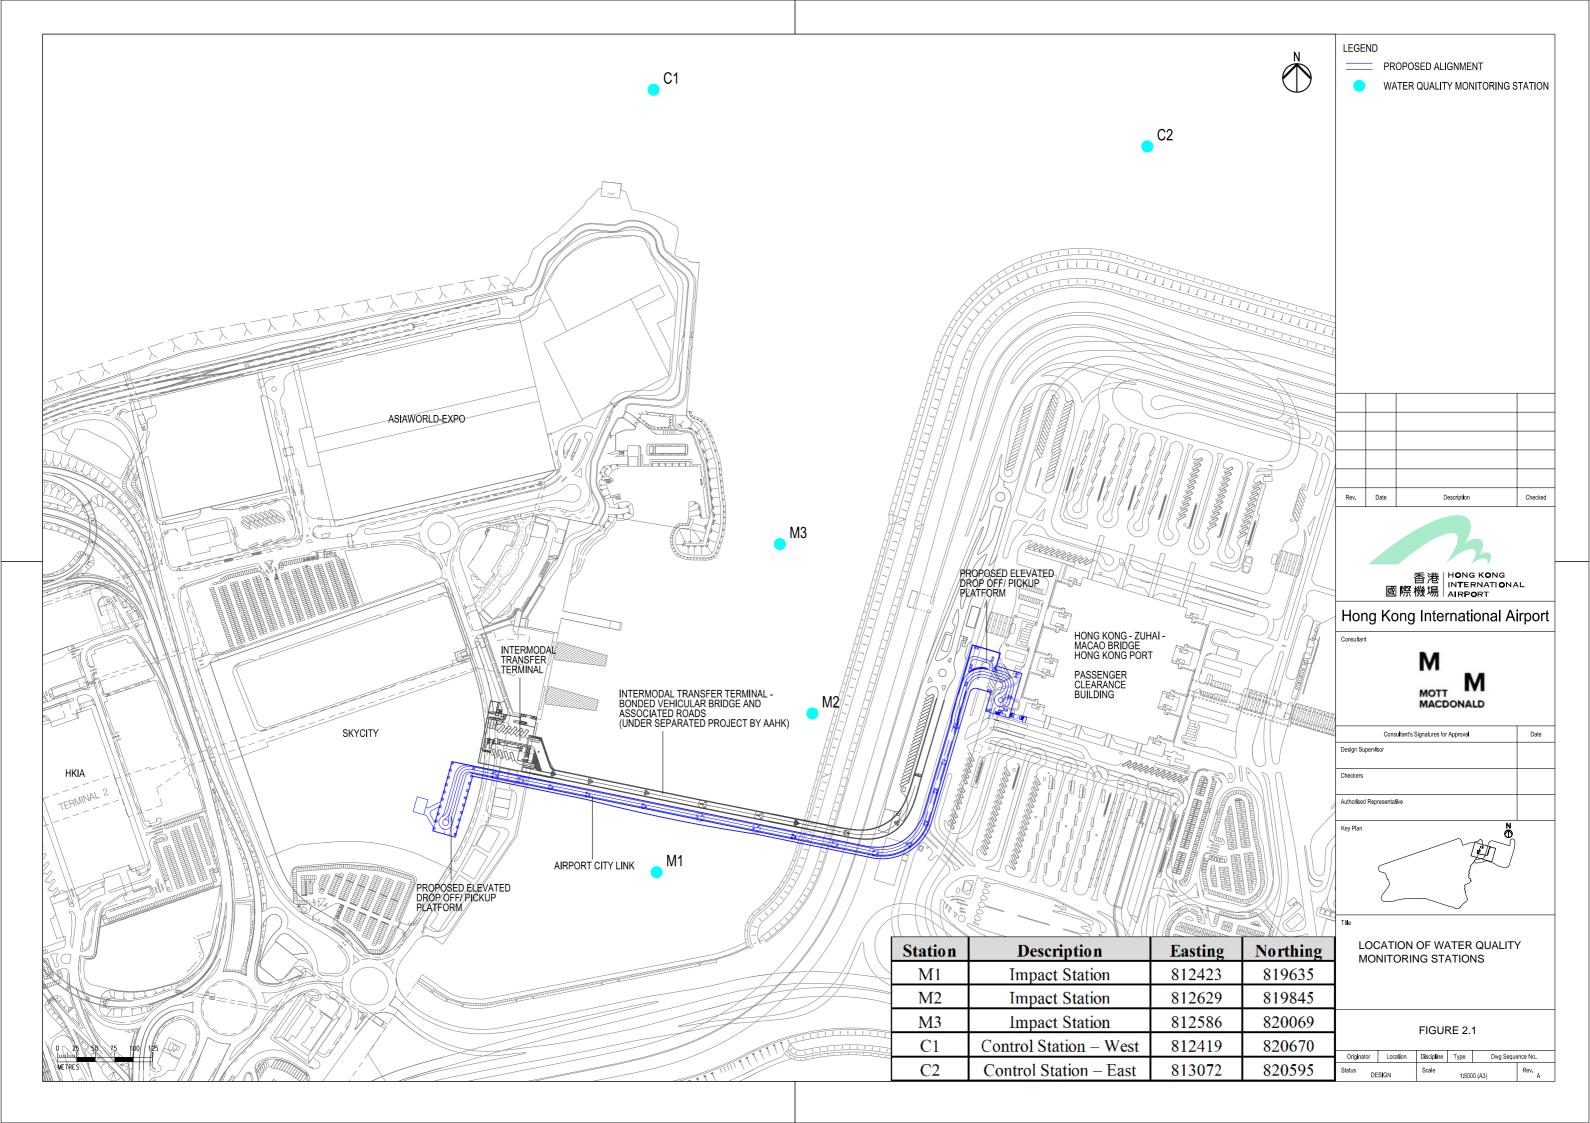
# **Figure 2.1 Water Quality Monitoring Locations**

The water quality monitoring was conducted at three locations in the sea channel between the HKIA and the HKBCF (M1, M2 and M3) and two control stations (C1 and C2), locations are shown in **Figure 2.1** and summarized in **Table 2.1**.

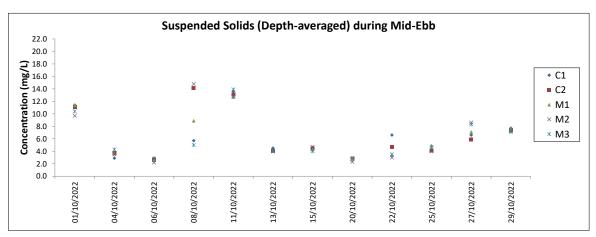
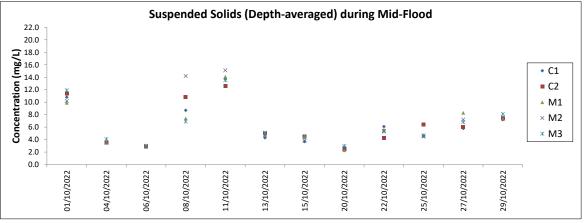
Note: The Action and Limit Level of suspended solids can be referred to Table 2.3 of the monthly EM&A report.
