Airport City Link

Monthly EM&A Report for December 2022 January 2023

Airport Authority Hong Kong

This Submission of Construction Phase Monthly Environmental Monitoring and Audit (EM&A) Report for December 2022

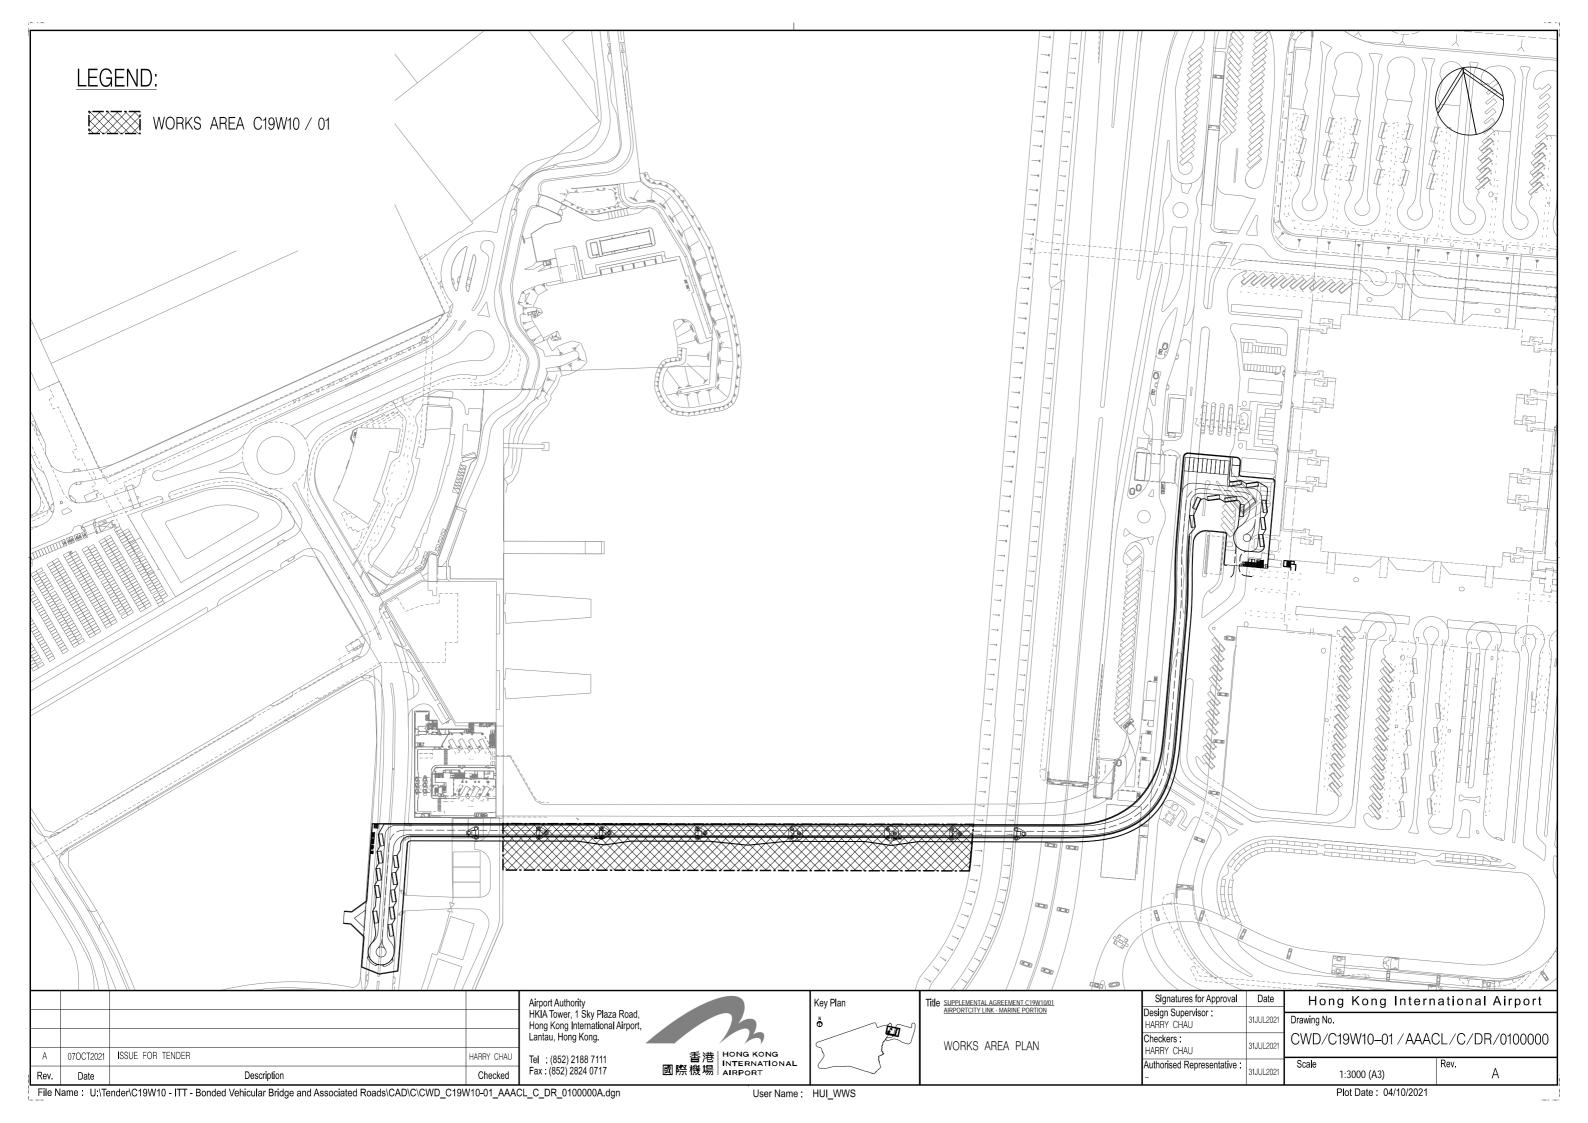
Appendix C. Construction Works Area

Marine Section

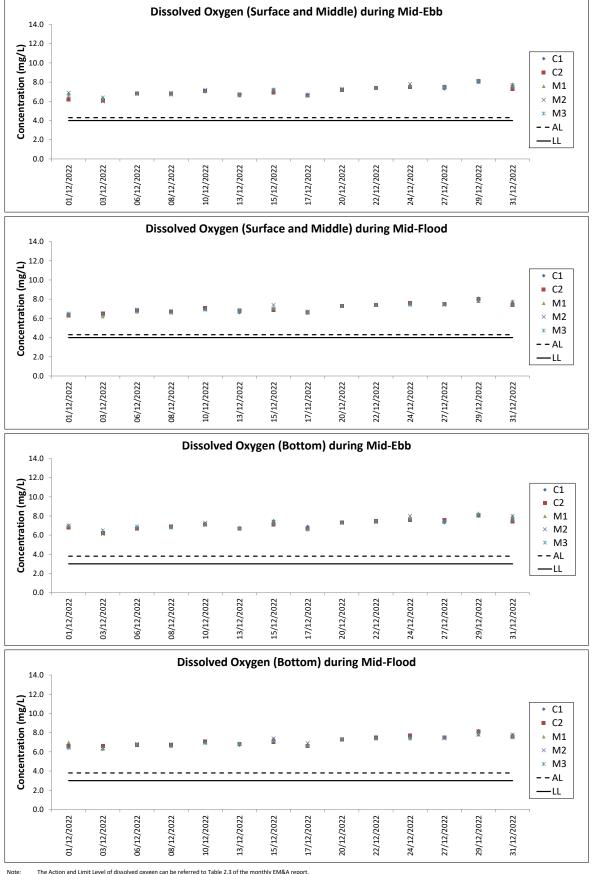
The Action and Limit Level of dissolved oxygen can be referred to Table 2.3 of the monthly EM&A report. Major site activities carried out during the reporting period are summarized in Section 1.4 of the monthly EM&A report. Weather conditions during monitoring are presented in the data tables above. QA/ QC requirements as stipulated in the EM&A Manual were carried out during measurement.

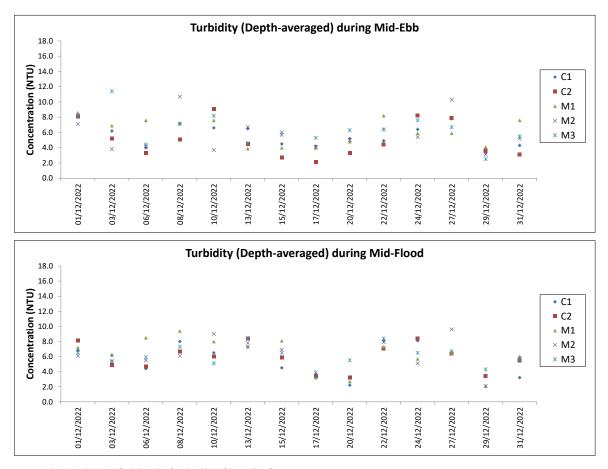
The Action and Limit Level of turbidity can be referred to Table 2.3 of the monthly EM&A report. Major site activities carried out during the reporting period are summarized in Section 1.4 of the monthly EM&A report. Weather conditions during monitoring are presented in the data tables above. QA/ QC requirements as stipulated in the EM&A Manual were carried out during measurement. Note:

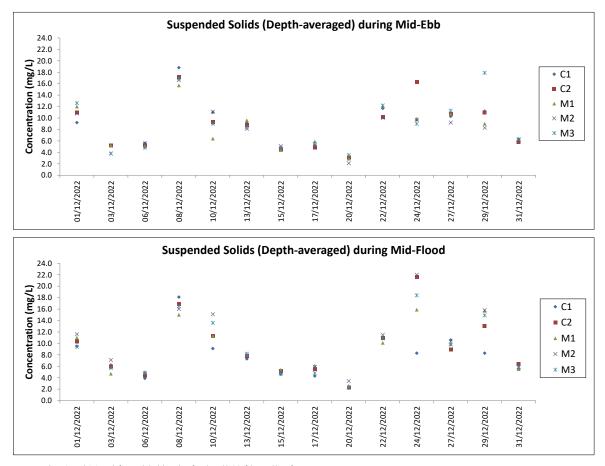
The Action and Limit Level of suspended solids can be referred to Table 2.3 of the monthly EM&A report. Major site activities carried out during the reporting period are summarized in Section 1.4 of the monthly EM&A report. Weather conditions during monitoring are presented in the data tables above. QA/ QC requirements as stipulated in the EM&A Manual were carried out during measurement. Note
