# **Airport City Link**

Monthly EM&A Report for March 2023

# This Submission of Construction Phase Monthly Environmental Monitoring and Audit (EM&A) Report for March 2023

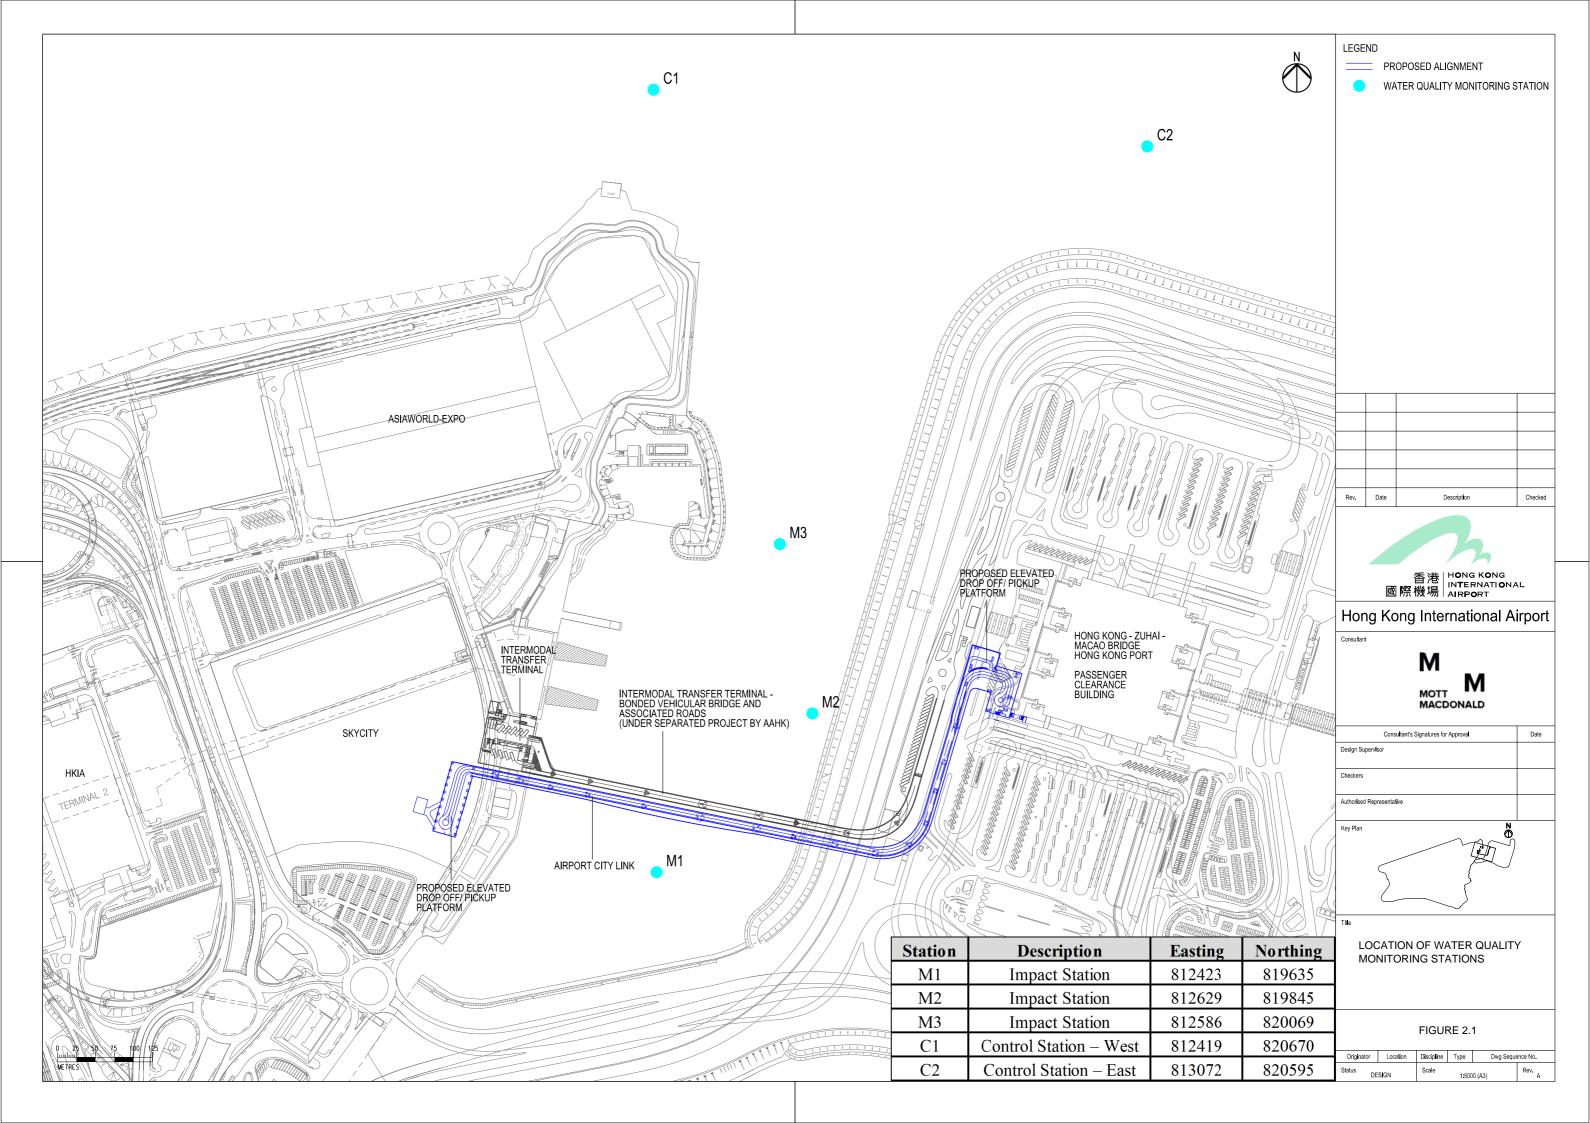
# **Figure 2.1 Water Quality Monitoring Locations**

The water quality monitoring was conducted at three locations in the sea channel between the HKIA and the HKBCF (M1, M2 and M3) and two control stations (C1 and C2), locations are shown in **Figure 2.1** and summarized in **Table 2.1**.

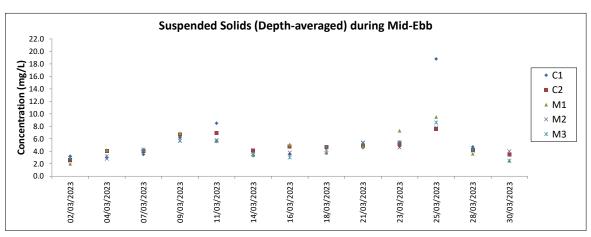
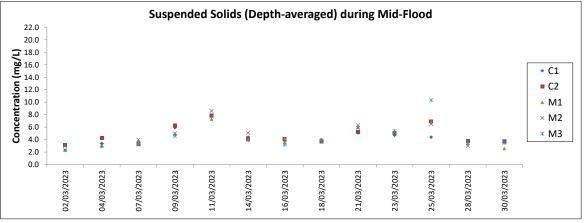
Note: The Action and Limit Level of suspended solids can be referred to Table 2.3 of the monthly EM&A report.
