Airport City Link

Monthly EM&A Report for August 2023

This Submission of Construction Phase Monthly Environmental Monitoring and Audit (EM&A) Report for August 2023

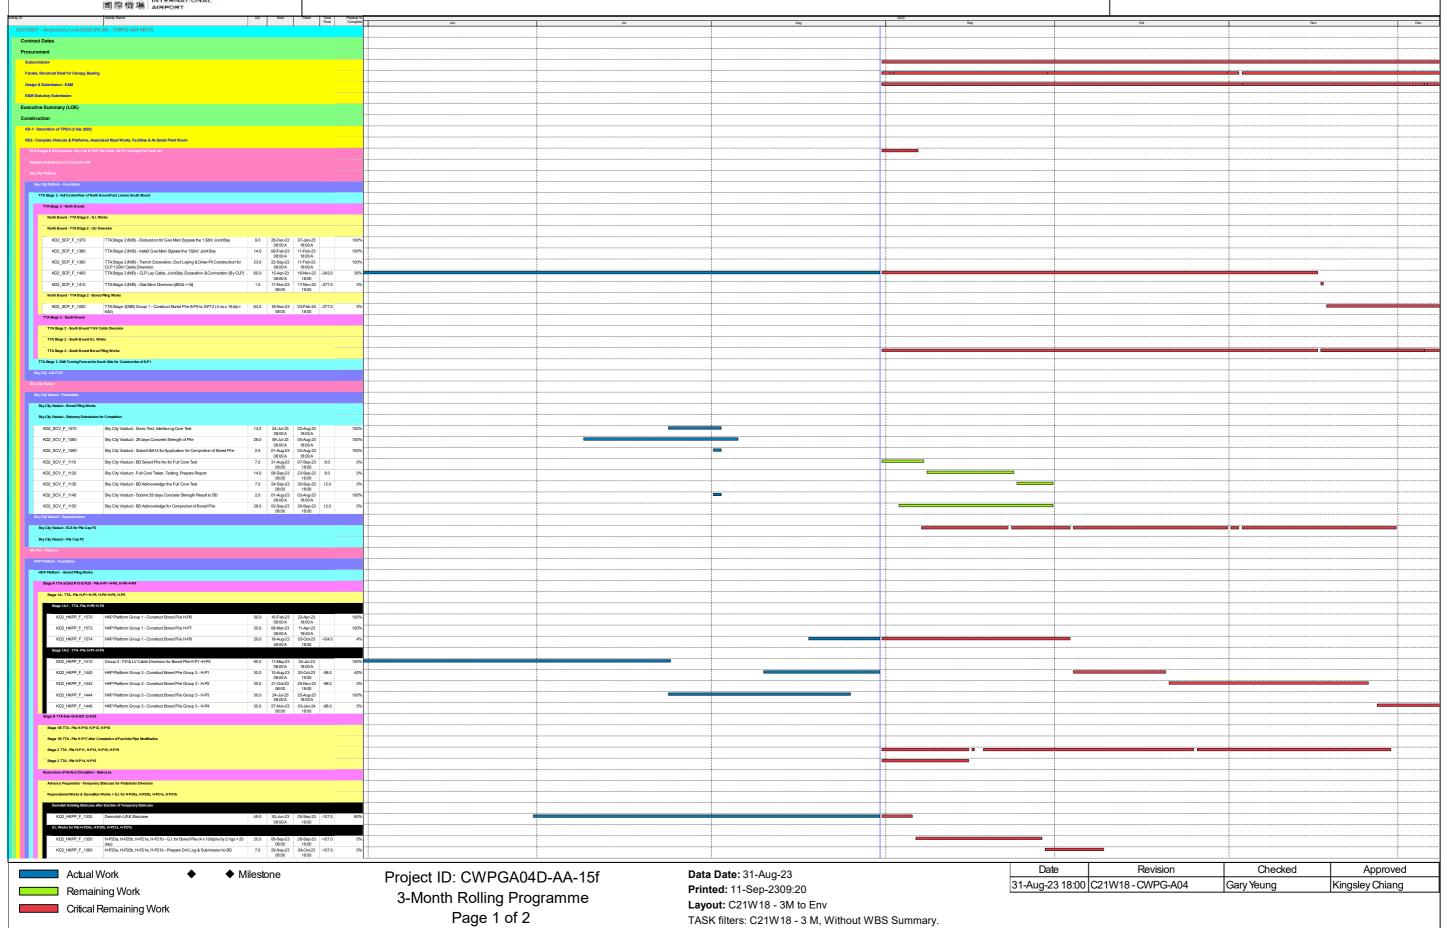
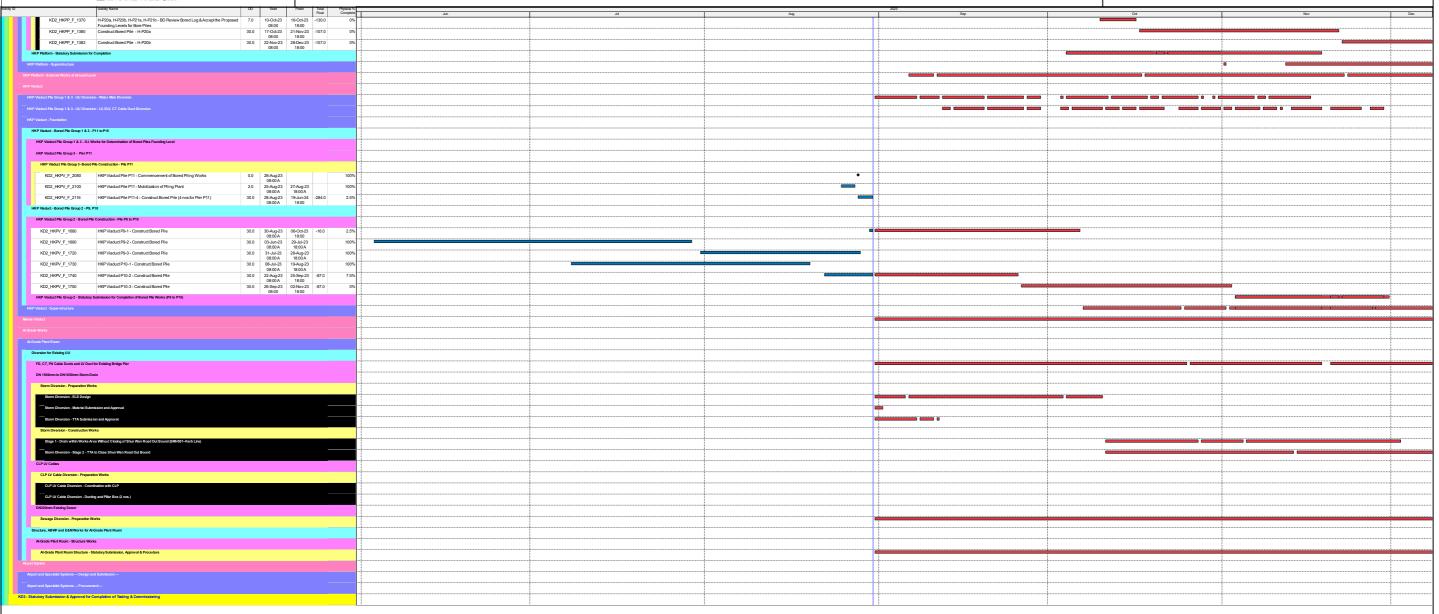
Contract C21W18 - Airportcity Link 20230831 - 3-Month Rolling Programme

TASK filters: C21W18 - 3 M, Without WBS Summary.

Actual Work

Remaining Work

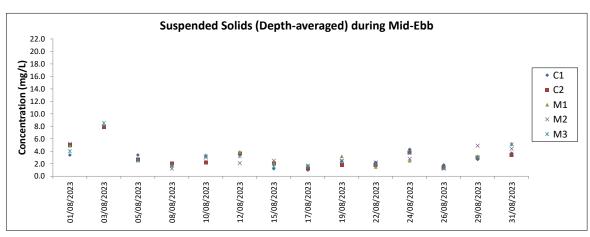
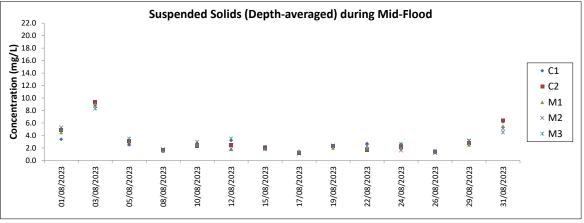
Note: The Action and Limit Level of suspended solids can be referred to Table 2.3 of the monthly EM&A report.
