# **Airport City Link**

Monthly EM&A Report for November 2023

# This Submission of Construction Phase Monthly Environmental Monitoring and Audit (EM&A) Report for November 2023

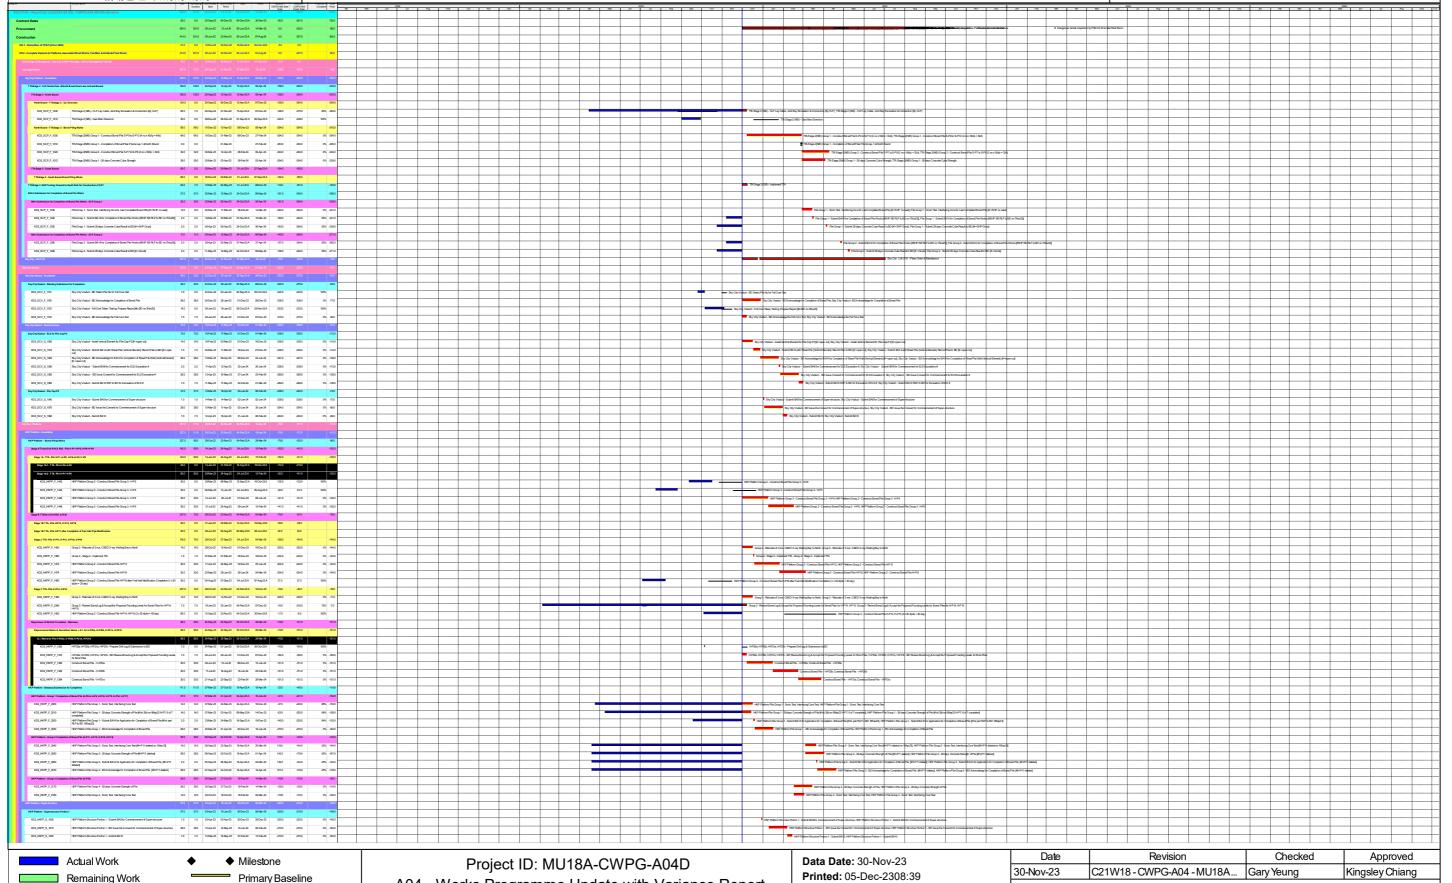
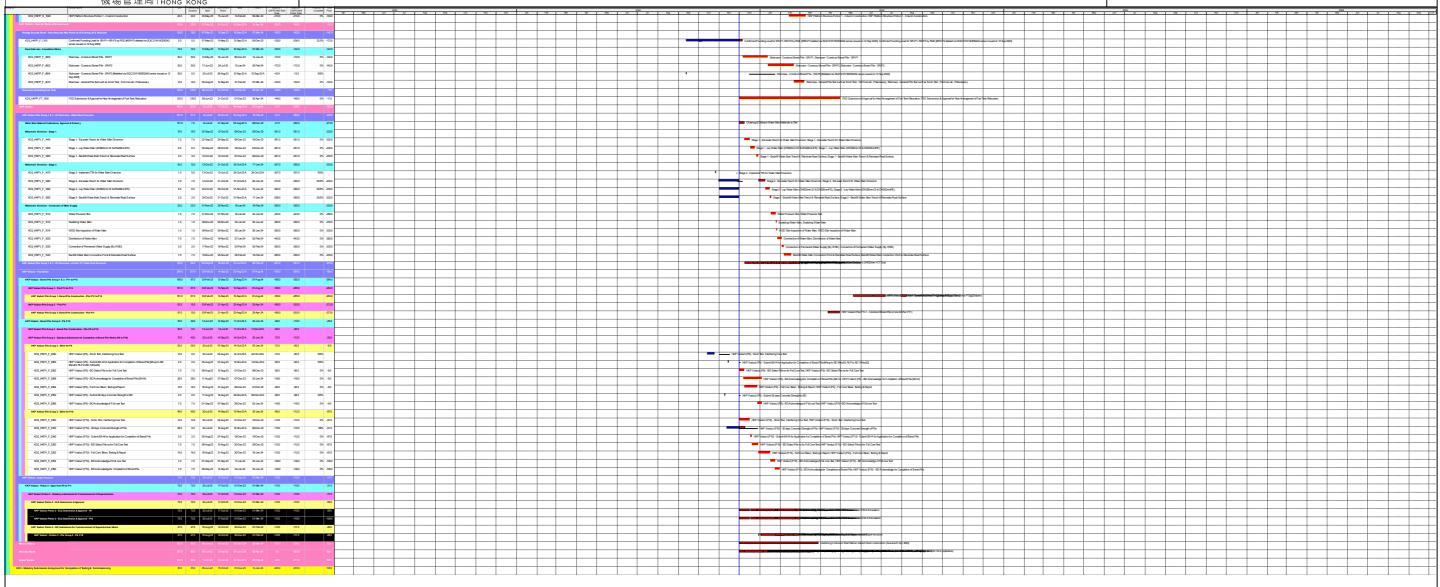
# Contract C21W18 - Airportcity Link - Land Viaducts at Hong Kong Port and Airport Island MU18A - Works Programme Update (CWPG-A04) DD 30-Nov-23

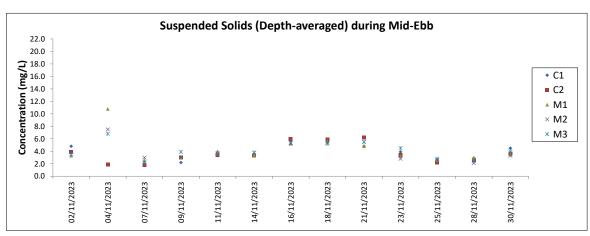
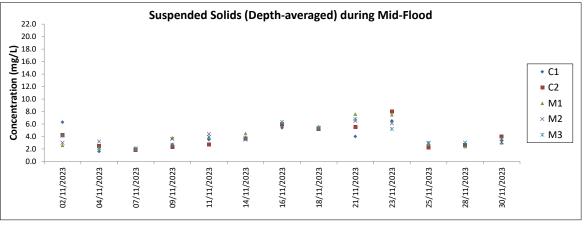
Note: The Action and Limit Level of suspended solids can be referred to Table 2.3 of the monthly EM&A report.
