**Contract No. EP/SP/58/08**

**Sludge Treatment Facilities**

**Quarterly Environmental Monitoring and Audit Report**

**December 2011 to February 2012**

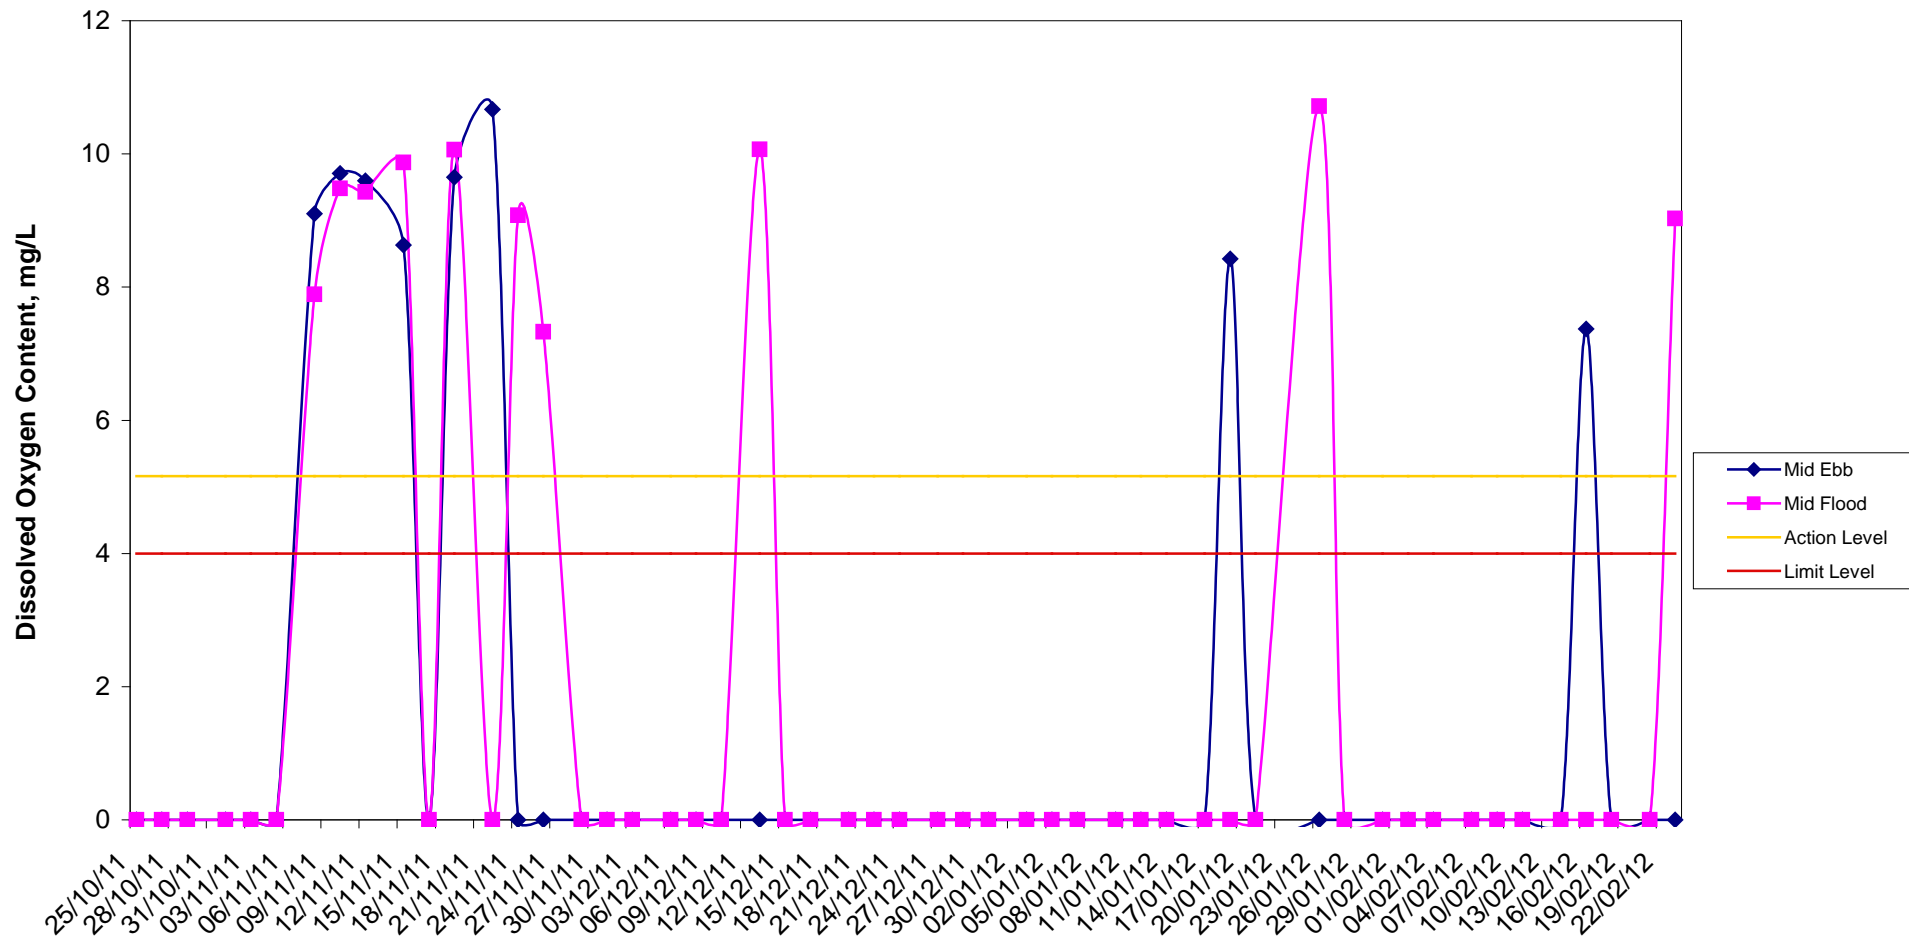
## C1 - Dissolved Oxygen Content

Remark: No water at C1 occasionally after 17/02/2011. Zero values are shown in the graph
