Route 8 (previously known as Route 9) between Cheung Sha Wan & Sha Tin

Contract No. HY/2003/10 - Environmental Team for Lai Chi Kok Viaduct and Eagle's Nest Tunnel

Monthly EM&A Report
Part II – Eagle's Nest Tunnel & Associated Works
(Version 1.0)

October 2007

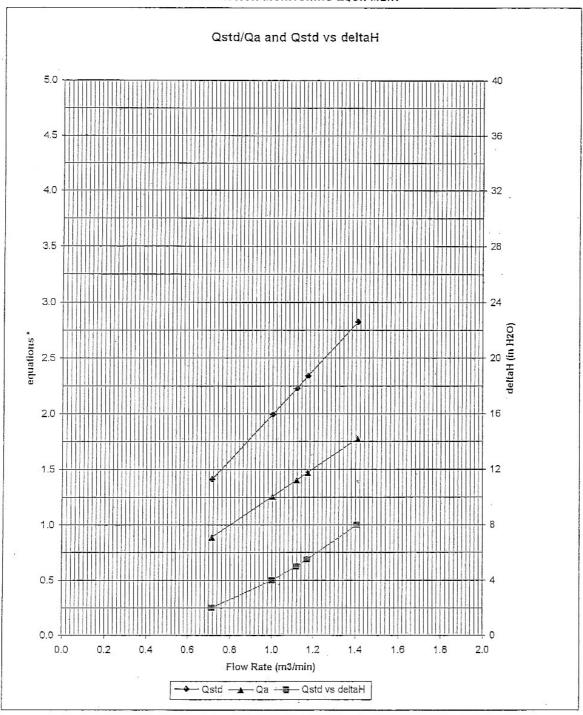
* y-axis equations:

Qstd series:
