**Proposed Extension of Public Golf Course
at Kau Sai Chau Island, Sai Kung**

**Monthly Environmental Monitoring & Audit (EM&A) Report
for December 2006**

(Report No. 382210/012)

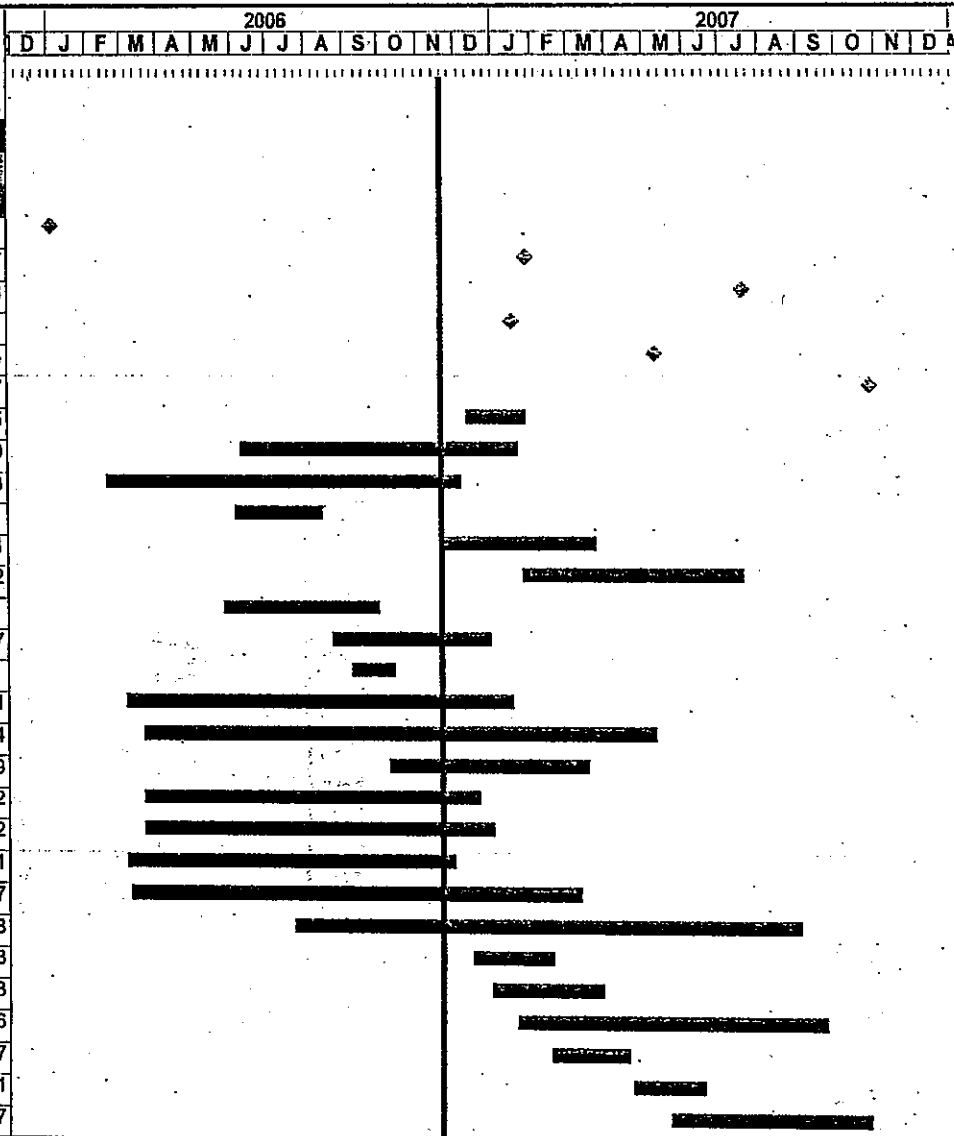
Start Date 28/12/05
 Finish Date 27/10/07
 Data Date 20/11/06
 Run Date 04/12/06 16:25

Summary Bar
 Progress Bar

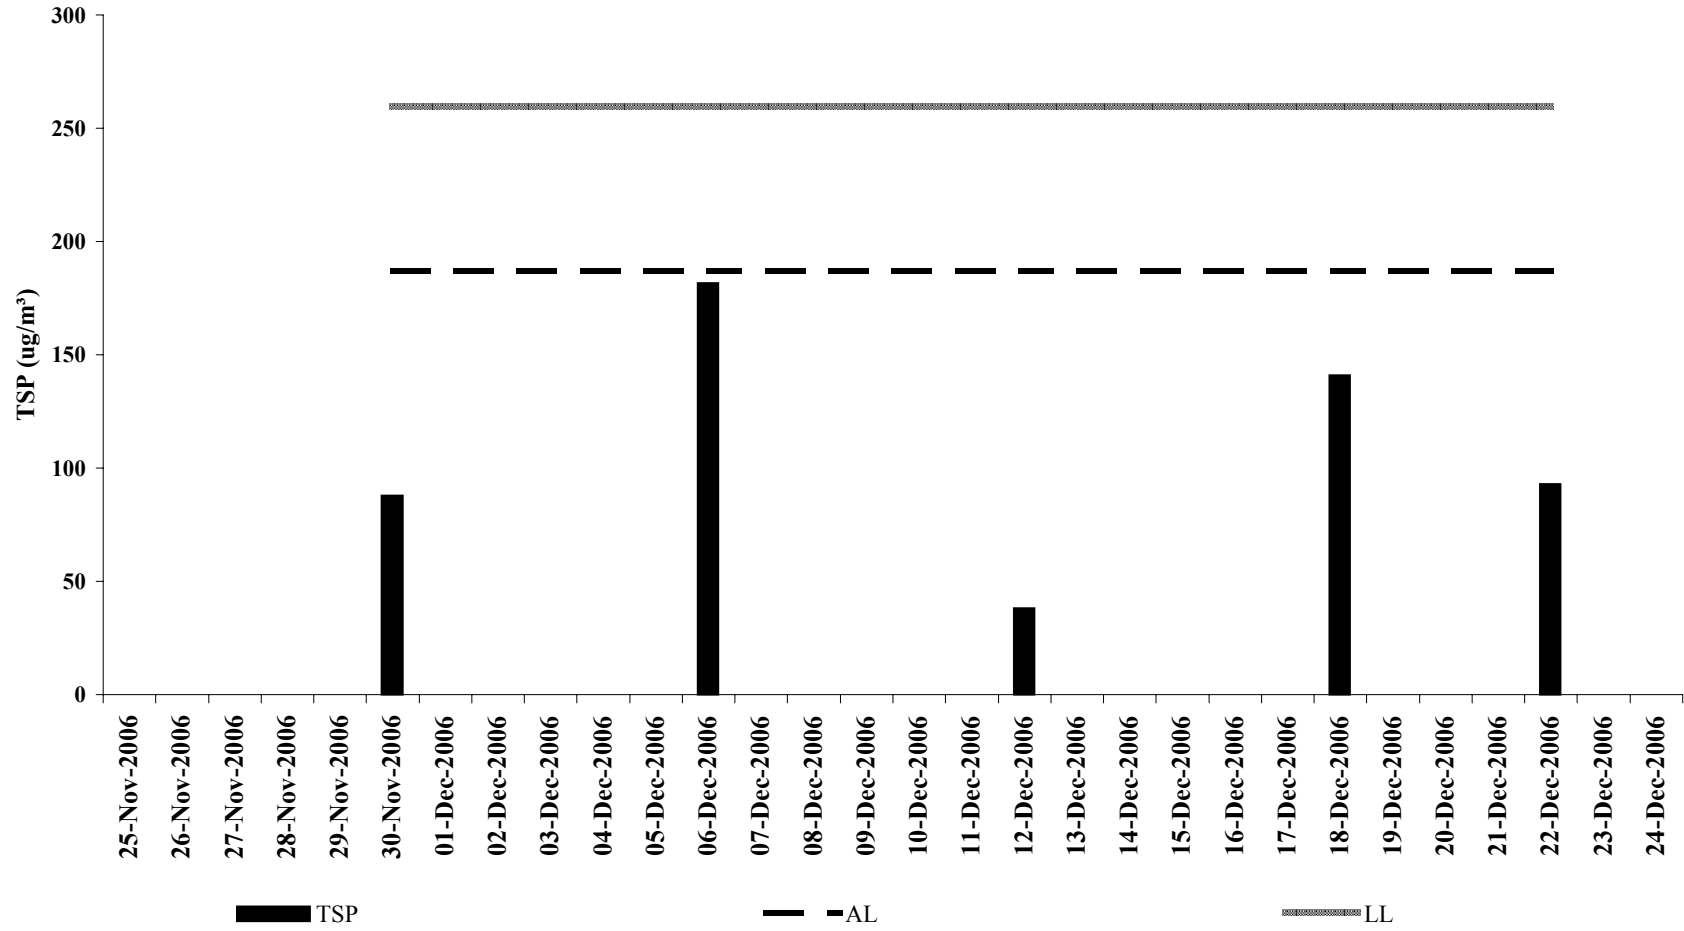
24-hour TSP Monitoring Results at Station GCA B1

Remark: **Bold** value indicated an Action level exceedance
 Bold & Italic value indicated an Limit level exceedance

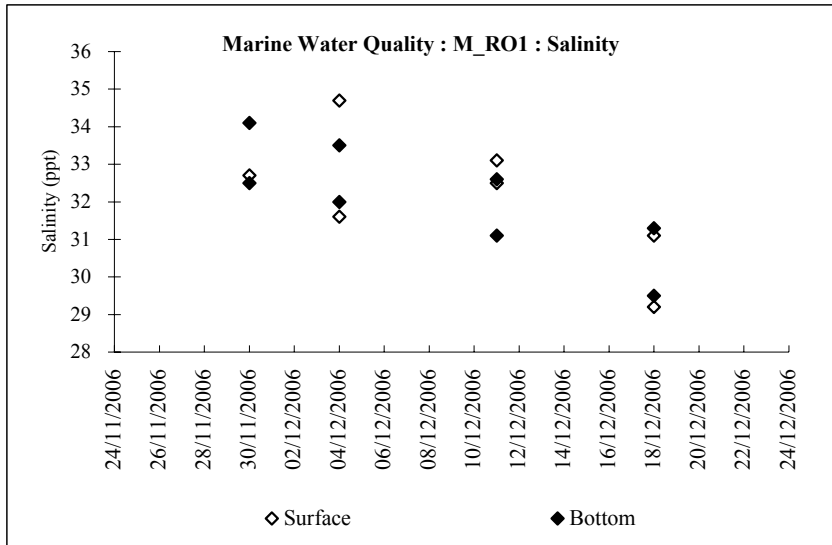
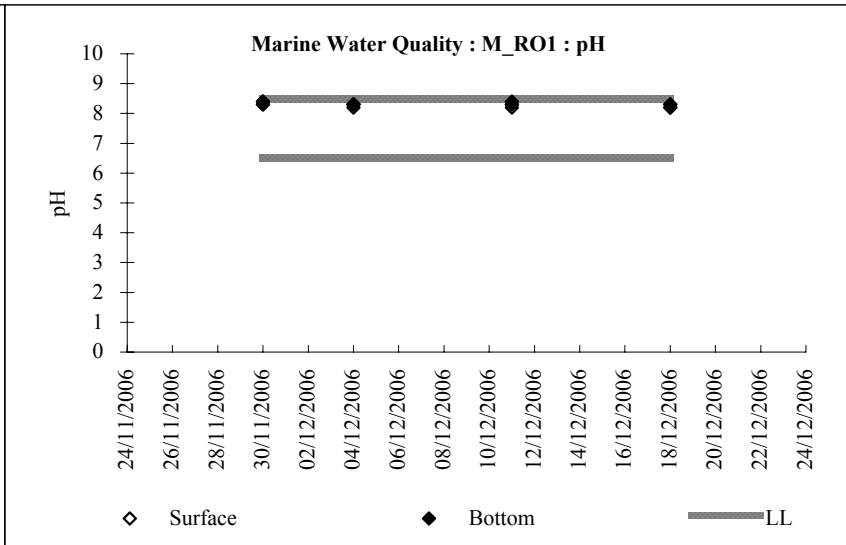
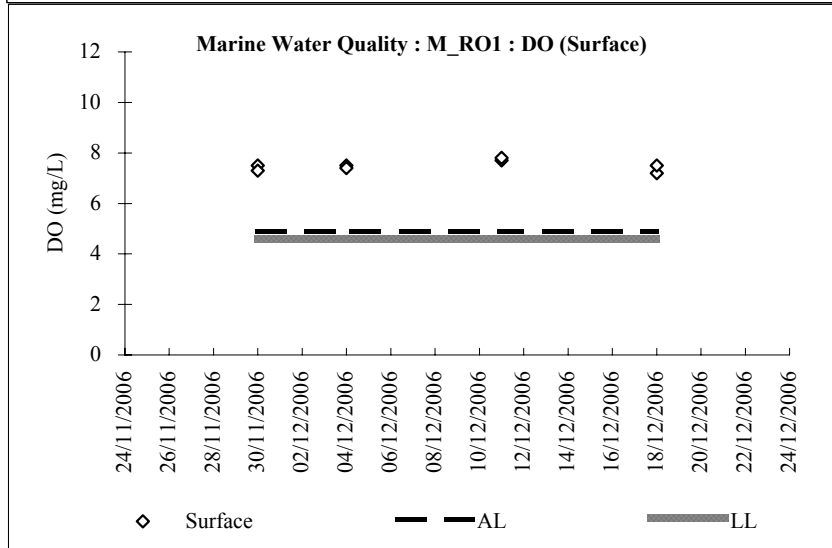
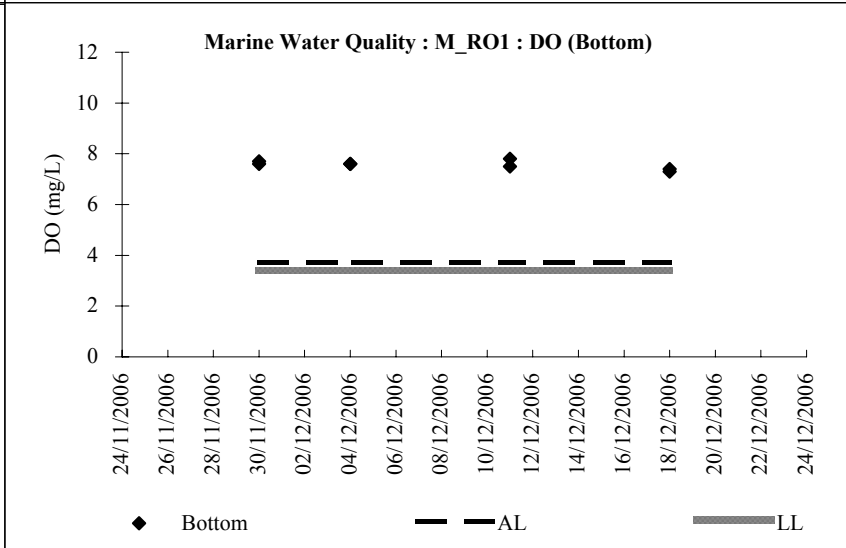
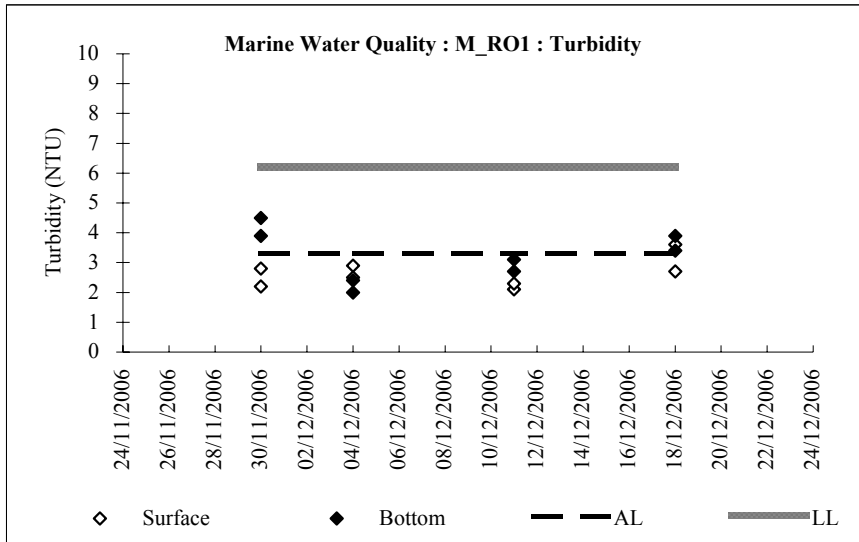
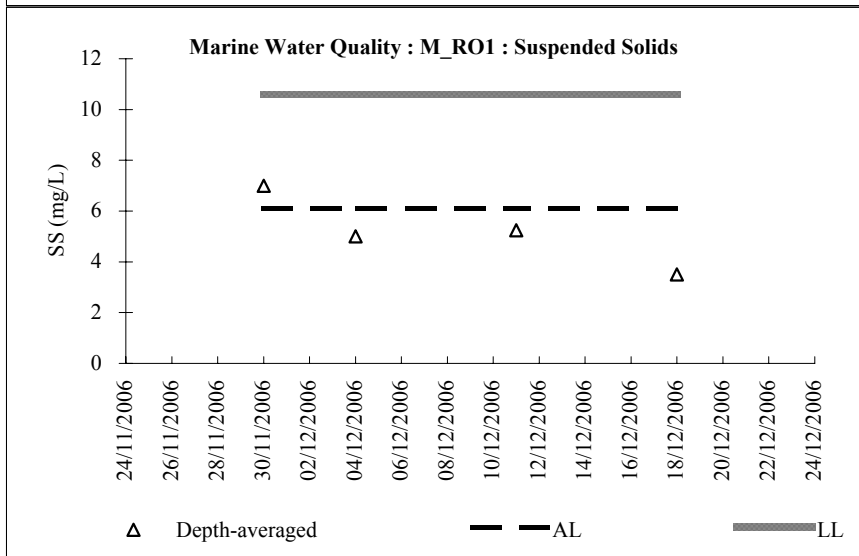
M_RO1	Mid-Ebb			Mid-Flood			Depth-averaged
	Surface	Middle	Bottom	Surface	Middle	Bottom	SS (mg/L)
30/11/2006	4.0	-	10.0	5.0	-	9.0	7.0
04/12/2006	6.0	-	7.0	3.0	-	4.0	5.0
11/12/2006	5.0	-	4.0	6.0	-	6.0	5.3
18/12/2006	4.0	-	3.0	3.0	-	4.0	3.5

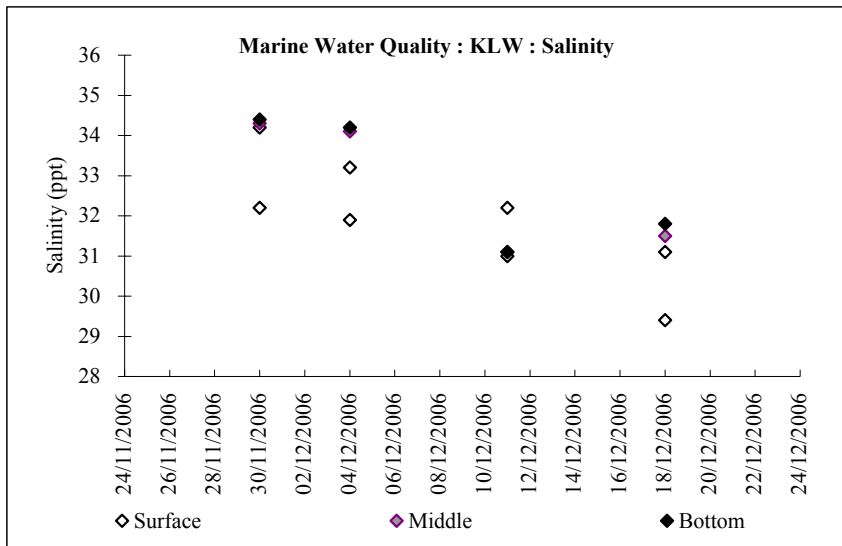
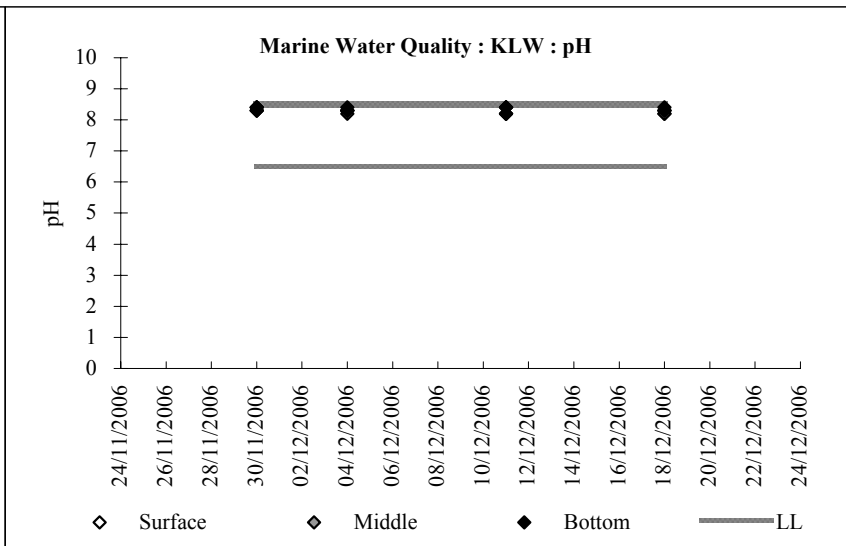
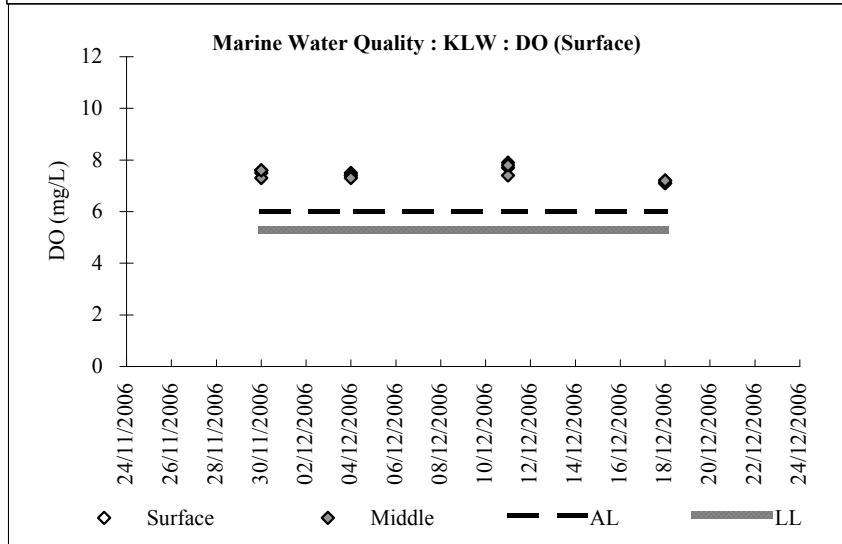
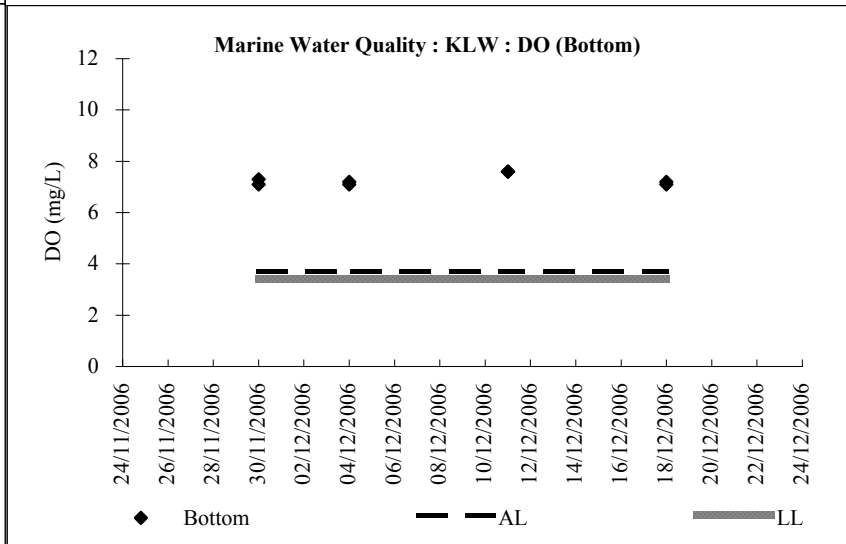
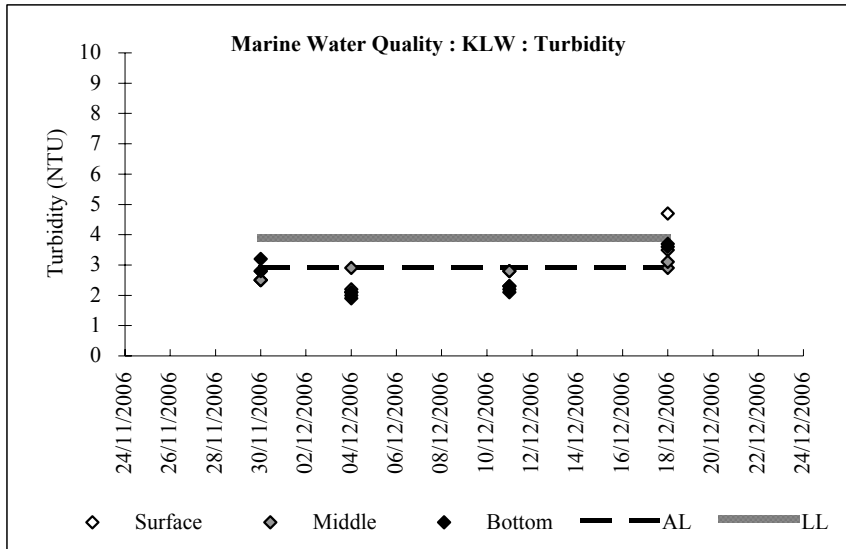
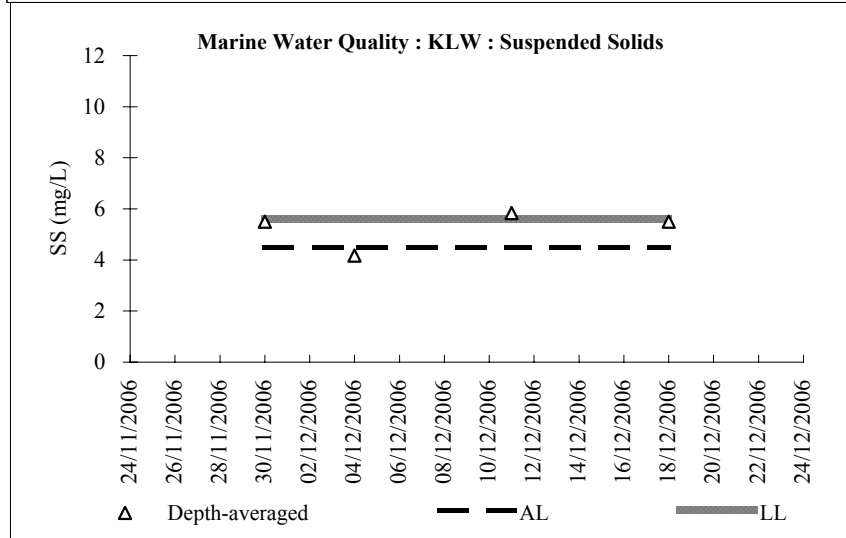
KLW	Mid-Ebb			Mid-Flood			Depth-averaged
	Surface	Middle	Bottom	Surface	Middle	Bottom	SS (mg/L)
30/11/2006	4.0	3.0	4.0	5.0	11.0	6.0	5.5
04/12/2006	3.0	4.0	5.0	4.0	6.0	3.0	4.2
11/12/2006	3.0	8.0	10.0	4.0	6.0	4.0	5.8
18/12/2006	5.0	6.0	5.0	6.0	5.0	6.0	5.5

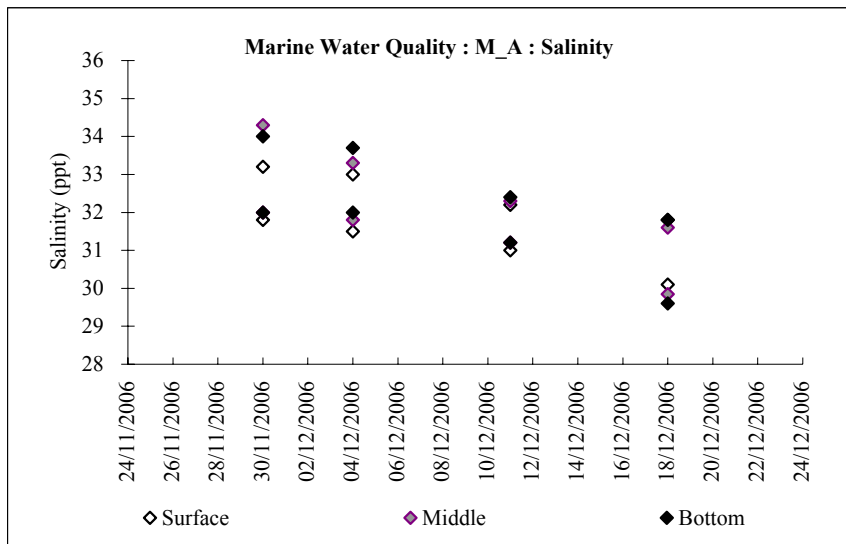
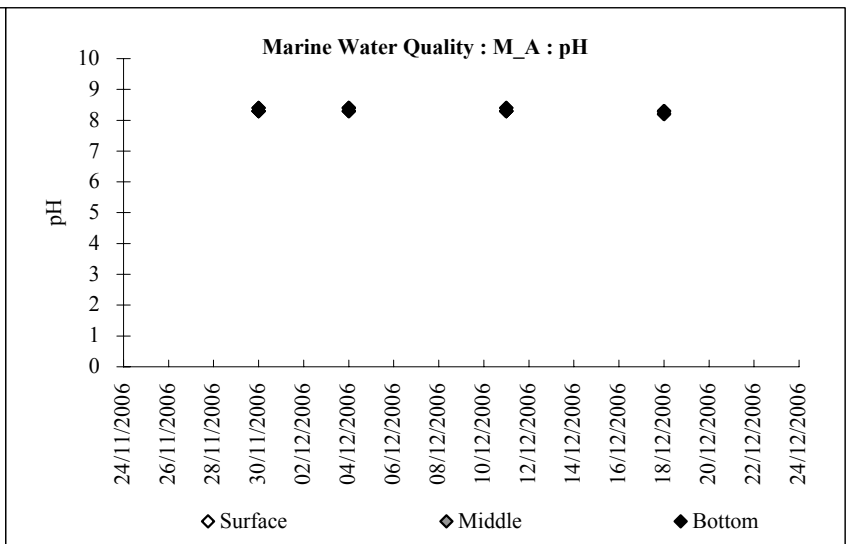
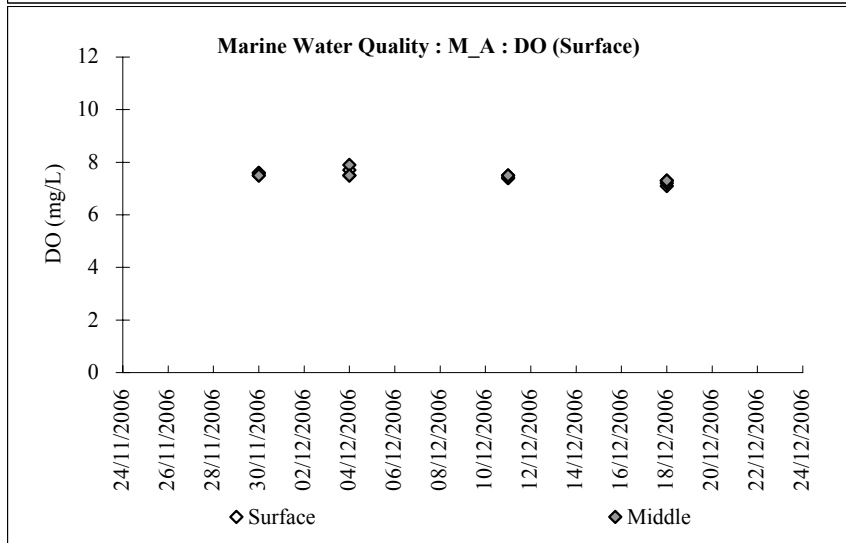
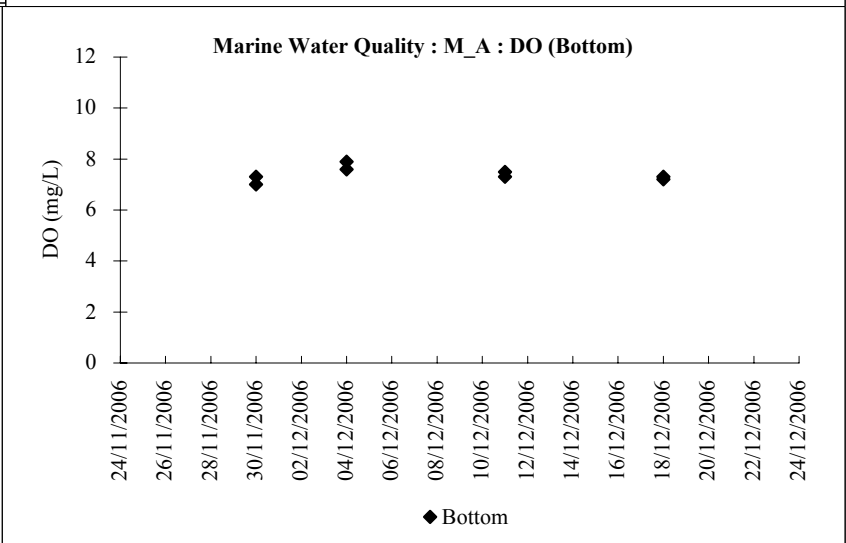
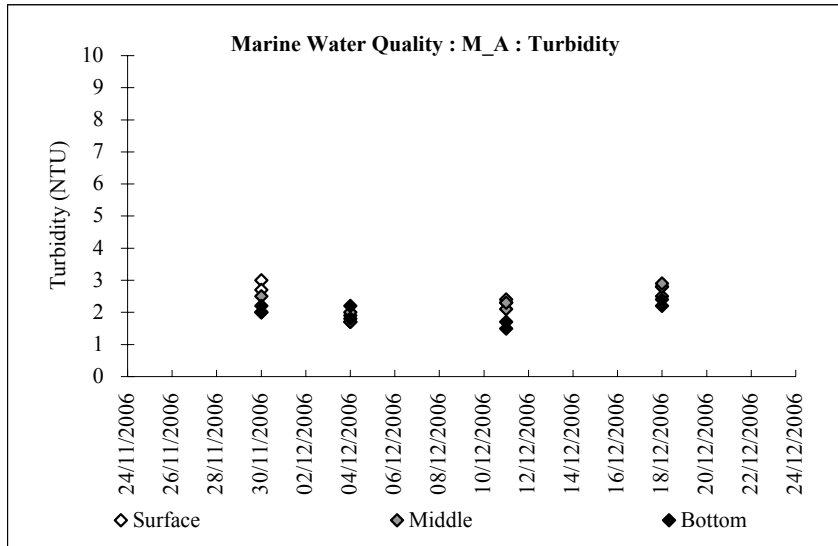
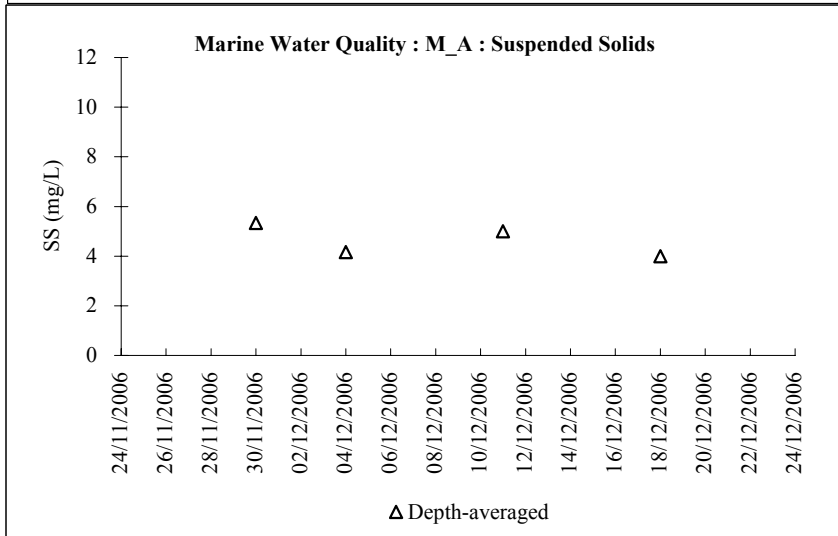
M_A	Mid-Ebb			Mid-Flood			Depth-averaged
	Surface	Middle	Bottom	Surface	Middle	Bottom	SS (mg/L)
30/11/2006	15.0	2.0	3.0	3.0	6.0	3.0	5.3
04/12/2006	4.0	4.0	5.0	4.0	4.0	4.0	4.2
11/12/2006	6.0	4.0	6.0	4.0	6.0	4.0	5.0
18/12/2006	4.0	4.0	4.0	3.0	6.0	3.0	4.0

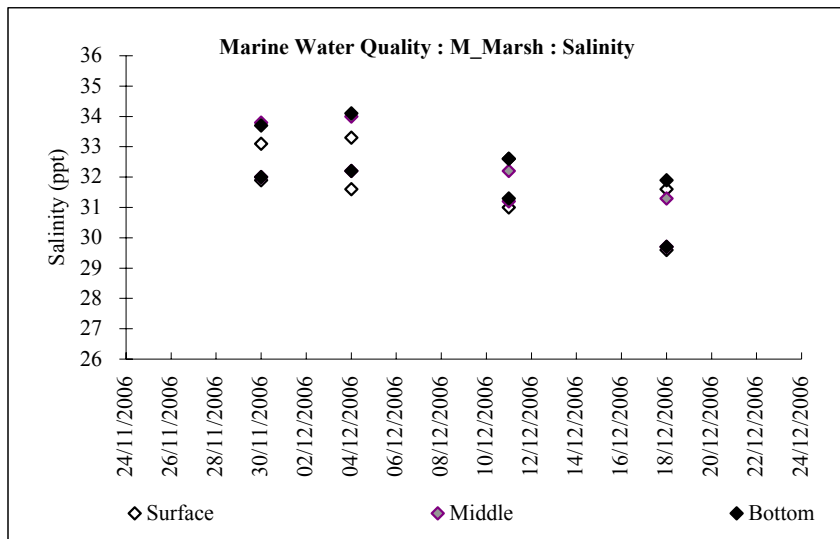
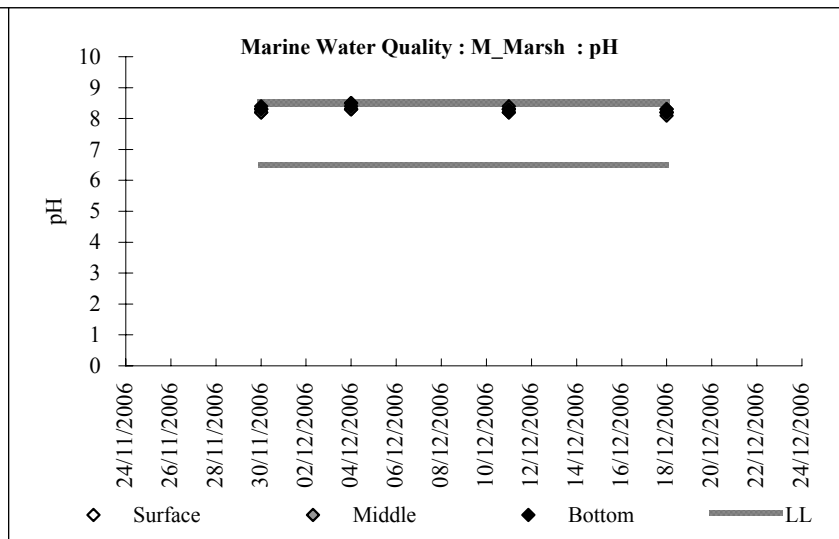
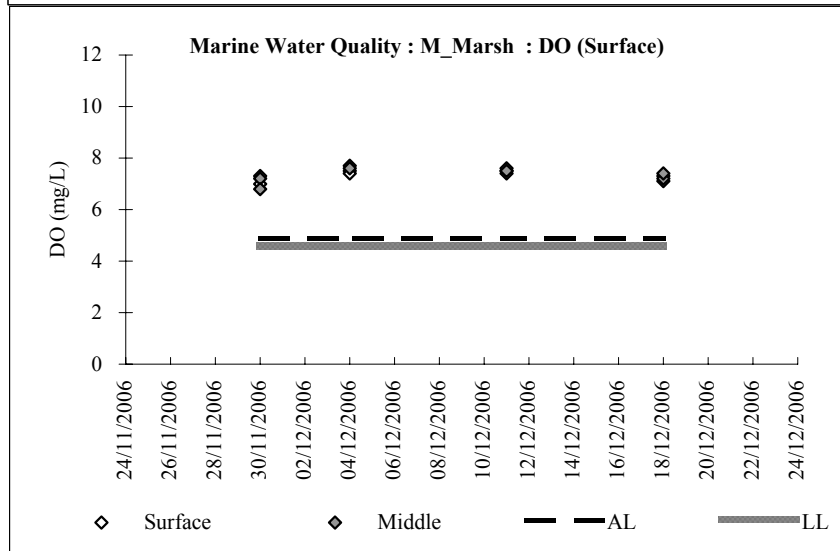
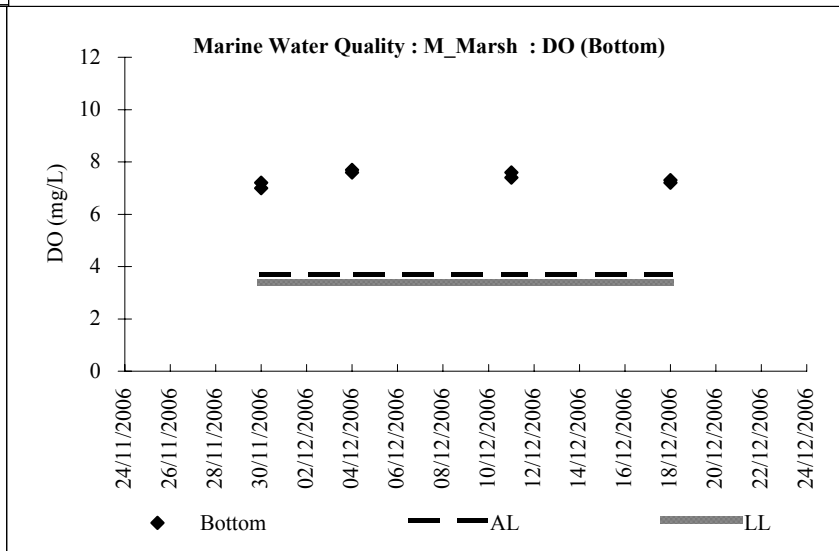
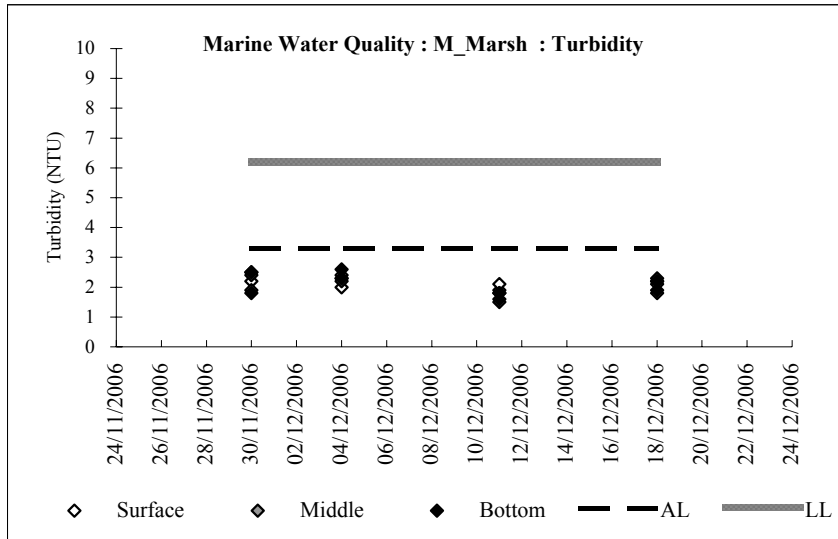
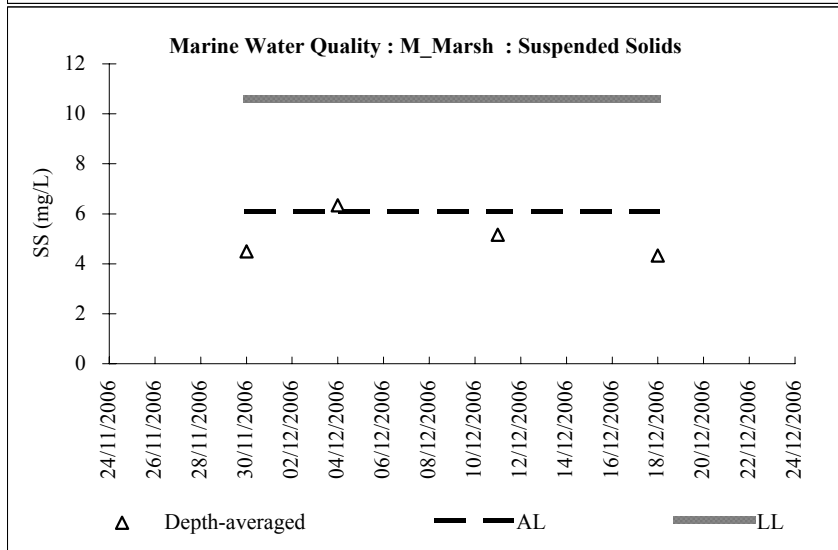
M_Marsh	Mid-Ebb			Mid-Flood			Depth-averaged
	Surface	Middle	Bottom	Surface	Middle	Bottom	SS (mg/L)
30/11/2006	4.0	4.0	5.0	4.0	6.0	4.0	4.5
04/12/2006	5.0	6.0	7.0	6.0	6.0	8.0	6.3
11/12/2006	4.0	5.0	4.0	10.0	4.0	4.0	5.2
18/12/2006	6.0	6.0	2.0	3.0	6.0	3.0	4.3

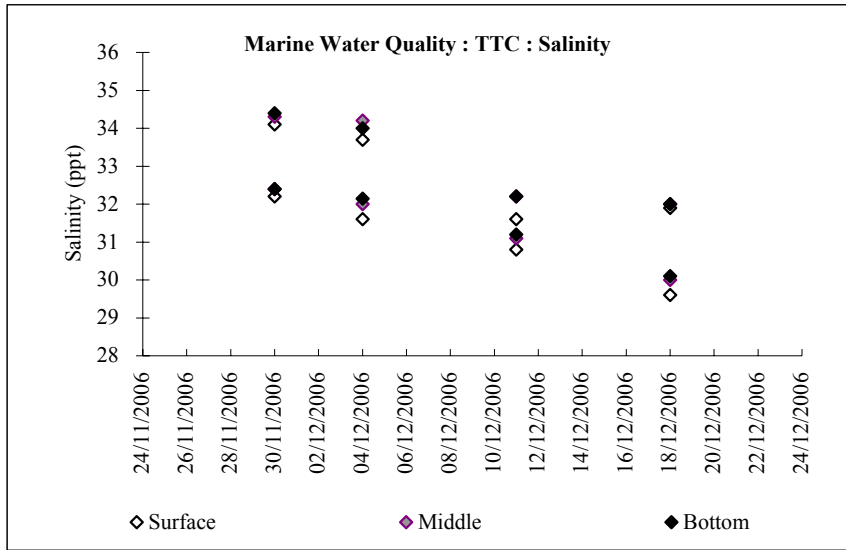
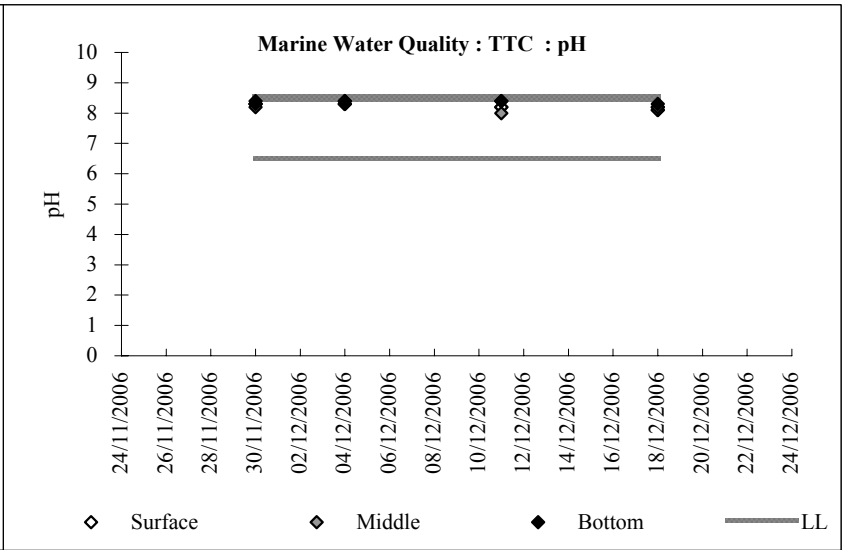
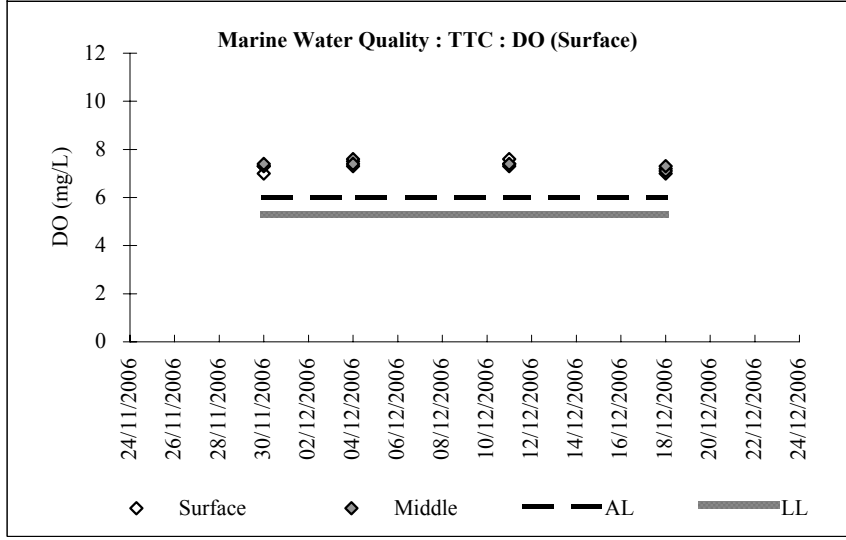
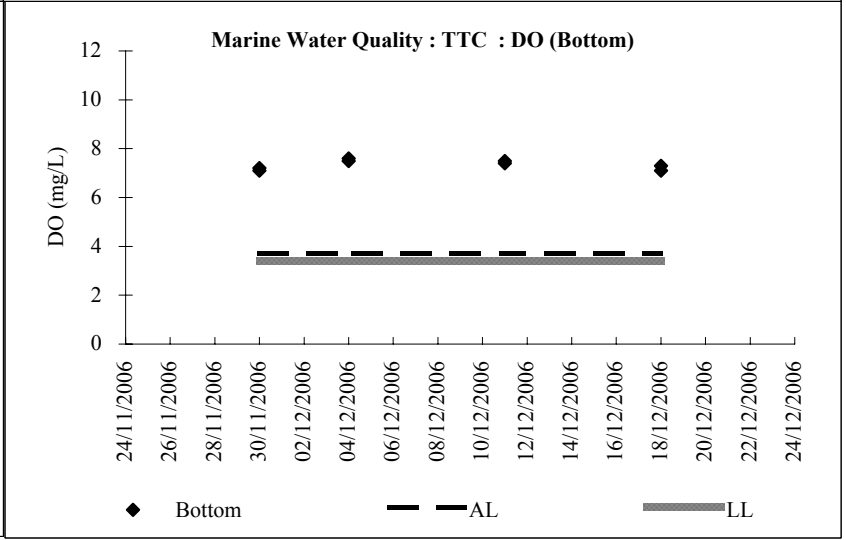
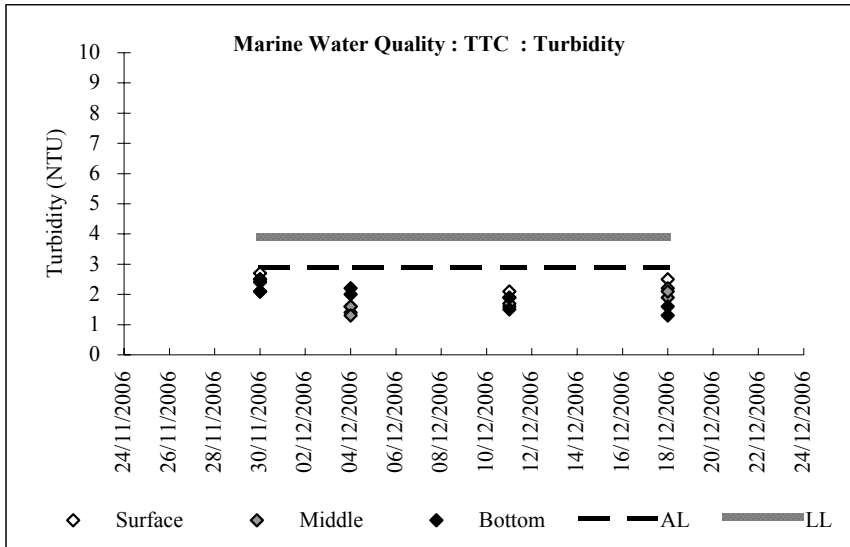
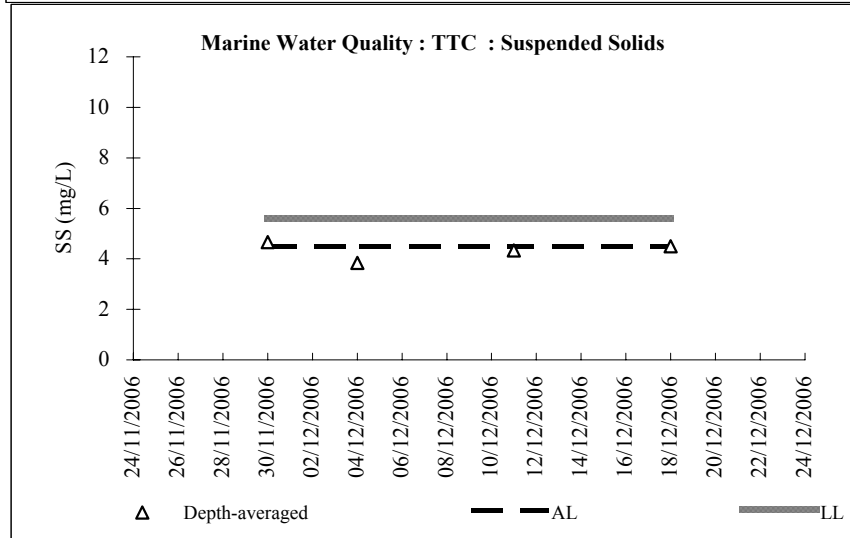
TTC	Mid-Ebb			Mid-Flood			Depth-averaged
	Surface	Middle	Bottom	Surface	Middle	Bottom	SS (mg/L)
30/11/2006	5.0	4.0	5.0	6.0	5.0	3.0	4.7
04/12/2006	4.0	5.0	5.0	2.0	2.0	5.0	3.8
11/12/2006	5.0	3.0	5.0	4.0	5.0	4.0	4.3
18/12/2006	3.0	4.0	12.0	2.0	4.0	2.0	4.5

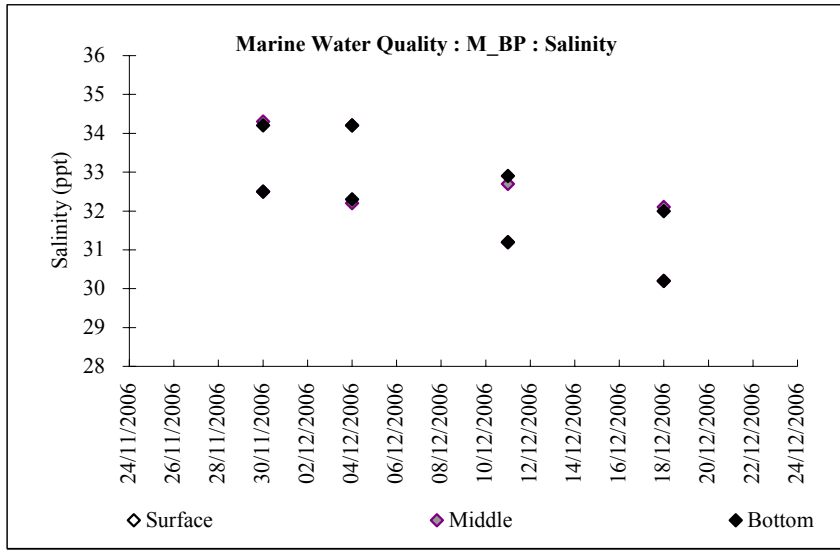
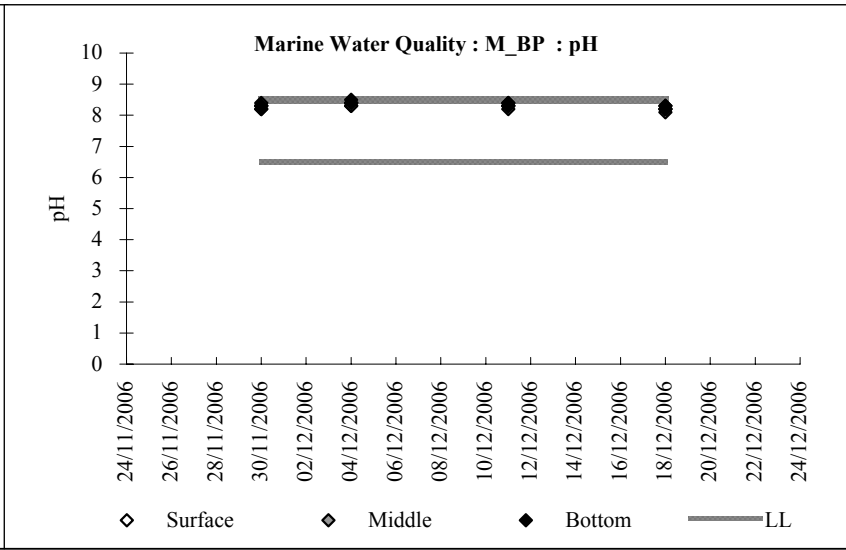
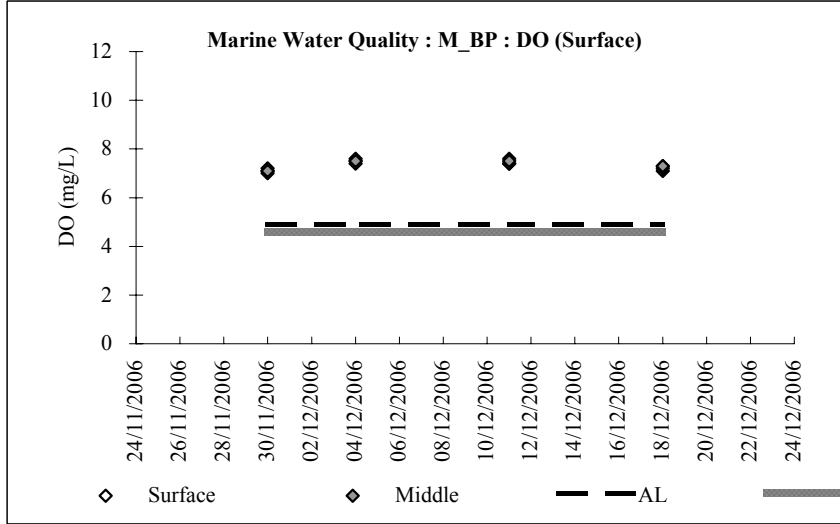
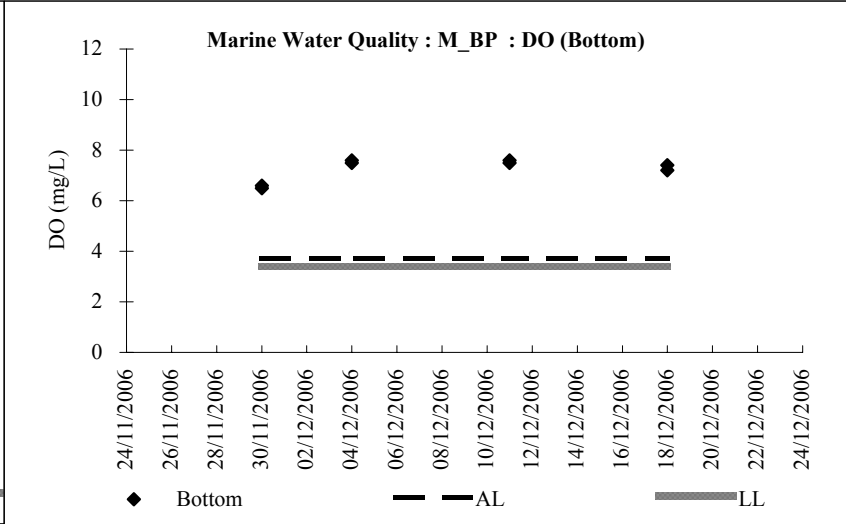
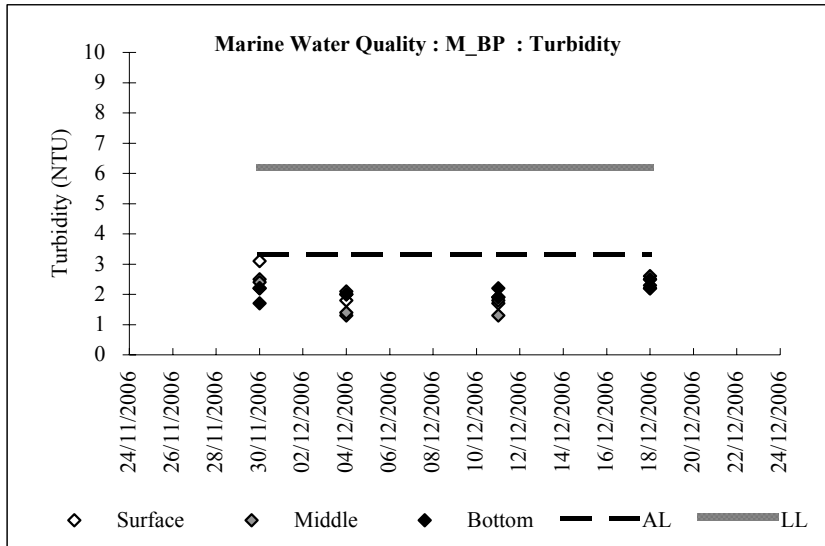
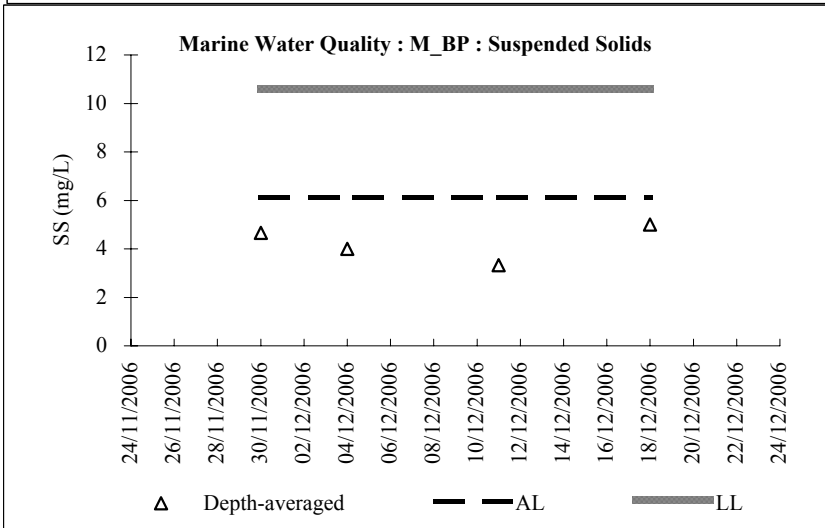
M_BP	Mid-Ebb			Mid-Flood			Depth-averaged
	Surface	Middle	Bottom	Surface	Middle	Bottom	SS (mg/L)
30/11/2006	6.0	5.0	6.0	4.0	4.0	3.0	4.7
04/12/2006	4.0	4.0	4.0	6.0	4.0	2.0	4.0
11/12/2006	3.0	3.0	4.0	4.0	3.0	3.0	3.3
18/12/2006	6.0	5.0	4.0	5.0	5.0	5.0	5.0

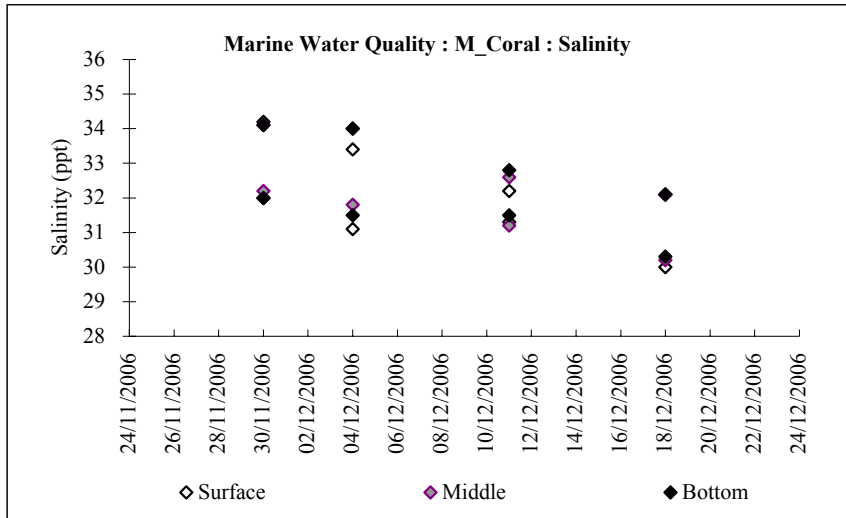
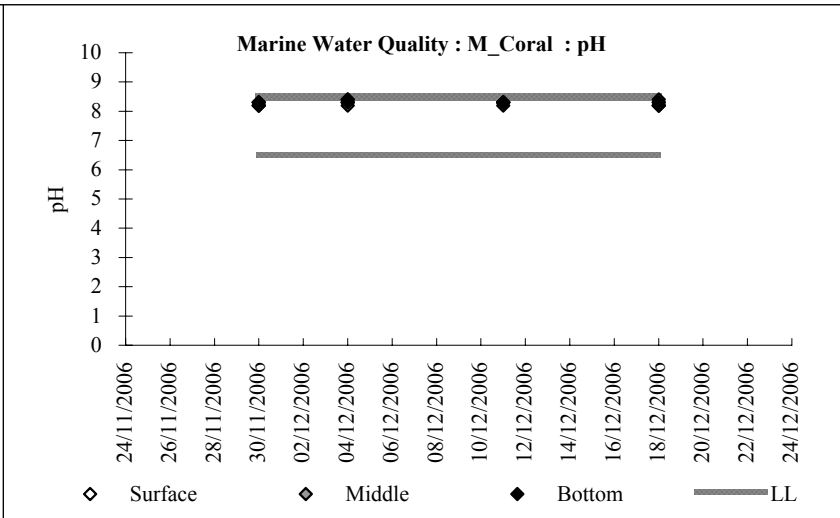
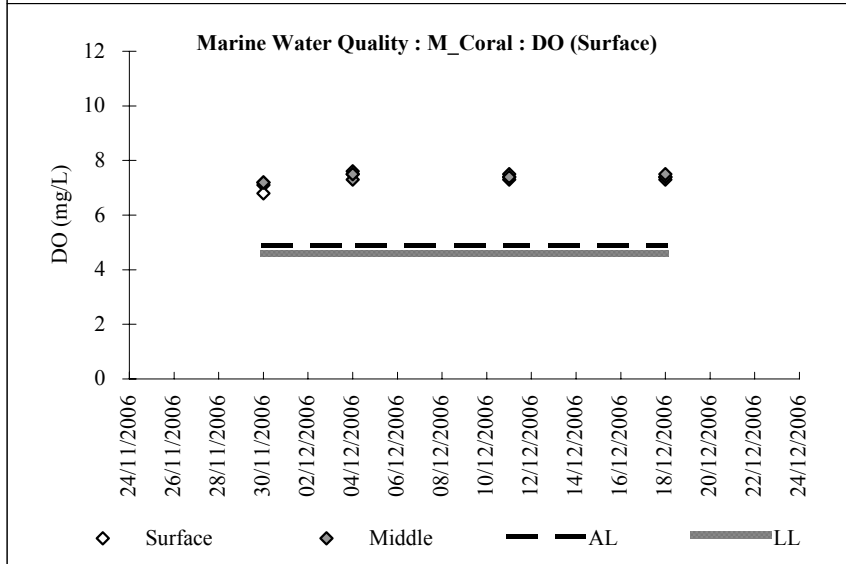
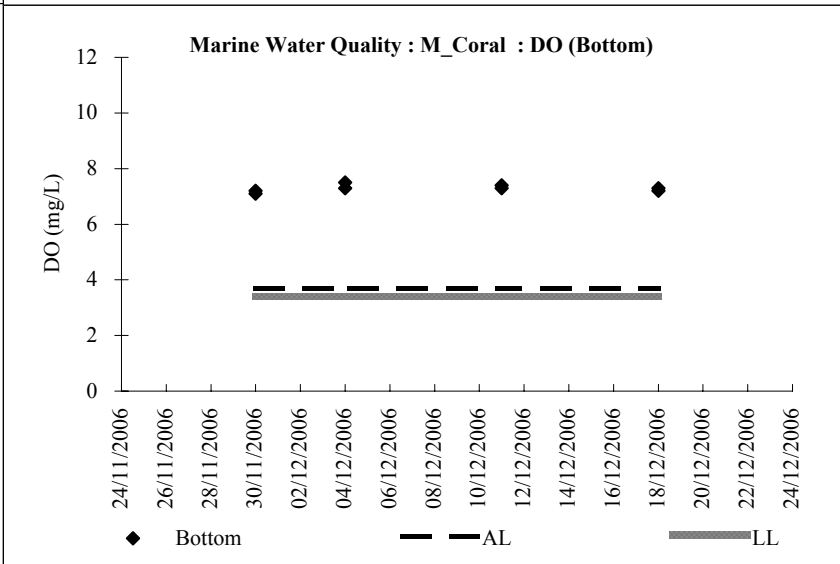
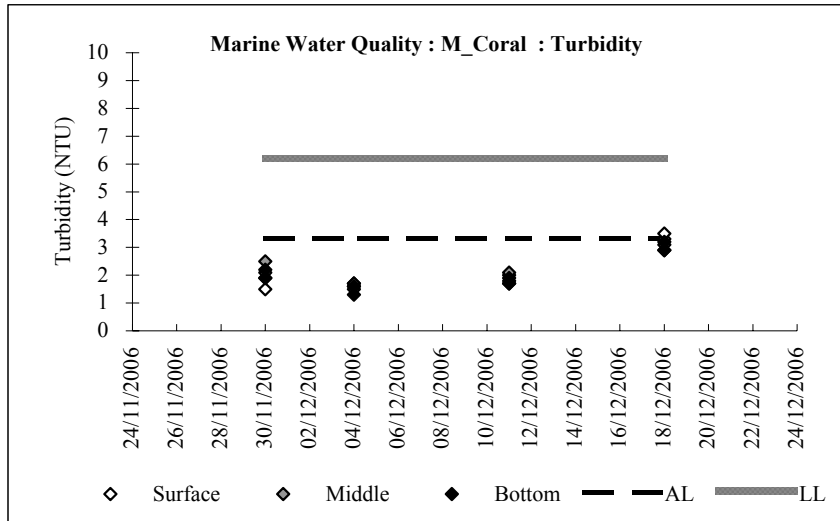
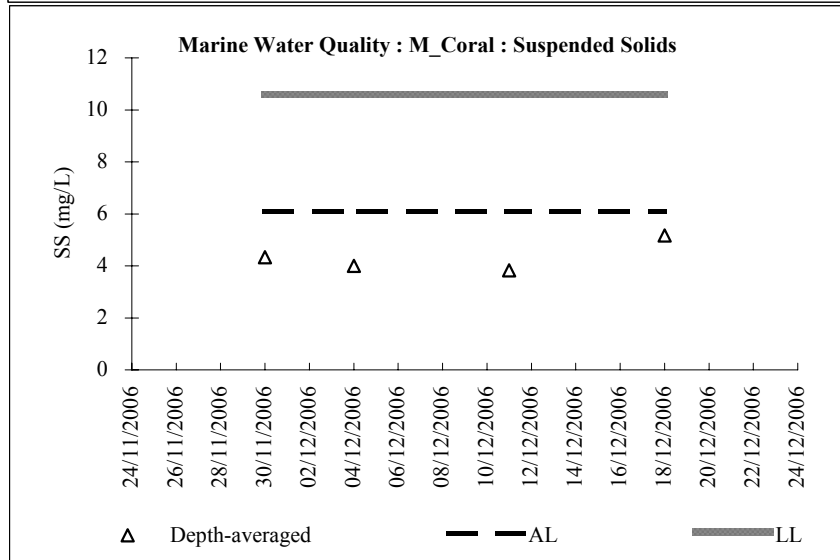
M_Coral		Middle							
tide condition	Date	time	Water depth (m)	Sampling depth (m)	Temp (°C)	Salinity (ppt)	DO (mg/L)	pH	Turbidity (NTU)
Mid-Ebb	30/11/2006	09:26	9.3	4.7	23.1	32.2	7.2	8.3	1.9
Mid-Ebb	04/12/2006	11:26	9.5	4.8	21.9	31.8	7.3	8.3	1.6
Mid-Ebb	11/12/2006	16:16	10.2	5.1	22.0	32.6	7.3	8.3	1.7
Mid-Ebb	18/12/2006	11:26	9.6	4.8	18.6	30.2	7.4	8.2	2.9

M_Coral		Middle							
tide condition	Date	time	Water depth (m)	Sampling depth (m)	Temp (°C)	Salinity (ppt)	DO (mg/L)	pH	Turbidity (NTU)
Mid-Flood	30/11/2006	13:16	10.0	5.0	23.1	34.1	7.2	8.2	2.5
Mid-Flood	04/12/2006	14:16	10.1	5.1	22.2	34.0	7.5	8.2	1.7
Mid-Flood	11/12/2006	13:11	9.3	4.7	21.6	31.2	7.4	8.3	2.1
Mid-Flood	18/12/2006	14:16	10.0	5.0	18.9	32.1	7.5	8.3	3.1

M_Coral		Bottom							
tide condition	Date	time	Water depth (m)	Sampling depth (m)	Temp (°C)	Salinity (ppt)	DO (mg/L)	pH	Turbidity (NTU)
Mid-Ebb	30/11/2006	9:25	9.3	8.3	23.2	32.0	7.2	8.3	1.9
Mid-Ebb	04/12/2006	11:25	9.5	8.5	22.2	31.5	7.3	8.4	1.6
Mid-Ebb	11/12/2006	16:15	10.2	9.2	22.4	32.8	7.3	8.3	1.9
Mid-Ebb	18/12/2006	11:25	9.6	8.6	18.6	30.3	7.2	8.2	3.2

M_Coral		Bottom							
tide condition	Date	time	Water depth (m)	Sampling depth (m)	Temp (°C)	Salinity (ppt)	DO (mg/L)	pH	Turbidity (NTU)
Mid-Flood	30/11/2006	13:15	10.0	9.0	23.3	34.1	7.1	8.2	2.2
Mid-Flood	04/12/2006	14:15	10.1	9.1	22.2	34.0	7.5	8.3	1.3
Mid-Flood	11/12/2006	13:10	9.3	8.3	22.1	31.5	7.4	8.3	1.7
Mid-Flood	18/12/2006	14:15	10.0	9.0	18.7	32.1	7.3	8.3	2.9

M_Coral	Mid-Ebb			Mid-Flood			Depth-averaged
	Surface	Middle	Bottom	Surface	Middle	Bottom	SS (mg/L)
30/11/2006	4.0	5.0	3.0	5.0	3.0	6.0	4.3
04/12/2006	6.0	3.0	5.0	3.0	4.0	3.0	4.0
11/12/2006	4.0	3.0	2.0	4.0	4.0	6.0	3.8
18/12/2006	4.0	6.0	6.0	4.0	6.0	5.0	5.2
