**Proposed Extension of Public Golf Course
at Kau Sai Chau Island, Sai Kung**

**Monthly Environmental Monitoring & Audit (EM&A) Report
for December 2006**

(Report No. 382210/012)

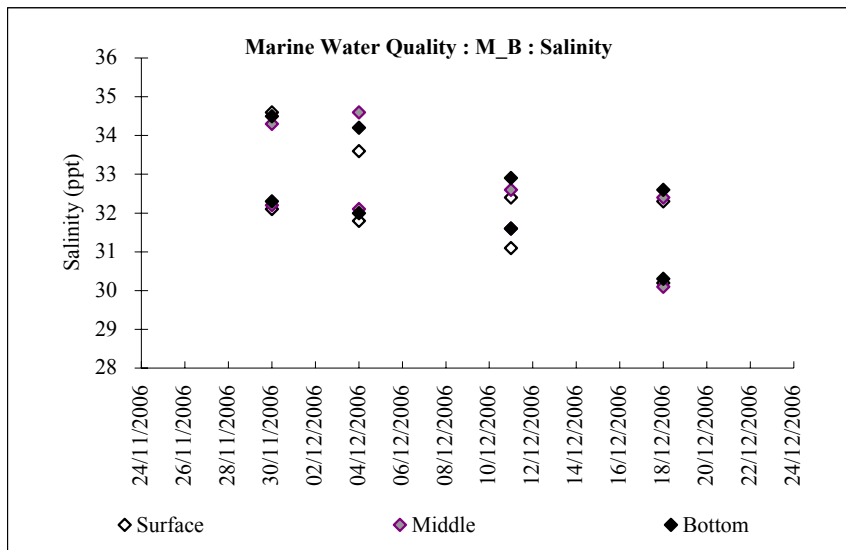
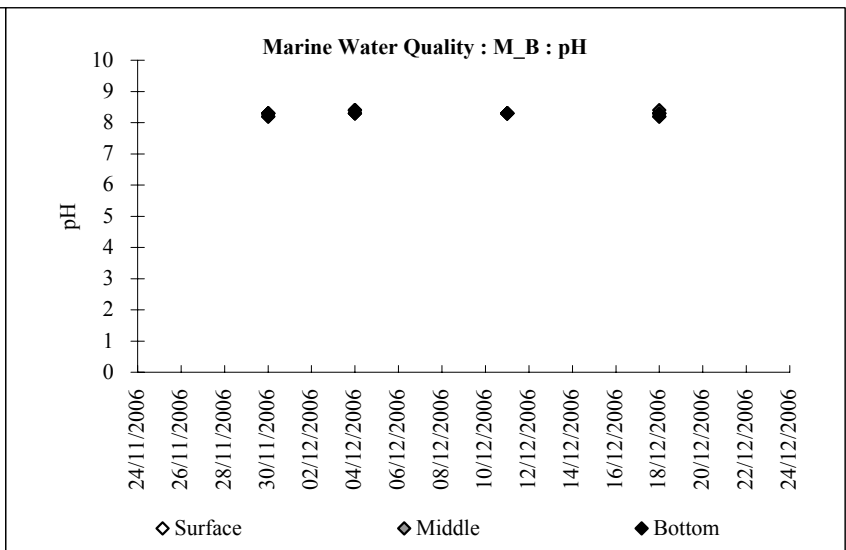
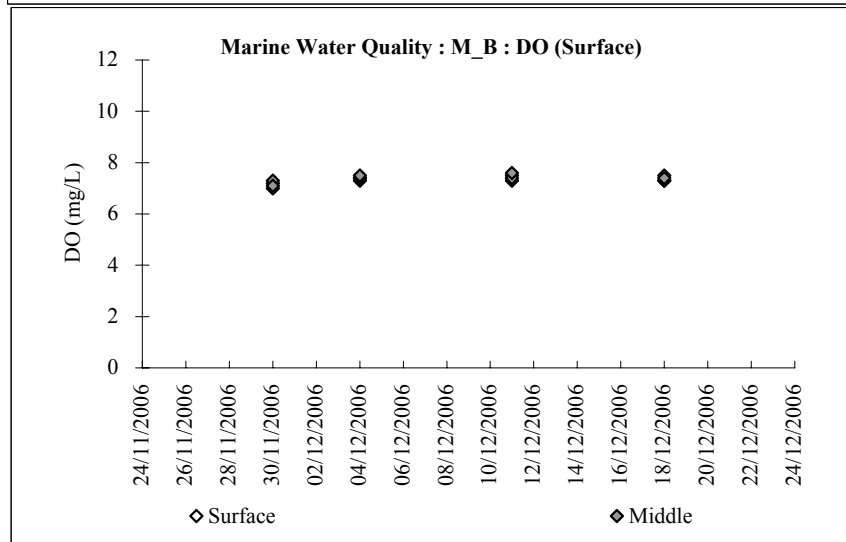
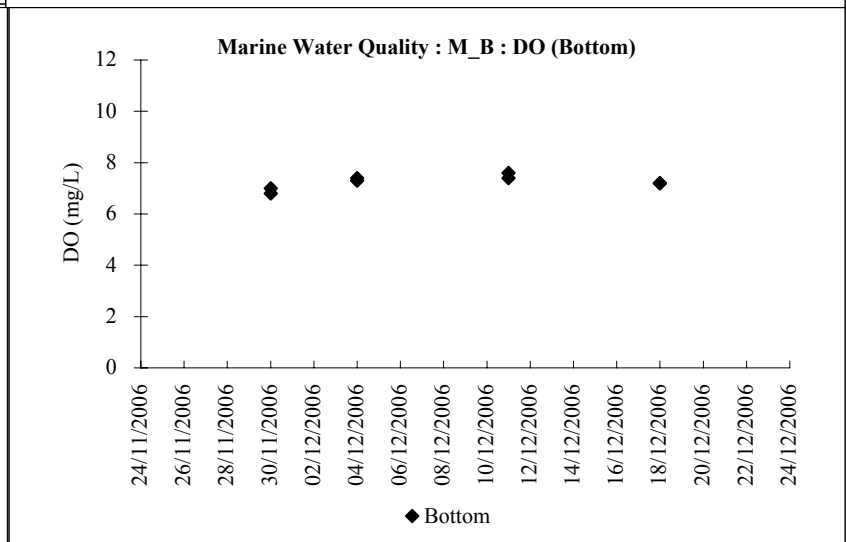
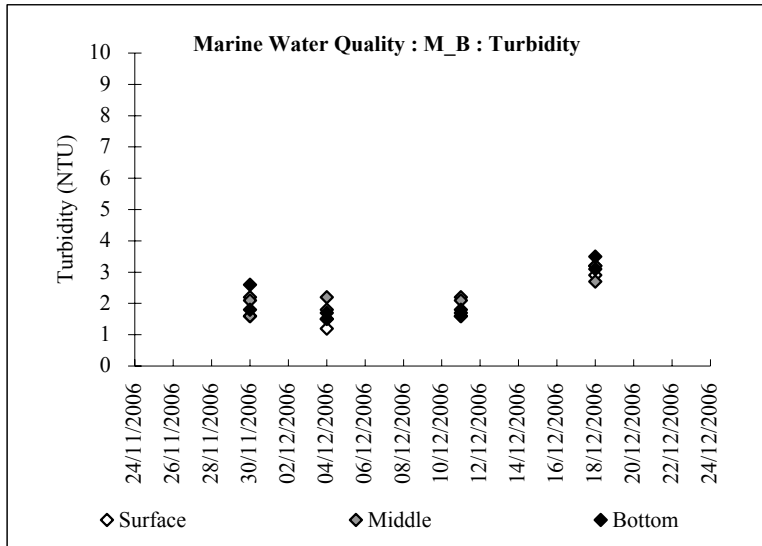
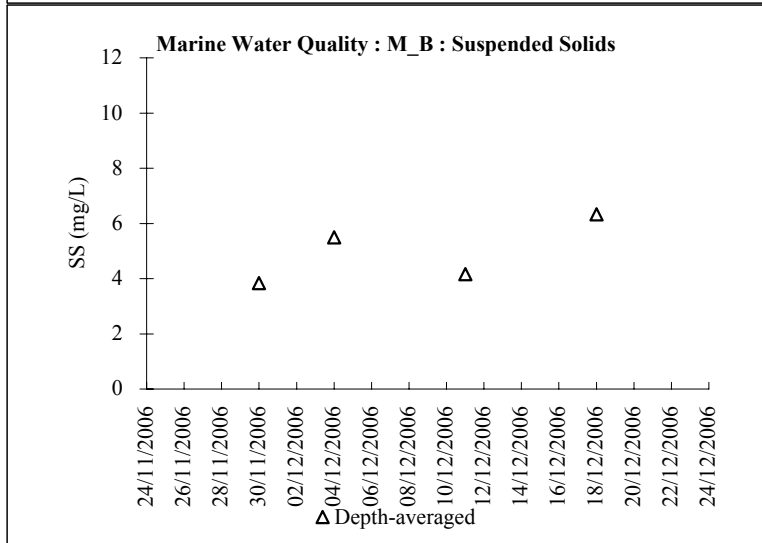
M B		Middle							
tide condition	Date	time	Water depth (m)	Sampling depth (m)	Temp (°C)	Salinity (ppt)	DO (mg/L)	pH	Turbidity (NTU)
Mid-Ebb	30/11/2006	09:36	16.8	8.4	23.1	32.2	7.3	8.3	2.1
Mid-Ebb	04/12/2006	12:11	16.5	8.3	22.4	32.1	7.4	8.4	1.8
Mid-Ebb	11/12/2006	16:26	17.3	8.7	22.3	32.6	7.4	8.3	2.2
Mid-Ebb	18/12/2006	12:11	16.7	8.4	18.2	30.1	7.3	8.3	2.7

M B		Middle							
tide condition	Date	time	Water depth (m)	Sampling depth (m)	Temp (°C)	Salinity (ppt)	DO (mg/L)	pH	Turbidity (NTU)
Mid-Flood	30/11/2006	13:26	17.2	8.6	23.2	34.3	7.1	8.3	1.6
Mid-Flood	04/12/2006	14:26	17.2	8.6	22.5	34.6	7.5	8.3	2.2
Mid-Flood	11/12/2006	13:21	16.7	8.4	21.9	31.6	7.6	8.3	2.1
Mid-Flood	18/12/2006	14:26	17.0	8.5	18.5	32.4	7.4	8.4	3.2

M B		Bottom							
tide condition	Date	time	Water depth (m)	Sampling depth (m)	Temp (°C)	Salinity (ppt)	DO (mg/L)	pH	Turbidity (NTU)
Mid-Ebb	30/11/2006	9:35	16.8	15.8	23.3	32.3	7.0	8.3	1.8
Mid-Ebb	04/12/2006	12:10	16.5	15.5	22.3	32.0	7.3	8.4	1.5
Mid-Ebb	11/12/2006	16:25	17.3	16.3	22.4	32.9	7.4	8.3	1.8
Mid-Ebb	18/12/2006	12:10	16.7	15.7	18.3	30.3	7.2	8.2	3.1

M B		Bottom							
tide condition	Date	time	Water depth (m)	Sampling depth (m)	Temp (°C)	Salinity (ppt)	DO (mg/L)	pH	Turbidity (NTU)
Mid-Flood	30/11/2006	13:25	17.2	16.2	23.3	34.5	6.8	8.2	2.6
Mid-Flood	04/12/2006	14:25	17.2	16.2	22.3	34.2	7.4	8.3	1.7
Mid-Flood	11/12/2006	13:20	16.7	15.7	22.2	31.6	7.6	8.3	1.6
Mid-Flood	18/12/2006	14:25	17.0	16.0	18.6	32.6	7.2	8.3	3.5

M_B	Mid-Ebb			Mid-Flood			Depth-averaged
	Surface	Middle	Bottom	Surface	Middle	Bottom	SS (mg/L)
30/11/2006	3.0	5.0	3.0	5.0	3.0	4.0	3.8
04/12/2006	9.0	6.0	5.0	3.0	6.0	4.0	5.5
11/12/2006	4.0	4.0	2.0	5.0	6.0	4.0	4.2
18/12/2006	6.0	5.0	5.0	13.0	3.0	6.0	6.3

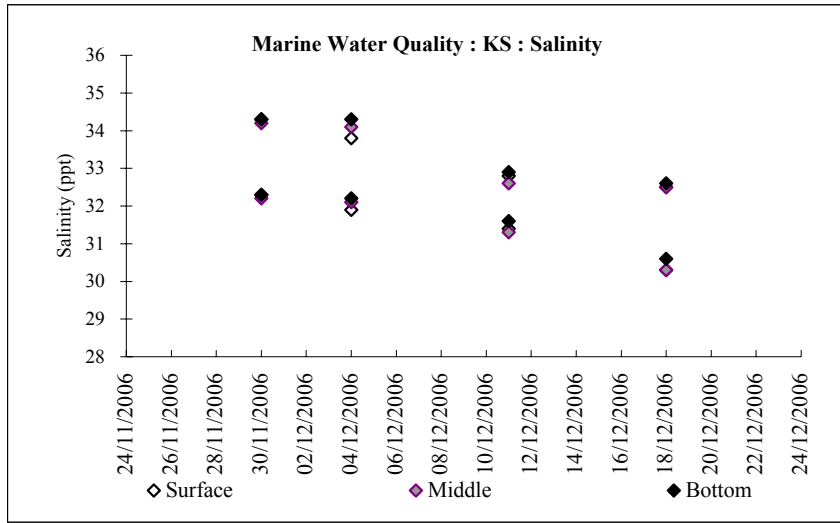
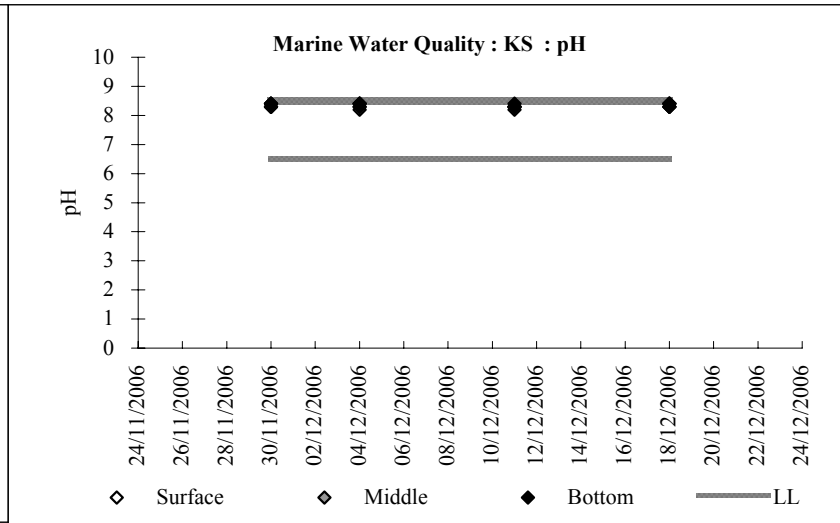
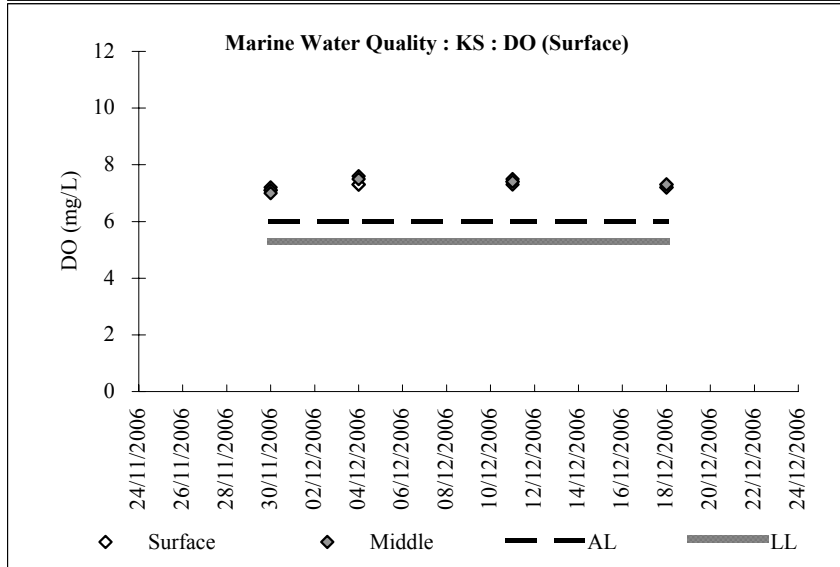
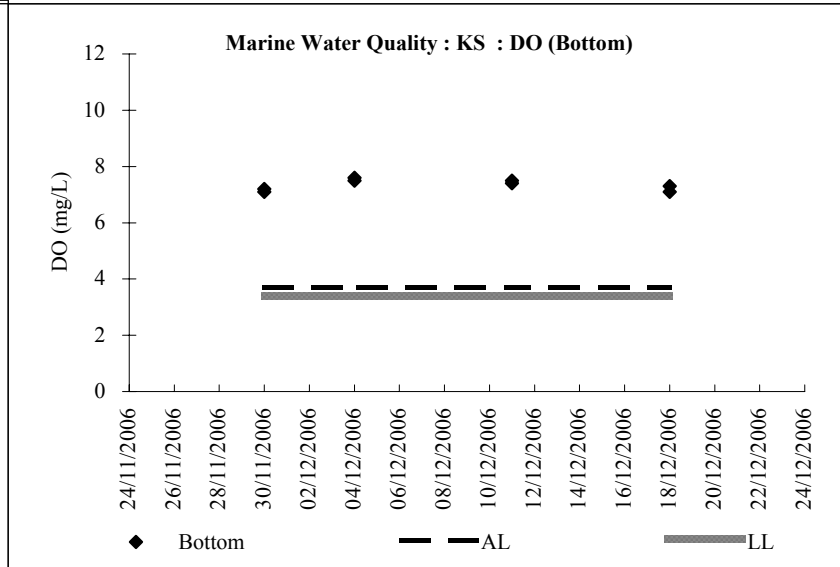
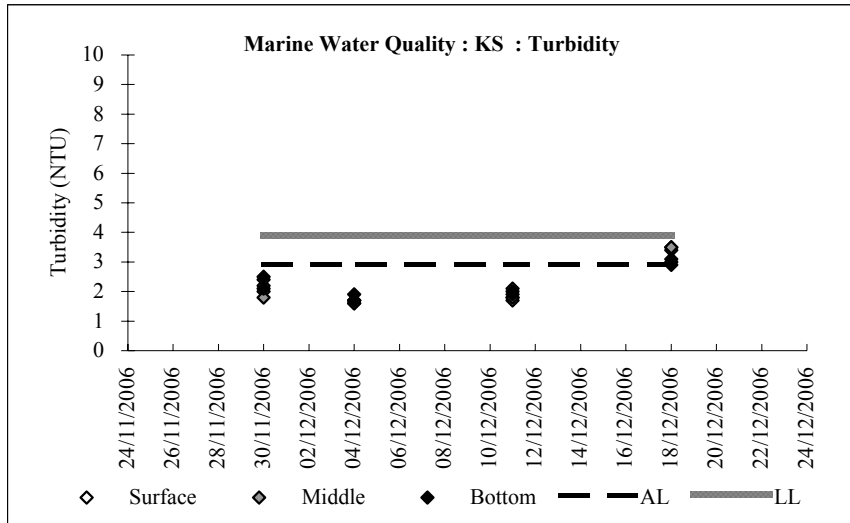
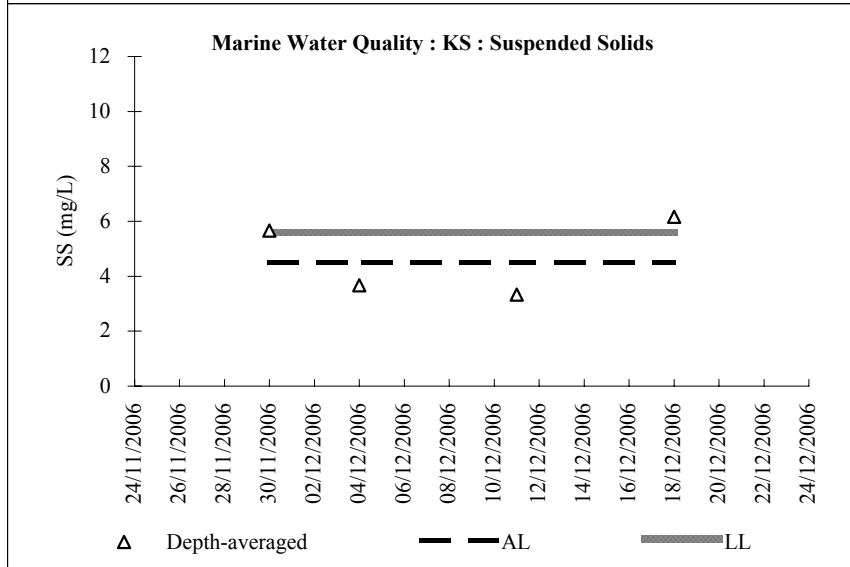
KS		Middle							
tide condition	Date	time	Water depth (m)	Sampling depth (m)	Temp (°C)	Salinity (ppt)	DO (mg/L)	pH	Turbidity (NTU)
Mid-Ebb	30/11/2006	09:56	13.1	6.6	23.2	32.2	7.1	8.4	1.8
Mid-Ebb	04/12/2006	12:31	13.5	6.8	22.3	32.1	7.6	8.4	1.6
Mid-Ebb	11/12/2006	16:46	13.8	6.9	21.9	32.6	7.3	8.3	2.1
Mid-Ebb	18/12/2006	12:31	13.4	6.7	18.5	30.3	7.2	8.3	3.5

KS		Middle							
tide condition	Date	time	Water depth (m)	Sampling depth (m)	Temp (°C)	Salinity (ppt)	DO (mg/L)	pH	Turbidity (NTU)
Mid-Flood	30/11/2006	13:56	13.6	6.8	23.4	34.2	7.0	8.3	2.4
Mid-Flood	04/12/2006	14:56	13.8	6.9	22.5	34.1	7.5	8.3	1.7
Mid-Flood	11/12/2006	13:51	13.1	6.6	21.4	31.3	7.4	8.3	1.8
Mid-Flood	18/12/2006	14:56	13.6	6.8	18.9	32.5	7.3	8.4	3.5

KS		Bottom							
tide condition	Date	time	Water depth (m)	Sampling depth (m)	Temp (°C)	Salinity (ppt)	DO (mg/L)	pH	Turbidity (NTU)
Mid-Ebb	30/11/2006	9:55	13.1	12.1	23.4	32.3	7.0	8.3	2.1
Mid-Ebb	04/12/2006	12:30	13.5	12.5	22.7	32.2	7.5	8.4	1.9
Mid-Ebb	11/12/2006	16:45	13.8	12.8	22.3	32.9	7.3	8.3	2.0
Mid-Ebb	18/12/2006	12:30	13.4	12.4	18.6	30.6	7.4	8.3	2.9

KS		Bottom							
tide condition	Date	time	Water depth (m)	Sampling depth (m)	Temp (°C)	Salinity (ppt)	DO (mg/L)	pH	Turbidity (NTU)
Mid-Flood	30/11/2006	13:55	13.6	12.6	23.4	34.3	7.2	8.4	2.5
Mid-Flood	04/12/2006	14:55	13.8	12.8	22.6	34.3	7.3	8.3	1.7
Mid-Flood	11/12/2006	13:50	13.1	12.1	22.1	31.6	7.4	8.4	1.9
Mid-Flood	18/12/2006	14:55	13.6	12.6	18.8	32.6	7.3	8.4	<i>3.1</i>

KS	Mid-Ebb			Mid-Flood			Depth-averaged
	Surface	Middle	Bottom	Surface	Middle	Bottom	SS (mg/L)
30/11/2006	10.0	5.0	6.0	4.0	4.0	5.0	5.7
04/12/2006	3.0	4.0	4.0	4.0	3.0	4.0	3.7
11/12/2006	4.0	4.0	4.0	3.0	2.0	3.0	3.3
18/12/2006	6.0	11.0	5.0	5.0	4.0	6.0	6.2

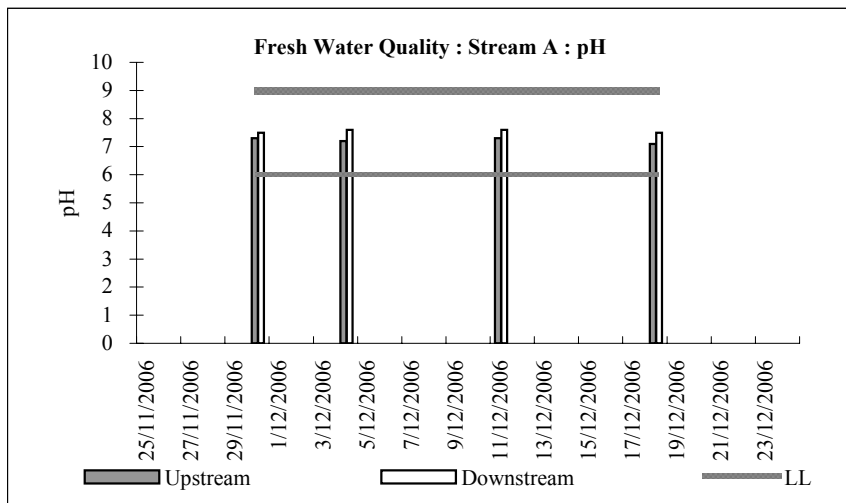
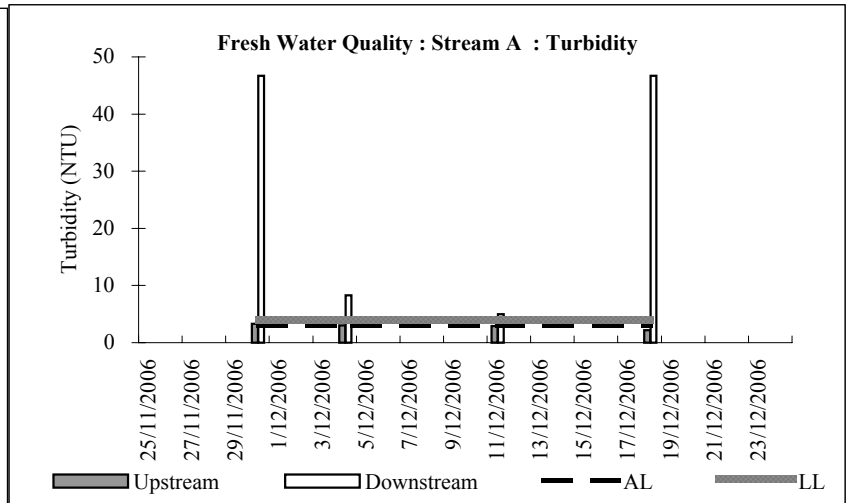
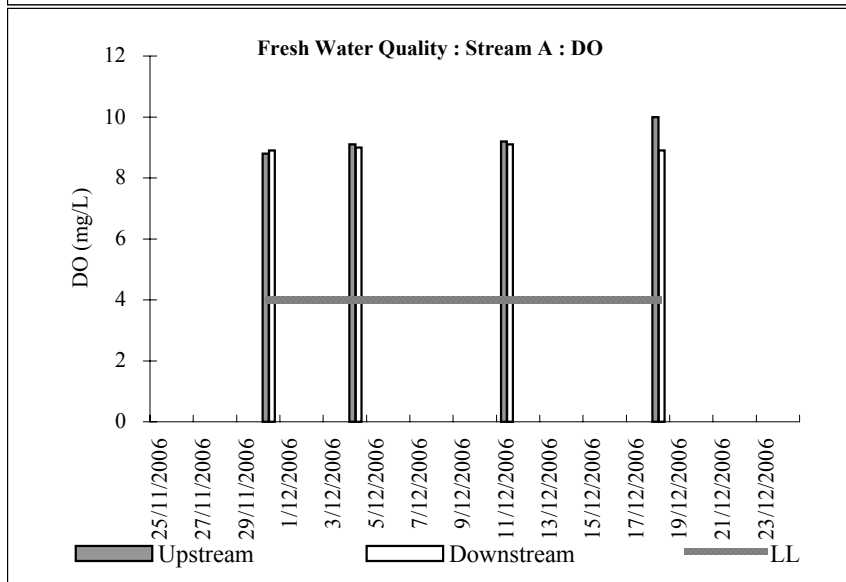
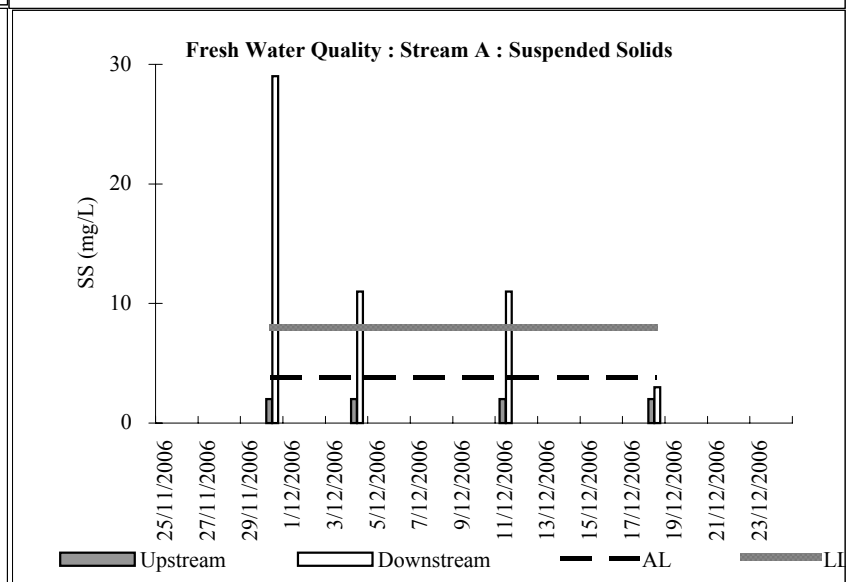
F UA	Mid depth						
Date	time	Temp (°C)	Salinity (ppt)	DO (mg/L)	pH	Turbidity (NTU)	SS (mg/L)
30/11/2006	11:50	21.1	<0.1	8.8	7.3	3.3	2.0
04/12/2006	11:05	19.8	<0.1	9.1	7.2	3.0	2.0
11/12/2006	11:15	19.3	<0.1	9.2	7.3	2.9	2.0
18/12/2006	11:05	14.4	<0.1	10.0	7.1	2.2	2.0

F DA	Mid depth						
Date	time	Temp (°C)	Salinity (ppt)	DO (mg/L)	pH	Turbidity (NTU)	SS (mg/L)
30/11/2006	11:55	21.0	<0.1	8.9	7.5	46.7	29.0
04/12/2006	11:10	19.9	<0.1	9.0	7.6	8.3	11.0
11/12/2006	11:20	19.3	<0.1	9.1	7.6	5.0	11.0
18/12/2006	11:10	21.0	<0.1	8.9	7.5	46.7	3.0

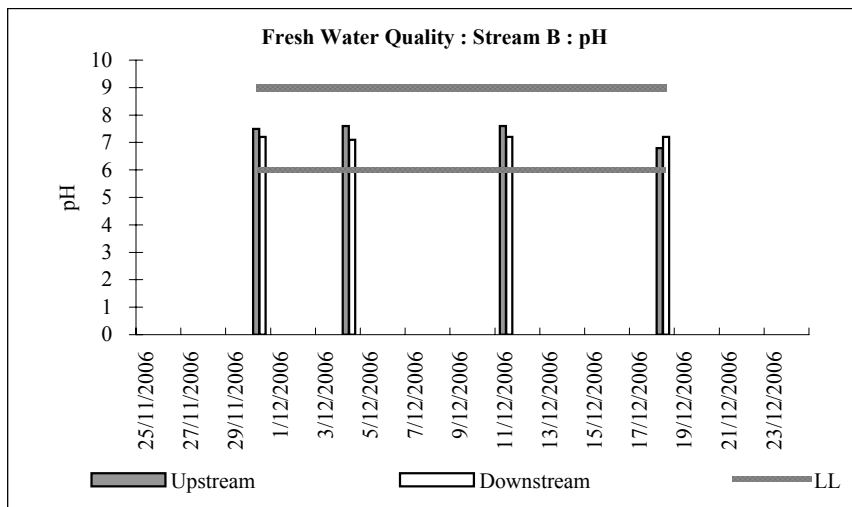
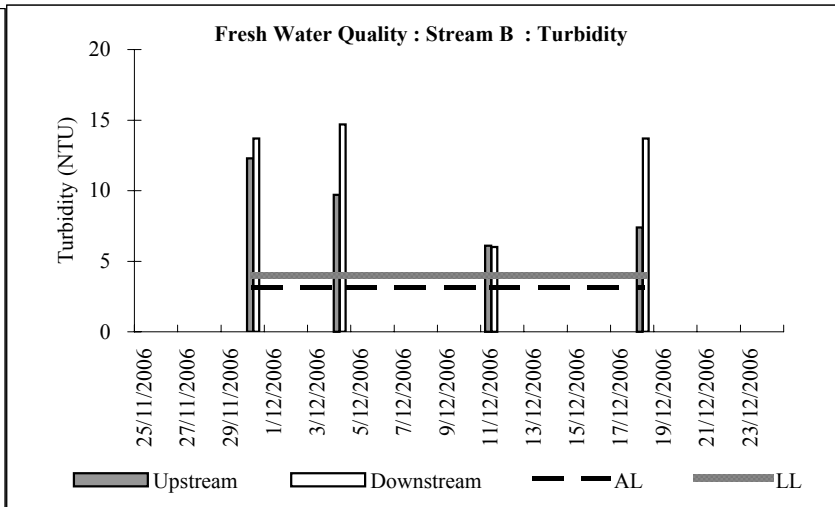
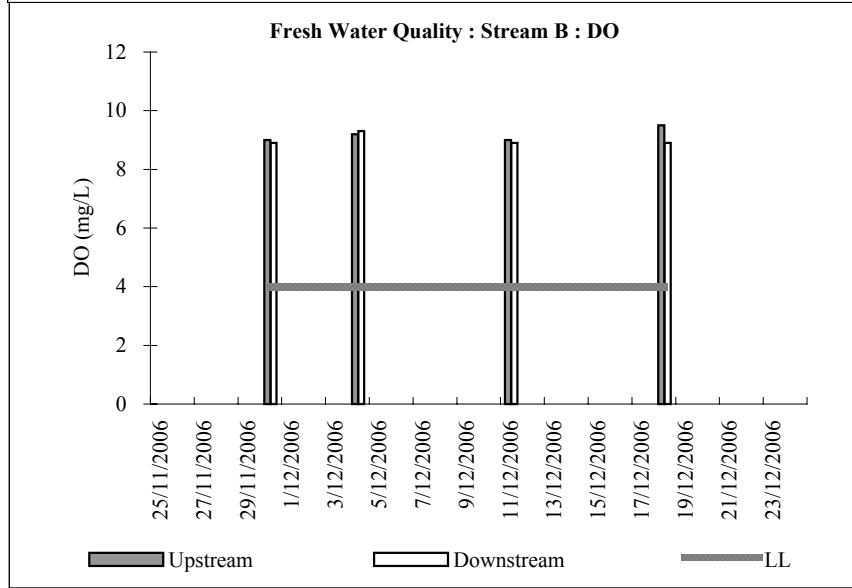
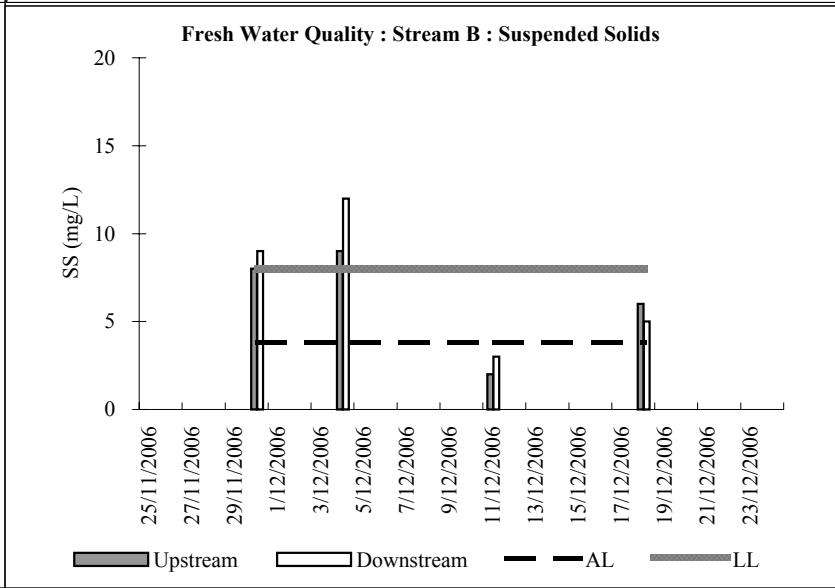
F UB	Mid depth						
Date	time	Temp (°C)	Salinity (ppt)	DO (mg/L)	pH	Turbidity (NTU)	SS (mg/L)
30/11/2006	12:05	21.2	<0.1	9.0	7.5	12.3	8.0
04/12/2006	10:40	19.9	<0.1	9.2	7.6	9.7	9.0
11/12/2006	11:35	19.5	<0.1	9.0	7.6	6.1	2.0
18/12/2006	10:40	15.0	<0.1	9.5	6.8	7.4	6.0

F DB	Mid depth						
Date	time	Temp (°C)	Salinity (ppt)	DO (mg/L)	pH	Turbidity (NTU)	SS (mg/L)
30/11/2006	12:15	21.1	<0.1	8.9	7.2	13.7	9.0
04/12/2006	10:50	19.9	<0.1	9.3	7.1	14.7	12.0
11/12/2006	11:45	19.5	<0.1	8.9	7.2	6.0	3.0
18/12/2006	10:50	21.1	<0.1	8.9	7.2	13.7	5.0

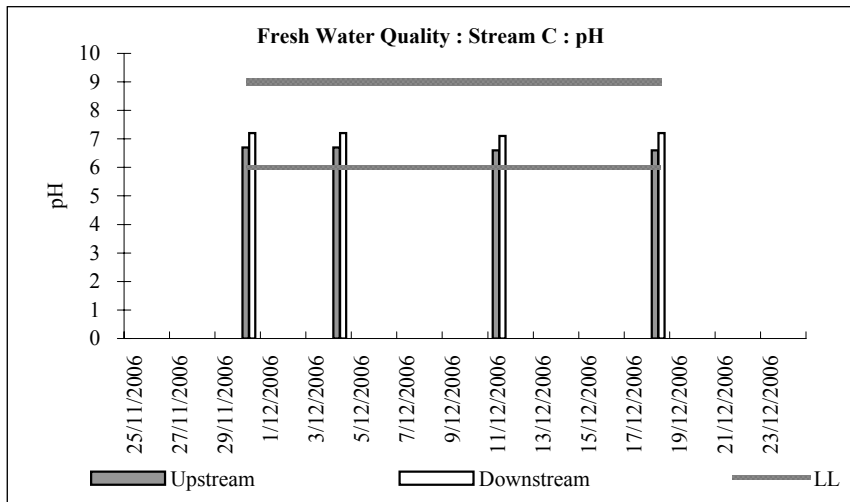
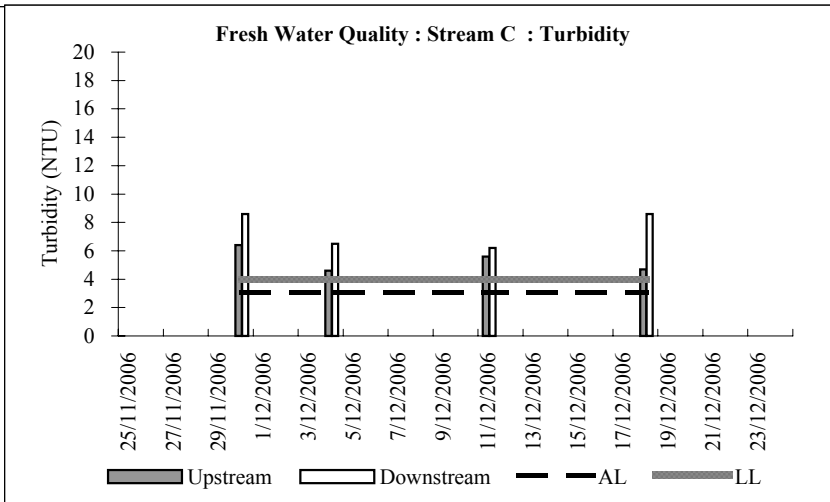
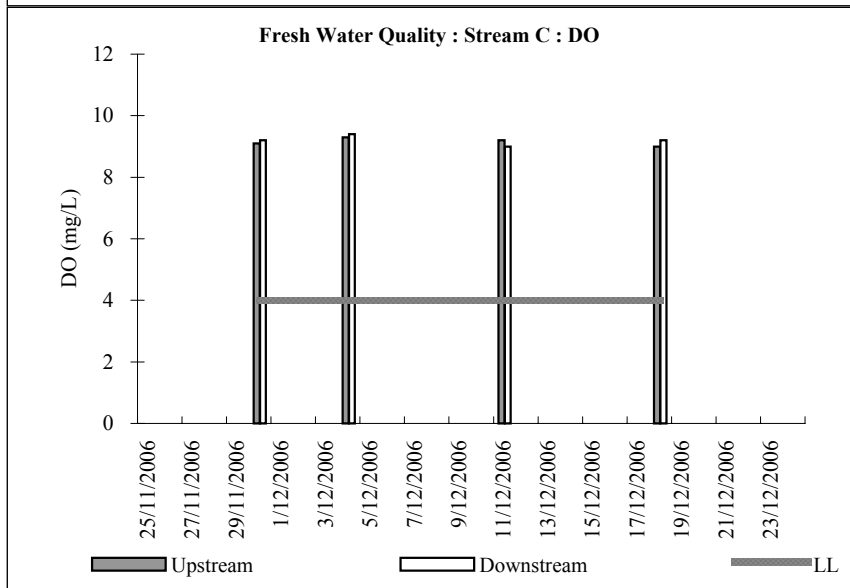
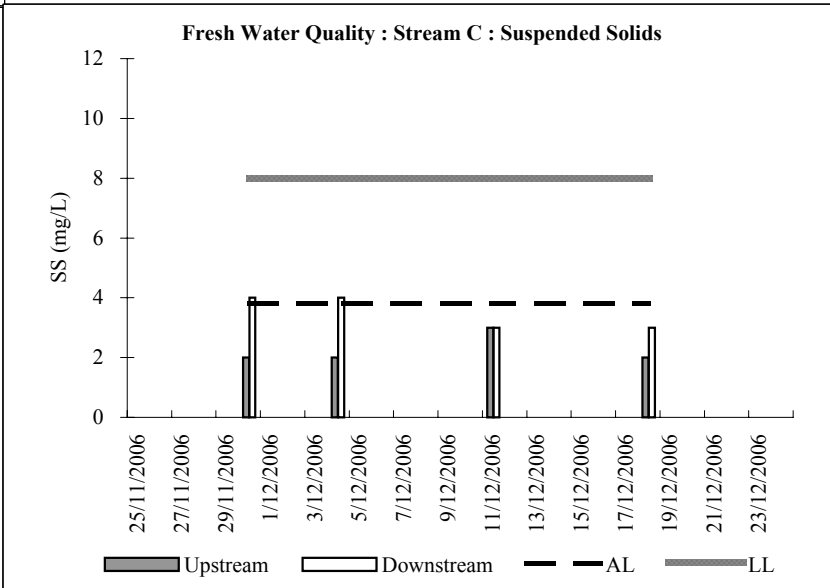
F UC	Mid depth						
Date	time	Temp (°C)	Salinity (ppt)	DO (mg/L)	pH	Turbidity (NTU)	SS (mg/L)
30/11/2006	12:40	21.0	<0.1	9.1	6.7	6.4	2.0
04/12/2006	11:45	19.7	<0.1	9.3	6.7	4.6	2.0
11/12/2006	11:55	19.0	<0.1	9.2	6.6	5.6	3.0
18/12/2006	11:45	15.5	<0.1	9.0	6.6	4.7	2.0

F DC	Mid depth						
Date	time	Temp (°C)	Salinity (ppt)	DO (mg/L)	pH	Turbidity (NTU)	SS (mg/L)
30/11/2006	12:50	20.8	<0.1	9.2	7.2	8.6	4.0
04/12/2006	11:55	19.5	<0.1	9.4	7.2	6.5	4.0
11/12/2006	12:05	19.2	<0.1	9.0	7.1	6.2	3.0
18/12/2006	11:55	20.8	<0.1	9.2	7.2	8.6	3.0

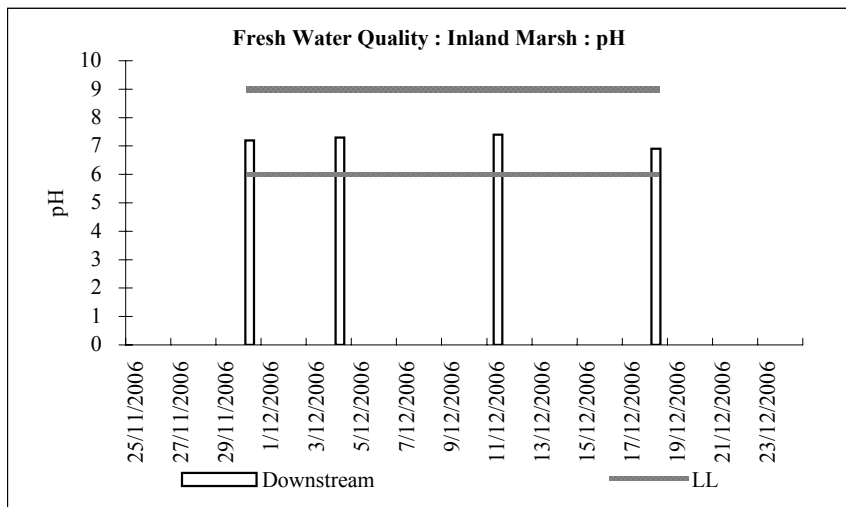
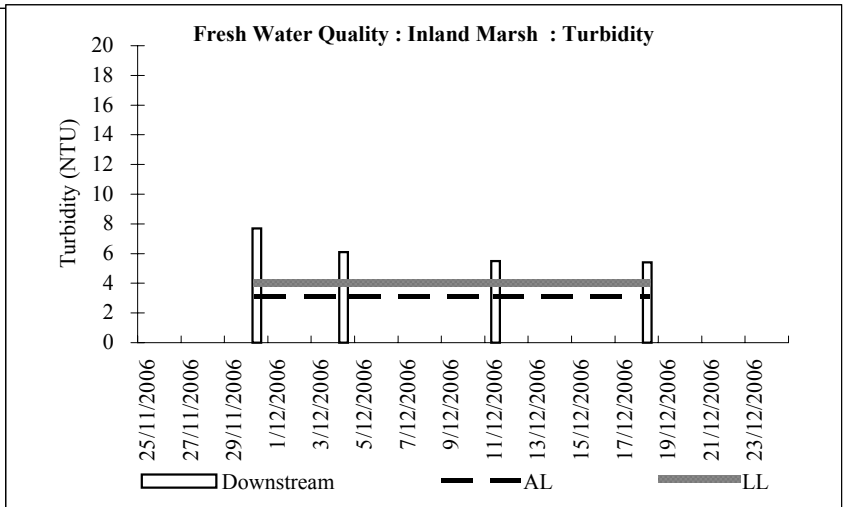
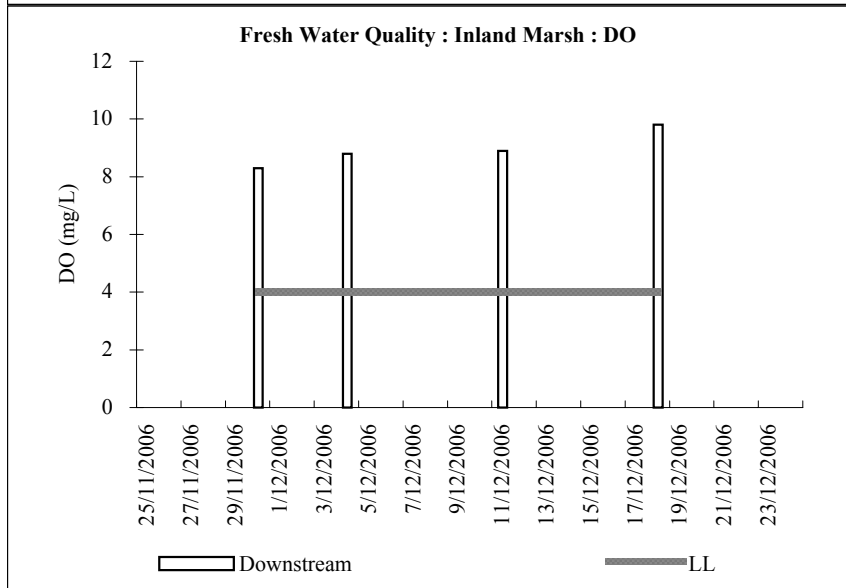
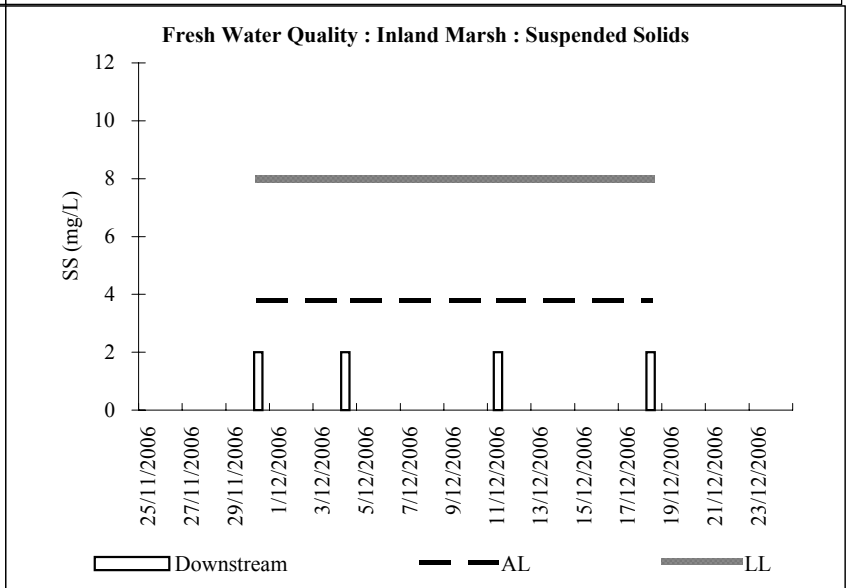
F_Inland M	Mid depth						
Date	time	Temp (°C)	Salinity (ppt)	DO (mg/L)	pH	Turbidity (NTU)	SS (mg/L)
30/11/2006	08:55	21.9	<0.1	8.3	7.2	7.7	2.0
04/12/2006	09:55	20.1	<0.1	8.8	7.3	6.1	2.0
11/12/2006	10:25	19.8	0.1	8.9	7.4	5.5	2.0
18/12/2006	09:55	13.9	<0.1	9.8	6.9	5.4	2.0

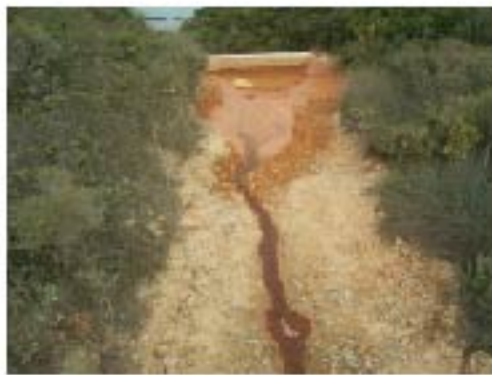
Plate 5.3-1 Photos of Stream Habitat

Stream A and Buffer Zone

5.3.5 In the present monitoring survey, the main stream course of Stream A (the section downstream to the confluence of tributaries A1 and A2) was found still to be filled up by rubbles which was first report in June 2006 (see **Photo Plate 5.3-1**). The rubbles were reported to be washed down from the upper Tributary A2 which had been under pipe culvert construction. Although the riparian vegetation was not affected by the rubbles, this section of stream channel was temporarily lost. Tributary A2 was converted to underground pipeline as proposed in the EIA report. Stream A was of the lowest ecological value among the four natural streams as it was heavily silted with sediments from eroded hillsides all year round. No stream fish and only very limited aquatic fauna were recorded in Stream A before. The impact from this temporary loss of stream channel would not be severe. But remedial works should be implemented to clear the rubbles and restore the channel, and improve the water quality, as the conditions of this stream is expected to improve after the construction of the golf course extension (in which the eroded hill slopes would be replaced by turf).

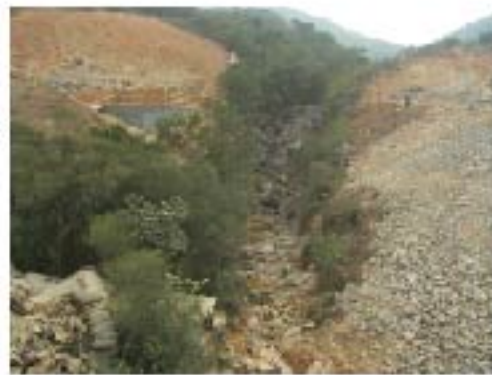
Stream Flow in upper Stream A

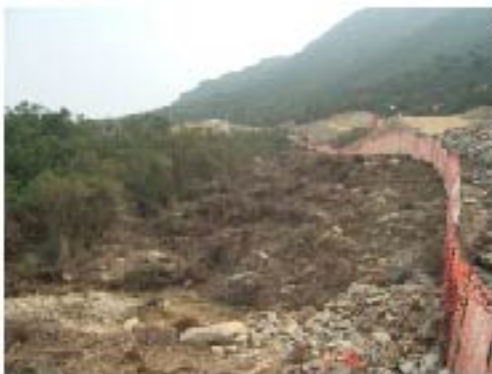
Stream B2 and the buffer zone

5.3.7 In the present survey, it was found that the flow in Stream B has restored from the minor turbidity reported in November. The stream bed and banks had no sign of severe sedimentation, probably due to the protection of the vegetation inside the buffer zone. Aquatic fauna including *Caridina trifasciata* were still sighted in the stream. An area of the buffer zone of Tributary B2 was however accidentally cleared (see **Figure 5.3.1**). This might affect the function of the buffer zone for the stream protection, and remedial plan such as replanting should be implemented.

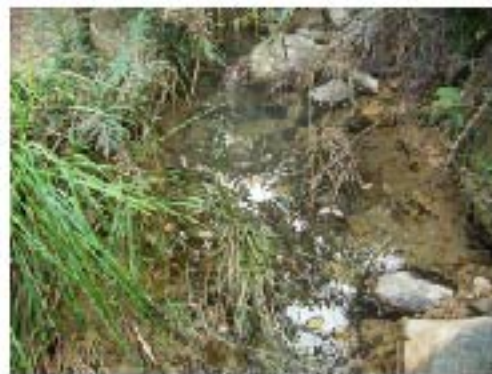
Stream B close-up

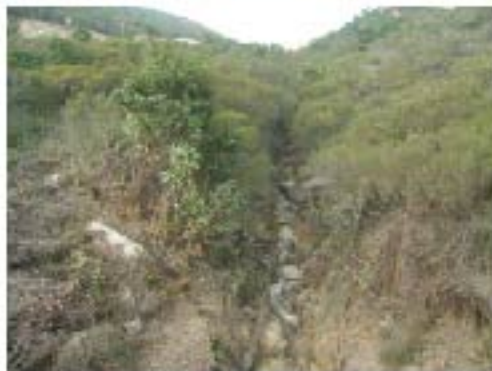
Stream C

- 5.3.11 The flow was found clear in Stream D, and Atyid shrimp *Caridina trifasciata* was still recorded in the present survey.
- 5.3.12 Photos of Streams A to D were shown in **Photo Plate 5.3-1 (Annex E)**.

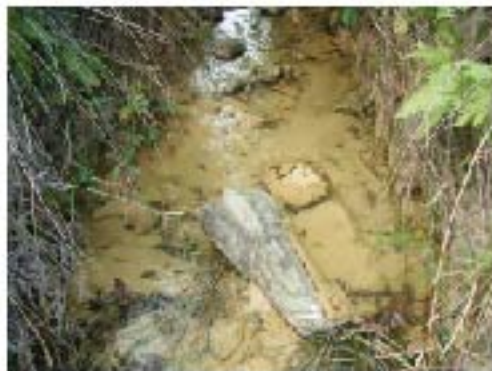
Stream C close-up

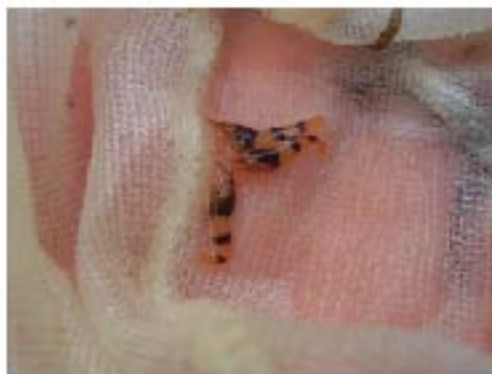
Shrimp in Stream C

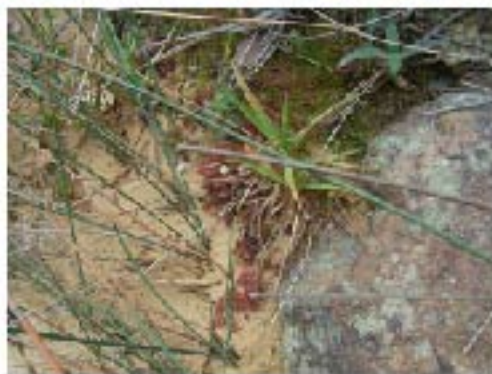
Riparian plants in Stream C

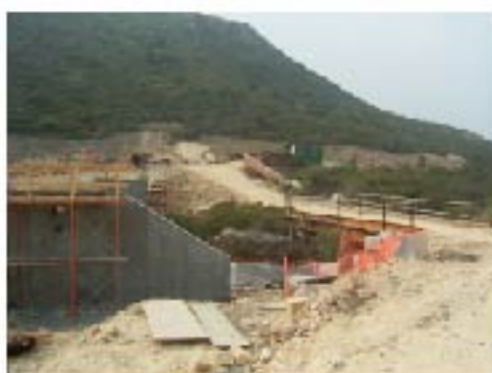
Temporary and permanent bridges at Stream C

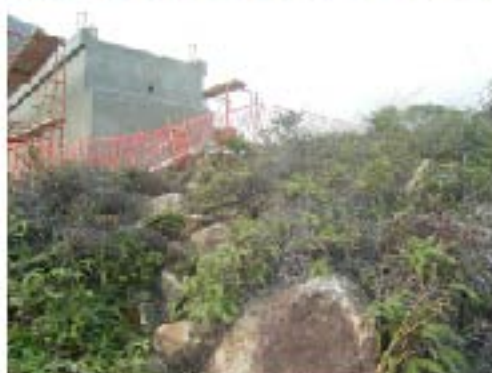
The piers of Stream C permanent bridge are outside the buffer zone

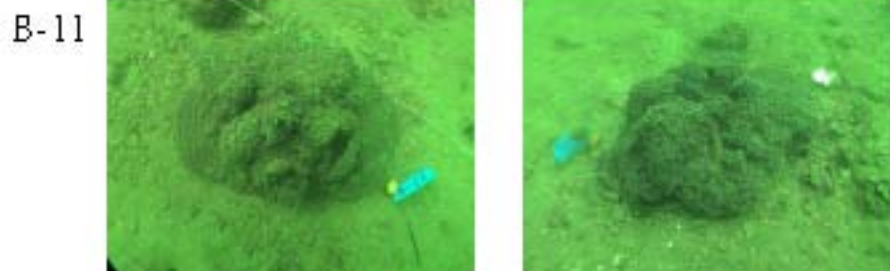
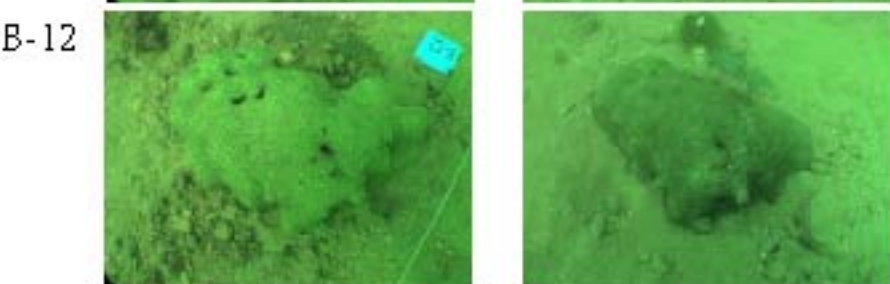
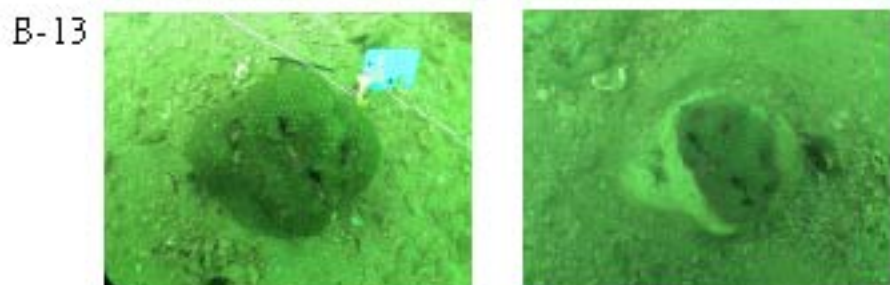
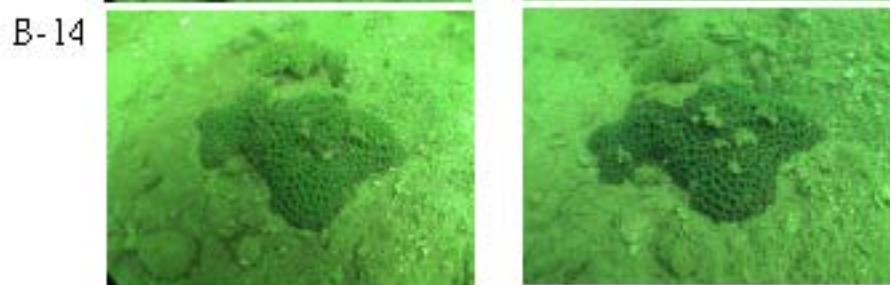
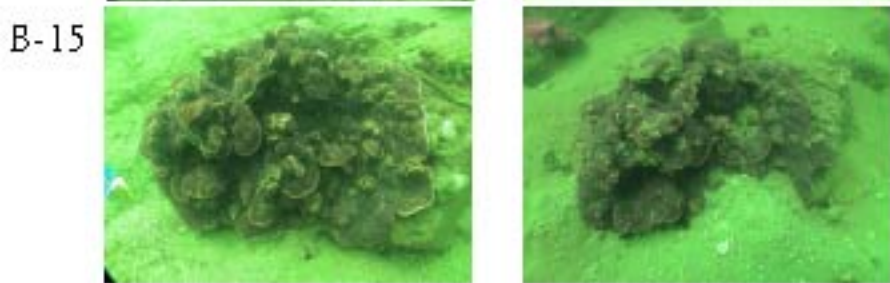
Baseline in Dec 05

Month 12 (Dec 06)

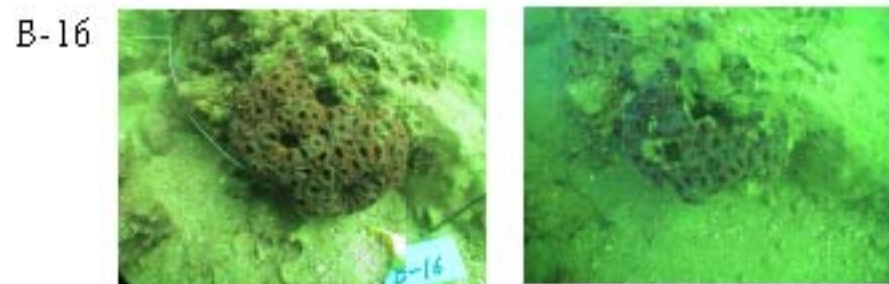
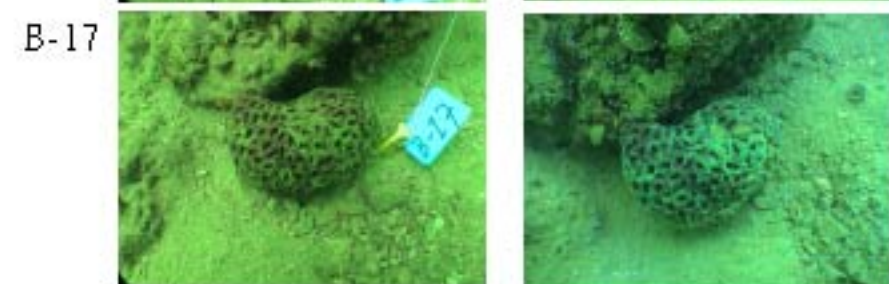
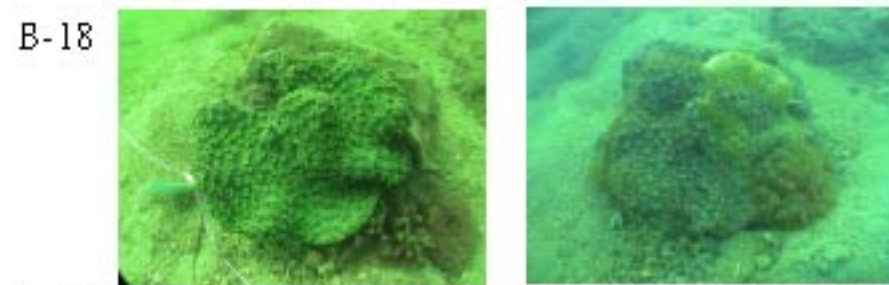
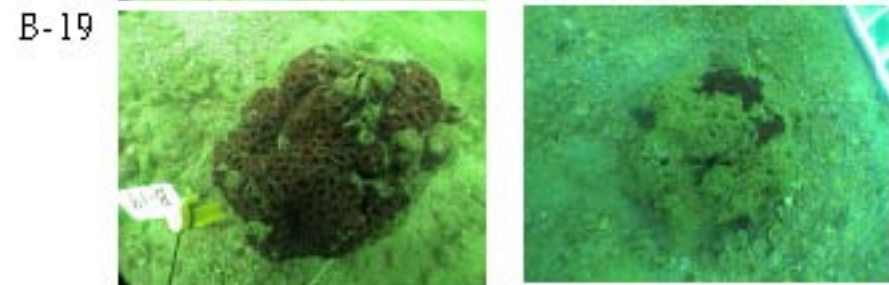
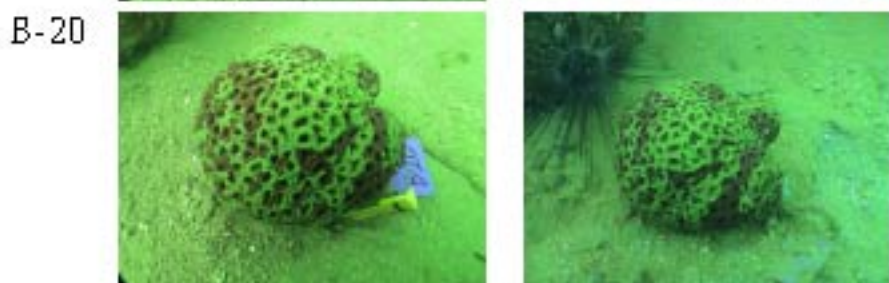
Baseline in Dec 05

Month 12 (Dec 06)

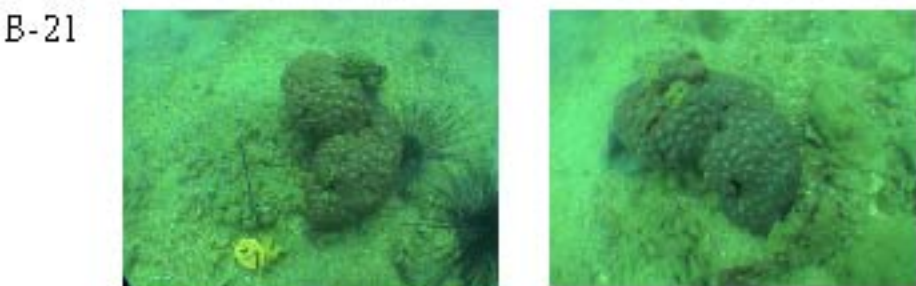
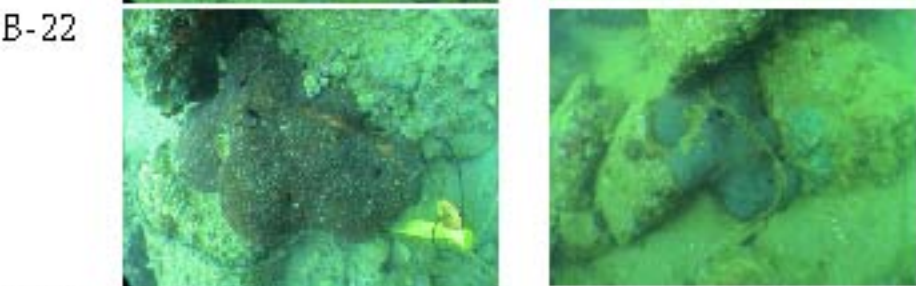
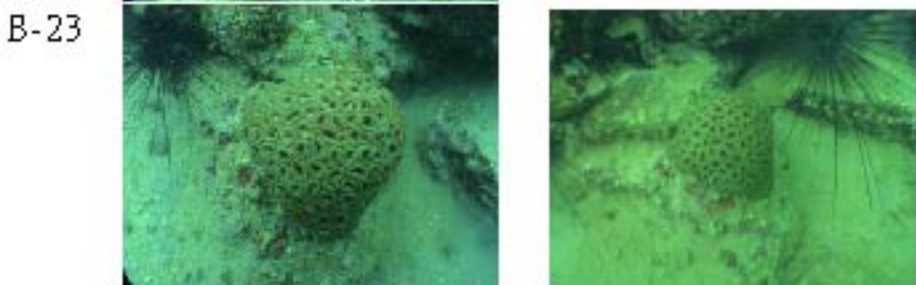
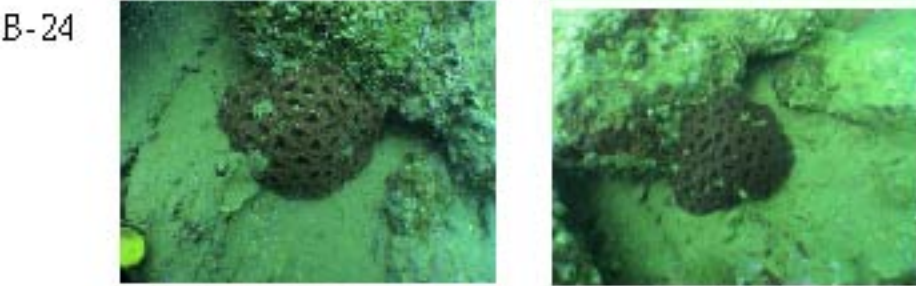
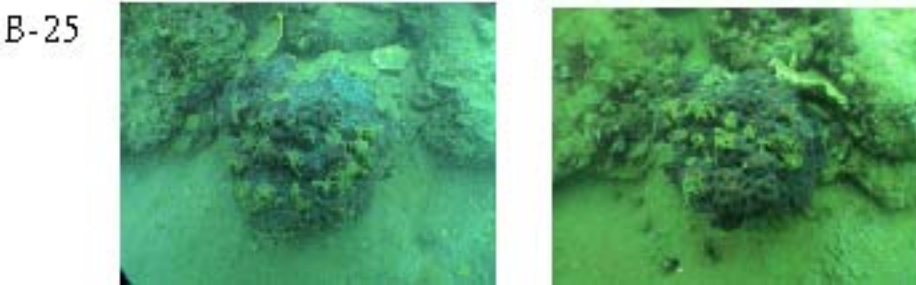
Baseline in April 06

Month 12 (Dec 06)

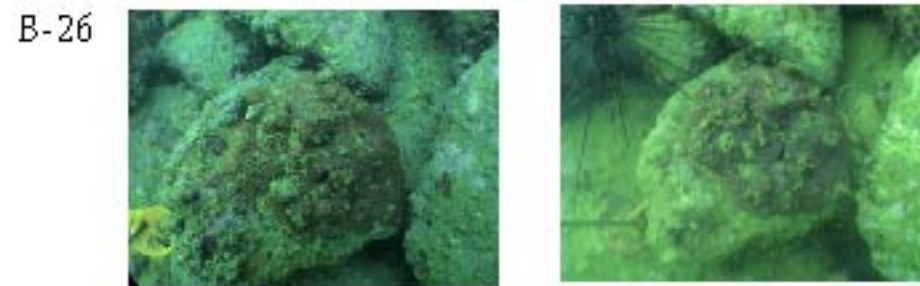
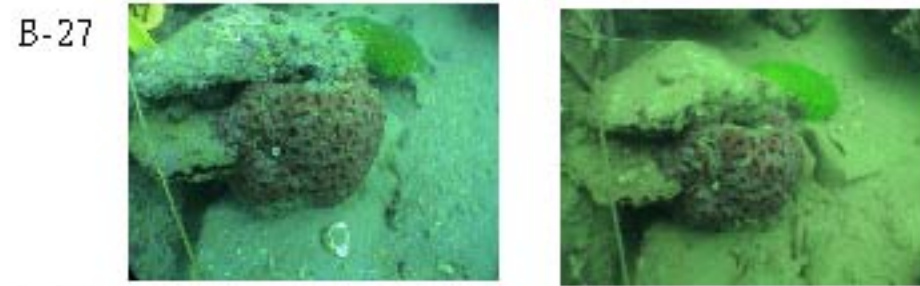
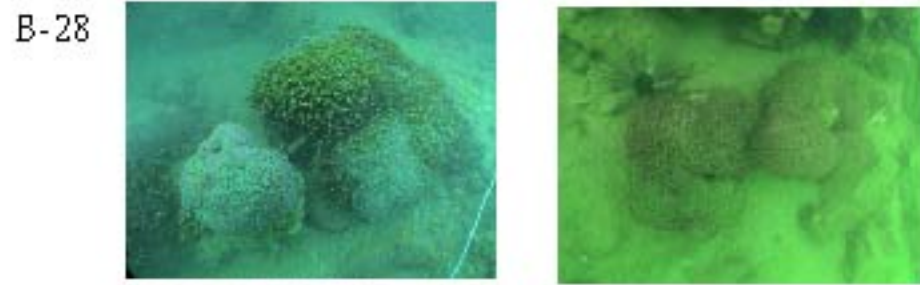
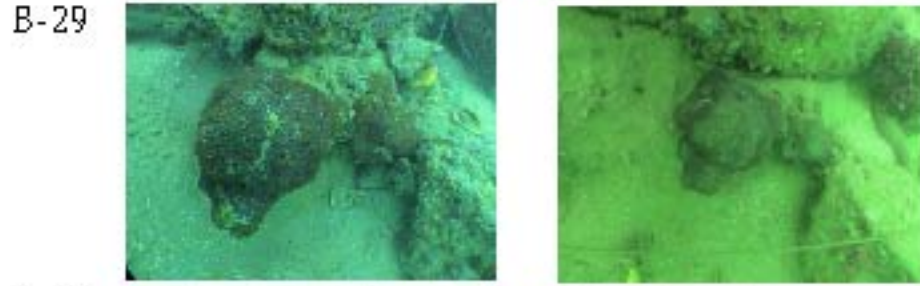
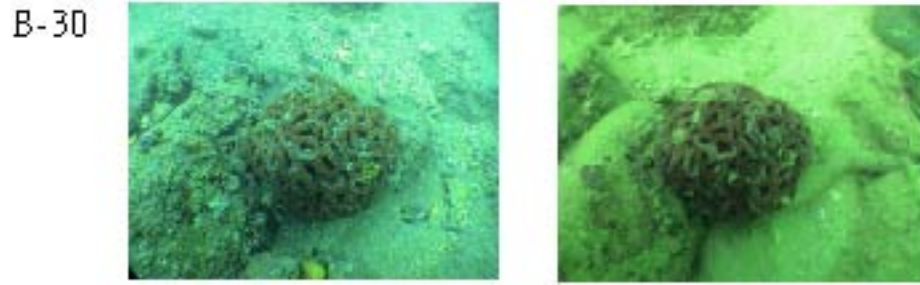
Baseline in April 06

Month 12 (Dec 06)
