**Proposed Extension of Public Golf Course
at Kau Sai Chau Island, Sai Kung**

**Monthly Environmental Monitoring & Audit (EM&A) Report
for December 2006**

(Report No. 382210/012)

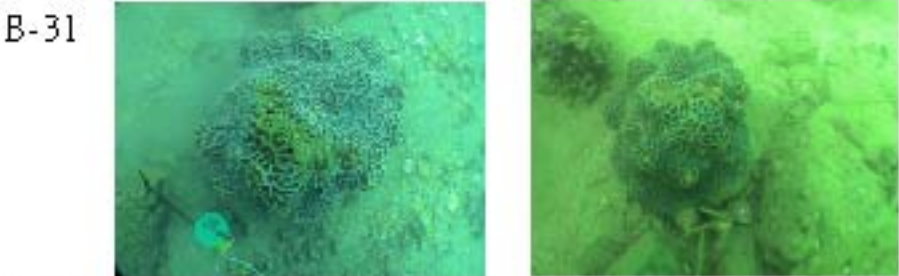
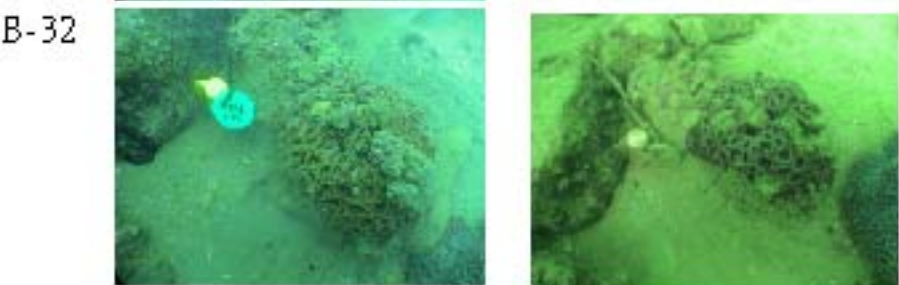
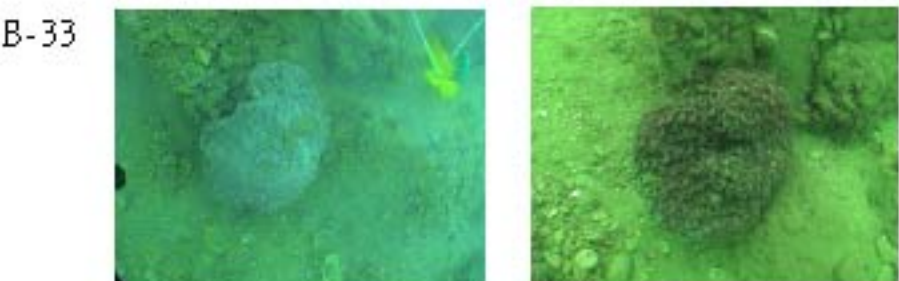
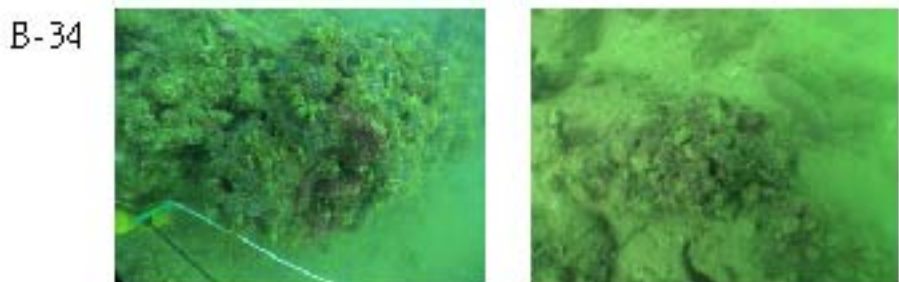
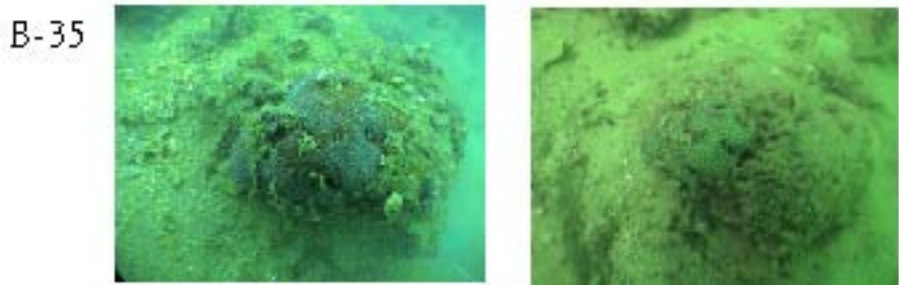
Baseline in April 06

Month 12 (Dec 06)

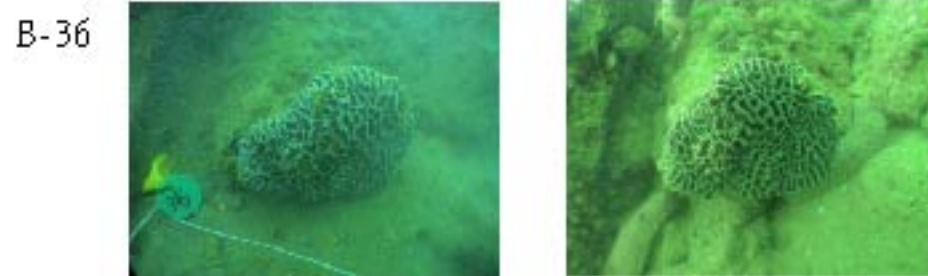
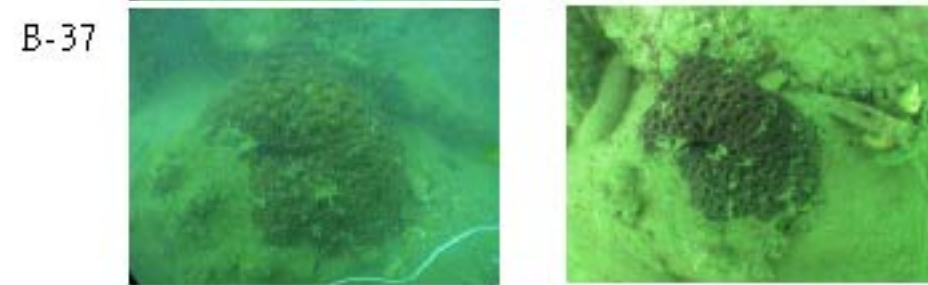
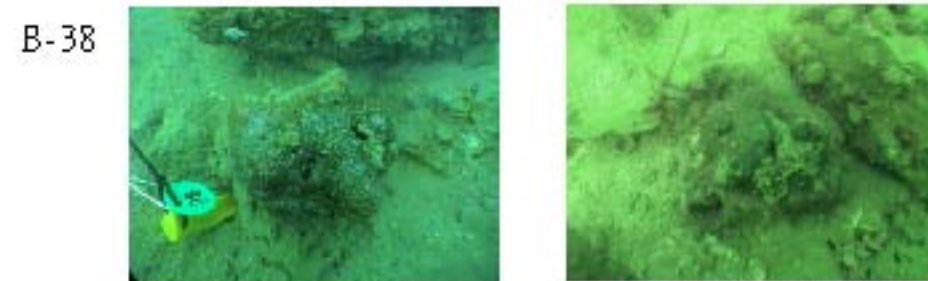
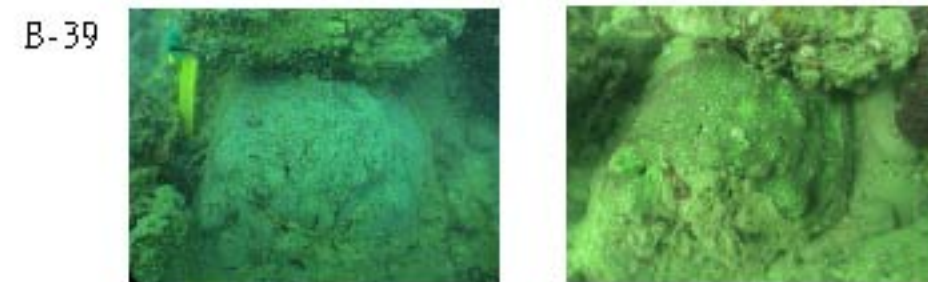
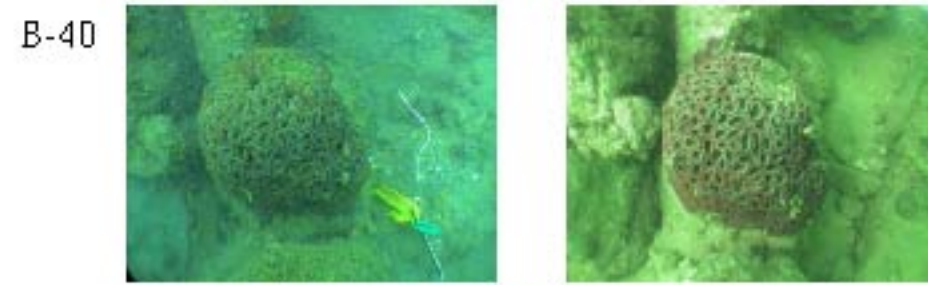
Baseline in April 06

Month 12 (Dec 06)

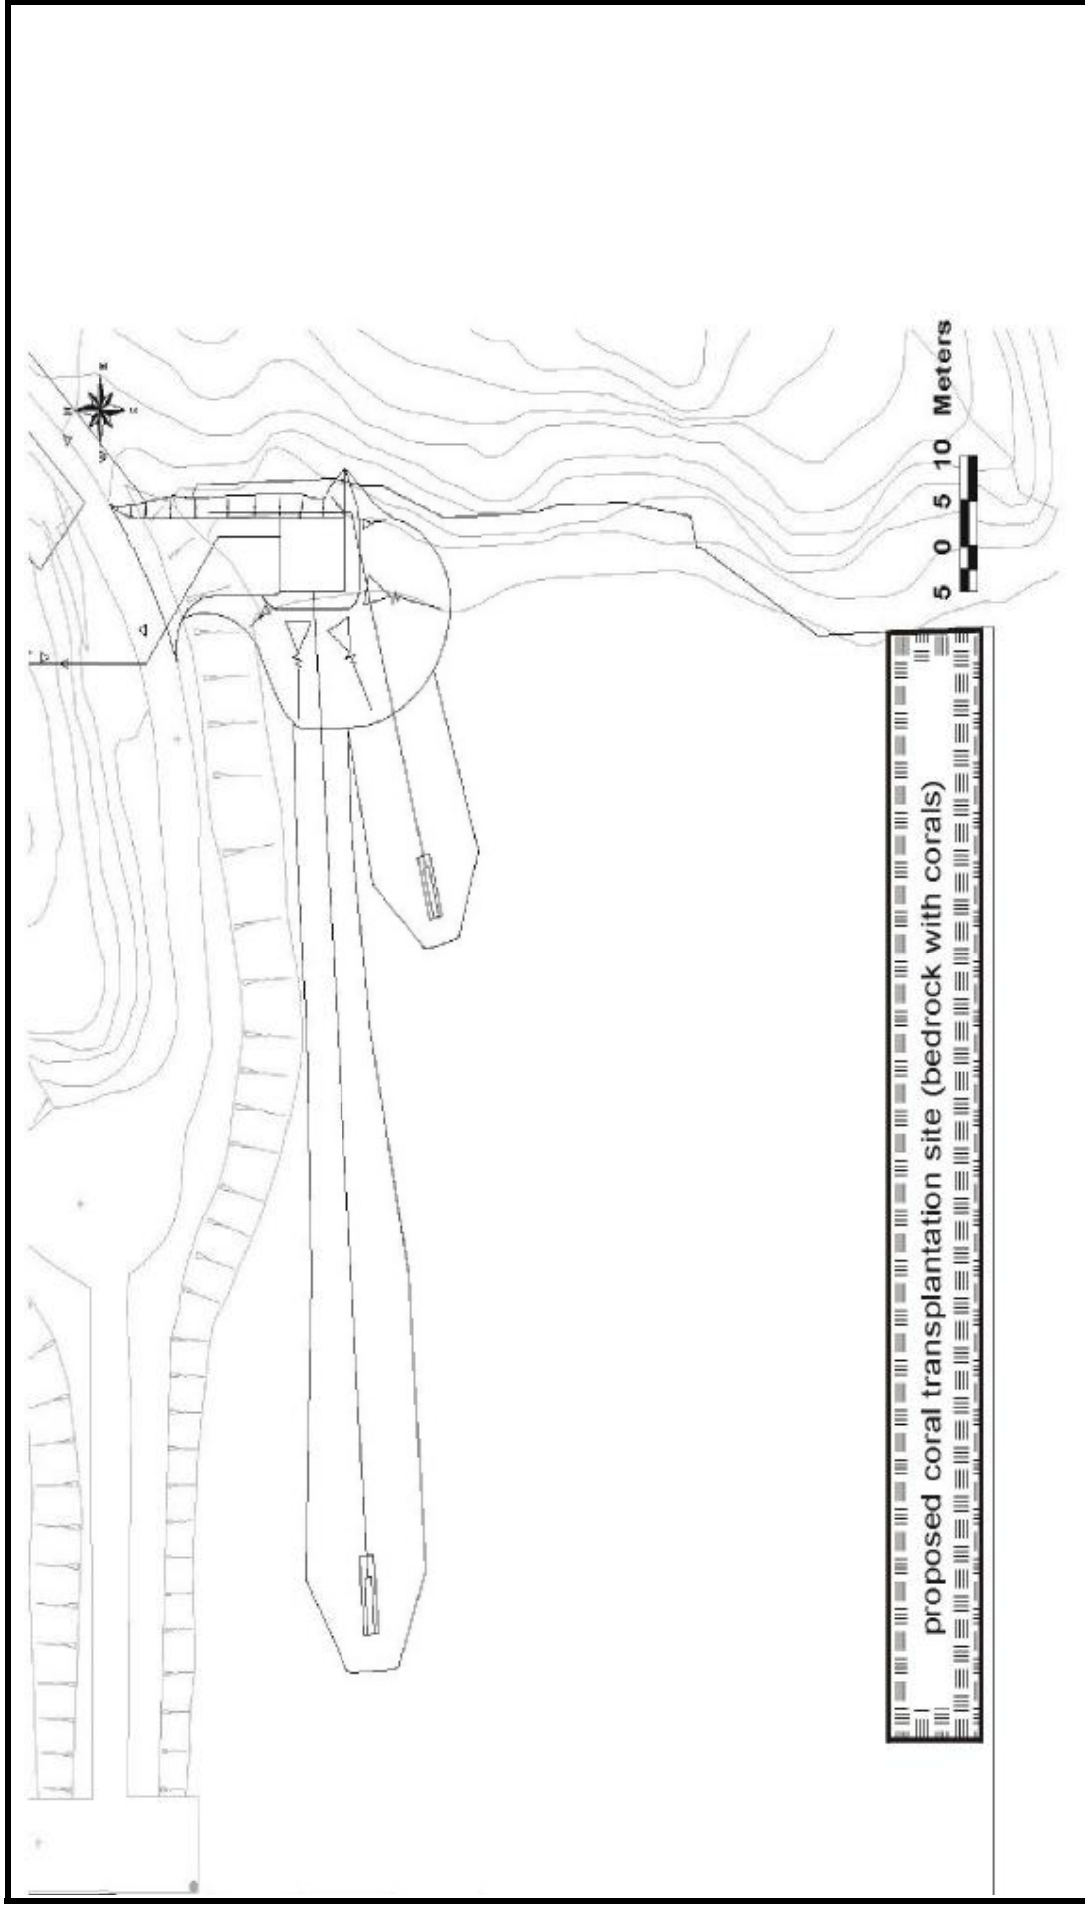
Fig 3.5

Location of proposed coral transplantation site (bedrock with corals)
