China State – China Railway Joint Venture

CE 28/2004 (GE)

Landslide Preventive Works at Po Shan Road, Mid-Levels – Design and Construction (Natural Terrain Risk Mitigation Works)

Monthly EM&A Report for January 2009

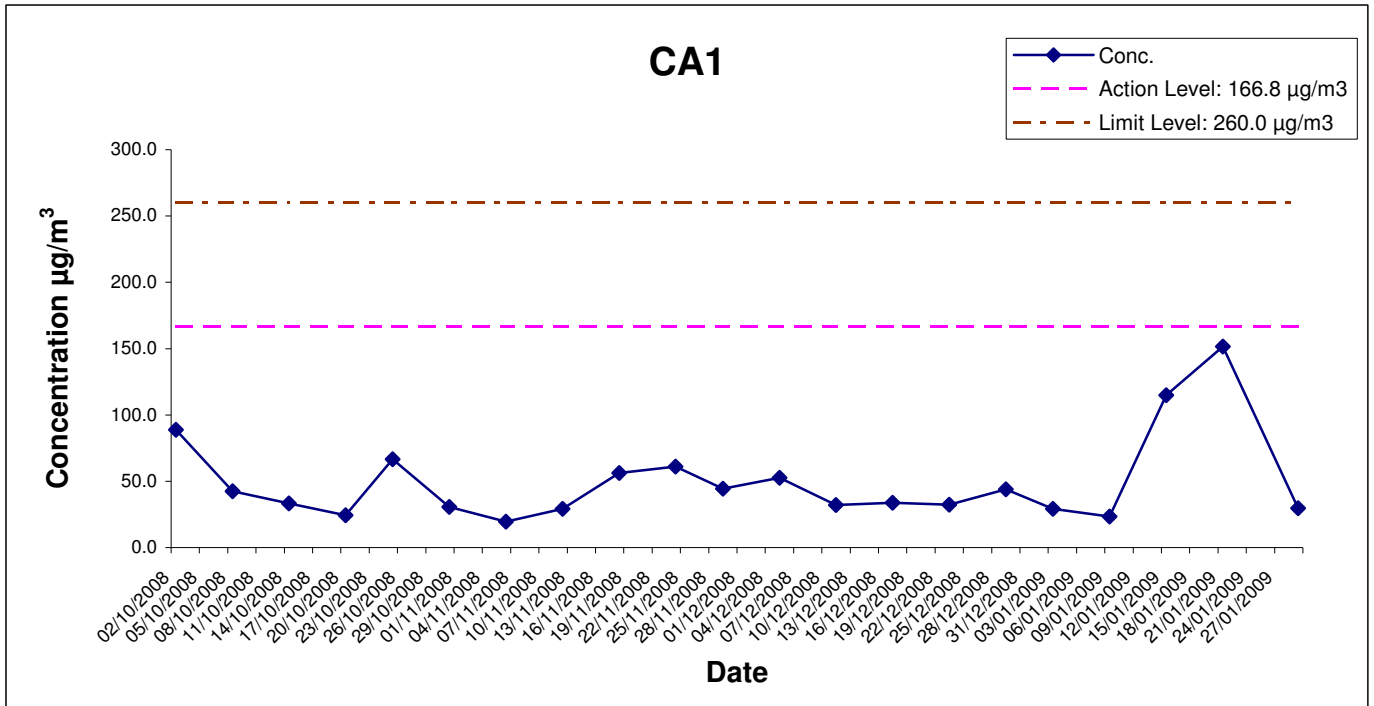
ENSR Asia (HK) Ltd		Impact Monitoring for Landslide Preventive Works at Po Shan Road, Mid-levels Design and Construction (Natural Terrain Risk Mitigation Works) Graphical Presentation of 24-hour TSP Monitoring Results	SCALE	N.T.S.	DATE	Feb-09
			CHECK	ENFL	DRAWN	RWHW
			JOB NO.	60039173	APPENDIX	F

Date	Filter Weight (g)		Flow Rate (m ³ /min.)		Elapse Time		Sampling Time(hrs.)	Conc. (µg/m ³)	Weather Condition	Air Temp. (°C)	Atmospheric Pressure(hPa)	Particulate weight(g)	Av. flow (m ³ /min)	Total vol. (m ³)	
	Initial	Final	Initial	Final	Initial	Final									
03-Jan-09	3.6211	3.6763	1.31	1.31	13415.28	13439.28	24.00	29.2	Sunny	15.1	1023.2	0.0552	1.31	1890.7	
09-Jan-09	3.7583	3.8044	1.37	1.37	13439.28	13463.28	24.00	23.4	Sunny	12.6	1026.0	0.0461	1.37	1972.8	
15-Jan-09	3.6684	3.8896	1.34	1.34	13463.28	13487.28	24.00	114.9	Sunny	13.2	1028.2	0.2212	1.34	1925.3	
21-Jan-09	3.6153	3.9047	1.33	1.33	13487.28	13511.28	24.00	151.4	Sunny	20.0	1016.9	0.2894	1.33	1910.9	
29-Jan-09	3.7640	3.8201	1.31	1.31	13511.28	13535.28	24.00	29.7	Sunny	16.3	1016.5	0.0561	1.31	1890.7	
								Min	23.4						
								Max	151.4						
								Average	69.7

Date	Filter Weight (g)		Flow Rate (m ³ /min.)		Elapse Time		Sampling Time(hrs.)	Conc. (µg/m ³)	Weather Condition	Air Temp. (°C)	Atmospheric Pressure(hPa)	Particulate weight(g)	Av. flow (m ³ /min)	Total vol. (m ³)	
	Initial	Final	Initial	Final	Initial	Final									
03-Jan-09	3.6182	3.7318	1.30	1.30	13158.90	13182.90	24.00	60.5	Sunny	15.1	1023.2	0.1136	1.30	1876.3	
09-Jan-09	3.7513	3.9326	1.31	1.31	13182.90	13206.90	24.00	95.9	Sunny	12.6	1026.0	0.1813	1.31	1890.7	
15-Jan-09	3.6667	3.8536	1.31	1.31	13206.90	13230.90	24.00	98.9	Sunny	13.2	1028.2	0.1869	1.31	1890.7	
21-Jan-09	3.6131	3.8453	1.31	1.31	13230.90	13254.90	24.00	122.8	Sunny	20.0	1016.9	0.2322	1.31	1890.7	
29-Jan-09	3.7664	3.8188	1.30	1.30	13254.90	13278.90	24.00	27.9	Sunny	16.3	1016.5	0.0524	1.30	1876.3	
								Min	27.9						
								Max	122.8						
								Average	81.2

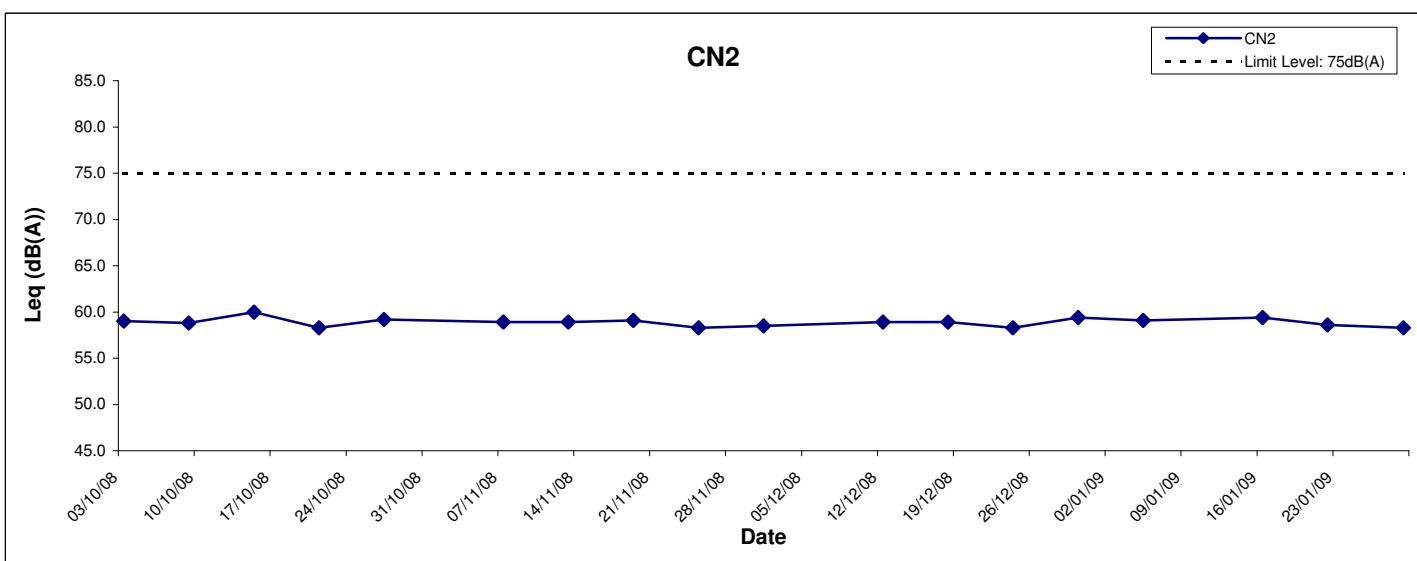
ENSR Asia (HK) Ltd		Impact Monitoring for Landslide Preventive Works at Po Shan Road, Mid-levels Design and Construction (Natural Terrain Risk Mitigation Works) Graphical Presentation of Noise Monitoring Results for Location CN1 and CN2	SCALE	N.T.S.	DATE	Feb-09
			CHECK	ENFL	DRAWN	RWHW
			JOB NO.	60039173	APPENDIX	1
