**Route 8 (previously known as Route 9) between
Cheung Sha Wan & Sha Tin**

**Contract No. HY/2003/10 - Environmental Team for
Lai Chi Kok Viaduct and Eagle's Nest Tunnel**

**Monthly EM&A Report
Part I – Lai Chi Kok Viaduct (Version 1.0)**

September 2008

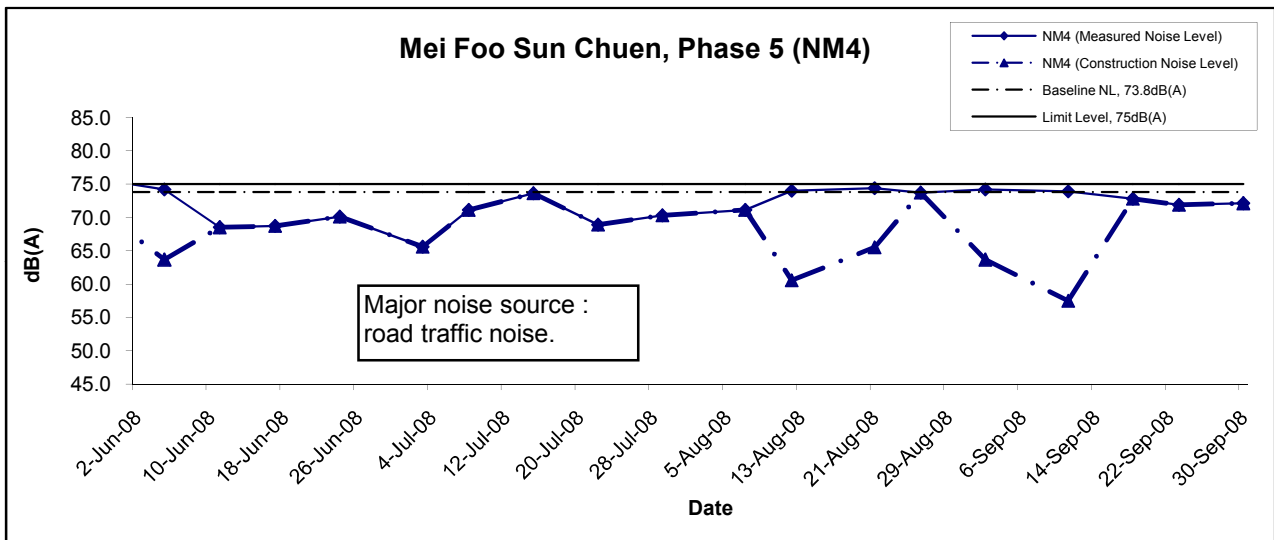
Noise Levels

* Construction Noise Level = Measured Noise Level - Baseline Level
 (If the measured noise level is lower than the baseline level, the construction noise level will be taken as the measured one)

Title Route 8 (previously known as Route 9) between Cheung Sha Wan and Sha Tin Contract HY/2003/01 - Lai Chi Kok Viaduct Graphical Presentation of Construction Noise Monitoring Results	Scale	Project No.	CINOTECH
	Date	Appendix	
	N.T.S	MA3024	
	Sep 08	G
