**Route 8 (previously known as Route 9) between
Cheung Sha Wan & Sha Tin**

**Contract No. HY/2003/10 - Environmental Team for
Lai Chi Kok Viaduct and Eagle's Nest Tunnel**

**Monthly EM&A Report
Part I – Lai Chi Kok Viaduct (Version 1.0) for**

December 2008

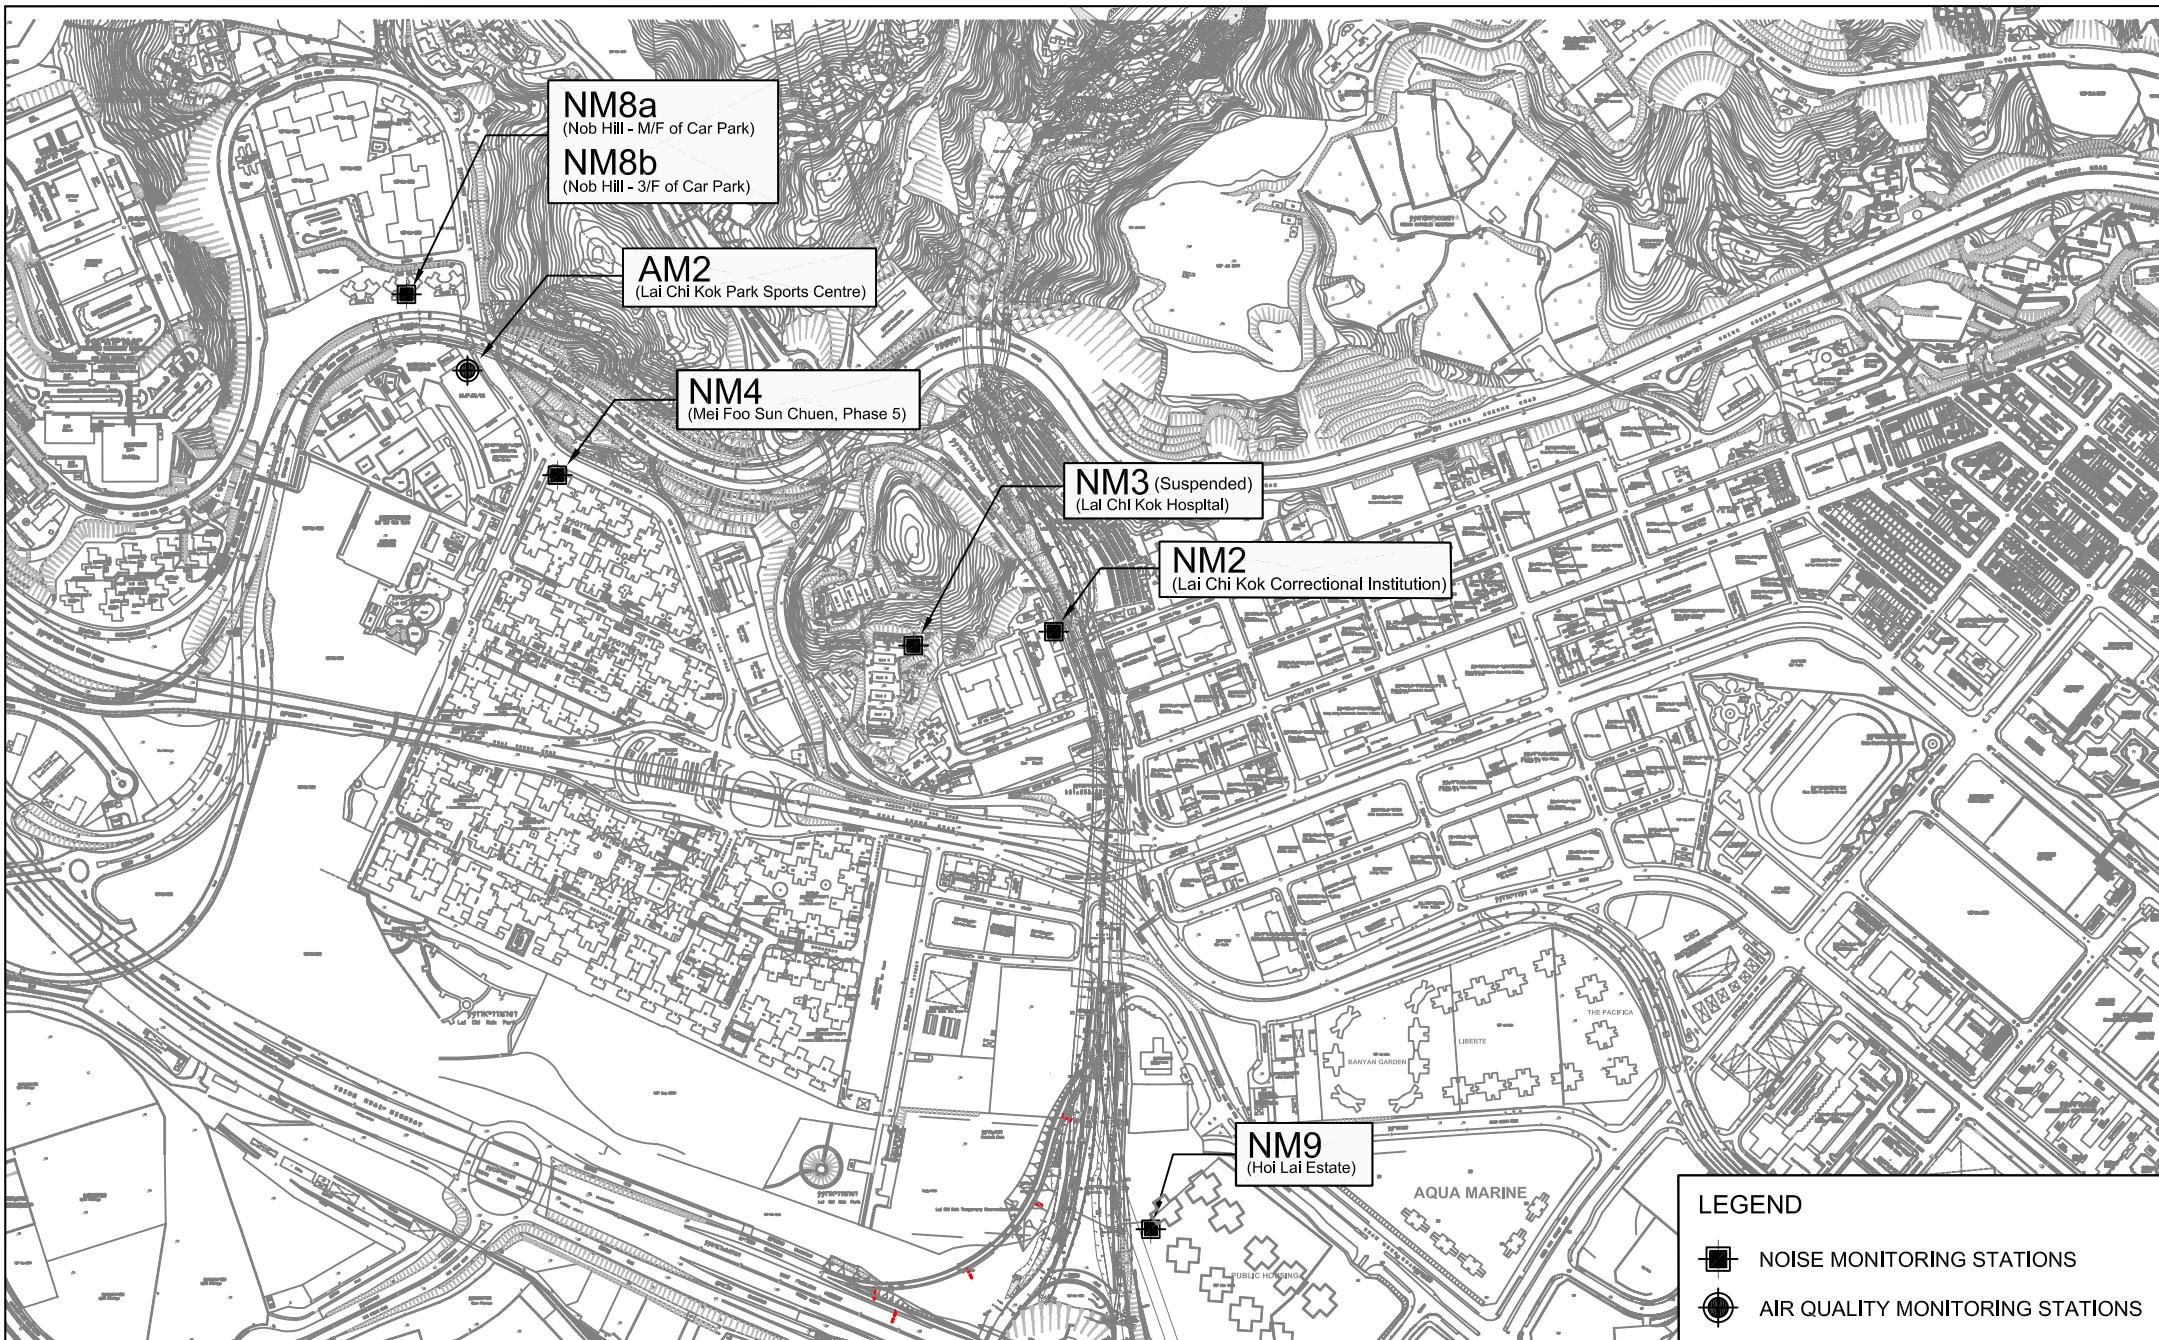
LOCATIONS OF MONITORING STATIONS

Title ROUTE 8 (PREVIOUSLY KNOWN AS ROUTE 9) BETWEEN CHEUNG SHA WAN AND SHA TIN
CONTRACT HY/2003/01 - LAI CHI KOK VIADUCT

Figure 1	Locations of Monitoring Stations
----------	----------------------------------
