**Highways Department**

**Environmental Team for the Widening of  
Tolo Highway / Fanling Highway between  
Island House Interchange and Fanling**

**(Stage 1)  
Between Island House Interchange and  
Tai Hang - Investigation**

**Annual EM&A Review Report  
for November 2012 - October 2013**

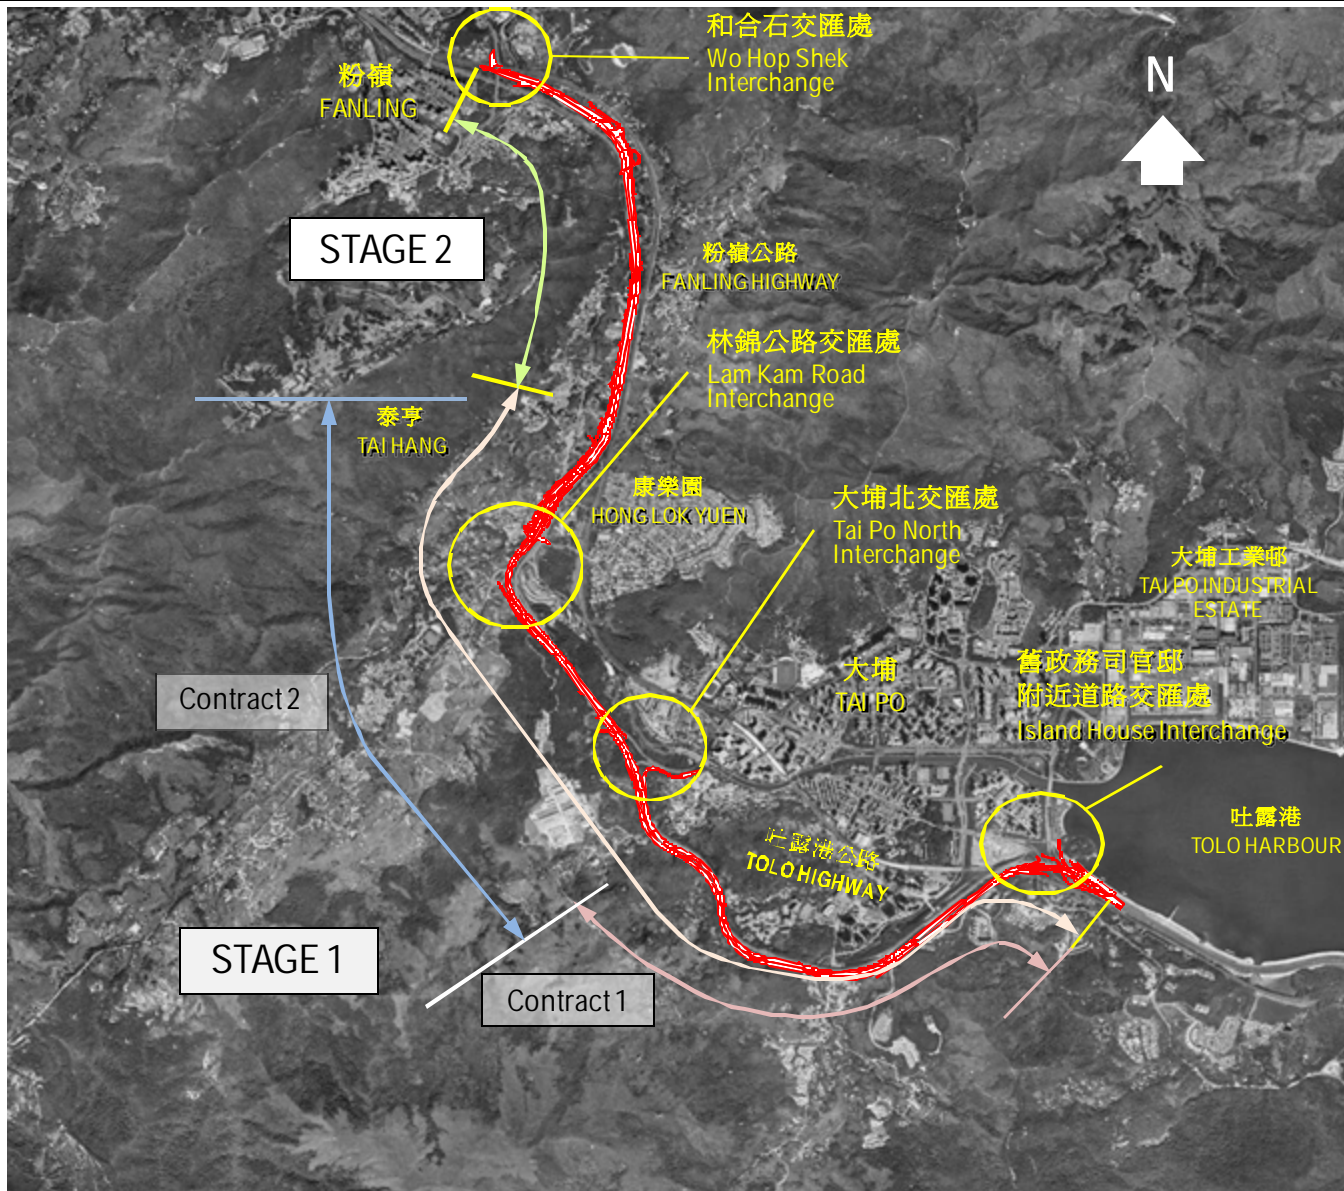
SCALE	N.T.S.	DATE	Dec-09
CHECK	ENFL	DRAWN	RWHW
JOB NO.	60102979	FIGURE NO.	1.1
			Rev 0

General Project Layout Plan

- 1.16. The general layout plan of the Project site showing the contract areas is shown in Figure 1.1.
- 1.17. The environmental mitigation measures implementation schedule (EMIS) are presented in Appendix B.

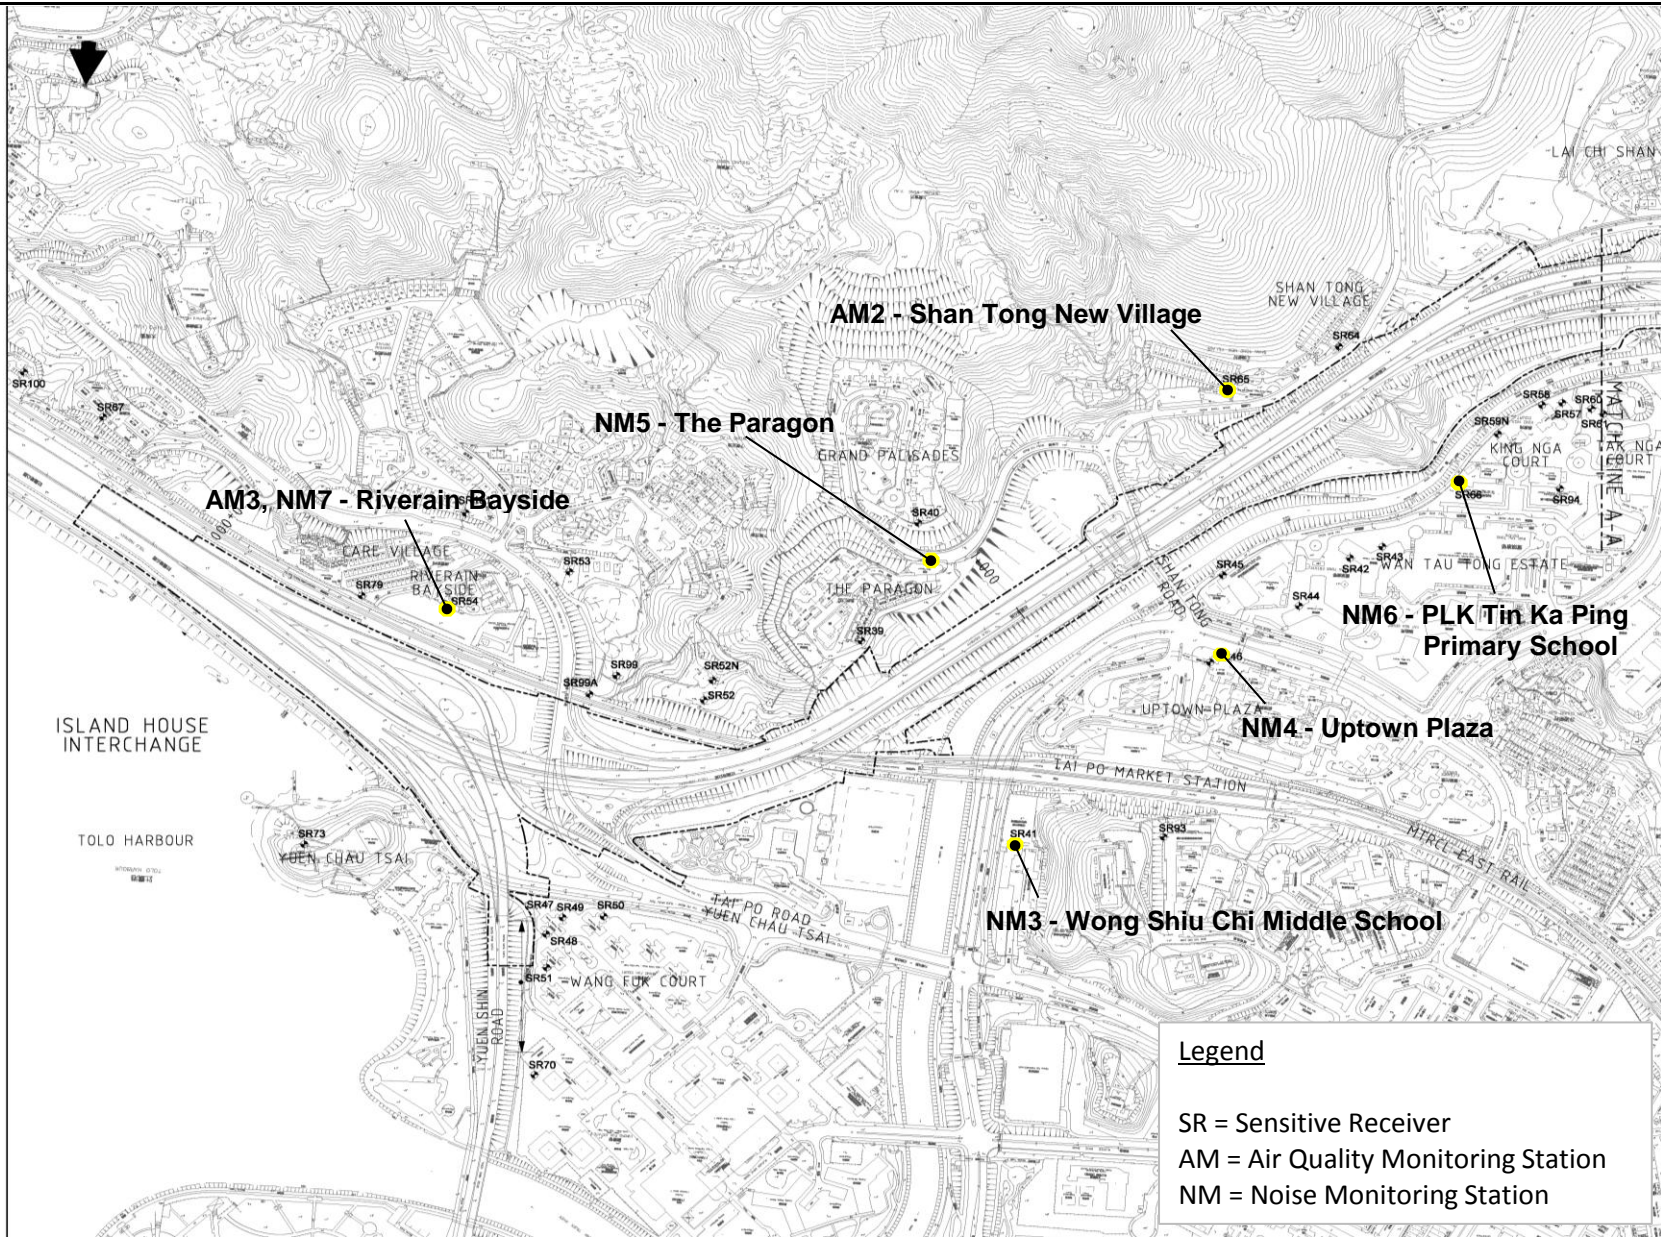
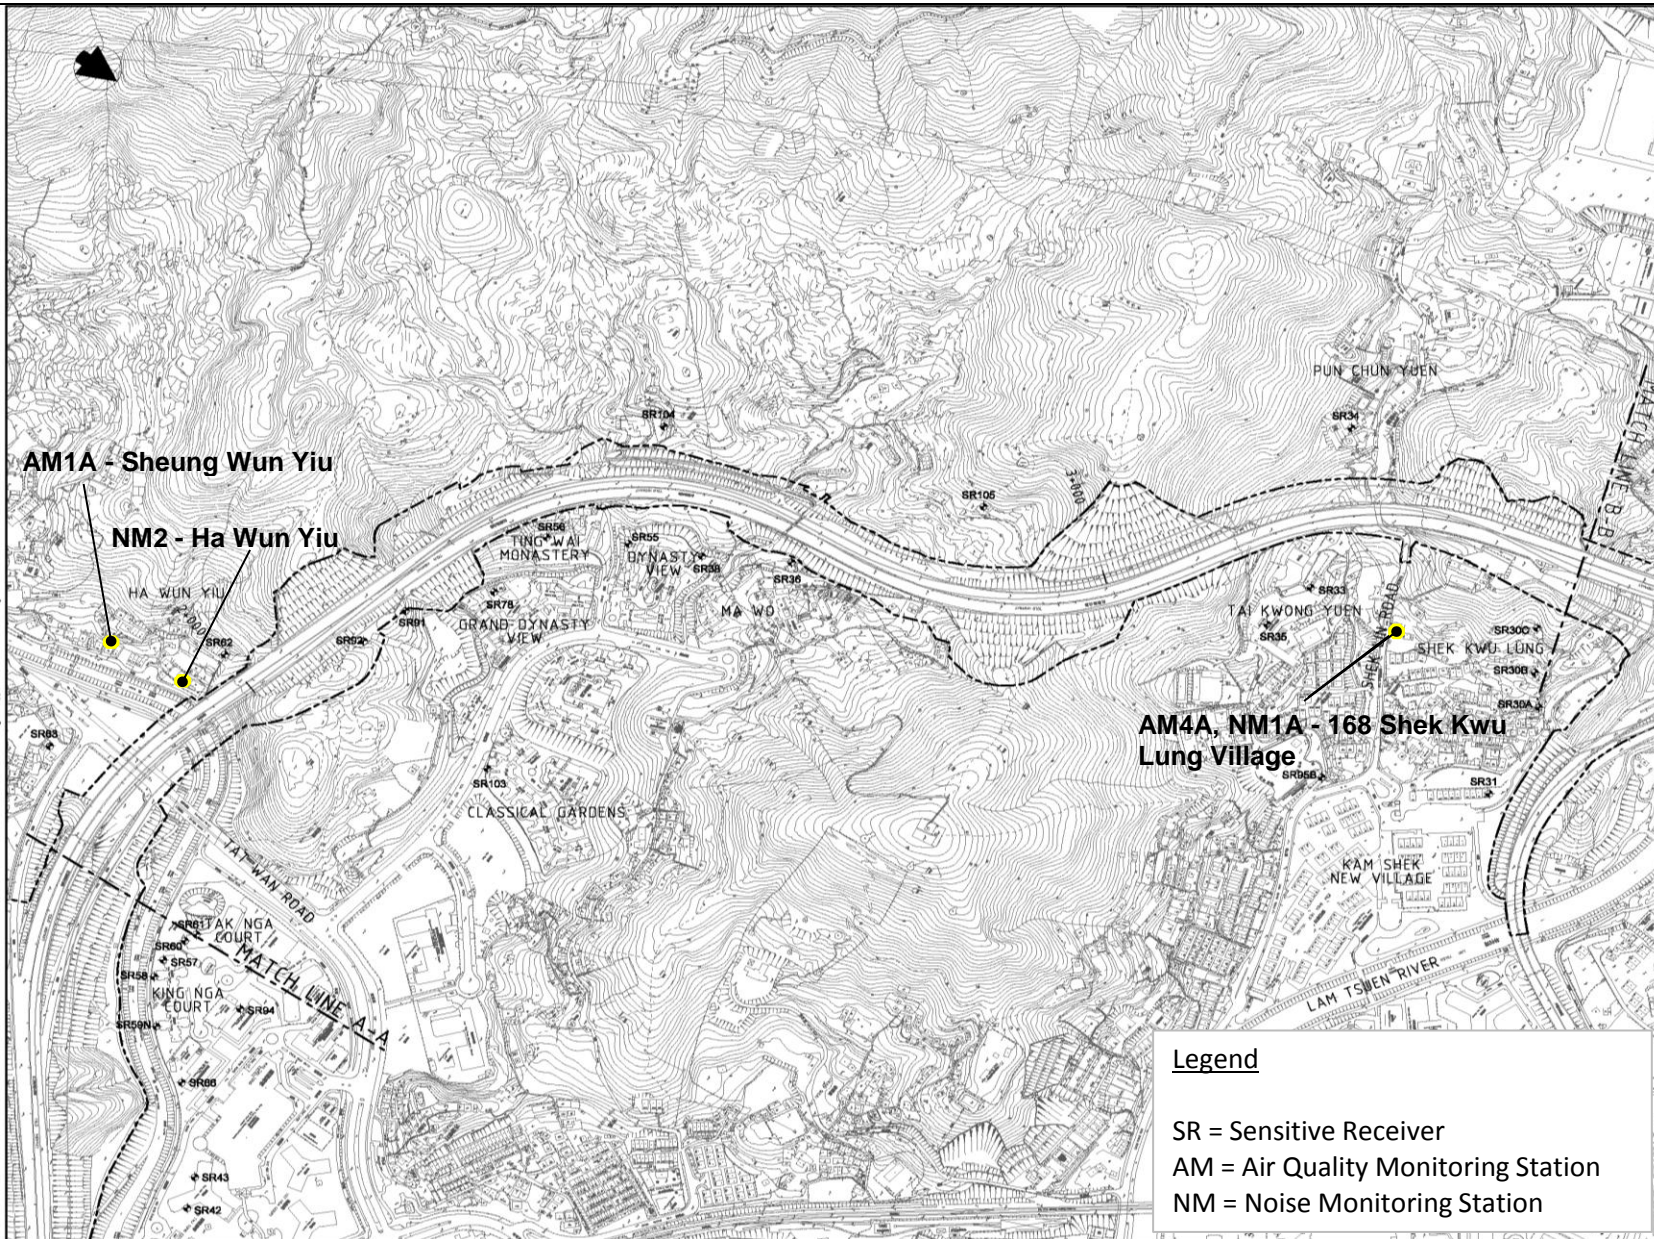
SCALE	N.T.S.	DATE	Sep-11
CHECK	ENFL	DRAWN	LCHC
JOB NO.	60102979	FIGURE NO.	2.1
		Rev	0

SR = Sensitive Receiver  
 AM = Air Quality Monitoring Station  
 NM = Noise Monitoring Station

<b>AECOM</b>	<b>Environmental Team for the Widening of Tolo Highway between Island House Interchange and Tai Hang - Investigation</b>	SCALE	N.T.S.	DATE	Sep-11
	EM&A Monitoring Locations (Sheet 1 of 2)	CHECK	ENFL	DRAWN	LCHC
		JOB NO.	60102979	FIGURE NO.	2.1

EM&A Monitoring Locations (Sheet 2 of 2)

- 2.5. The monitoring locations used during the reporting period are depicted in Figure 2.1.
- 2.6. The updated EM&A Manual also required environmental site inspections for air quality, noise, water quality, chemical, waste management, ecology and landscape and visual impact.

- 3.1. Air quality monitoring, including 1-hour and 24-hour TSP, was conducted at least 3 times every 6 days and at least once every 6 days respectively at the 4 monitoring stations, in accordance with the updated EM&A Manual.
- 3.2. Figure 2.1 shows the locations of monitoring stations used during the reporting period. Table 3.1 describes the details of the monitoring stations.

- 4.1. Construction noise monitoring was conducted at 7 monitoring stations for at least once per week during 07:00 – 19:00 in the reporting period.
- 4.2. Figure 2.1 shows the locations of the monitoring stations used during the reporting period. Table 4.1 describes the details of the monitoring stations.

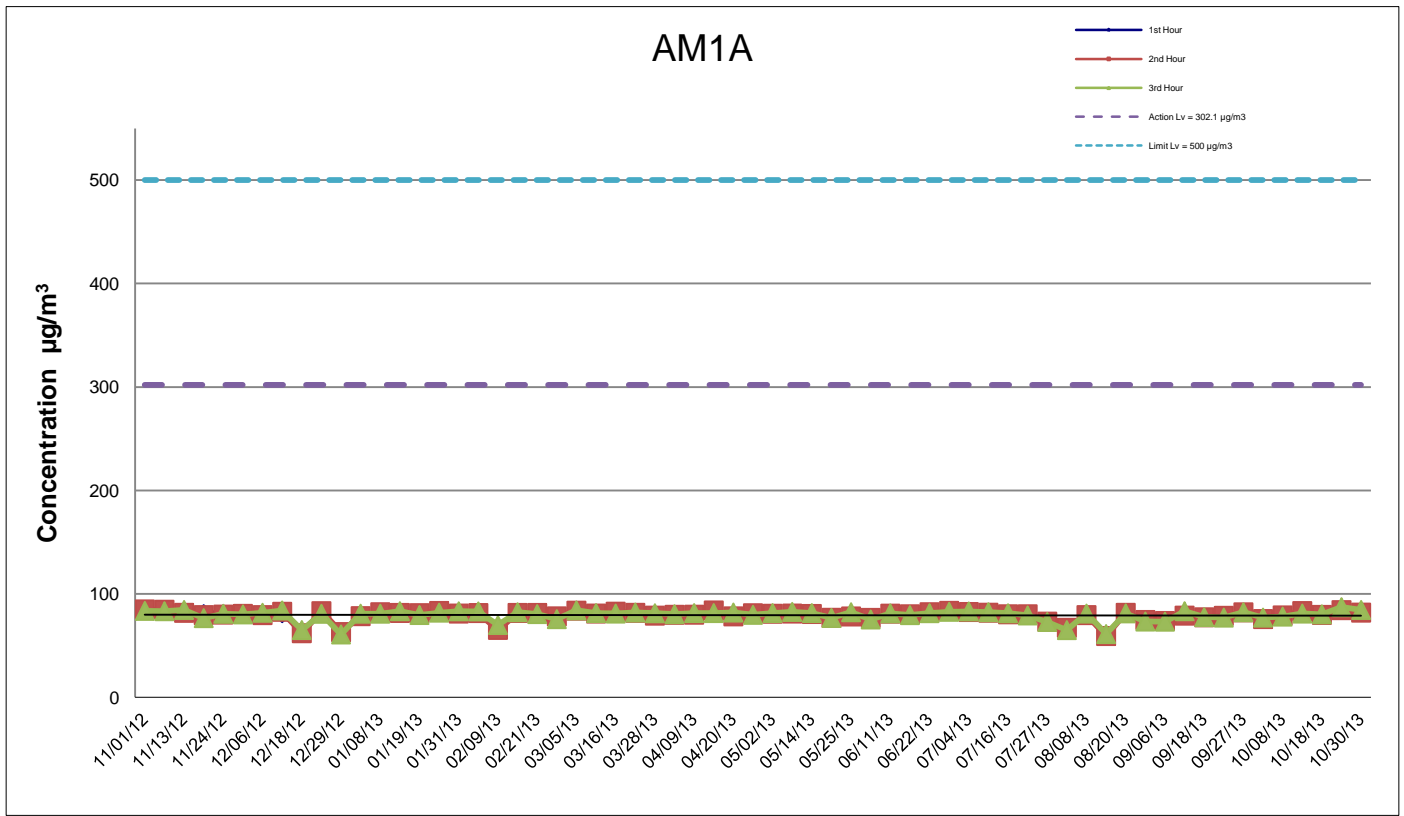
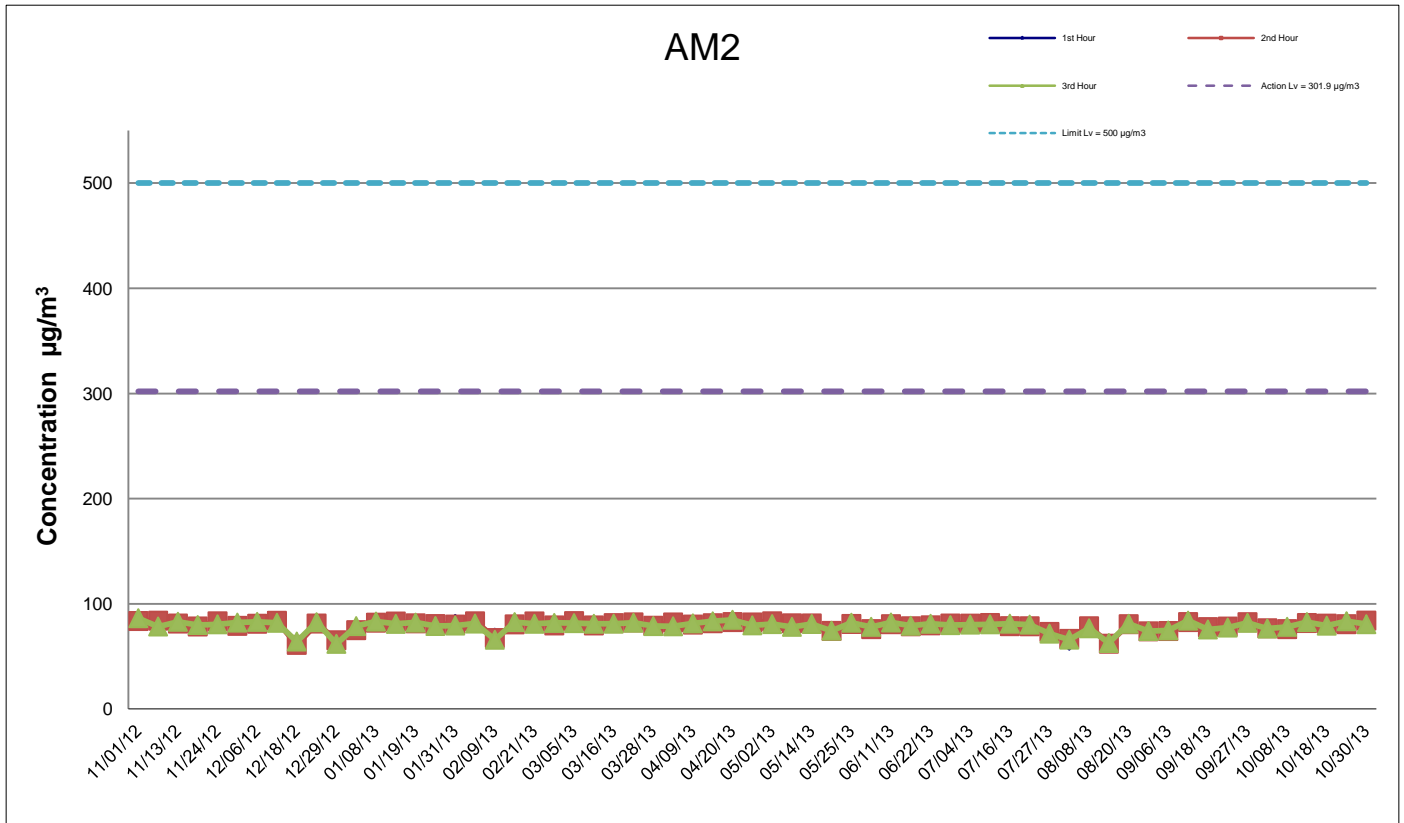
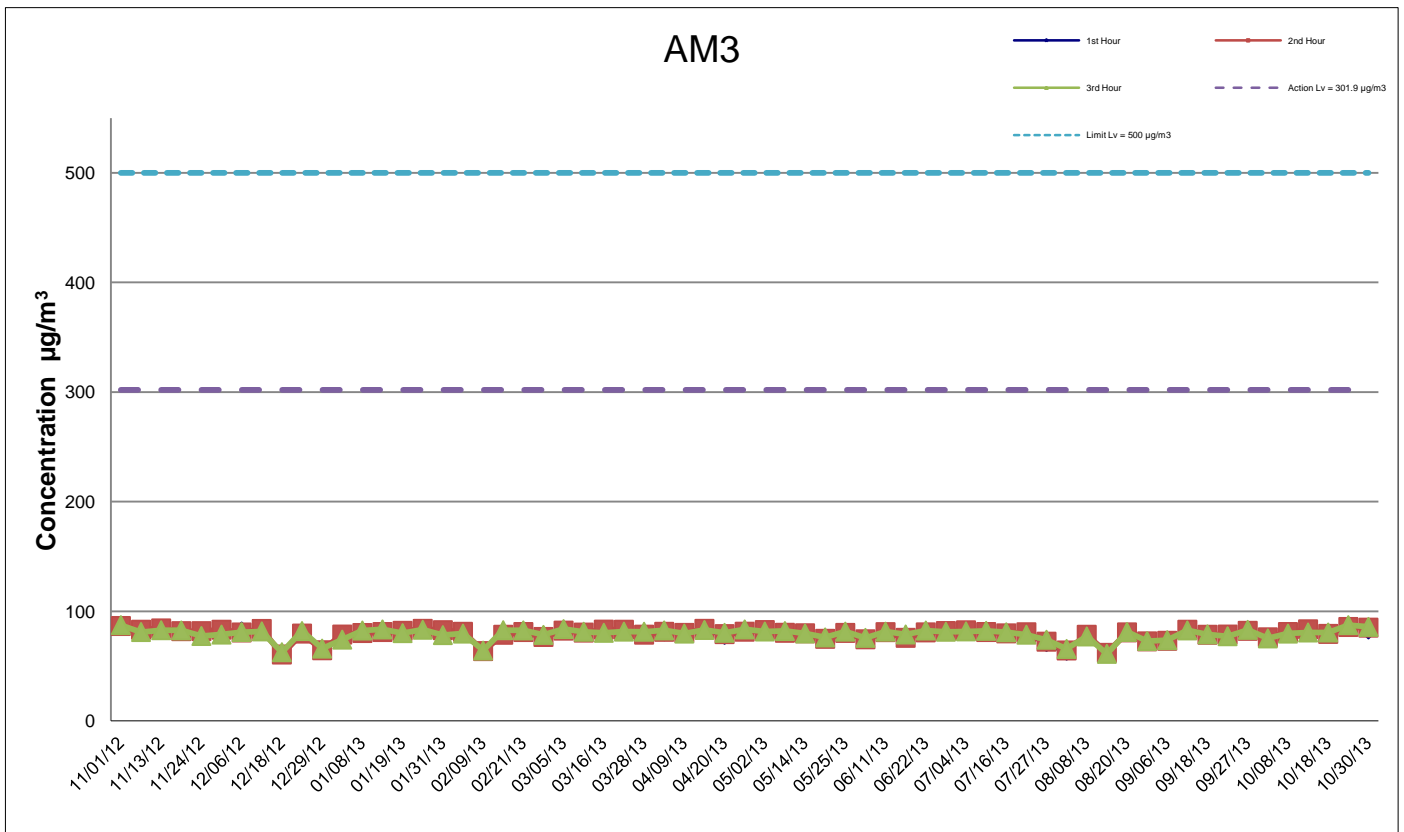
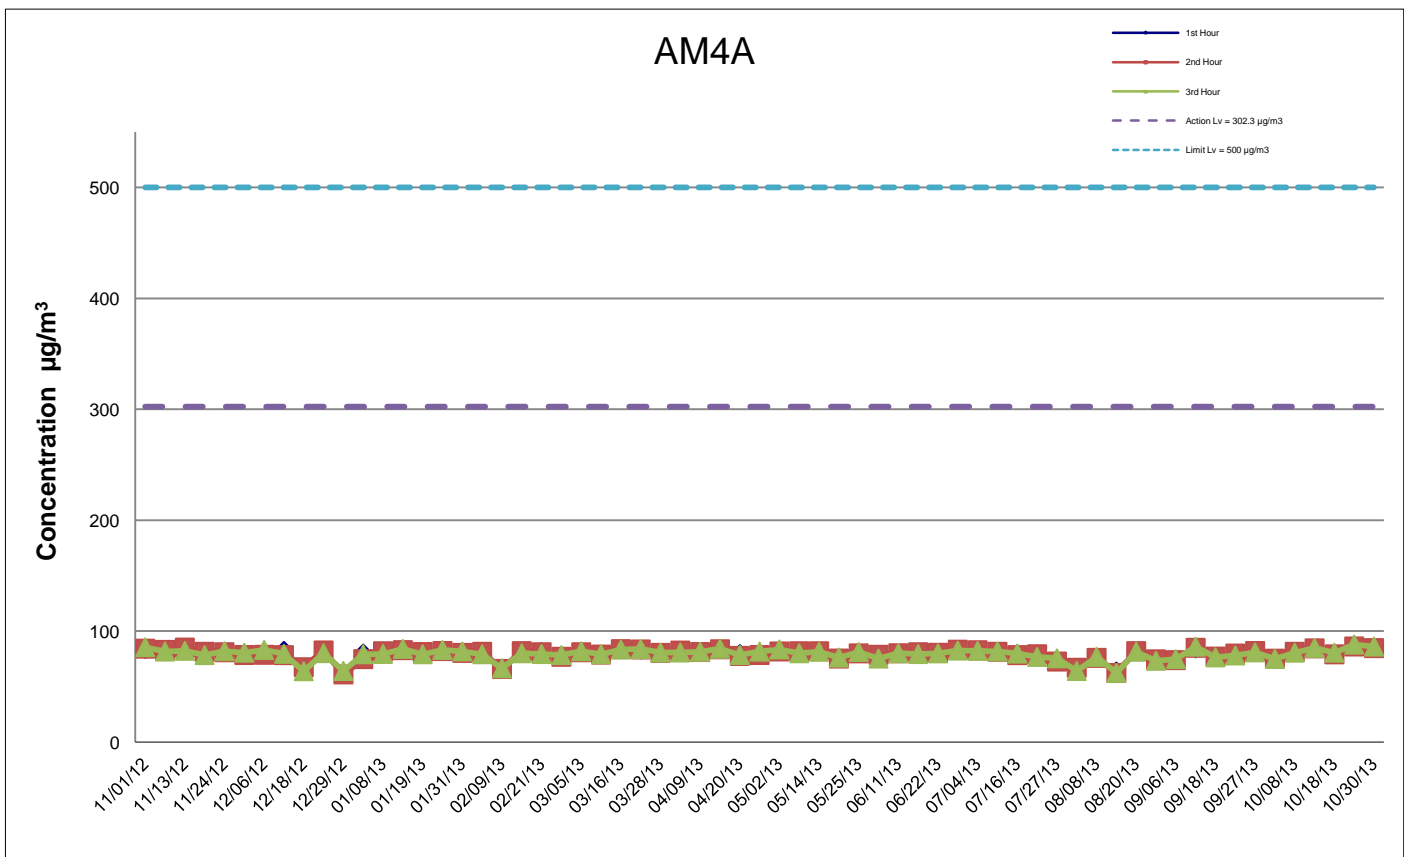
<b>AECOM</b>	<b>Environmental Team for the Widening of Tolo Highway between Island House Interchange and Tai Hang - Investigation</b>	SCALE	N.T.S.	DATE	Jan-14
	Graphical Presentation of Impact 1-hour TSP Monitoring Results	CHECK	ENFL	DRAWN	JCYK
		JOB NO.	60102979	APPENDIX No.	D

**Remark:** The monitoring station at Tai Kwong Secondary School (AM4) was relocated to 168 Shek Kwu Lung Village (AM4A) starting from 1 September 2011 due to the mentioned school was closed down.

<b>AECOM</b>	<b>Environmental Team for the Widening of Tolo Highway between Island House Interchange and Tai Hang - Investigation</b>	SCALE	N.T.S.	DATE	Jan-14
	Graphical Presentation of Impact 1-hour TSP Monitoring Results	CHECK	ENFL	DRAWN	JCYK
		JOB NO.	60102979	APPENDIX No.	
				D	-

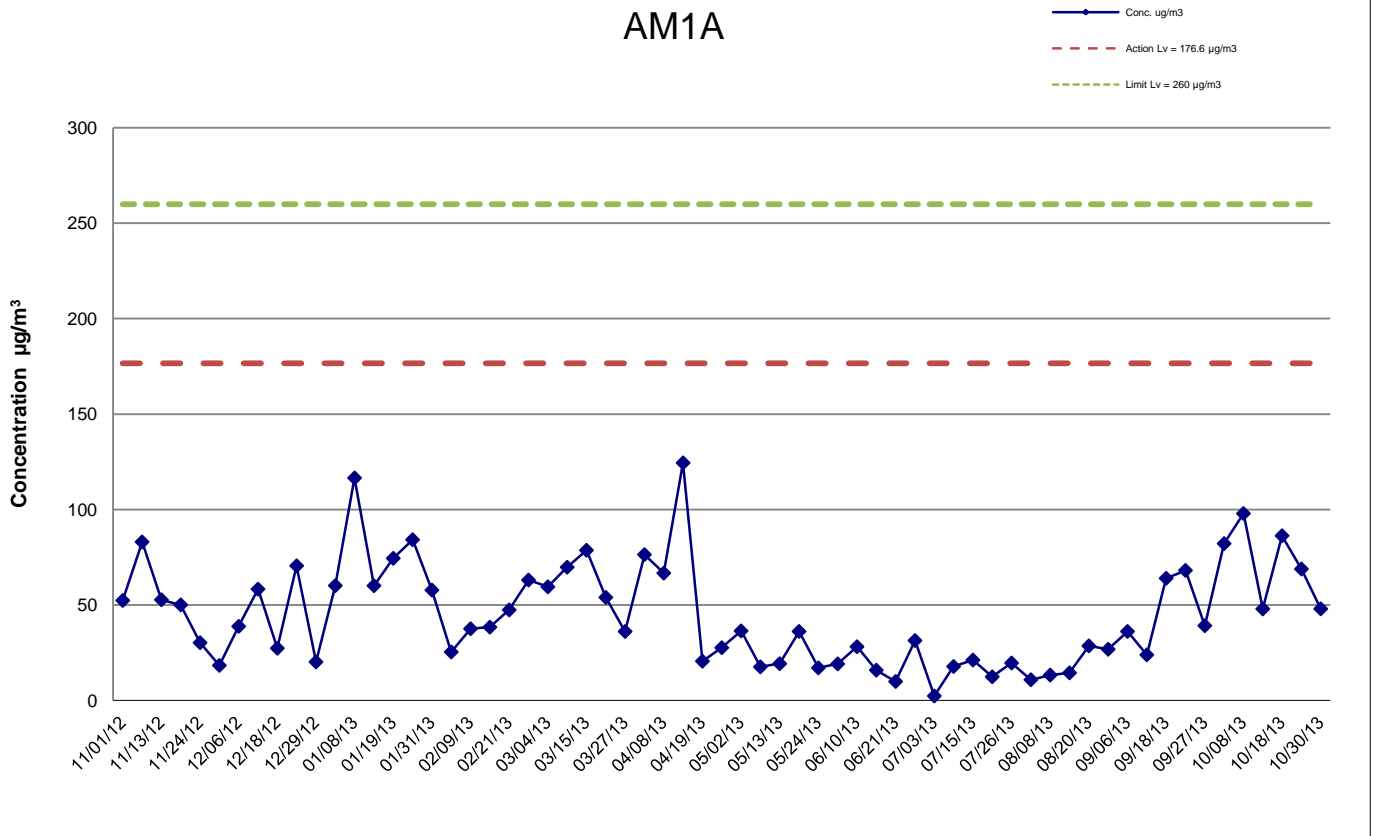
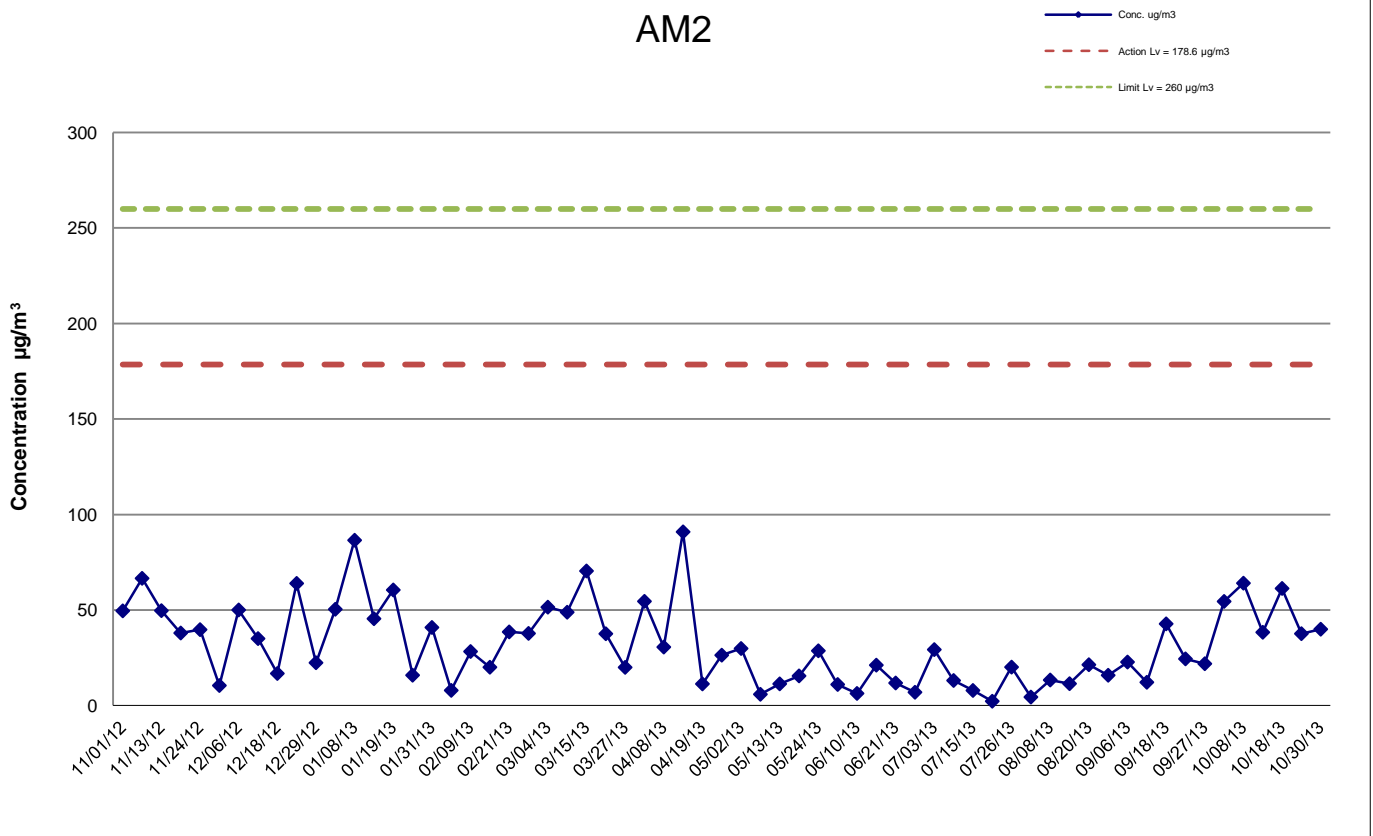
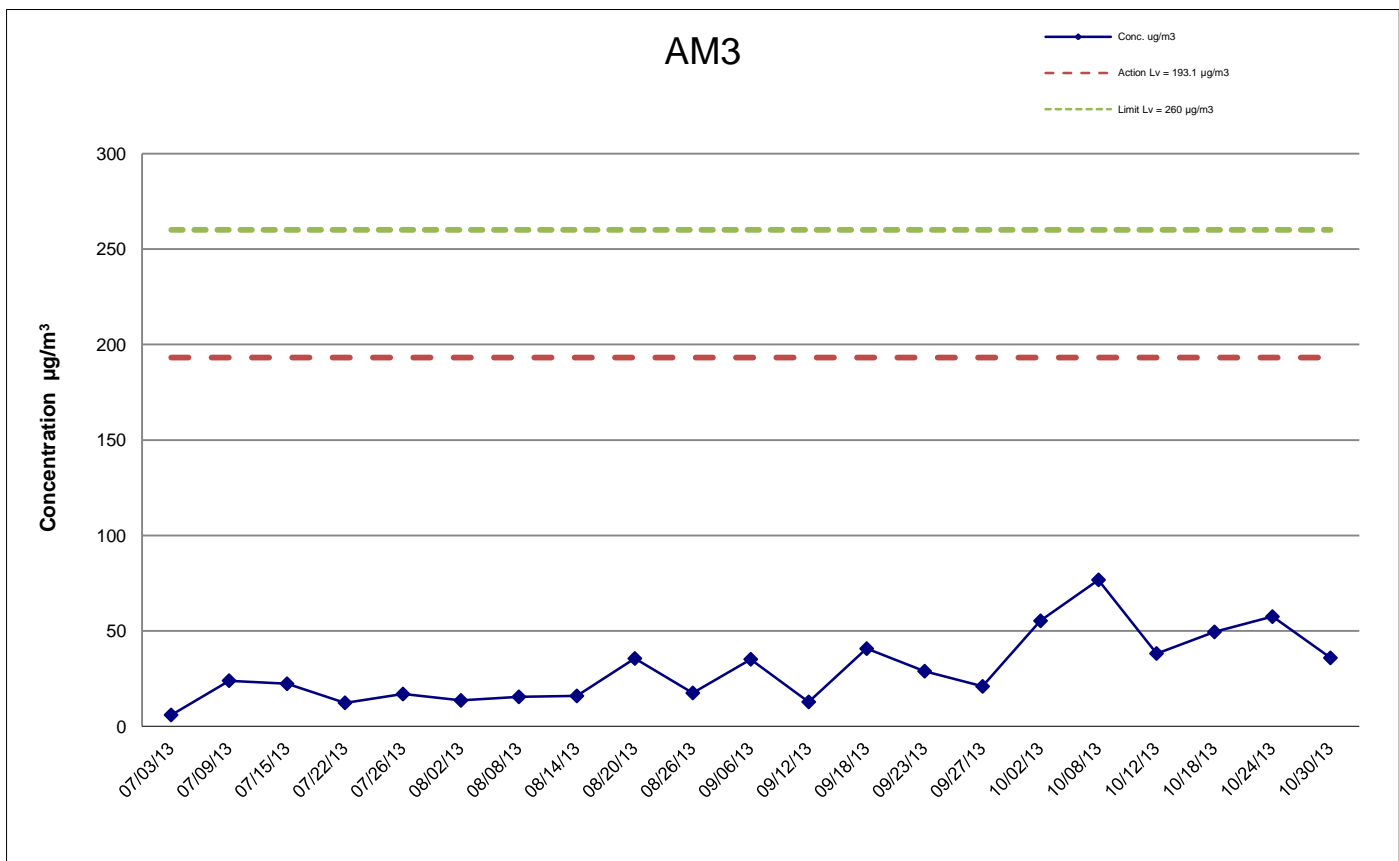
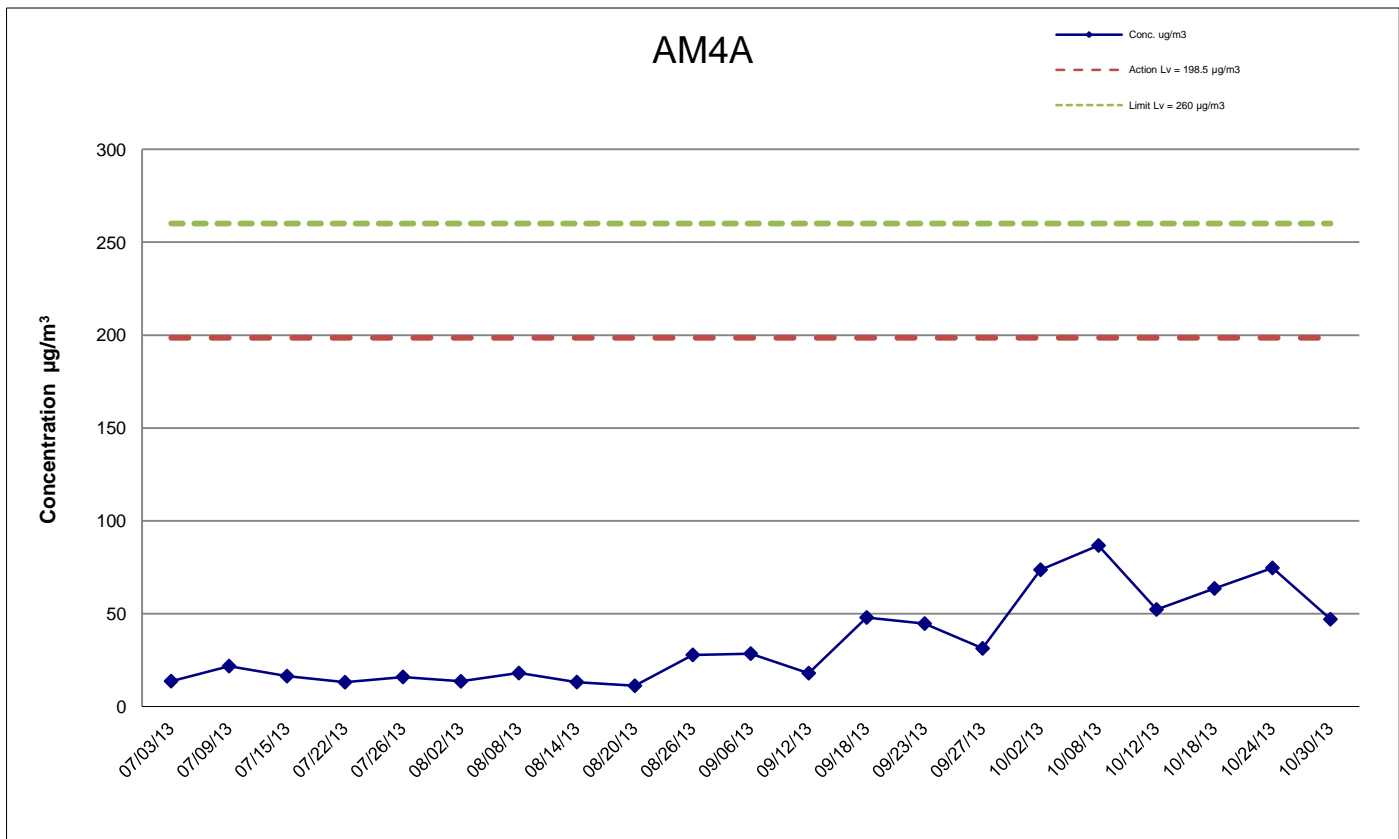
Graphical Presentation of Impact 24-hour TSP Monitoring  
Results

**Remark:** The monitoring station at Tai Kwong Secondary School (AM4) was relocated to 168 Shek Kwu Lung Village (AM4A) starting from 1 September 2011 due to the mentioned school was closed down.

<b>Environmental Team for the Widening of Tolo Highway between Island House Interchange and Tai Hang - Investigation</b>	SCALE	N.T.S.	DATE	Jan-14
	Graphical Presentation of Impact 24-hour TSP Monitoring Results	CHECK	ENFL	DRAWN	JCYK
		JOB NO.	60102979	APPENDIX No. D

With reference to the monitoring results recorded on days near to the day of complaint at the nearest EM&A monitoring station (AM1A- 3 Sheung Wun Yiu), the 24-hour TSP levels on 27 September 2013 and 2 October 2013 were found to be 39.2ug/m<sup>3</sup> and 36.2ug/m<sup>3</sup> respectively, which were below the action level of 198.5 ug/m<sup>3</sup>. Besides, the average 1-hour TSP levels on 27 September 2013 and 2 October 2013 at the nearest EM&A monitoring station (AM1A- 3 Sheung Wun Yiu) were found to be 81.8ug/m<sup>3</sup> and 76.3ug/m<sup>3</sup> respectively, which were also below the action level of 302.3ug/m<sup>3</sup>.

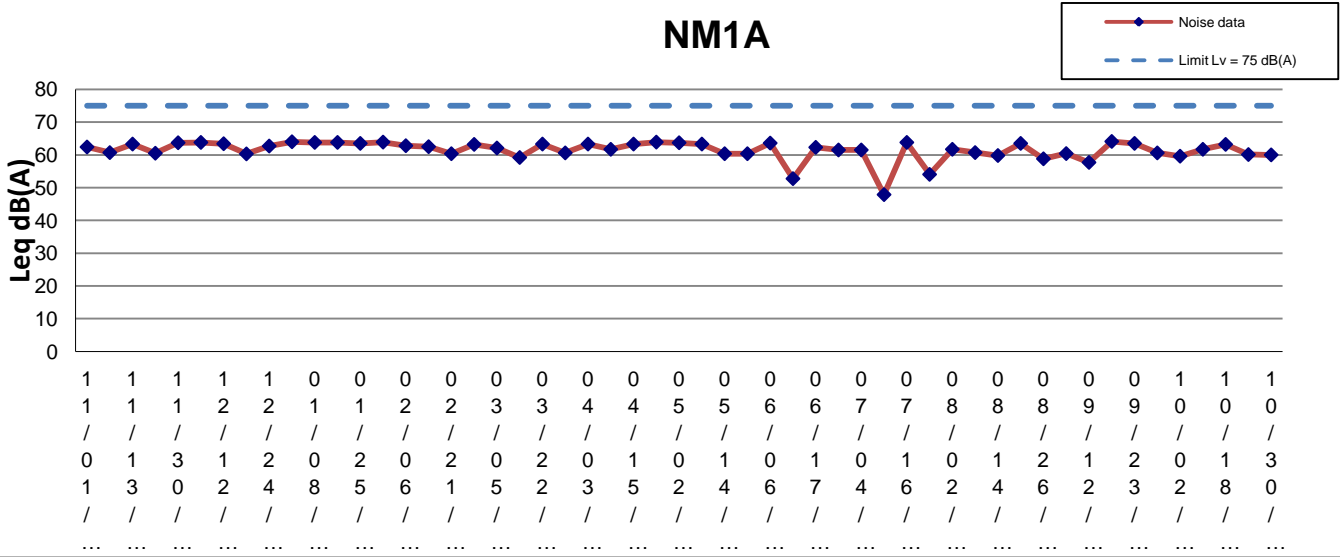
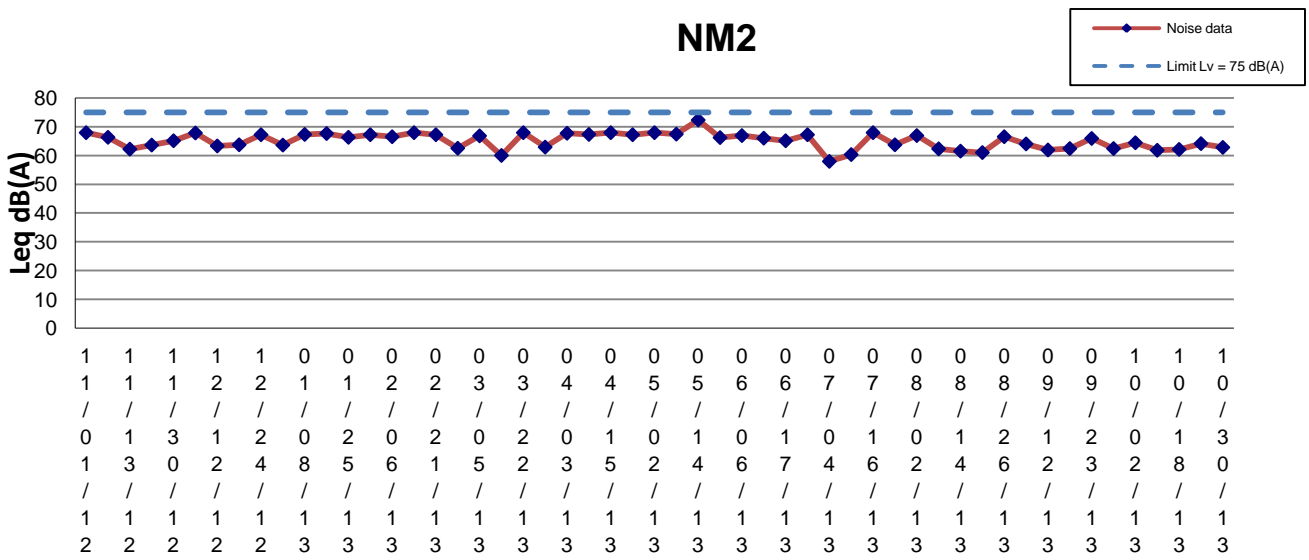
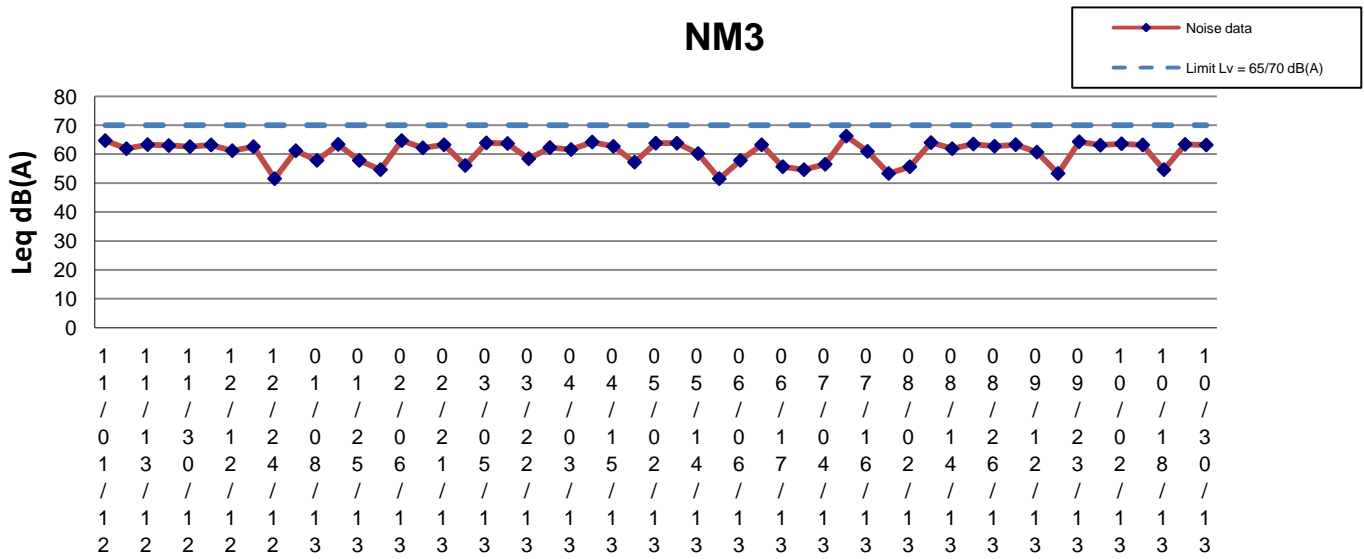
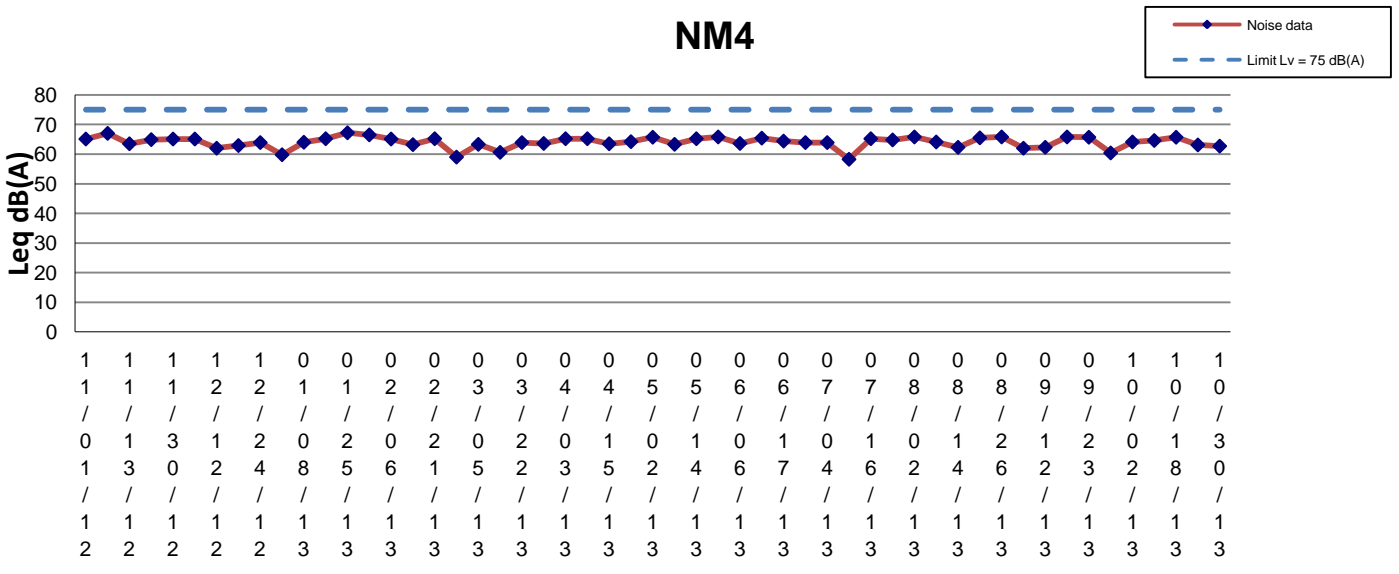
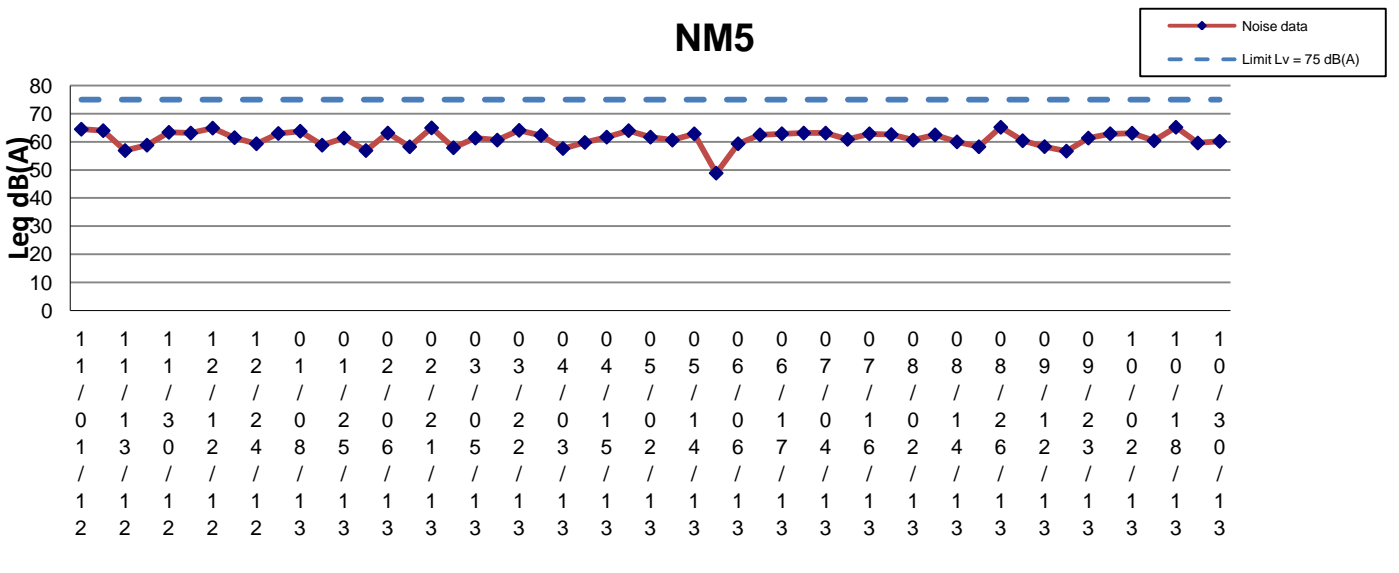
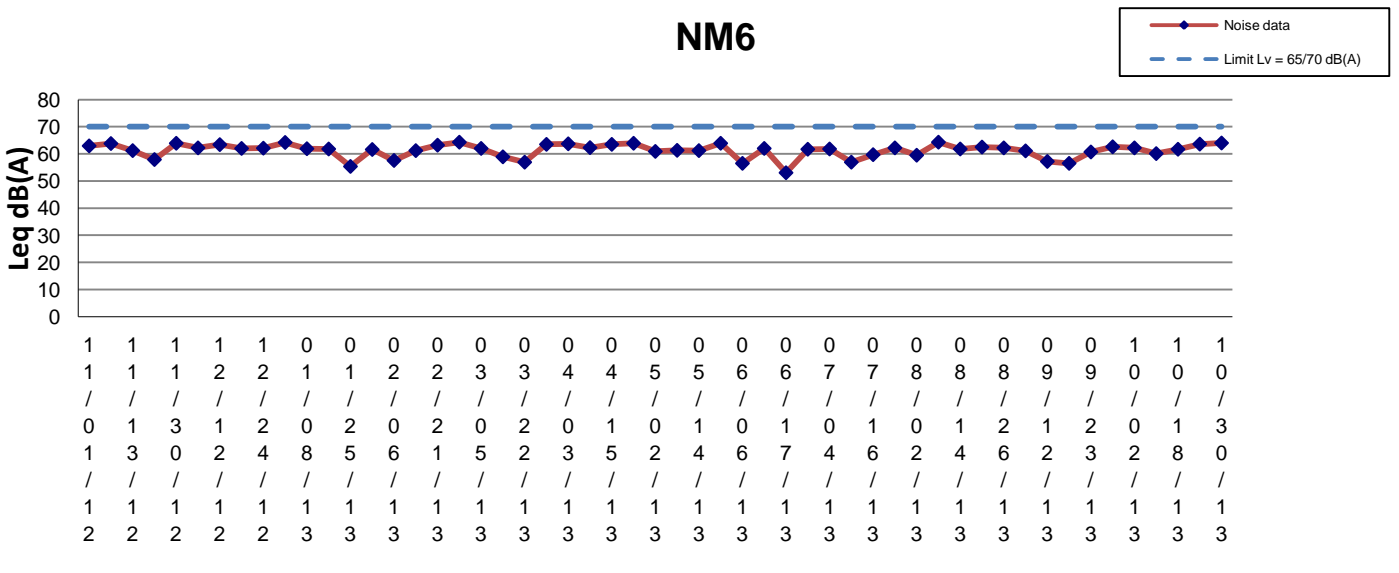
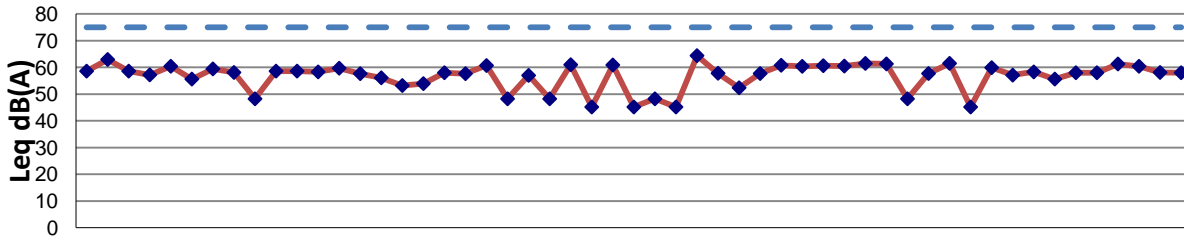
Remarks: (1) The monitoring station at Tai Kwong Secondary School (NM1) was relocated to 168 Shek Kwu Lung Village (NM1A) starting from 1 September 2011 due to the mentioned school was closed down;  
 (2) Measured noise level would be shown if Measured noise level (Leq) <= Baseline noise level

<b>Environmental Team for the Widening of Tolo Highway between Island House Interchange and Tai Hang - Investigation</b>	SCALE	N.T.S.	DATE	Jan-14	
		CHECK	ENFL	DRAWN	JCYK	
	Graphical Presentation of Impact Daytime Construction Noise Monitoring Results	JOB NO.	60102979	APPENDIX No.	E	Rev.

Remark: Measured noise level would be shown if Measured noise level (Leq) <= Baseline noise level

<b>Environmental Team for the Widening of Tolo Highway between Island House Interchange and Tai Hang - Investigation</b>	SCALE	N.T.S.	DATE	Jan-14
	Graphical Presentation of Impact Daytime Construction Noise Monitoring Results	CHECK	ENFL	DRAWN	JCYK
		JOB NO.	60102979	APPENDIX No.	E

**Remark:** Measured noise level would be shown if Measured noise level (Leq) <= Baseline noise level
