The Jockey Club CPS Limited

Central Police Station Conservation and Revitalisation Project: Twelfth Quarterly EM&A Report (1 August 2014 to 31 October 2014)

Issue Date: November 2014

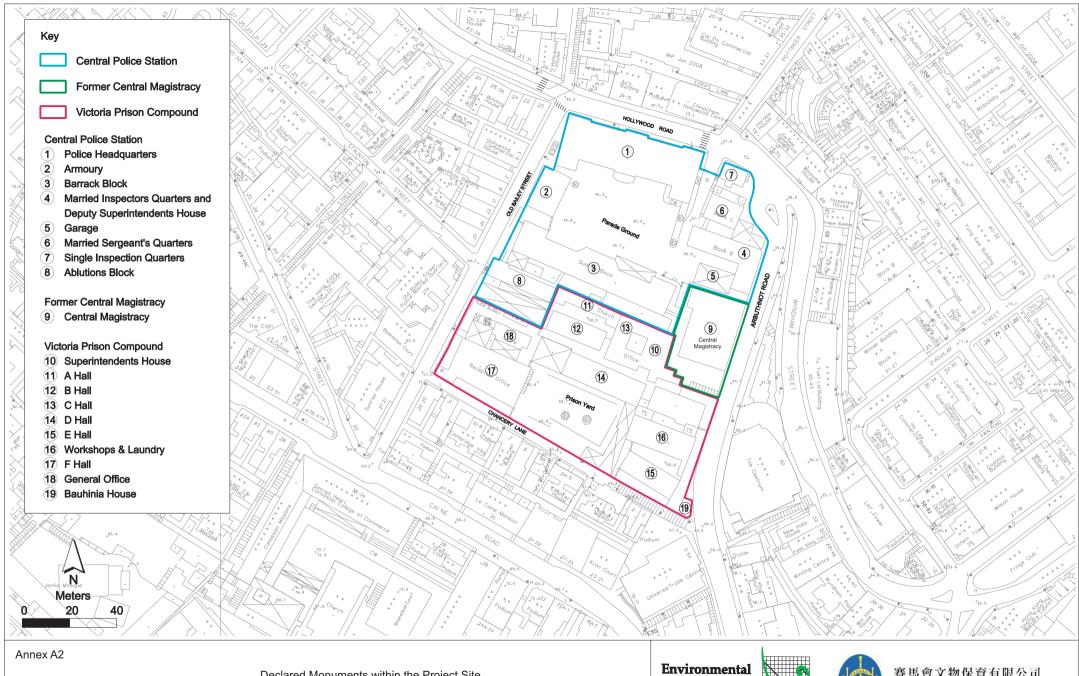
Annex A2

Declared Monuments within the Project Site

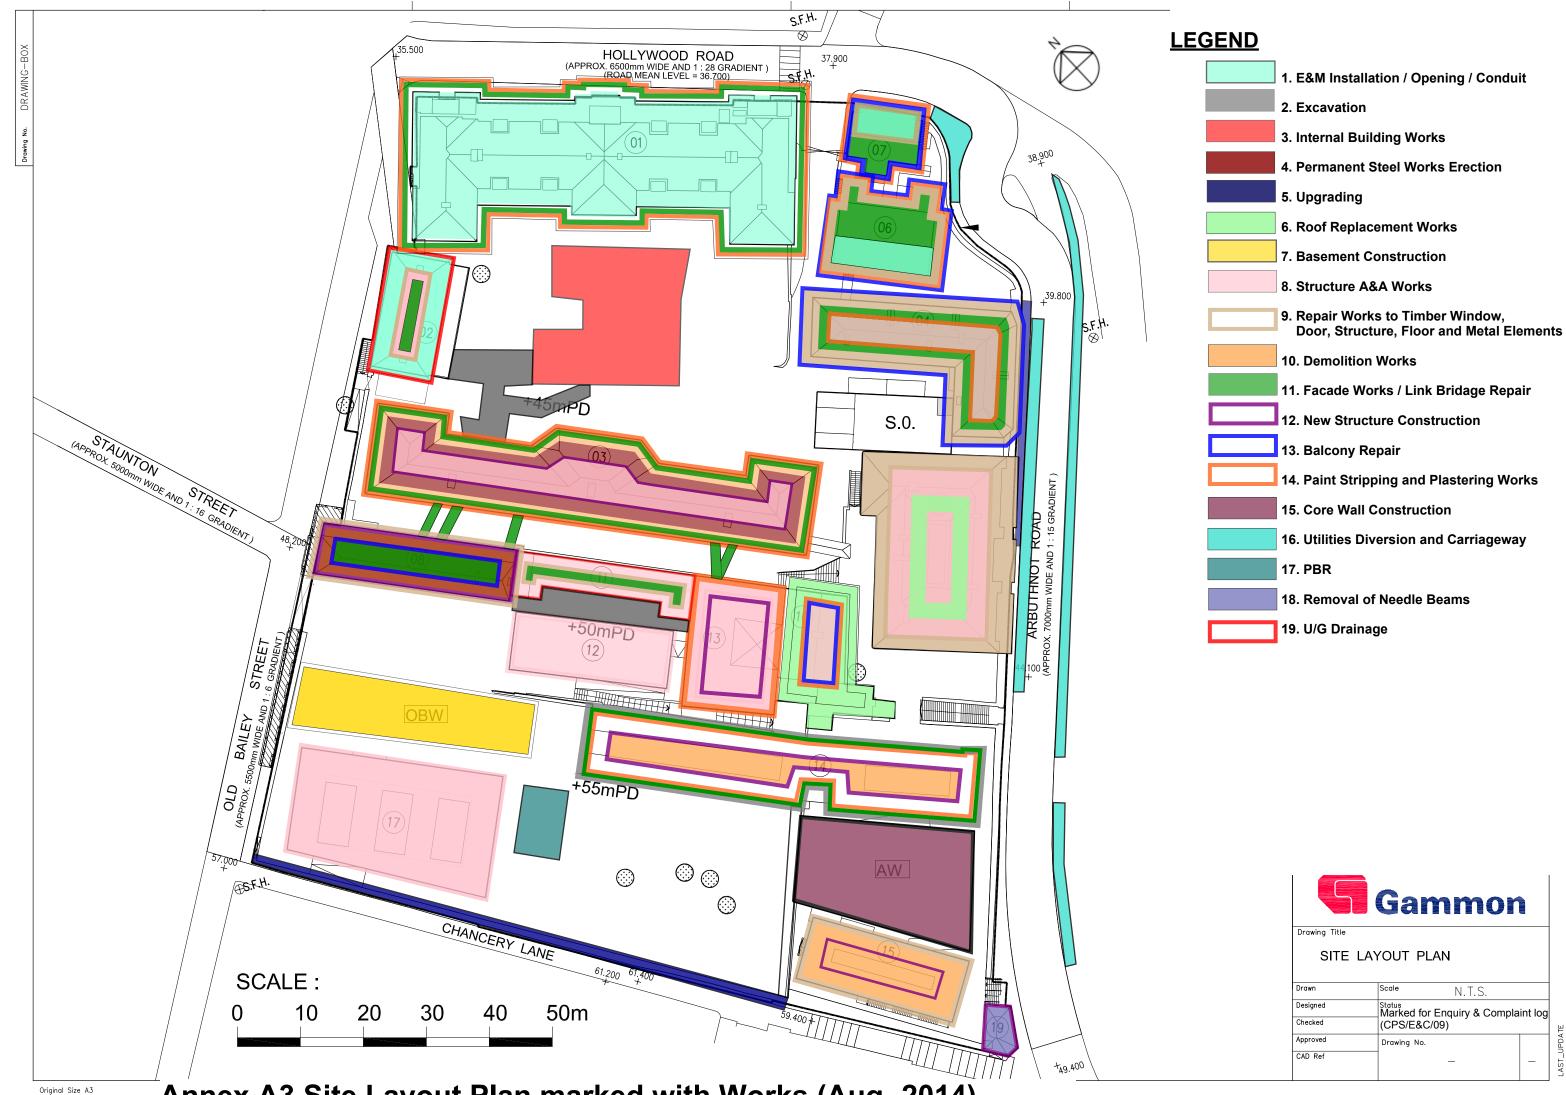
Site Layout Plan marked with Works

Annex A3 Site Layout Plan marked with Works (Aug- 2014)

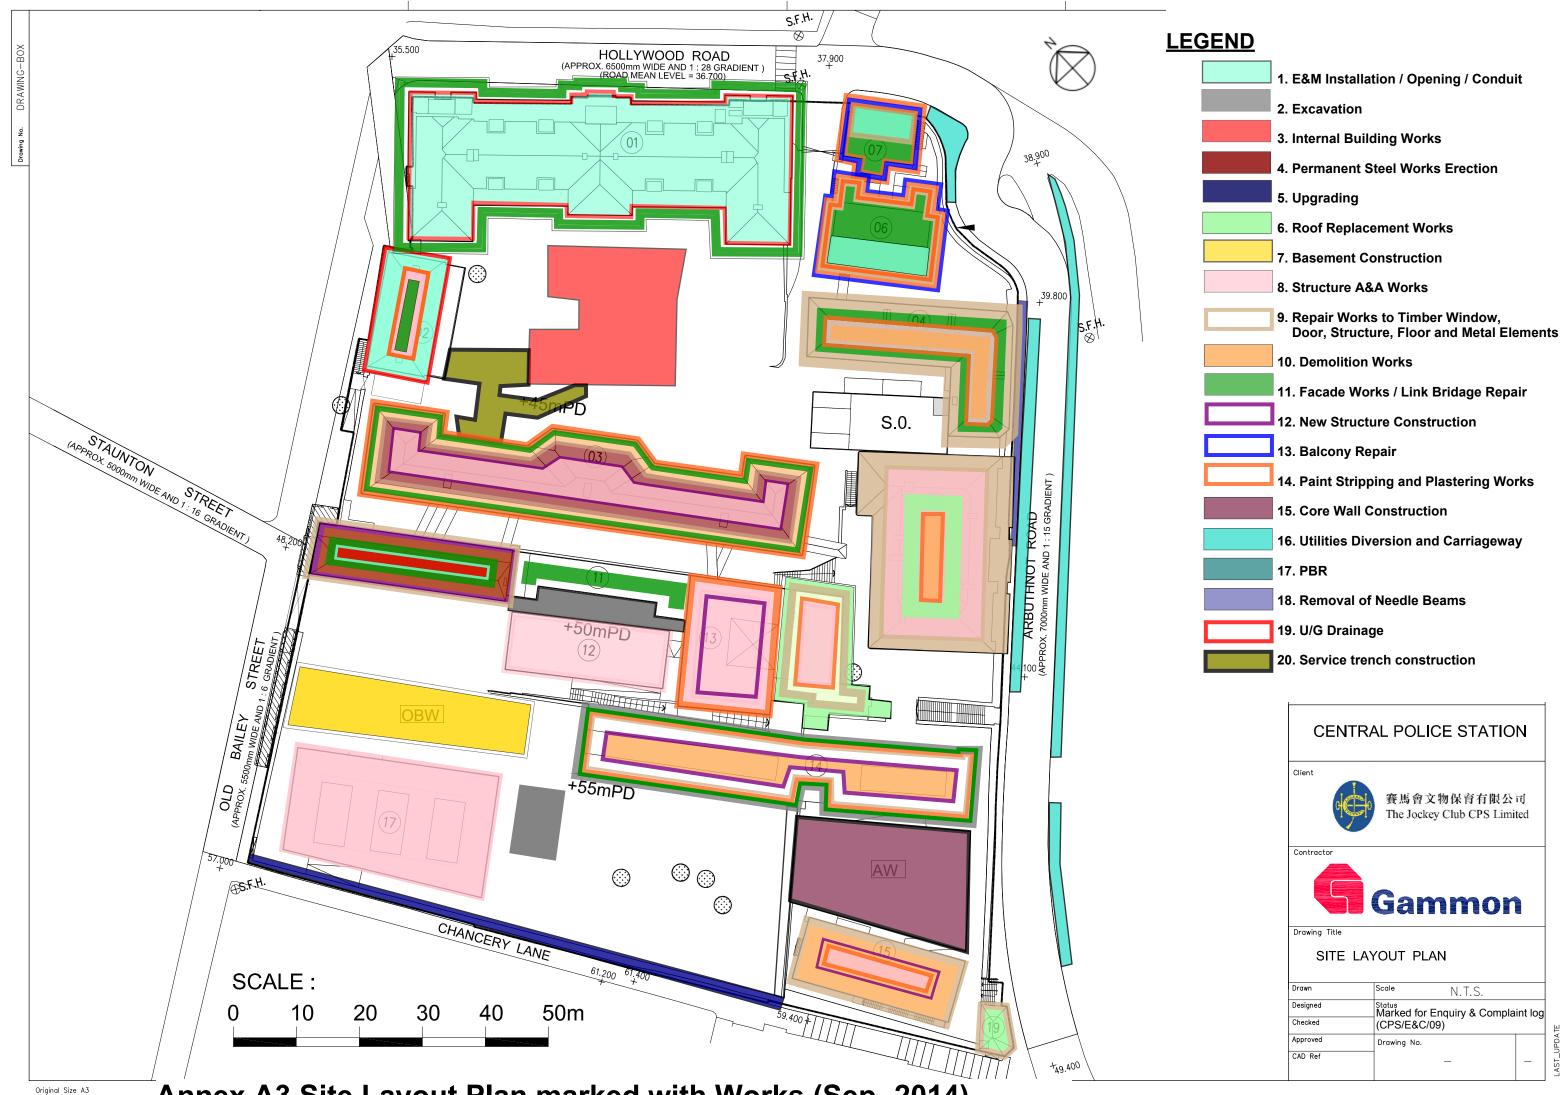
Annex A3 Site Layout Plan marked with Works (Sep- 2014)

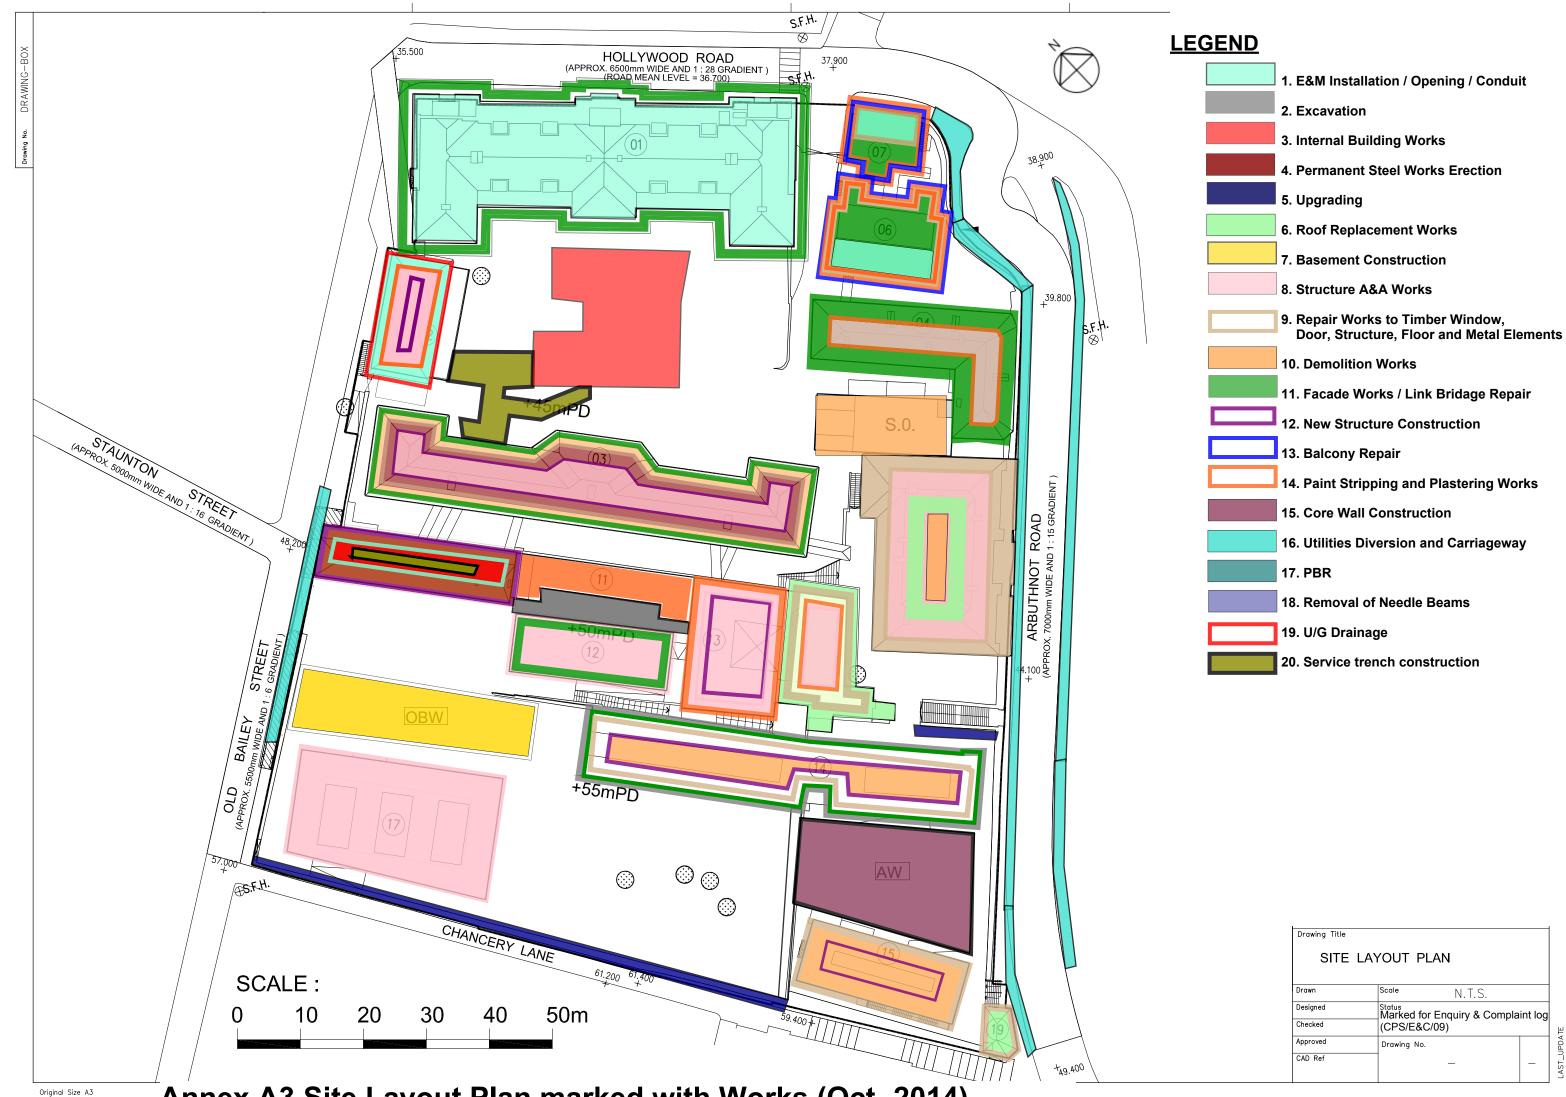
Annex A3 Site Layout Plan marked with Works (Oct- 2014)

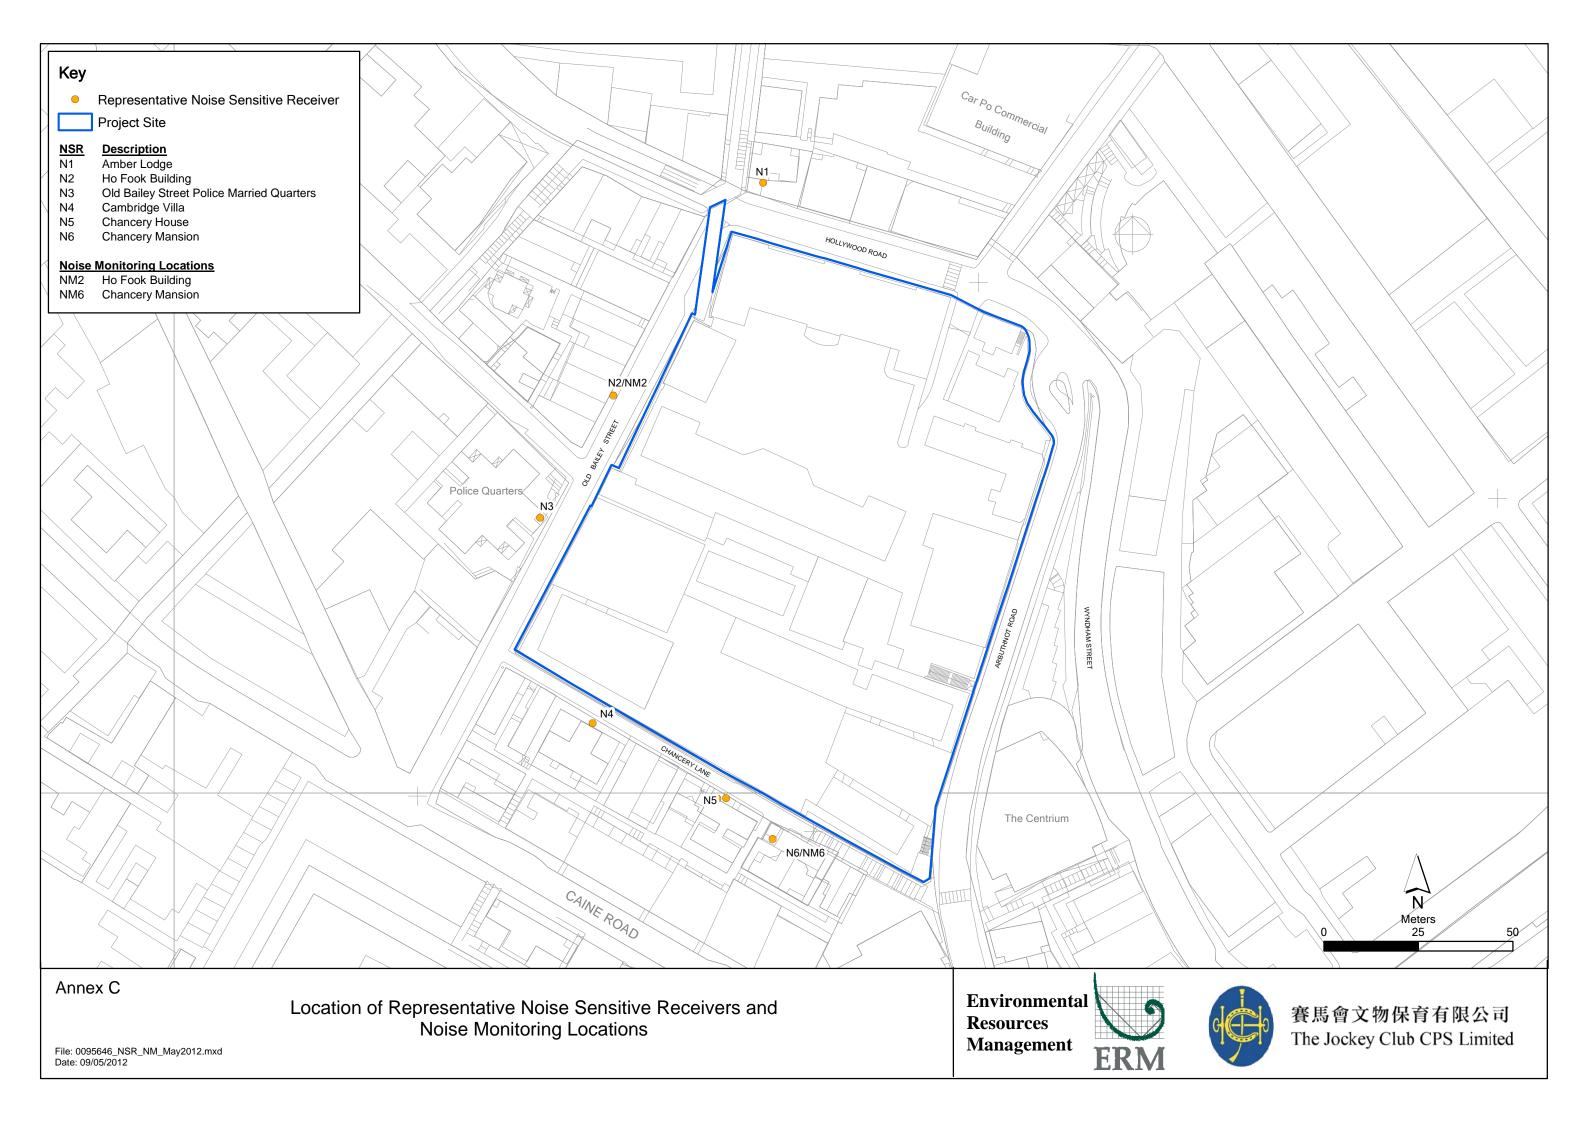
Annex C

Locations of Noise Monitoring Stations and Noise Sensitive Receivers

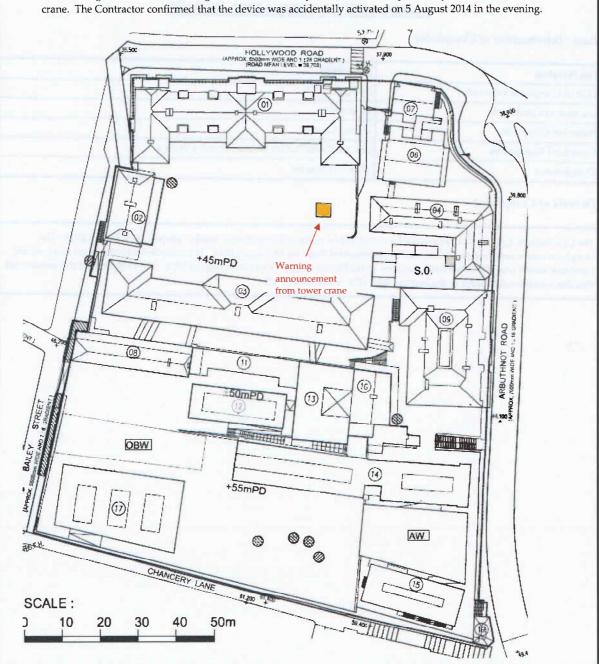
- According to the Contractor, the noise was originated from a device on the hook of the tower crane that provides
 warning announcement to the workers working underneath the lifting operation. The location of the warning
 announcement from tower crane is shown in the figure below.
- 2. The warning announcement is designed to be activated by a remote control operated by the banksman of the tower crane. The Contractor confirmed that the device was accidentally activated on 5 August 2014 in the evening.

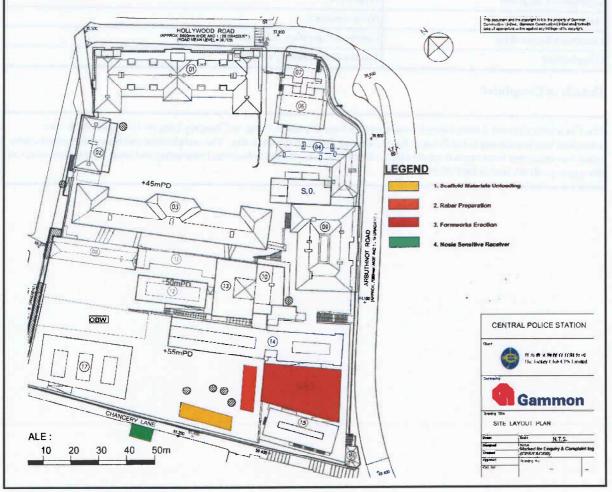
- 1. According to the Contractor's works summary, the noise nuisance is suspected to be related to day-to-day manual construction activities at the upper platform area during normal working hours. The locations of these manual construction activities are shown in the figure below.
- 2. On 11 August 2014 morning, the complainant invited the Contractor to visit his dwelling to discuss the construction noise from the CPS Project Site. The following construction works were observed from his dwelling:
 - Scaffold materials unloading between Block 14 and Block 15;
 - Rebar preparation near Block 14; and
 - Formworks erection at Arbuthnot Wing.
- Weekly daytime noise monitoring at designated noise monitoring stations (NM2 and NM6) are conducted according to EM&A requirement. Noise monitoring results in the past 4 weeks showed compliance with the construction noise standard.

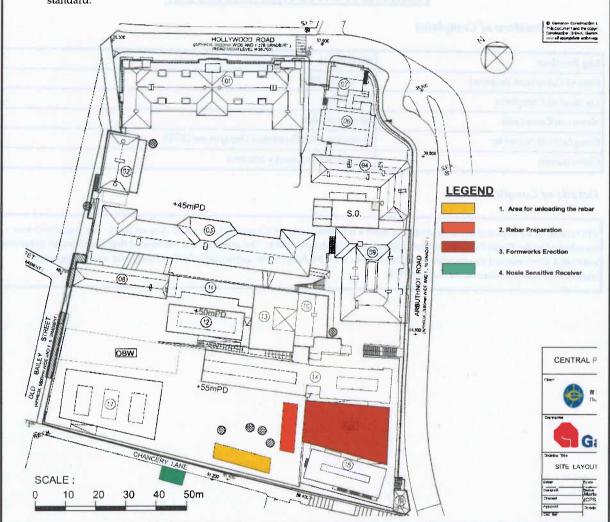
- 1. The noise nuisance is suspected to be related to loading and unloading of a batch of rebar at the upper platform area during normal working hours. The locations of these manual construction activities are shown in the figure below.
- 2. Weekly daytime noise monitoring at designated noise monitoring stations (NM2 and NM6) are conducted according to EM&A requirement. Noise monitoring results in the past 4 weeks showed compliance with the construction noise standard.

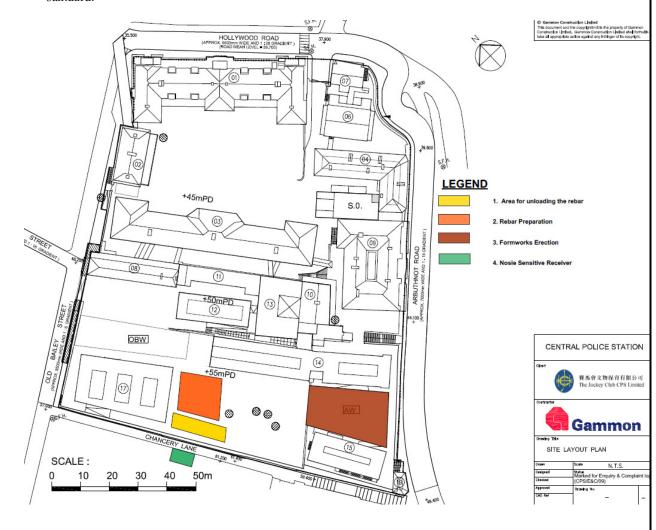
- 1. The noise nuisance is suspected to be related to handling of rebars after 0800 hour during normal working hours on 22 September 2014. The location of the mentioned works is shown in the figure below.
- 2. Weekly daytime noise monitoring at designated noise monitoring stations (NM2 and NM6) are conducted according to EM&A requirement. Noise monitoring results in the past 4 weeks showed compliance with the construction noise standard.

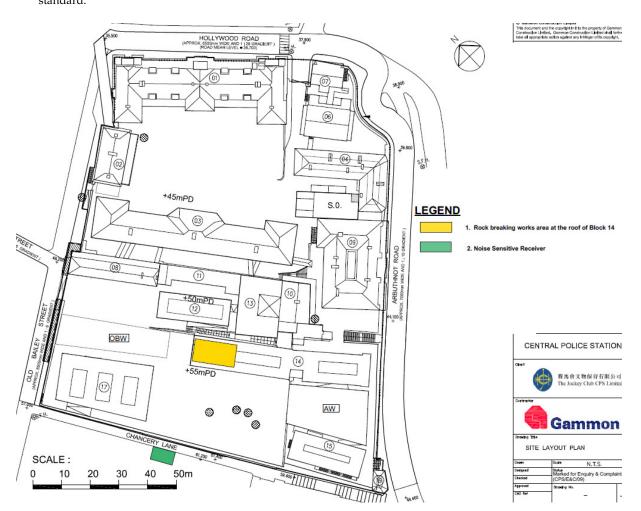
- 1. The noise nuisance is suspected to be related to concrete breaking works at the rooftop of Block 14 during normal working hours on 26 September 2014. The location of the mentioned works is shown in the figure below.
- 2. Weekly daytime noise monitoring at designated noise monitoring stations (NM2 and NM6) are conducted according to EM&A requirement. Noise monitoring results in the past 4 weeks showed compliance with the construction noise standard.

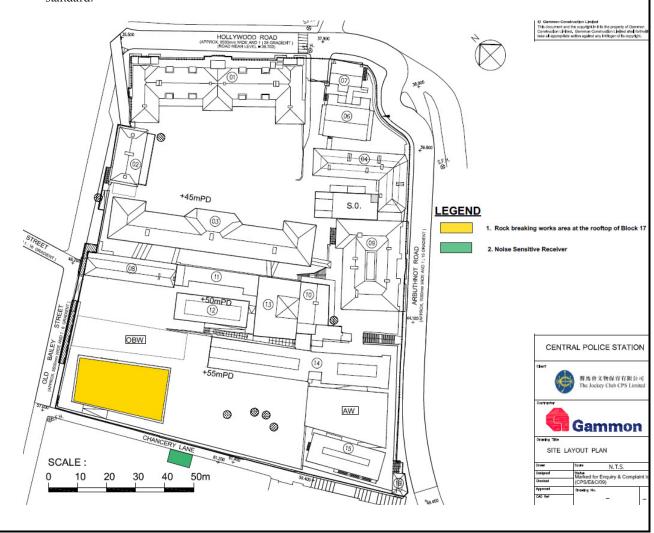
- 1. The noise nuisance is suspected to be related to concrete breaking works for the removal of existing rendering and kerb at the rooftop of Block 17 during normal working hours on 17 October 2014. The location of the mentioned works is shown in the figure below.
- 2. Weekly daytime noise monitoring at designated noise monitoring stations (NM2 and NM6) are conducted according to EM&A requirement. Noise monitoring results in the past 4 weeks showed compliance with the construction noise standard.
