Contract No. HY/2011/03

Hong Kong-Zhuhai-Macao Bridge Hong Kong Link Road Section between Scenic Hill and Hong Kong Boundary Crossing Facilities

Quarterly EM&A Report No. 37 (September 2021 to November 2021)

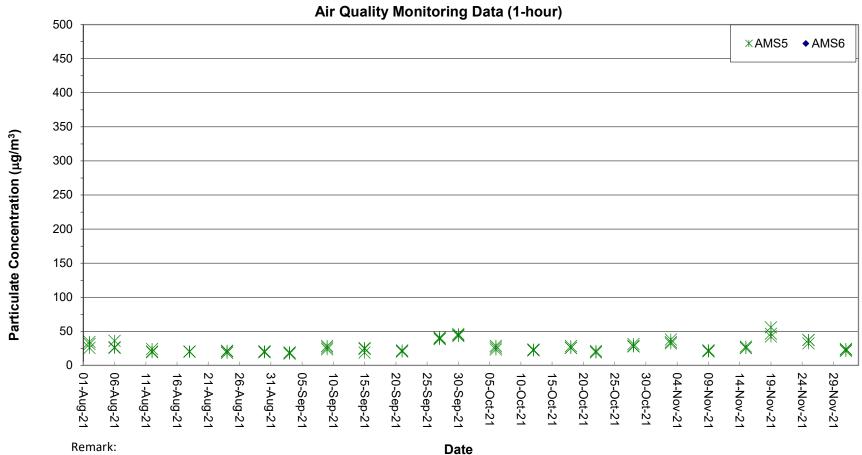
Graphical Plot of 1-hour TSP at AMS5 and AMS6

1) The existing air quality monitoring location AMS6 - Dragonair / CNAC (Group) Building (HKIA) was handed over to Airport Authority Hong Kong on 31 March 2021. 1-hr TSP monitoring at AMS6 was temporarily suspended starting from 1 April 2021.

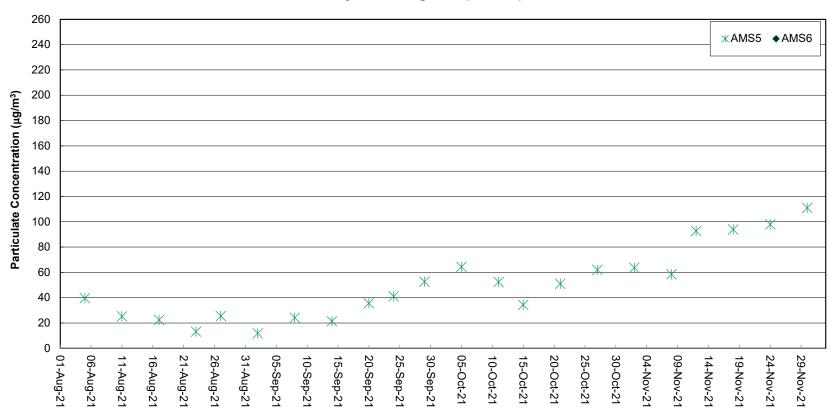
Graphical Plot of 24-hour TSP at AMS5 and AMS6

1) The existing air quality monitoring location AMS6 - Dragonair / CNAC (Group) Building (HKIA) was handed over to Airport Authority Hong Kong on 31 March 2021. 24-hr TSP monitoring at AMS6 was temporarily suspended starting from 1 April 2021.

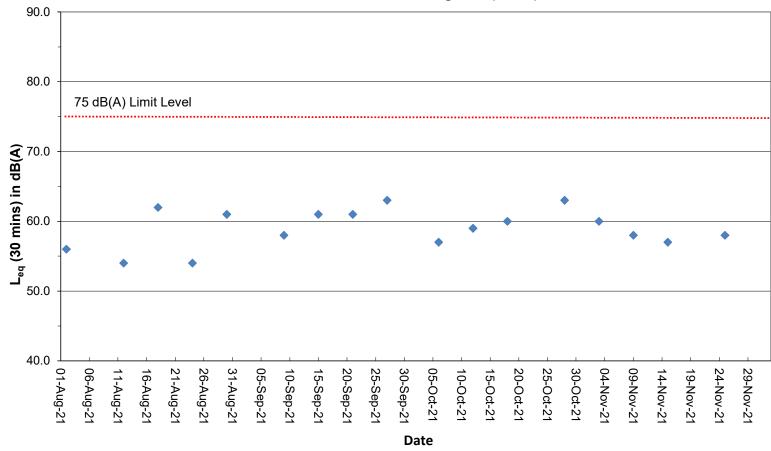
Graphical Plot of Noise Levels at NMS5

(1) A facade correction of +3 dB(A) was applied to the measured noise level.

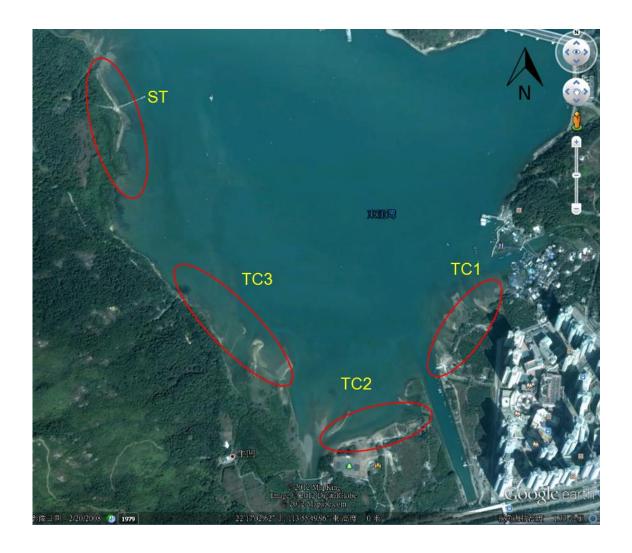
Figure 2.1 Locations of sampling zones. The study site was divided into three sampling zones (TC1, TC2, TC3) in Tung Chung Bay and one zone in San Tau (ST) (map generated from Google Map).

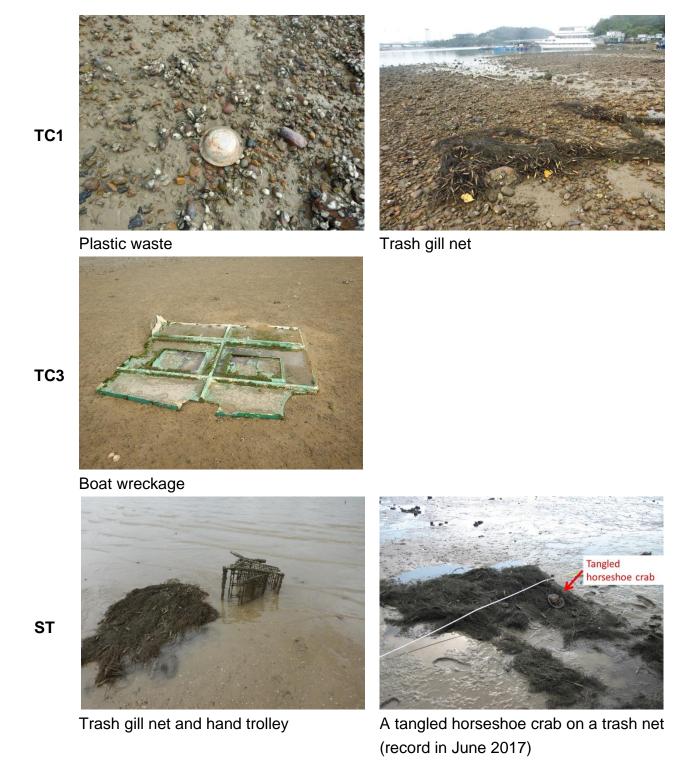
Figure 2.3 Examples of photographic record of the big trashes found on the mudflat.

- 3.6.9 In June 2017, a big horseshoe crab was tangled by a trash gill net in ST mudflat (**Figure 2.3 of Appendix O**). It was released to sea once after photo recording. The horseshoe crab of such size should be inhabiting sub-tidal environment while it forages on intertidal shore occasionally

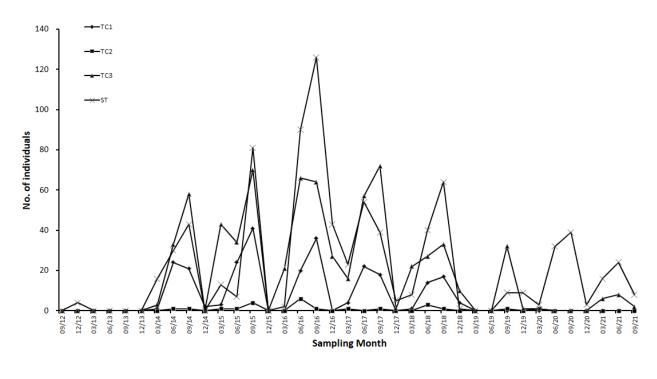
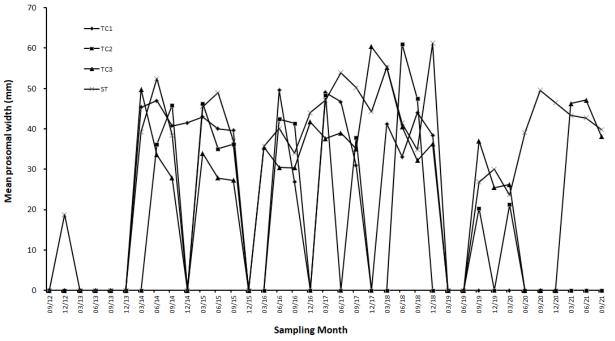
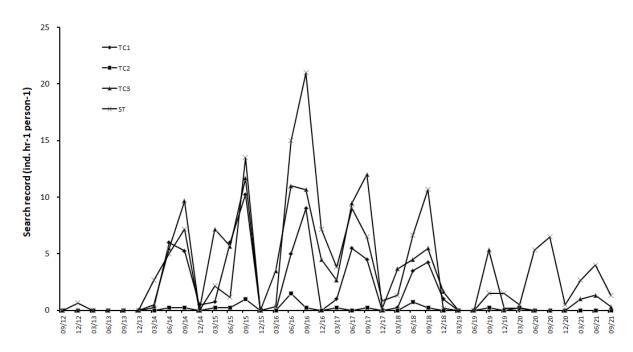
Figure 3.5 Changes of number of individuals mean prosomal width and search record of horseshoe crab Carcinoscorpius rotundicauda in every sampling zone along the sampling months

Figure 3.5 (Cont'd) Changes of number of individuals mean prosomal width and search record of horseshoe crab Carcinoscorpius rotundicauda in every sampling zone along the sampling months

- 3.6.24 **Figure 3.5** and **3.6 of Appendix O** show the changes of number of individuals, mean prosomal width and search record of horseshoe crabs *Carcinoscorpius rotundicauda* and *Tachypleus tridentatus* in respectively in each sampling zone throughout the monitoring period.

3.6.29 Throughout the monitoring period, the search records of horseshoe crabs were fluctuated and at moderate – very low level in June (Figures 3.5 and 3.6 of Appendix O). Low – Very low search record was found in June 2013, totally 82 individuals of Tachypleus tridentatus and 0 ind. of Carcinoscorpius rotundicauda were found in TC1, TC3 and ST. Compare with the search record of June 2013, the numbers of Tachypleus tridentatus were gradually decreased in June 2014 and 2015 (55 ind. in 2014 and 18 ind. in 2015); the number of Carcinoscorpius rotundicauda raise to 88 and 66 individuals in June 2014 and 2015 respectively. In June 2016, the search record increased about 3 times compare with June 2015. In total, 182 individuals of Carcinoscorpius rotundicauda and 47 individuals of Tachypleus tridentatus were noted, respectively. Then, the search record was similar to June 2016. The number of recorded Carcinoscorpius rotundicauda (133 ind.) slightly dropped in June 2017. However, that of Tachypleus tridentatus rapidly increased (125 ind.). In June 2018, the search record was low to moderate while the numbers of Tachypleus tridentatus dropped sharply (39 ind.). In June 2019, 10 individuals of Tachypleus tridentatus were observed in TC3 and ST. All of them, however, were large individuals (prosomal width >100mm), their records are excluded from the

- 3.6.30 The search record of horseshoe crab declined obviously in all sampling zones during dry season especially December (Figures 3.5 and 3.6 of Appendix O) throughout the monitoring period. Very low - low search record was found in December from 2012 to 2015 (0-4 ind. of Carcinoscorpius rotundicauda and 0-12 ind. of Tachypleus tridentatus). The horseshoe crabs were inactive and burrowed in the sediments during cold weather (<15 °C). Similar results of low search record in dry season were reported in a previous territory-wide survey of horseshoe crab. For example, the search records in Tung Chung Wan were 0.17 ind. hr⁻¹person⁻¹ and 0.00 ind. hr⁻¹ person⁻¹ in wet season and dry season respectively (details see Li, 2008). Compare with the search record of December from 2012 to 2015, which of December 2016 were much higher relatively. There were totally 70 individuals of Carcinoscorpius rotundicauda and 24 individuals of Tachypleus tridentatus in TC3 and ST. Since the survey was carried in earlier December with warm and sunny weather (~22 °C during dawn according to Hong Kong Observatory database, Chek Lap Kok station on 5 December 2016), the horseshoe crab was more active (i.e. move onto intertidal shore during high tide for foraging and breeding) and easier to be found. In contrast, there was no search record in TC1 and TC2 because the survey was conducted in mid-December with colder and cloudy weather (~20 °C during dawn on 19 December). The horseshoe crab activity would decrease gradually with the colder climate. In December of 2017, 2018 and 2019, very low search records were found again as mentioned above.

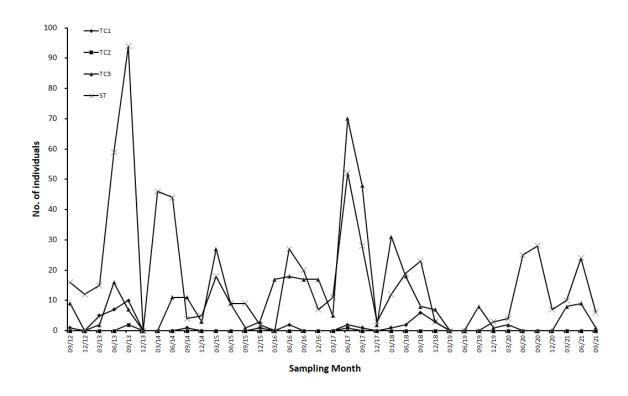
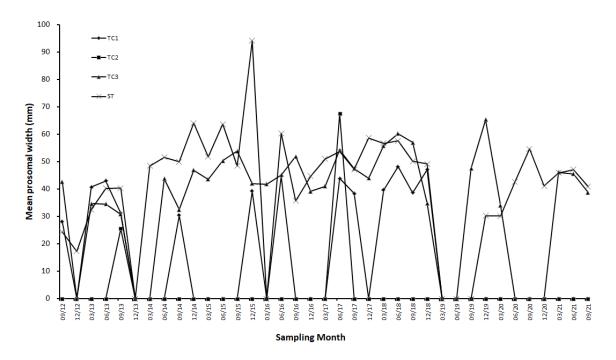
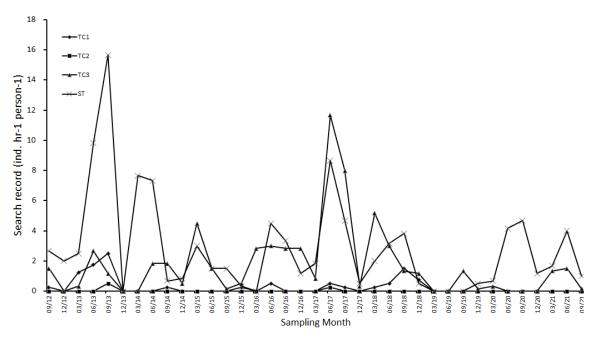
Figure 3.6 Changes of number of individuals mean prosomal width and search record of horseshoe crab Tachypleus tridentatus in every sampling zone along the sampling months

Figure 3.6 (Cont'd) Changes of number of individuals mean prosomal width and search record of horseshoe crab Tachypleus tridentatus in every sampling zone along the sampling months

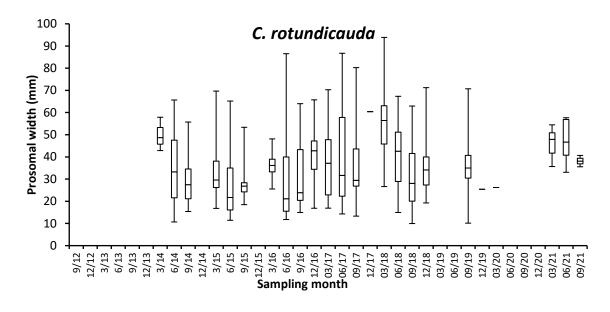
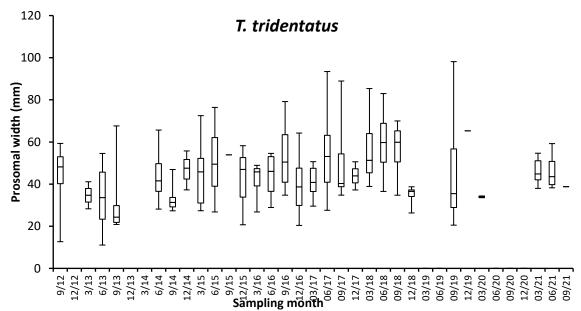
Figure 3.7 Box plot of prosomal width of horseshoe crab in the sampling zone TC3 along the sampling months. (The box represents 50% of the sample (upper to lower quartile) with a middle line showing the median value. The upper whisker and lower whisker showed the 25% of sample above upper quartile and below the lower quartile respectively)

- 3.6.34 **Figure 3.7 of Appendix O** shows the changes of prosomal width of *Carcinoscorpius rotundicauda* and *Tachypleus tridentatus* in TC3. As mentioned above, *Carcinoscorpius rotundicauda* was rarely found between September 2012 and December 2013 hence the data were lacking. In March 2014, the major size (50% of individual records between upper (top box) and lower quartile (bottom box)) ranged 40 60 mm while only few individuals were found. From March 2014 to September 2018, the median prosomal width (middle line of whole box) and major size (whole box) decreased after March of every year. It was due to more small individuals found in June indicating new rounds of spawning. Also, there were slight increasing trends of body size from June to March of next year since 2015. It indicated a stable growth of individuals. Focused on larger juveniles (upper whisker), the size range was quite variable (prosomal width 60 90 mm) along the sampling months. Juveniles reaching this size might gradually migrate to sub-tidal habitats.

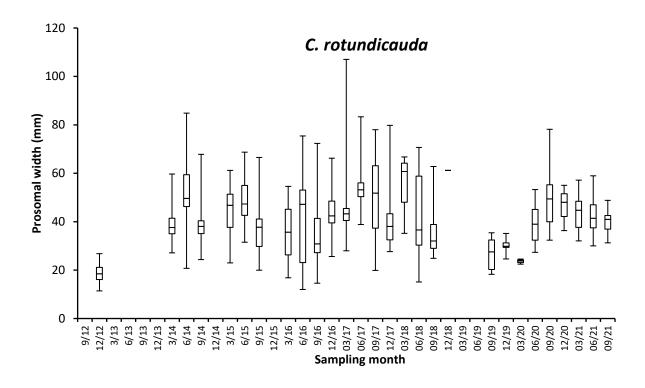
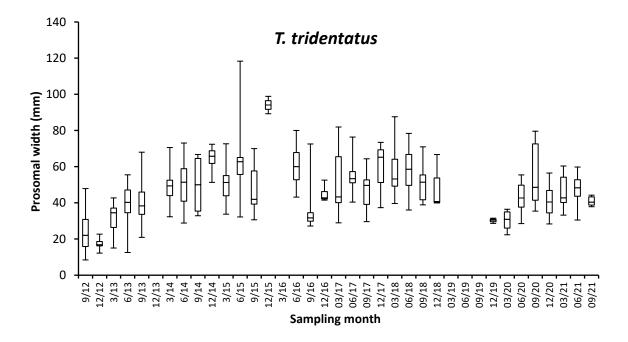
Figure 3.8 Box plot of prosomal width of horseshoe crabin the sampling zone ST along the sampling months. (The box represents 50% of the sample (upper to lower quartile) with a middle line showing the median value. The upper whisker and lower whisker showed the 25% of sample above upper quartile and below the lower quartile respectively.)

- 3.6.36 **Figure 3.8 of Appendix O** shows the changes of prosomal width of *Carcinoscorpius rotundicauda* and *Tachypleus tridentatus* in ST. As mentioned above, *Carcinoscorpius rotundicauda* was rarely found between September 2012 and December 2013 hence the data were lacking. From March 2014 to September 2018, the size of major population decreased and more small individuals (i.e. lower whisker) were recorded after June of every year. It indicated new round of spawning. Also, there were similar increasing trends of body size from September to June of next year between 2014 and 2017. It indicated a stable growth of individuals. The larger juveniles (i.e. upper whisker usually ranged 60 80 mm in prosomal width except one individual (prosomal width 107.04 mm) found in March 2017. It reflected juveniles reaching this size would gradually migrate to sub-tidal habitats.

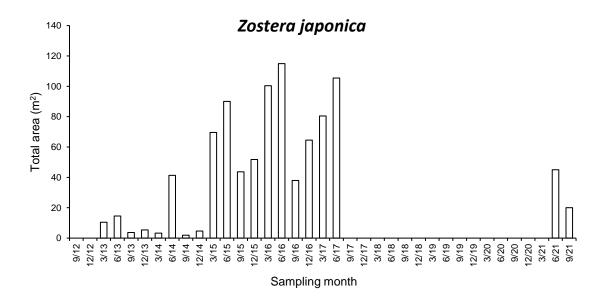
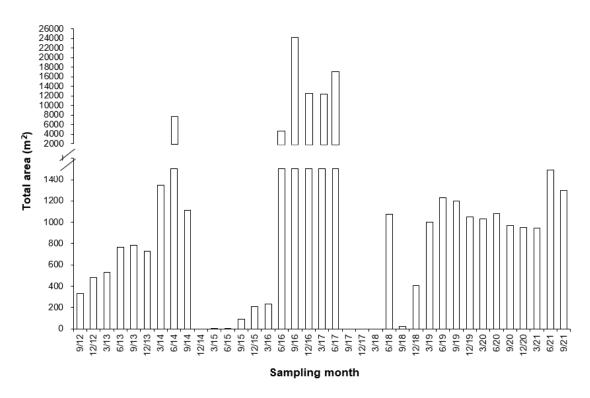
Figure 3.11 Temporal changes of estimated total area of seagrass beds in ST

Figure 3.11 of Appendix O shows the changes of estimated total area of seagrass beds in ST along the sampling months. For *Zostera japonica*, it was not recorded in the 1st and 2nd surveys of monitoring programme. Seasonal recruitment of few, small patches (total seagrass area: 10 m²) was found in Mach 2013 that grew within the large patch of seagrass Halophila ovalis. Then, the patch size increased and merged gradually with the warmer climate from March to June 2013 (15 m²). However the patch size decreased and remained similar from September 2013 (4 m²) to March 2014 (3 m²). In June 2014, the patch size increased obviously again (41 m²) with warmer climate followed by a decrease between September 2014 (2 m²) and December 2014 (5 m²). From March to June 2015, the patch size increased sharply again (90 m²). It might bedue to the disappearance of the originally dominant seagrass Halophila ovalis resulting in less competition for substratum and nutrients. From September 2015 to June 2016, it was found coexisting with seagrass Halophila ovalis with steady increasing patch size (from 44 m² to 115 m²) and variable coverage. In September 2016, the patch size decreased again to (38 m²) followed by an increase to a horizontal strand (105.4 m²) in June 2017. And it did no longer coexist with Halophila ovalis. Between September 2014 and June 2017, an increasing trend was noticed from September to June of next year followed by a rapid decline in September of next year. It was possibly the causes of heat stress, typhoon and stronger grazing pressureduring wet season. However, such increasing trend was not found from September 2017 to March 2021,

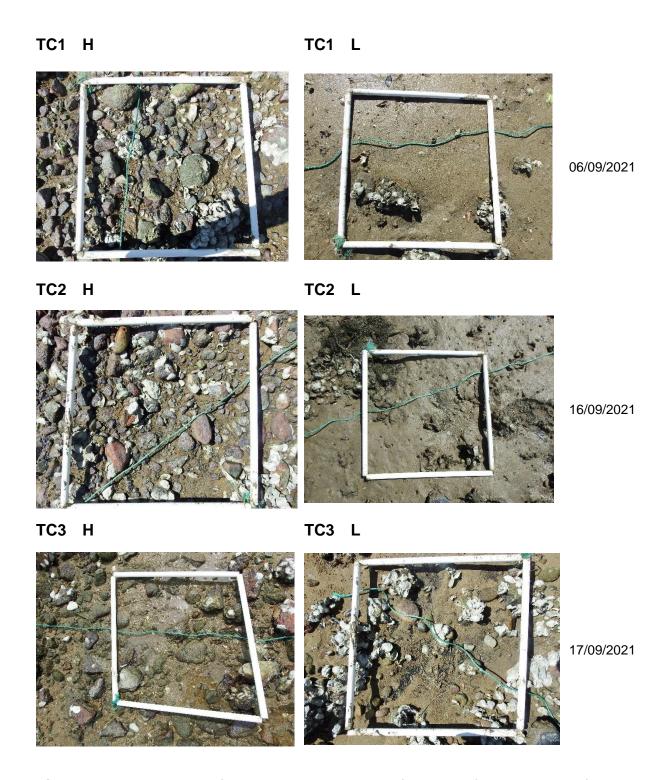
Figure 3.13 Examples of photographic records of quadrat for intertidal soft shore community survey (H: 2.0 m above C.D.; M: 1.5 m above C.D.; L: 1.0 m above C.D.)

- 3.6.57 **Table 3.3 and Figure 3.13 of Appendix O** show the substratum types along the horizontal transect at every tidal level in all sampling zones. The relative distribution of substratum types was estimated by categorizing the substratum types (Gravels & Boulders / Sands / Soft mud) of the ten random quadrats along the horizontal transect. The distribution of substratum types varied among tidal levels and sampling zones:
 - In TC1, high percentages of 'Gravels and Boulders' (H: 70%; M: 40%) were recorded at high and mid tidal levels. Low percentages of 'Gravels and Boulders' (10%) and high percentage of 'Soft mud' (50%) were recorded at low tidal level.

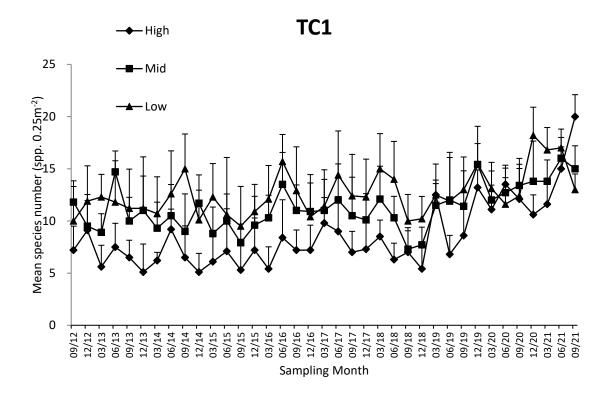
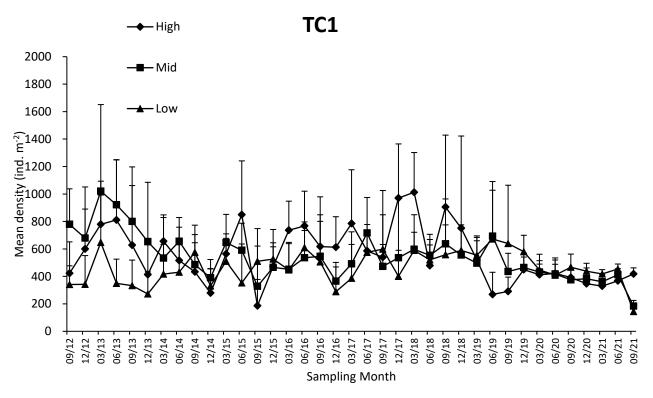
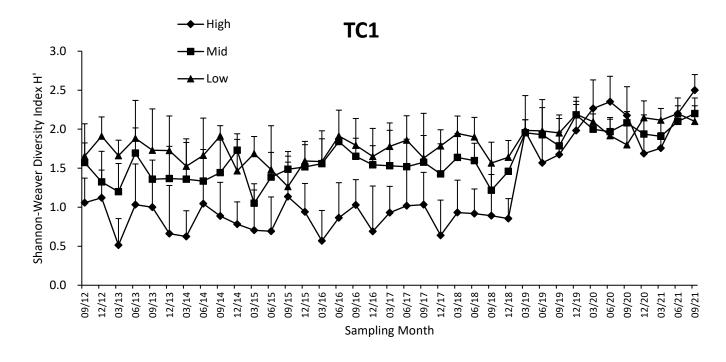
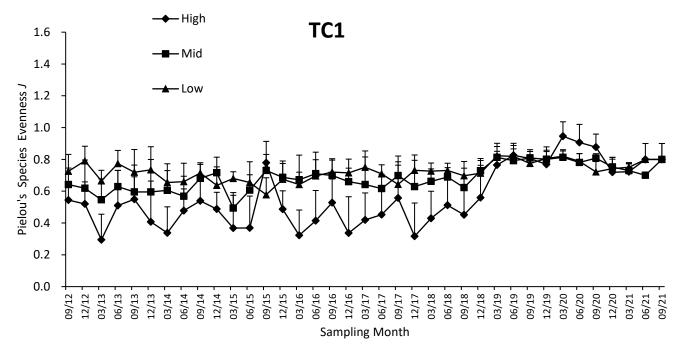
Figure 3.14 Temporal changes of mean number of species, mean density, Shannon-Weaver Diversity Index (H') and Pielou's Species Evenness (J) (mean + SD)at every tidal level in sampling zone TC1

Figure 3.14(Cont'd) Temporal changes of mean number of species, mean density, Shannon-Weaver Diversity Index (H') and Pielou's Species Evenness (J) (mean + SD)at every tidal level in sampling zone TC1

- 3.6.71 In the present survey, no clear trend of mean species number, mean density, H' and J observed among the tidal level.
- 3.6.72 **Figures 3.14 to 3.17 of Appendix O** show the temporal changes of mean species number, mean density, H' and J at every tidal level and in every sampling zone along the sampling months. In general, all the biological parameters fluctuated seasonally throughout the monitoring period. Lower mean species number and density were recorded in dry season (December) but the mean H' and J fluctuated within a limited range.

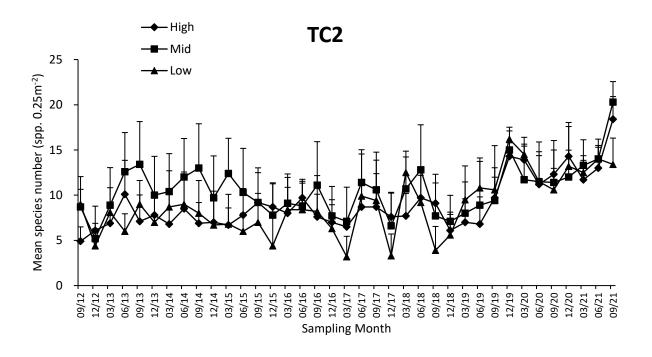
Figure 3.15 Temporal changes of mean number of species, mean density, Shannon-Weaver Diversity Index (H') and Pielou's Species Evenness (J) (mean + SD) at every tidal level in sampling zone TC2

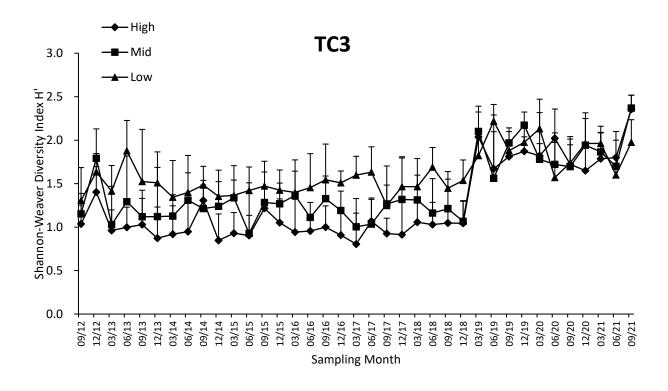
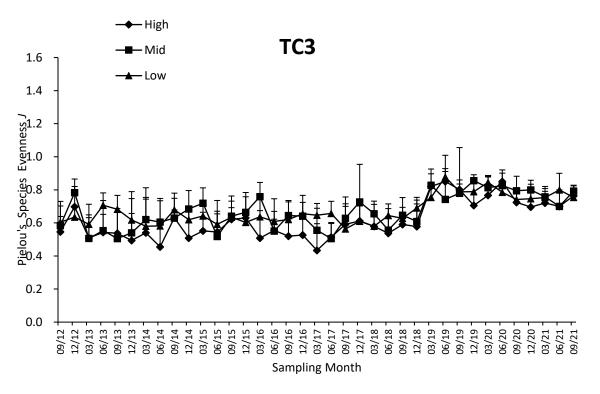
Figure 3.16 Temporal changes of mean number of species, mean density, Shannon-Weaver Diversity Index (H') and Pielou's Species Evenness (J) (mean + SD) at every tidal level in sampling zone TC3

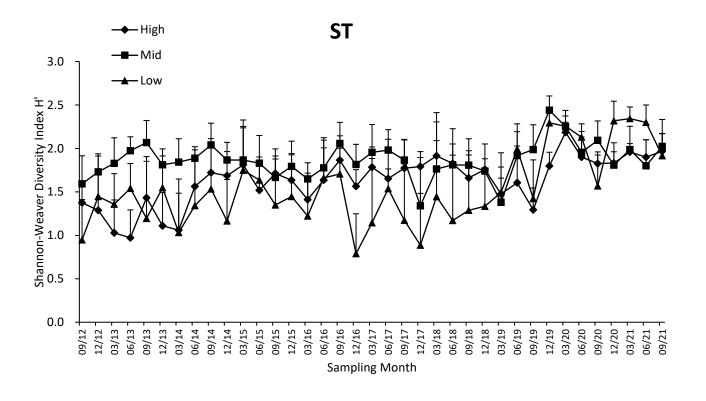
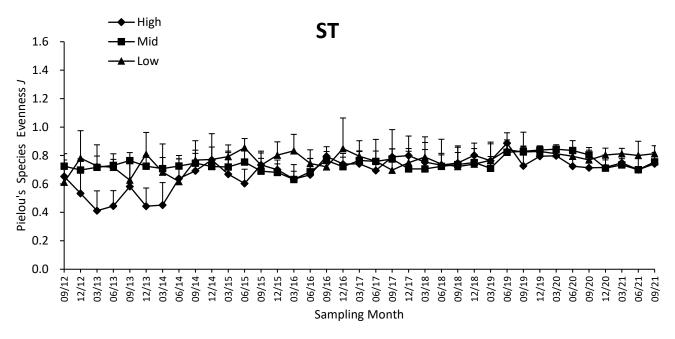
Figure 3.17 Temporal changes of mean number of species, mean density, Shannon-Weaver Diversity Index (H') and Pielou's Species Evenness (J) (mean + SD) at every tidal level in sampling zone S

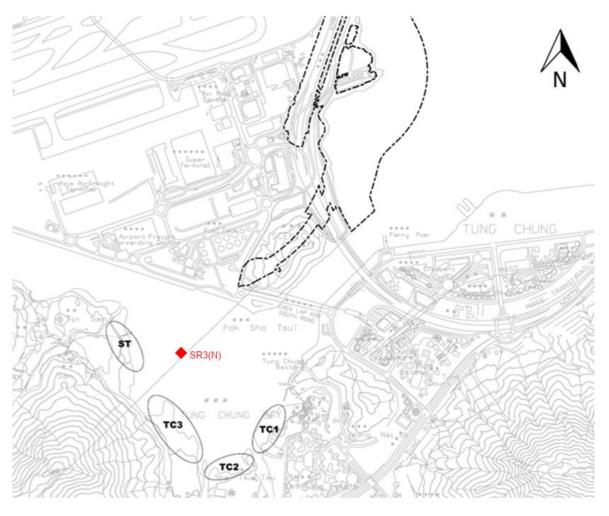
Annex I Location of sampling zones (map from ATKINS China Ltd.)
