**Re: Agreement No. CE 48/2011 (EP)  
Environmental Project Office for the  
HZMB Hong Kong Link Road, HZMB Hong Kong Boundary Crossing Facilities,  
and Tuen Mun-Chek Lap Kok Link – Investigation**

**Contract No. HY/2013/03 – HZMB HKBCF – Vehicle Clearance Plazas and  
Ancillary Buildings and Facilities  
Monthly Environmental Monitoring & Audit Report for November 2017**

This is the 27<sup>th</sup> Monthly EM&A Report for the Contract which summaries findings of the EM&A programme during the reporting period from 1 November 2017 to 30 November 2017 (includes the findings of the EM&A programme of Contract No. HY/2013/06 within Contract No. HY/2013/03 works area during the reporting period from 1 November 2017 to 30 November 2017) (the “reporting period”). The monthly EM&A programme was undertaken in accordance with the Updated EM&A Manual for HKBCF (Version 1.0). It should be noted that the air quality and noise monitoring works for the Contract are covered by Contract No. HY/2013/01 “Hong Kong-Zhuhai-Macao Bridge HKBCF – Passenger Clearance Building” and Contract No. HY/2011/03 “Hong Kong-Zhuhai-Macao Bridge Hong Kong Link Road – Section between Scenic Hill and HKBCF”. The ET o

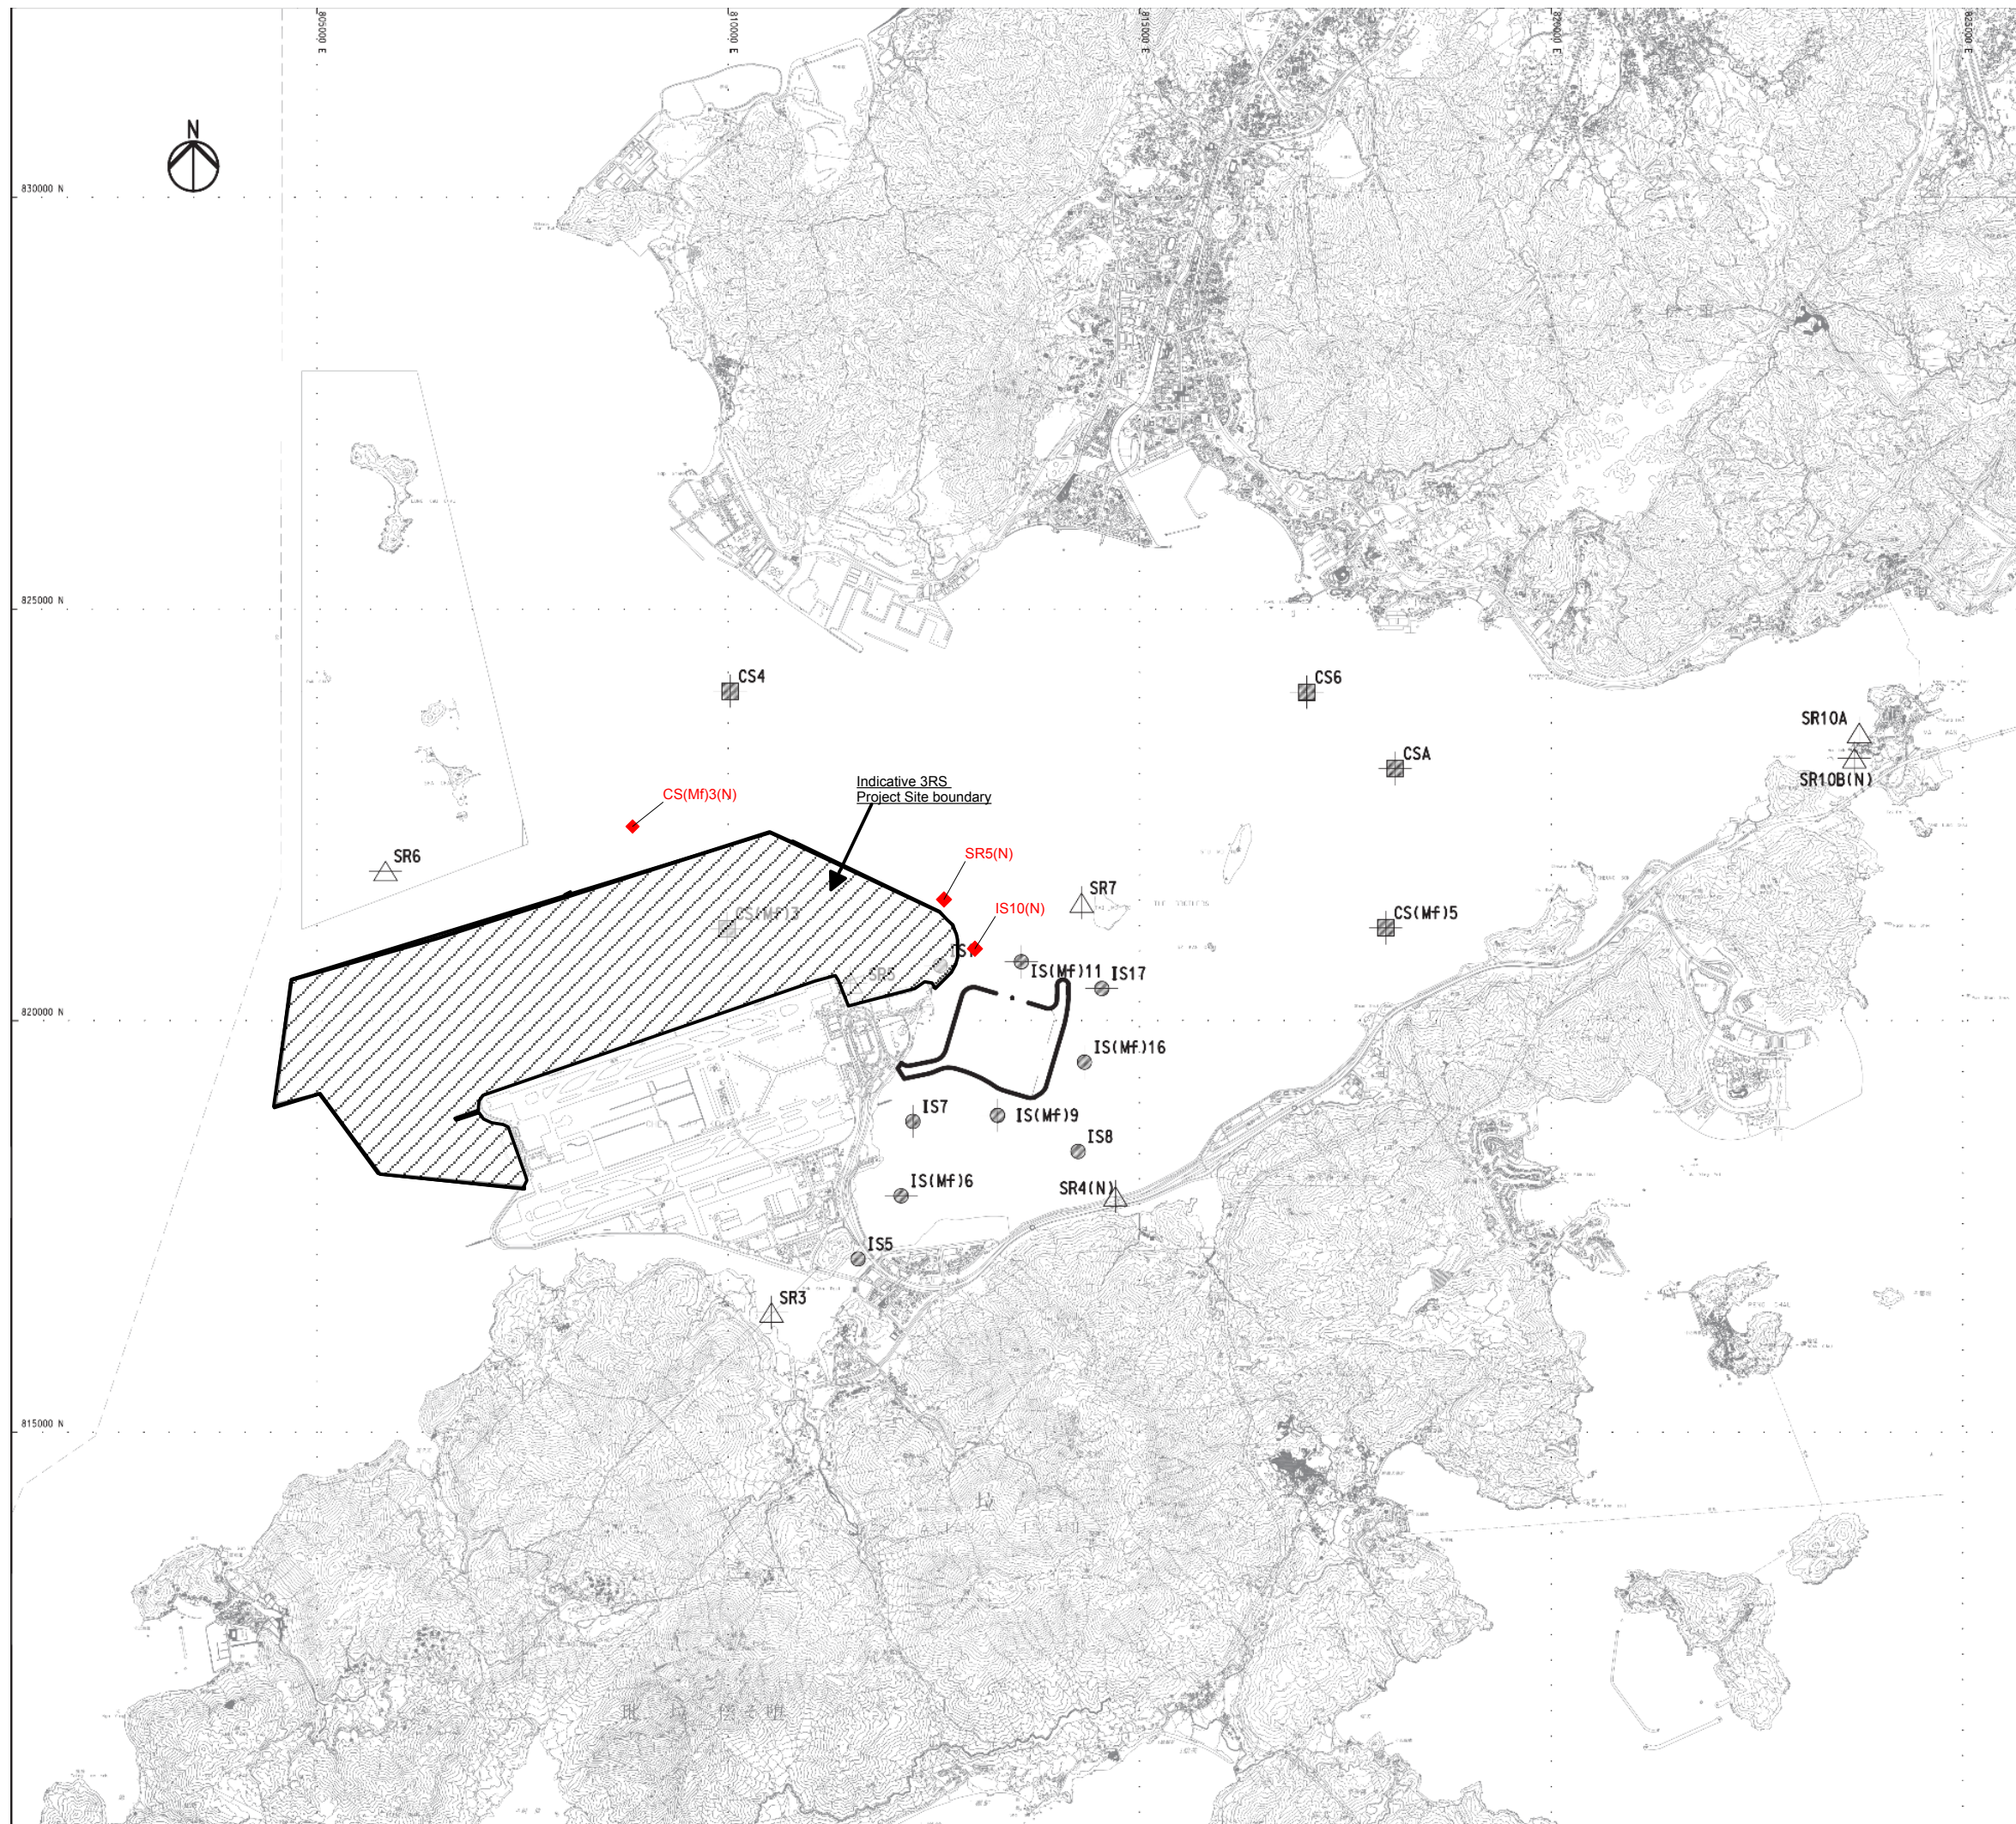
### **Figure 1**

#### **The Location of WQM Stations**

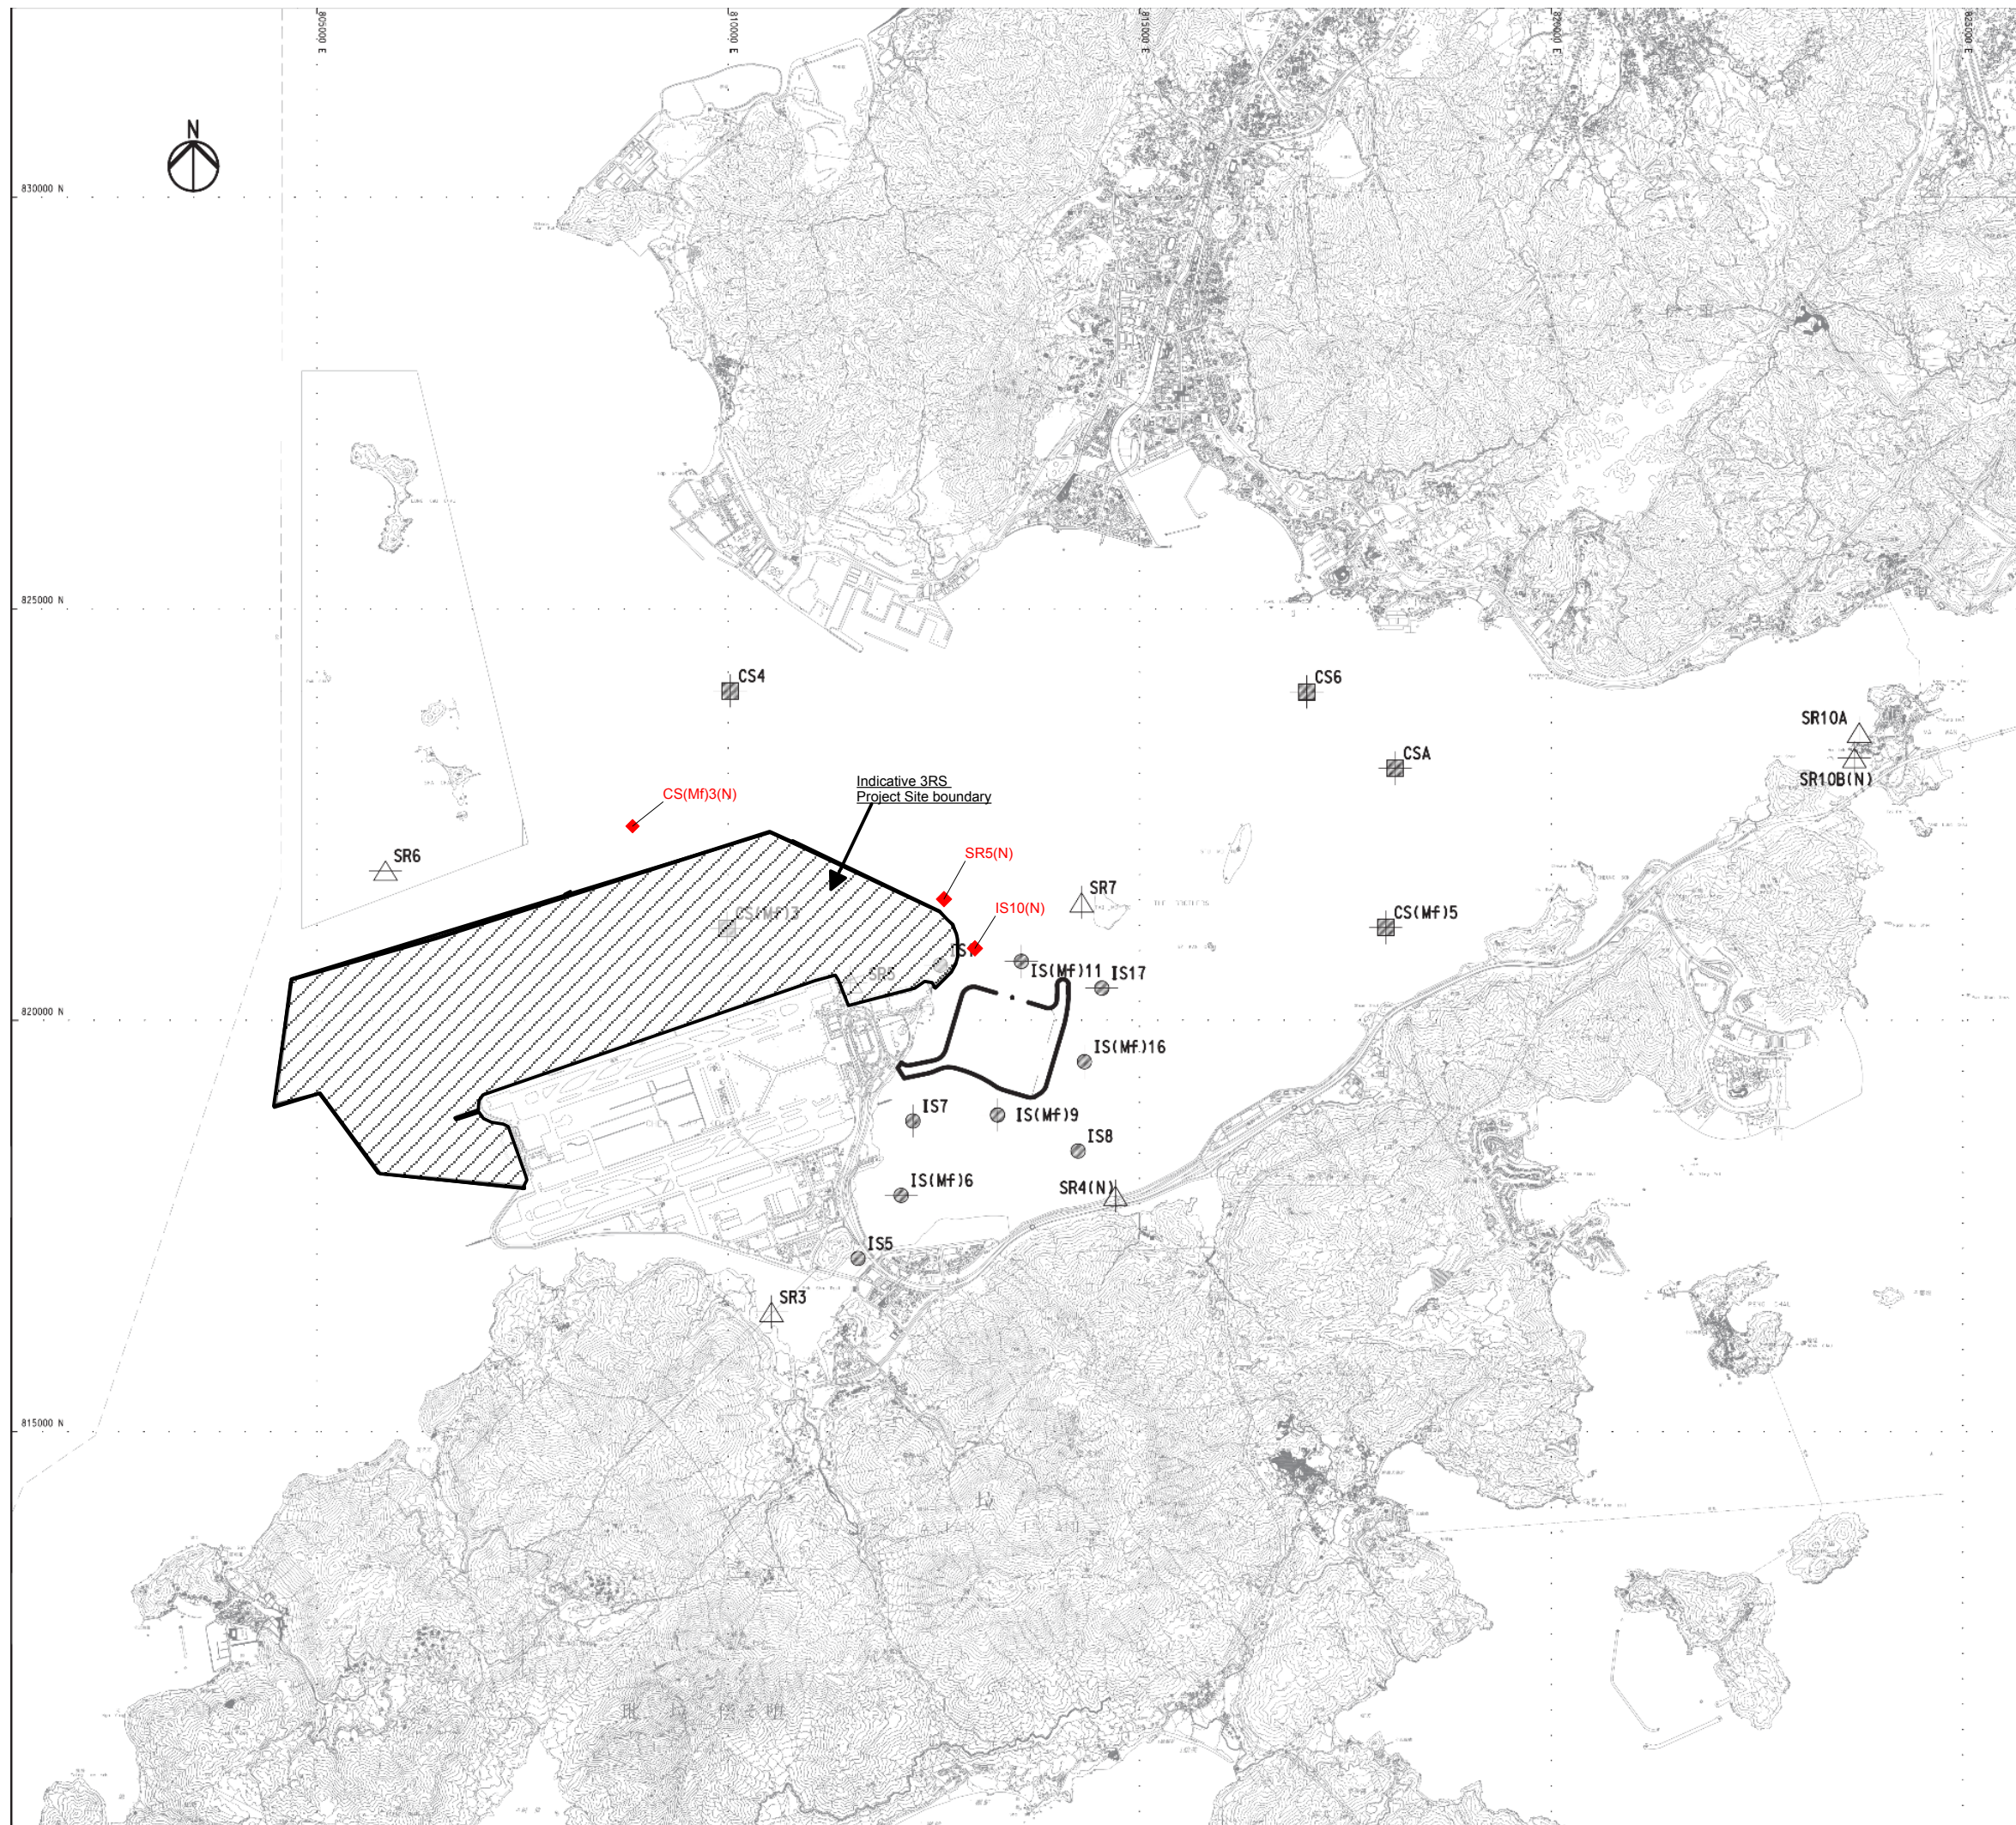
### **Figure 1**

#### **The Location of WQM Stations**
