**Contract No. HY/2013/03**  
**Hong Kong-Zhuhai-Macao Bridge Hong Kong Boundary Crossing Facilities –**  
**Vehicle Clearance Plazas and Ancillary Buildings and Facilities**  
**EP Condition 5.4 – Monthly EM&A Report (November 2017)**

This is the 27<sup>th</sup> Monthly EM&A Report for the Contract which summaries findings of the EM&A programme during the reporting period from 1 November 2017 to 30 November 2017 (includes the findings of the EM&A programme of Contract No. HY/2013/06 within Contract No. HY/2013/03 works area during the reporting period from 1 November 2017 to 30 November 2017) (the "reporting period"). The monthly EM&A programme was undertaken in accordance with the Updated EM&A Manual for HKBCF (Version 1.0). It should be noted that the air quality and noise monitoring works for the Contract are covered by Contract No. HY/2013/01 "Hong Kong-Zhuhai-Macao Bridge HKBCF – Passenger Clearance Building" and Contract No. HY/2011/03 "Hong Kong-Zhuhai-Macao Bridge Hong Kong Link Road – Section between Scenic Hill and HKBCF". The ET of the Contract or another ET of the HZMB project is required to conduct impact air quality monitoring at AMS6 and AMS7, noise monitoring at N

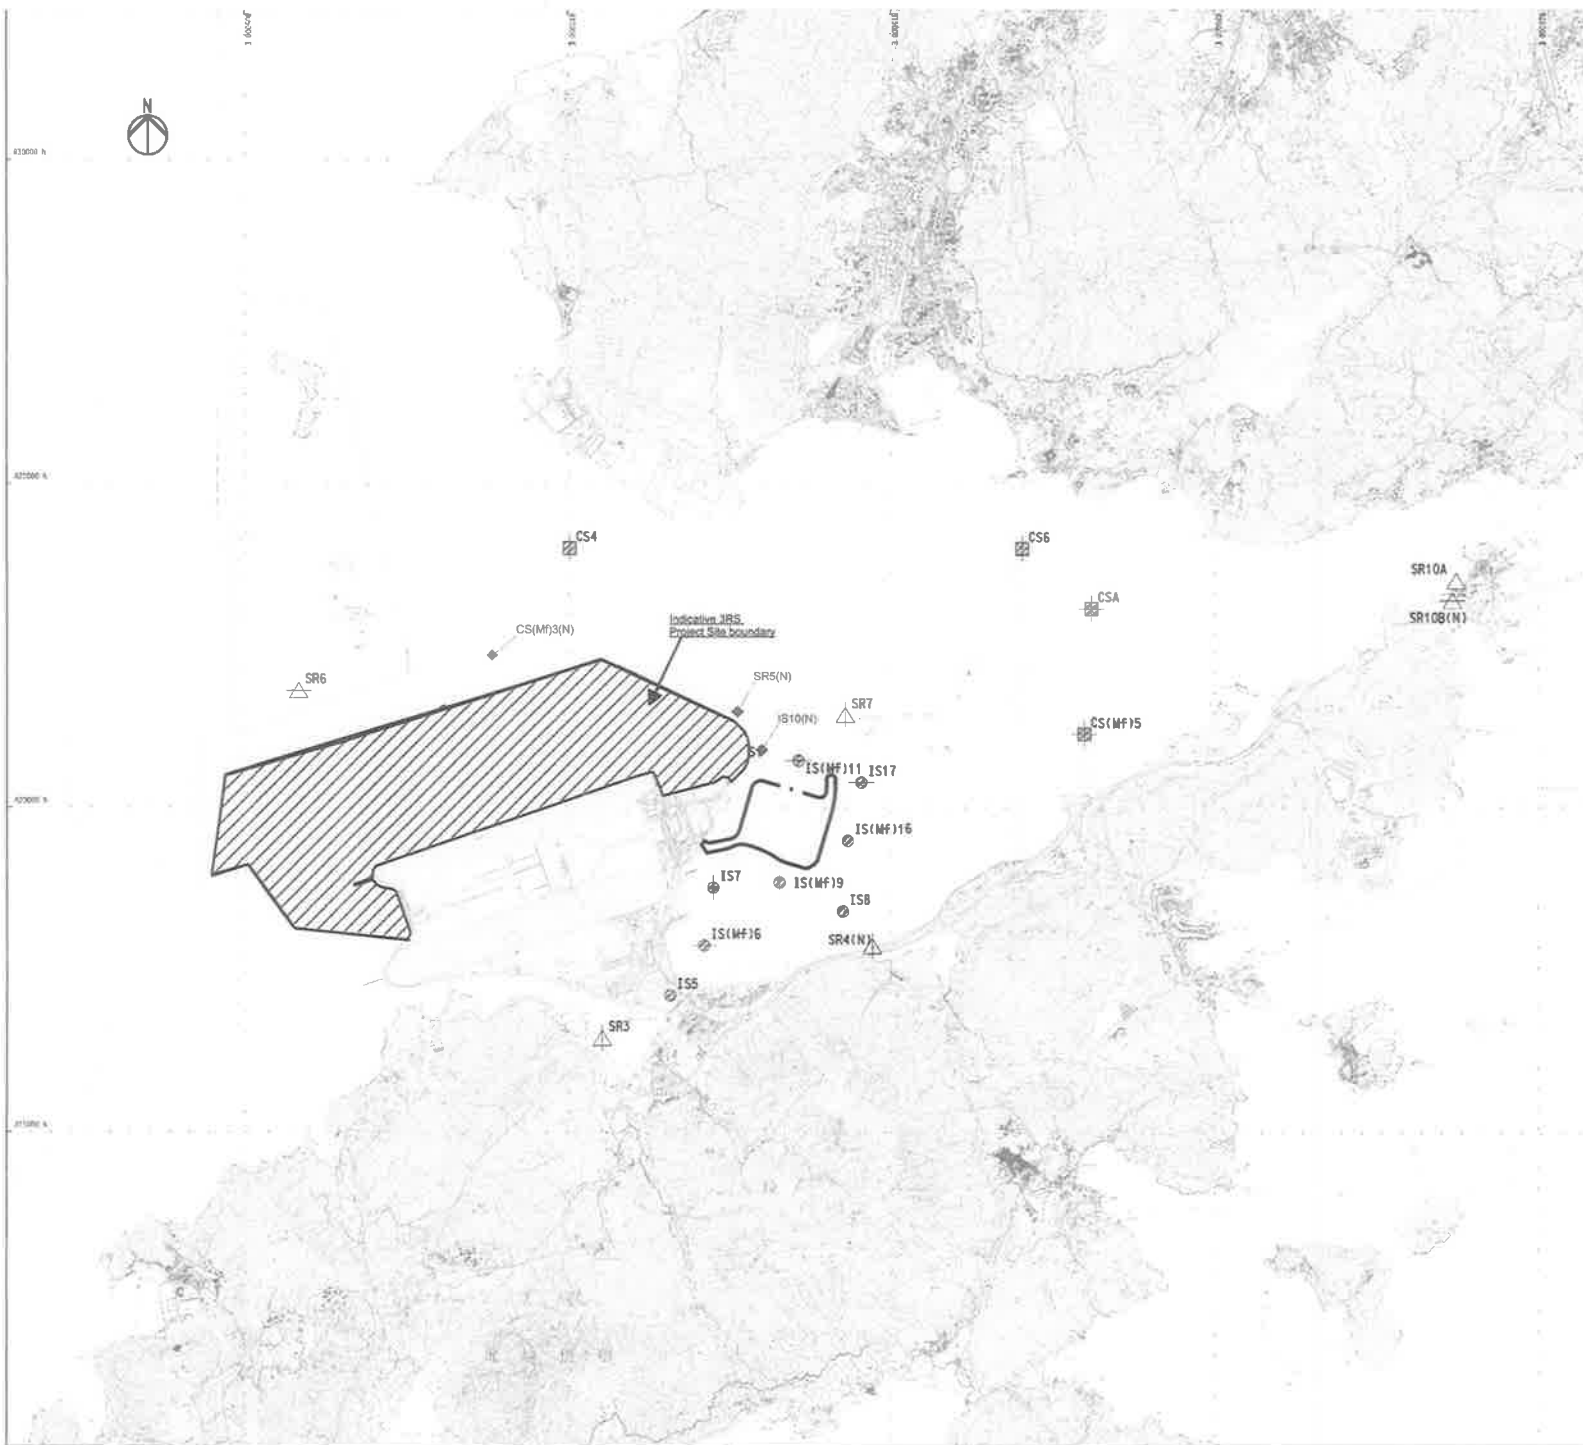
### **Figure 1**

#### **The Location of WQM Stations**

- IS      IMPACT STATIONS
- CS      CONTROL / FAR FIELD STATIONS
- △ SR      SENSITIVE RECEIVERS STATIONS

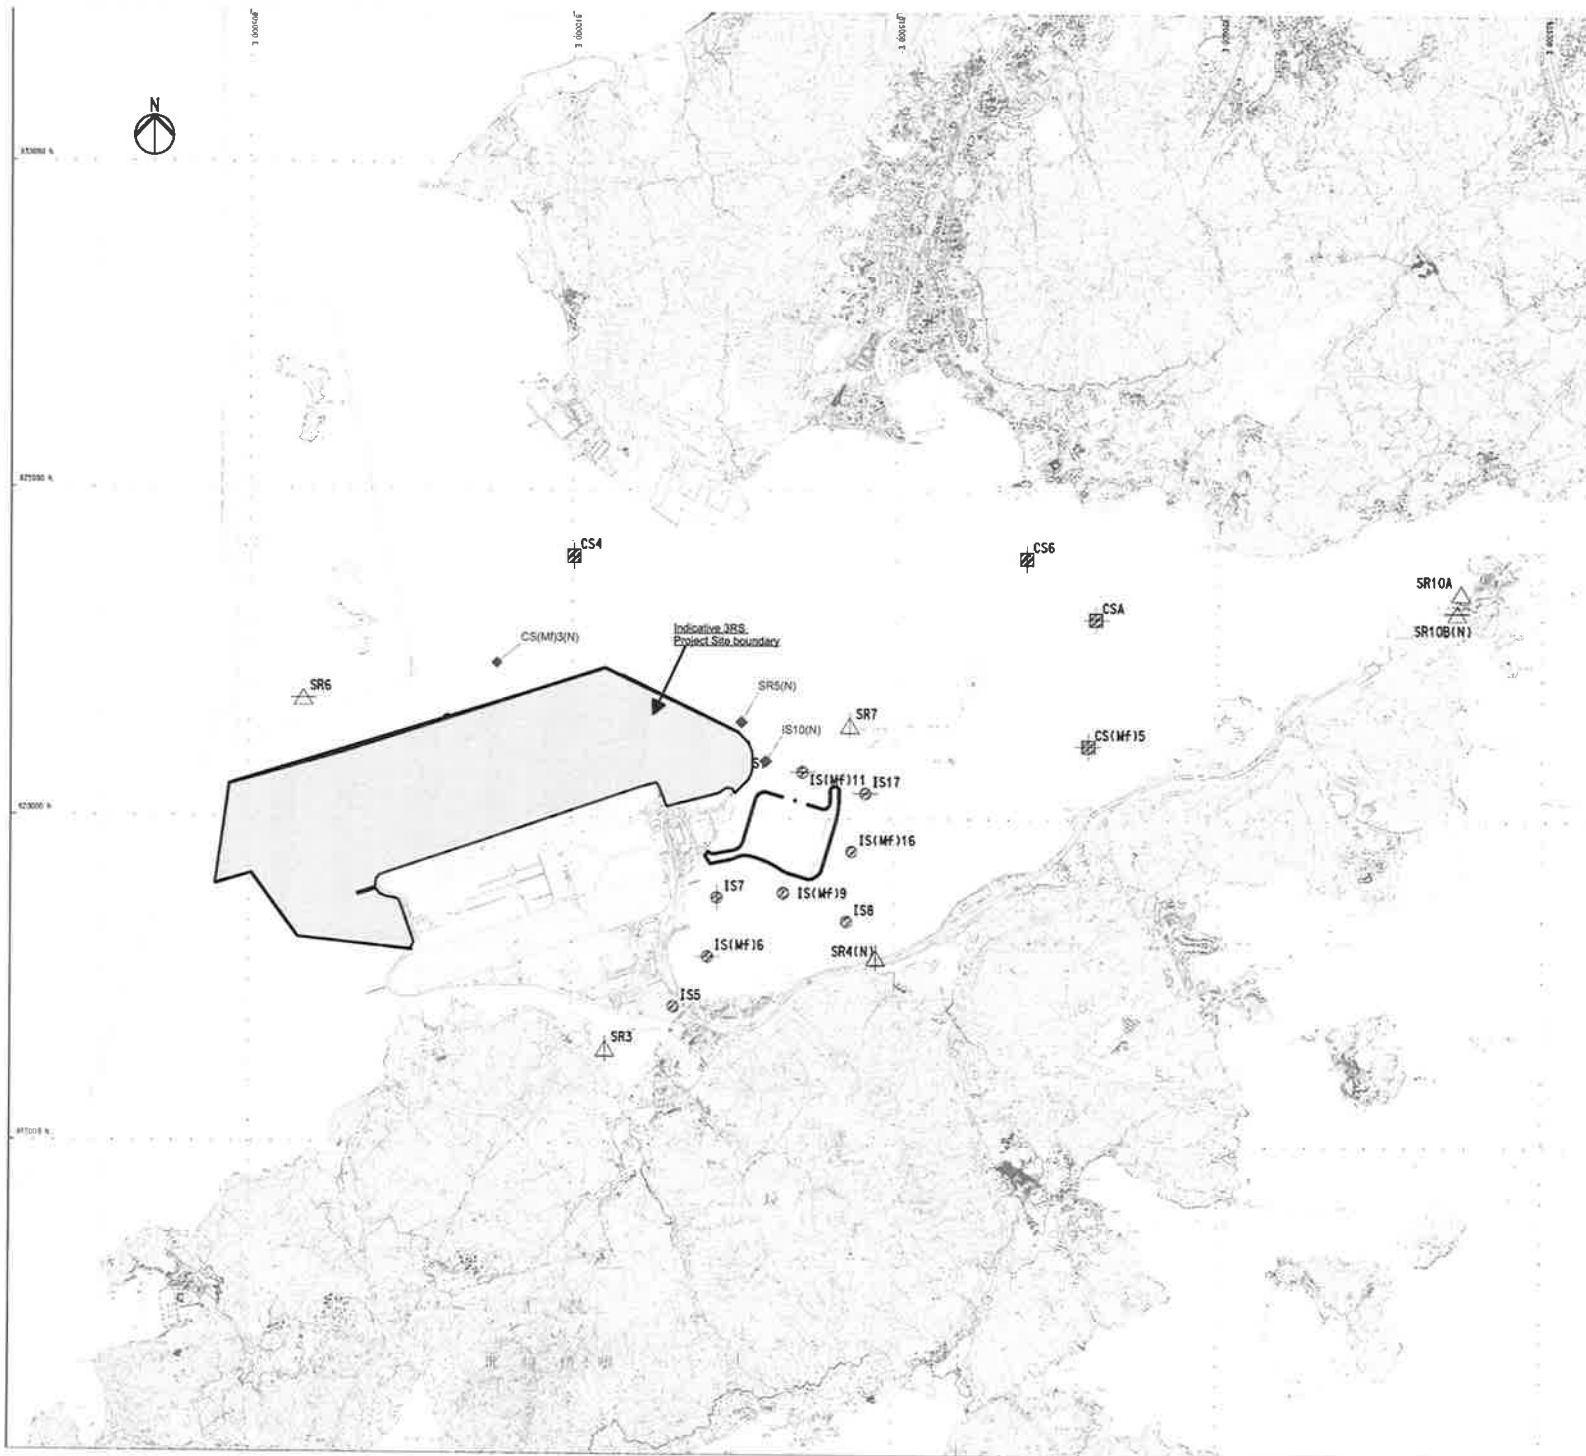
### **Figure 1**

#### **The Location of WQM Stations**

- LEGEND**
- IS      IMPACT STATIONS
  - CS      CONTROL / FAR FIELD STATIONS
  - △ SR      SENSITIVE RECEIVERS STATIONS

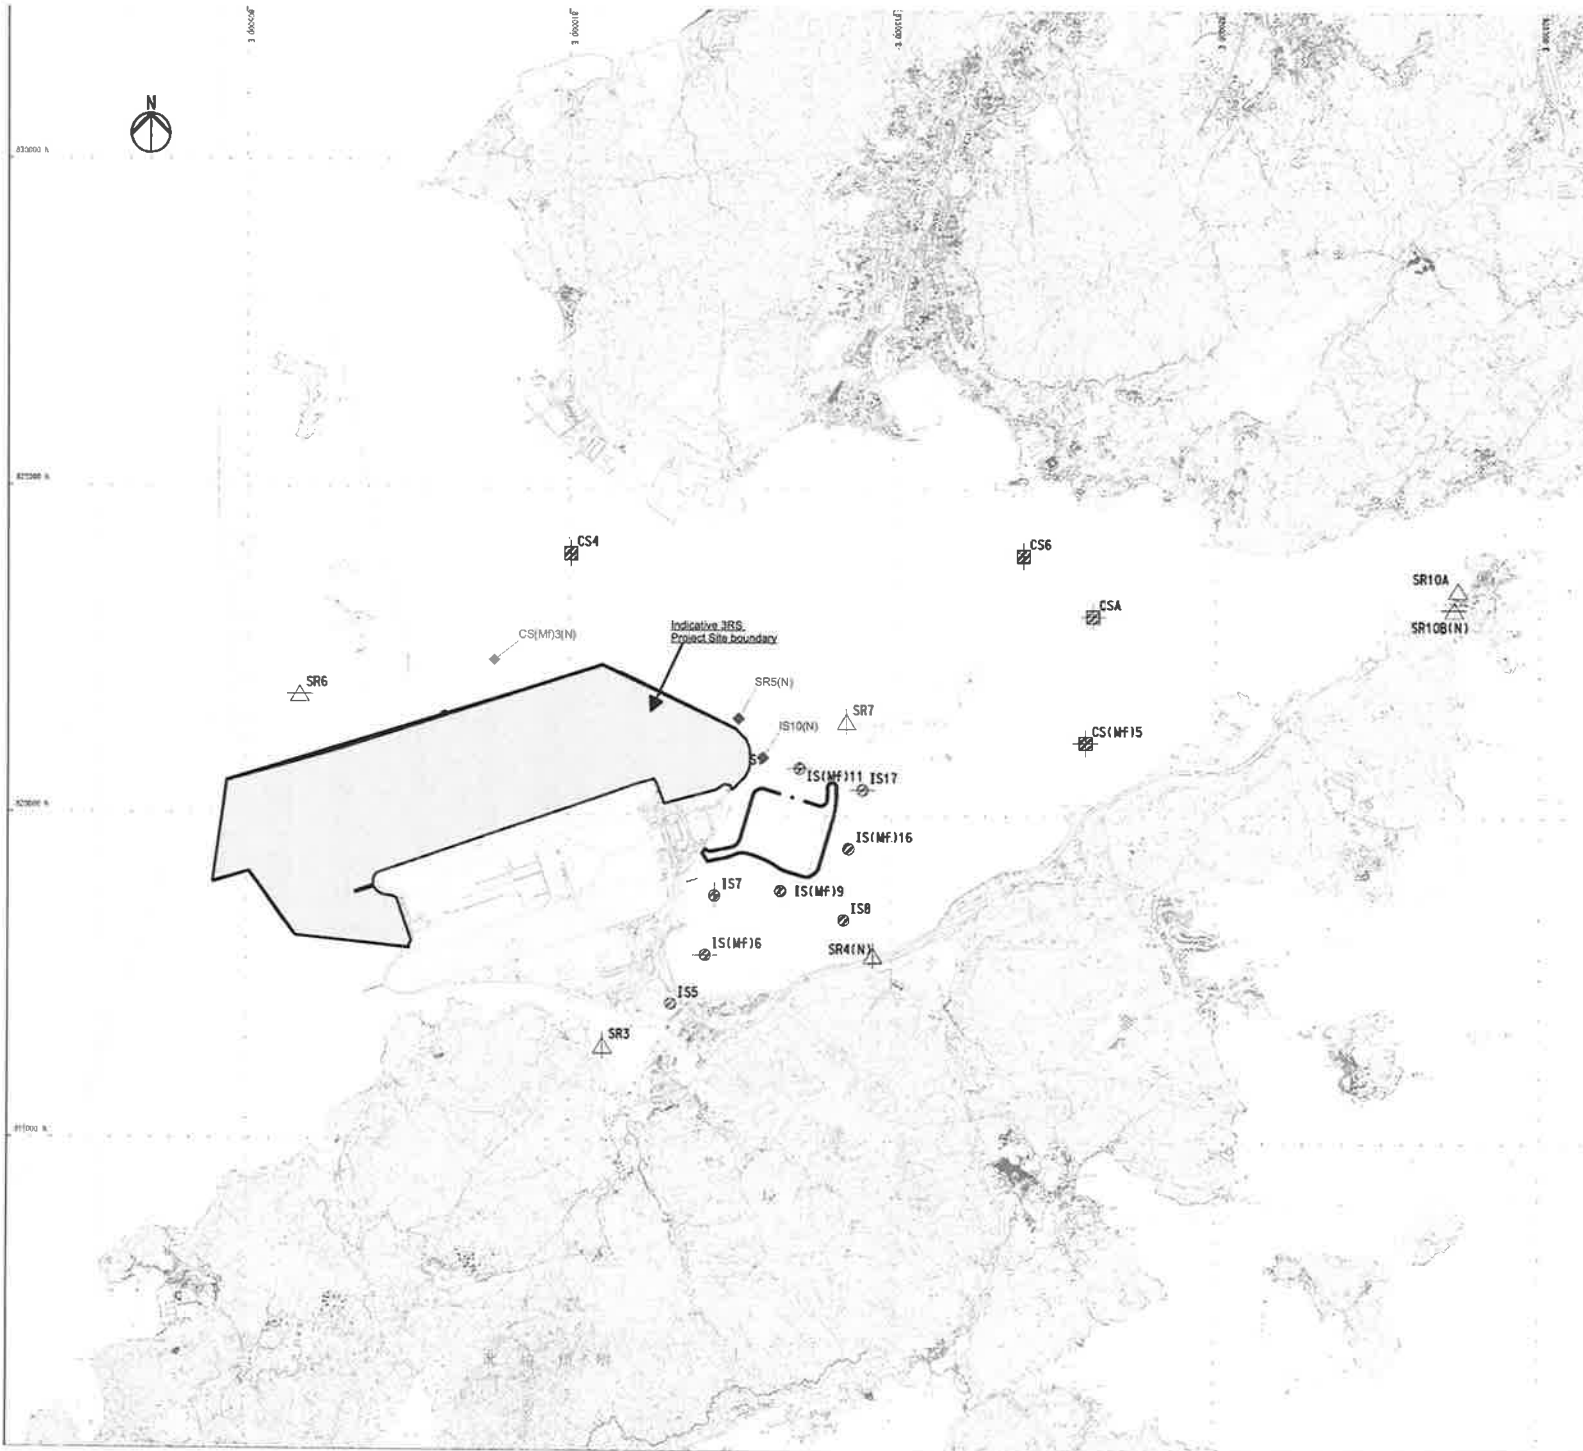
### **Figure 1**

#### **The Location of WQM Stations**

- IS IMPACT STATIONS
- CS CONTROL / FAR FIELD STATIONS
- △ SR SENSITIVE RECEIVERS STATIONS

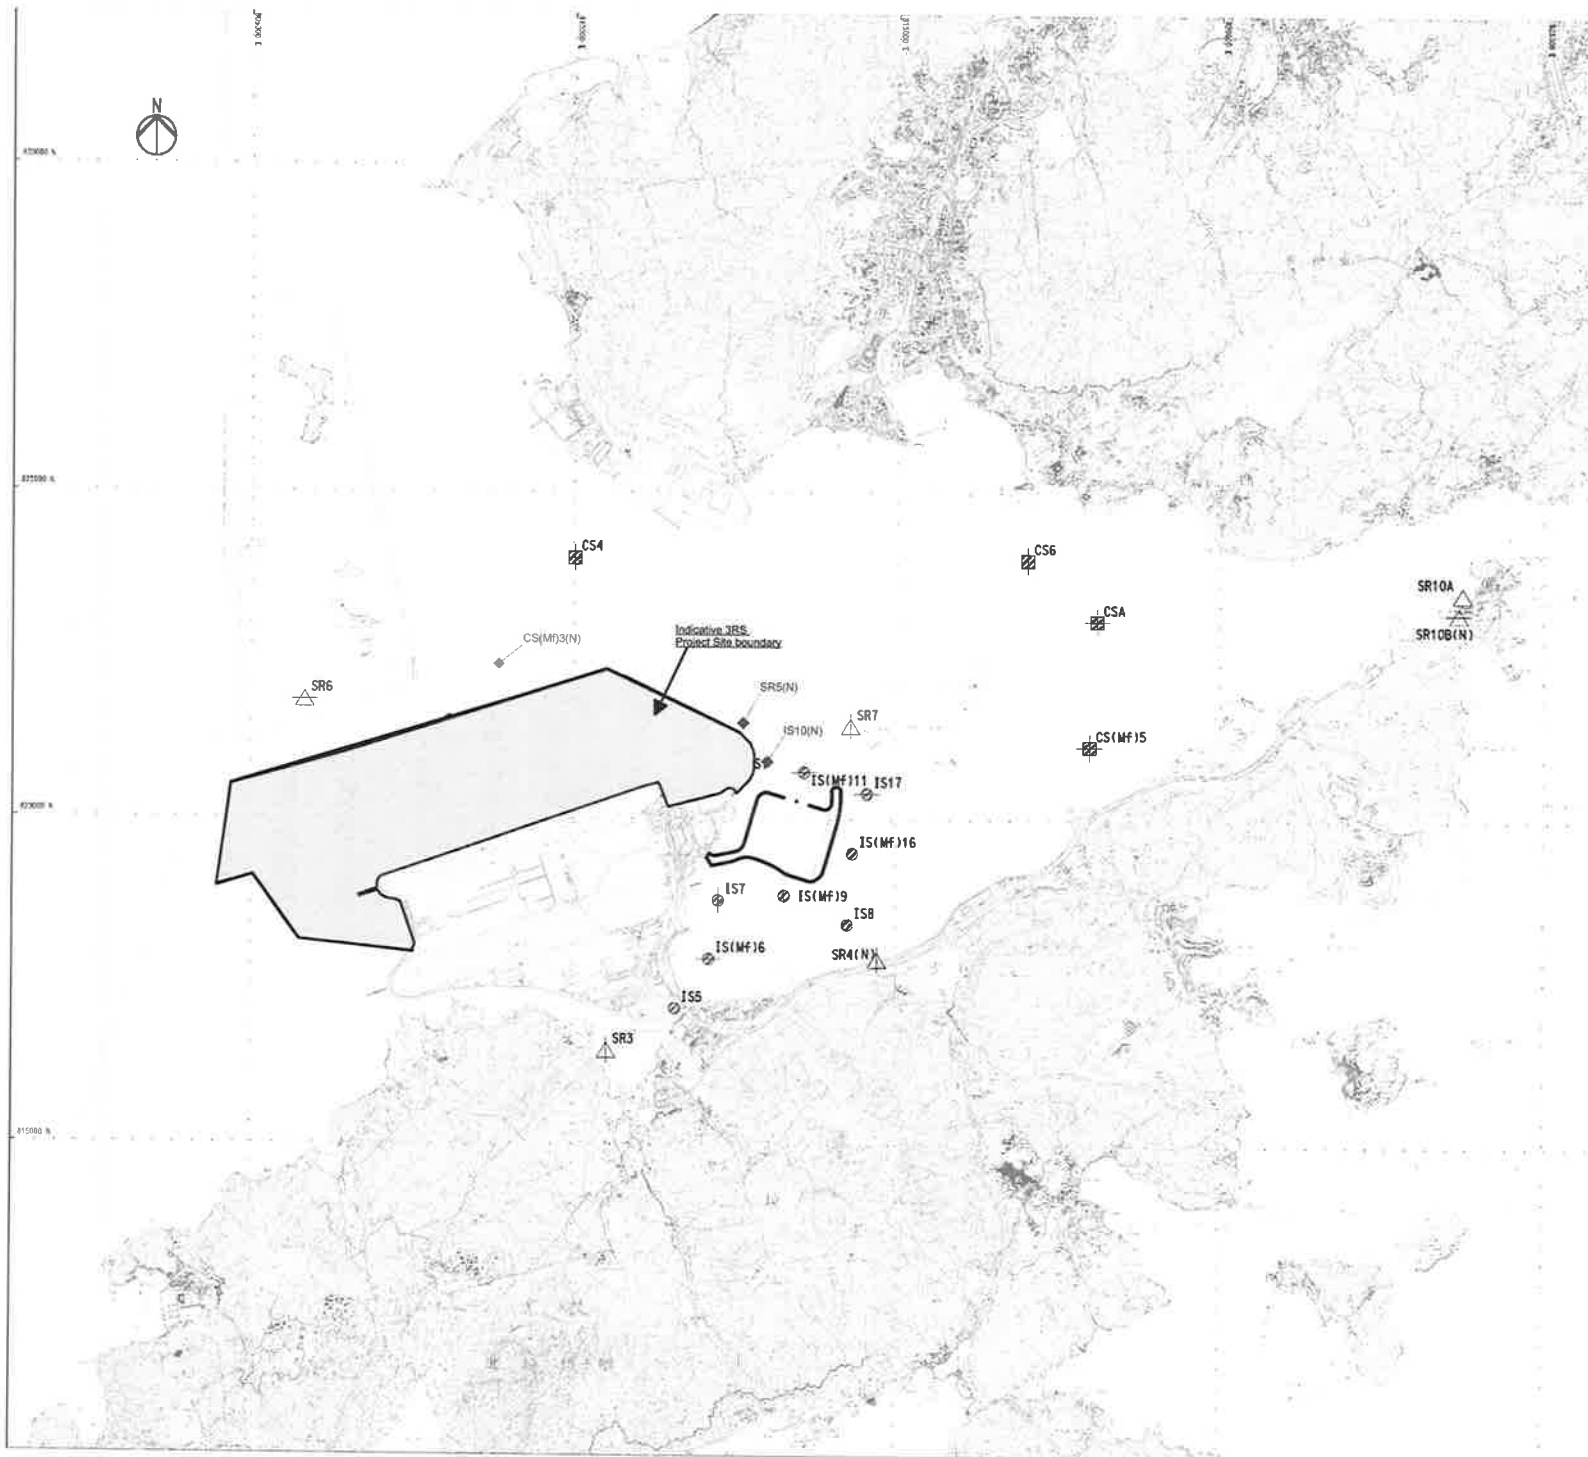
### **Figure 1**

#### **The Location of WQM Stations**
