中國港灣工程有限責任公司

CHINA HARBOUR ENGINEERING COMPANY LIMITED
HONG KONG REPRESENTATIVE: ZHEN HUA ENGINEERING CO., LTD.

Contract No. HY/2013/03
Hong Kong-Zhuhai-Macao Bridge Hong Kong Boundary Crossing Facilities –
Vehicle Clearance Plazas and Ancillary Buildings and Facilities
EP Condition 5.4 – Quarterly EM&A Report (December 2017 – February 2018)

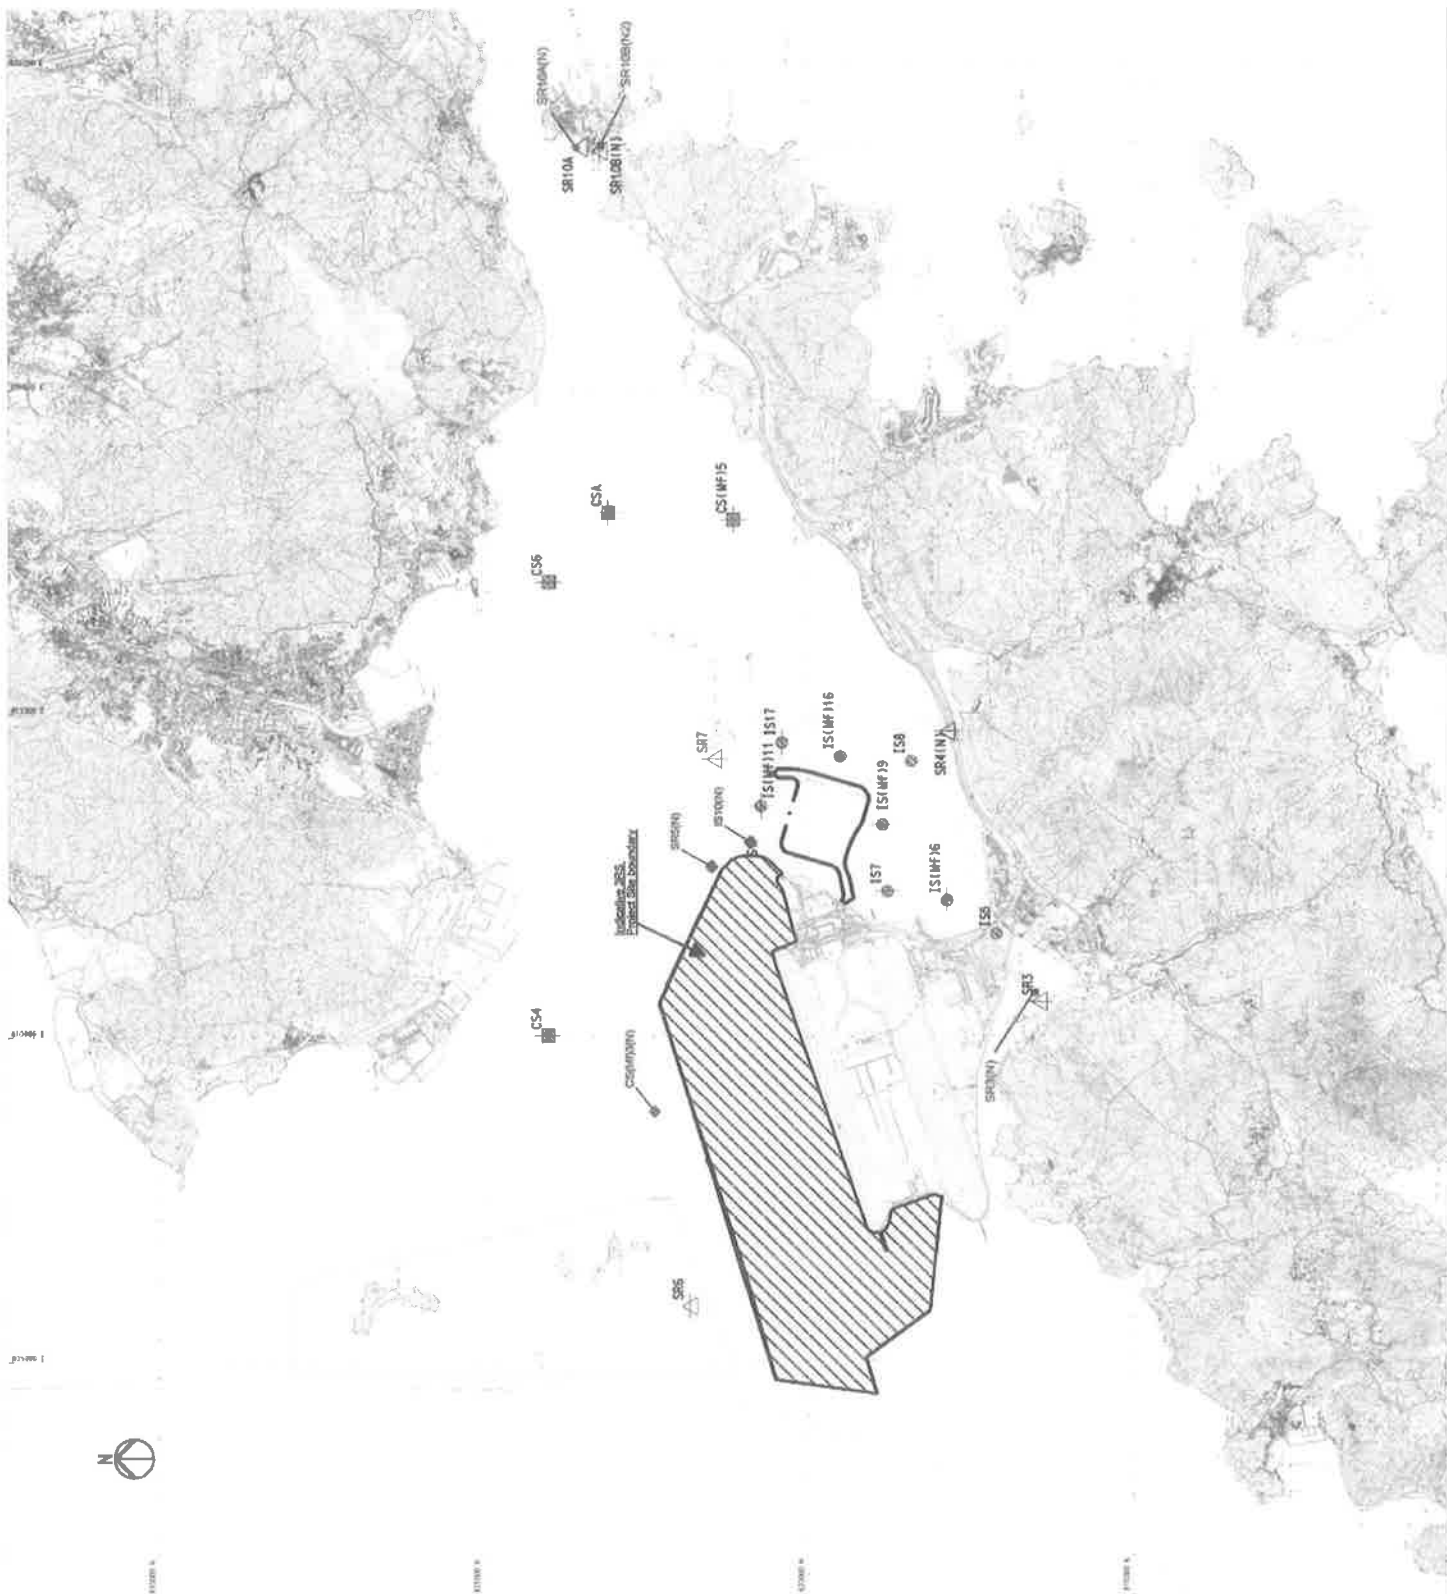
Figure 3

Water Quality Monitoring Stations

FIGURE 4.1 – LOCATION OF WATER QUALITY MONITORING STATIONS SETTING OUT SCHEDULE

- 2.1.3 The water monitoring works for the Contract are covered by Contract No. HY/2013/01 "Hong Kong-Zhuhai-Macao-Bridge HKBCF – Passenger Clearance Building". The water quality monitoring station (SR3, SR10A and SR10B(N)) had been slightly re-located since 22 December 2017. A summary of water quality monitoring stations are presented in **Table 2.2**. The location of water quality monitoring stations are shown as in **Figure 3**.

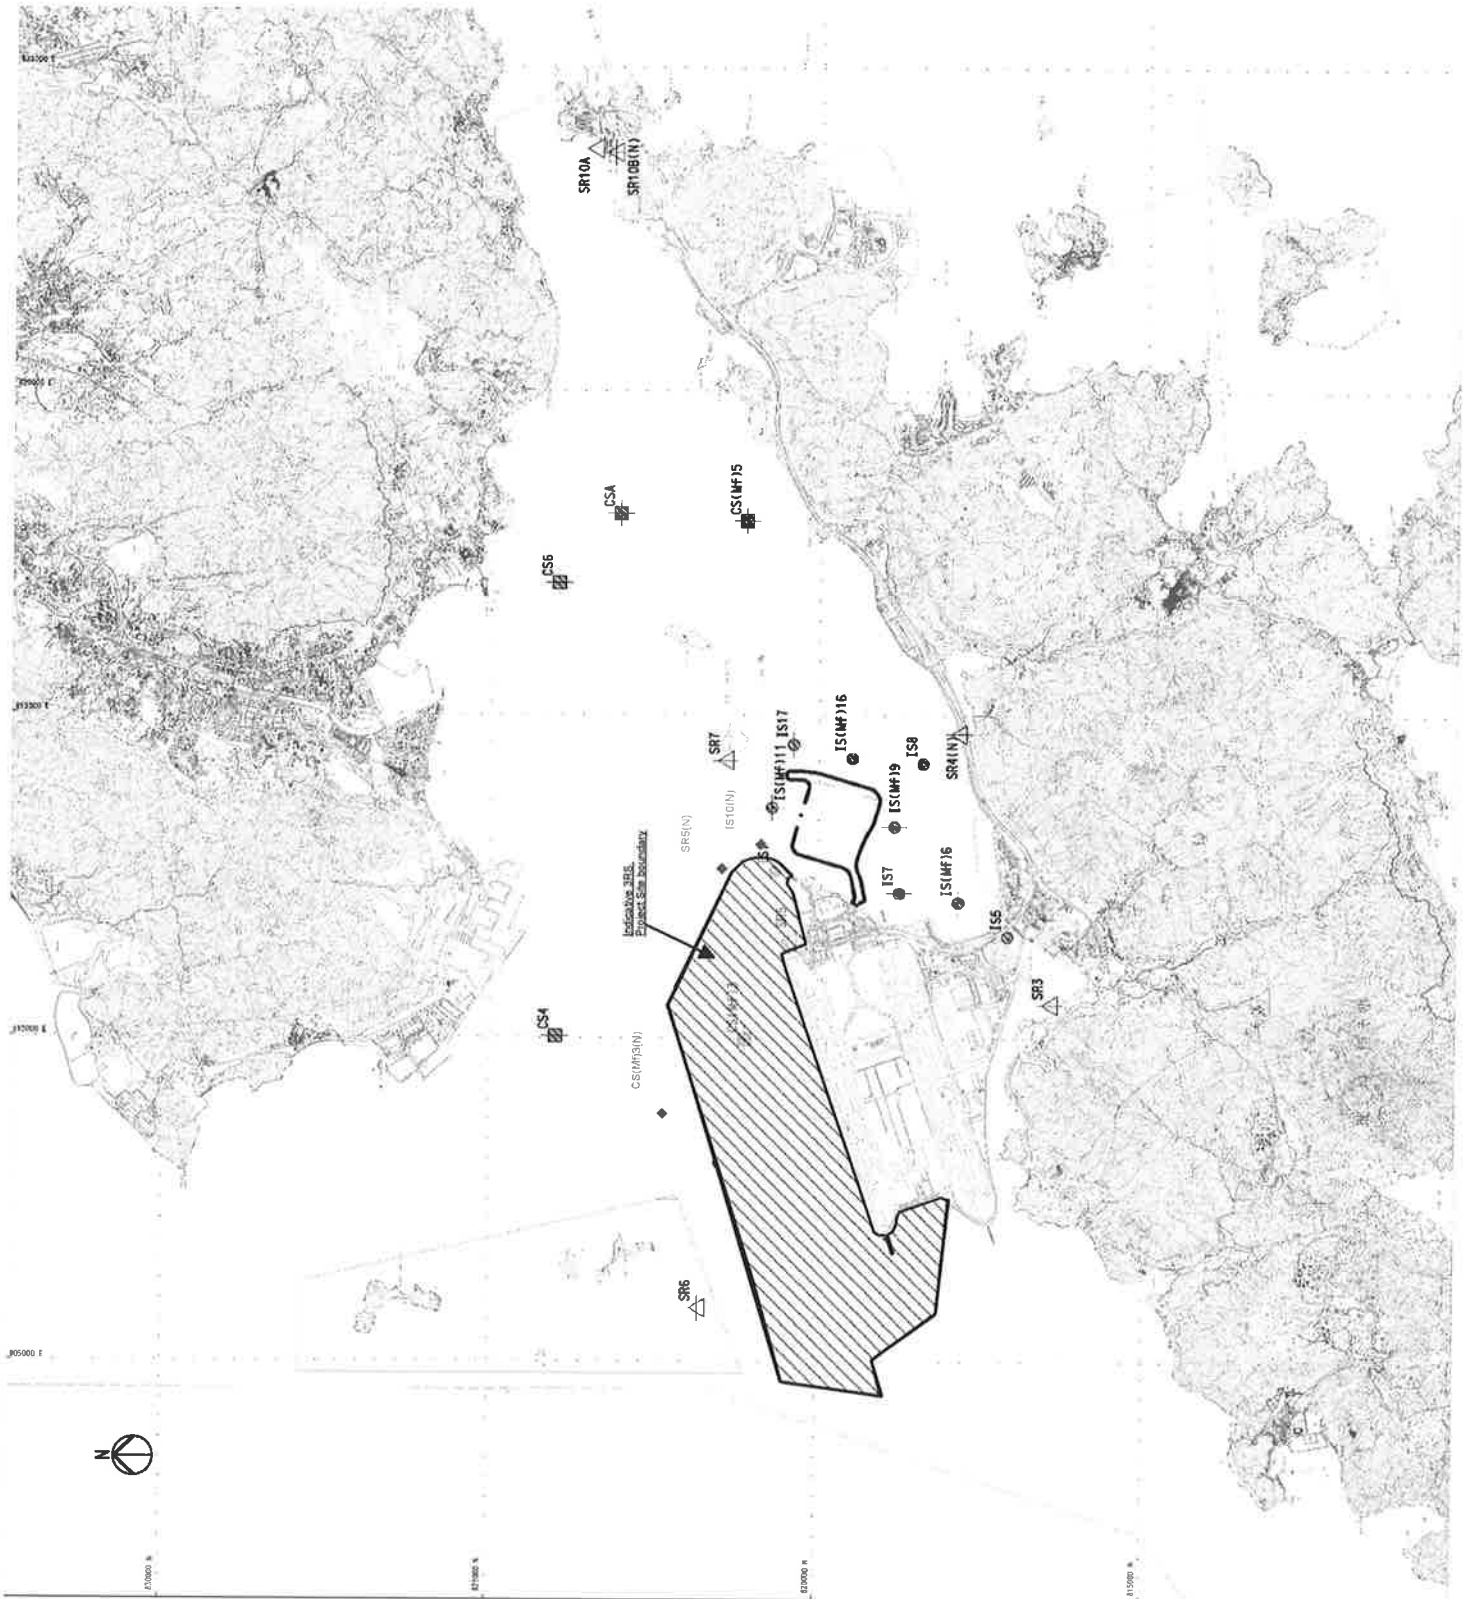
Figure 1

The Location of WQM Stations

- LEGEND**
- IS IMPACT STATIONS
 - CS CONTROL / FAR FIELD STATIONS
 - SR SENSITIVE RECEIVERS STATIONS

FIGURE 4.1— LOCATION OF WATER QUALITY MONITORING STATIONS

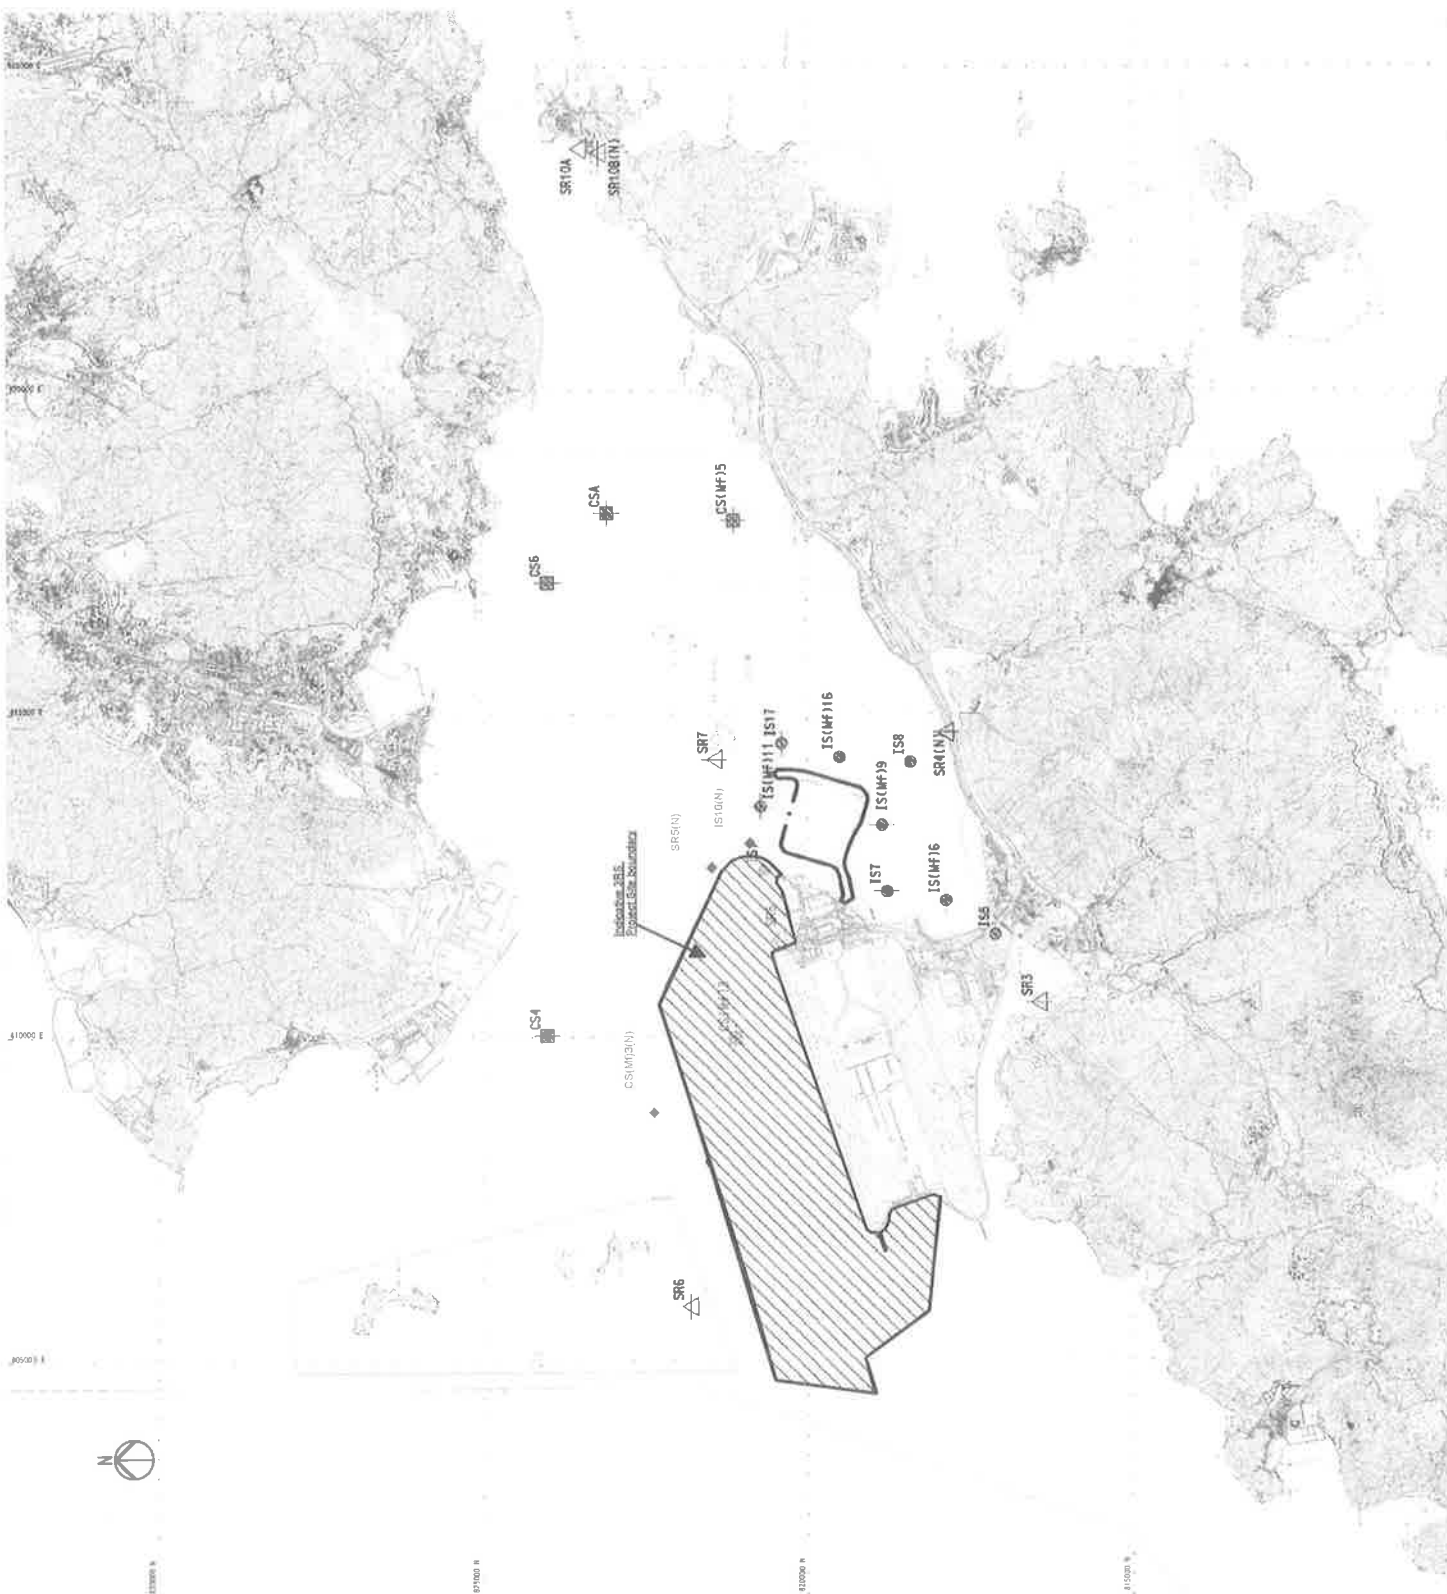
Figure 1

The Location of WQM Stations

- LEGEND**
- IS IMPACT STATIONS
 - CS CONTROL / FAR FIELD STATIONS
 - SR SENSITIVE RECEIVERS STATIONS

FIGURE 4.1 – LOCATION OF WATER QUALITY MONITORING STATIONS

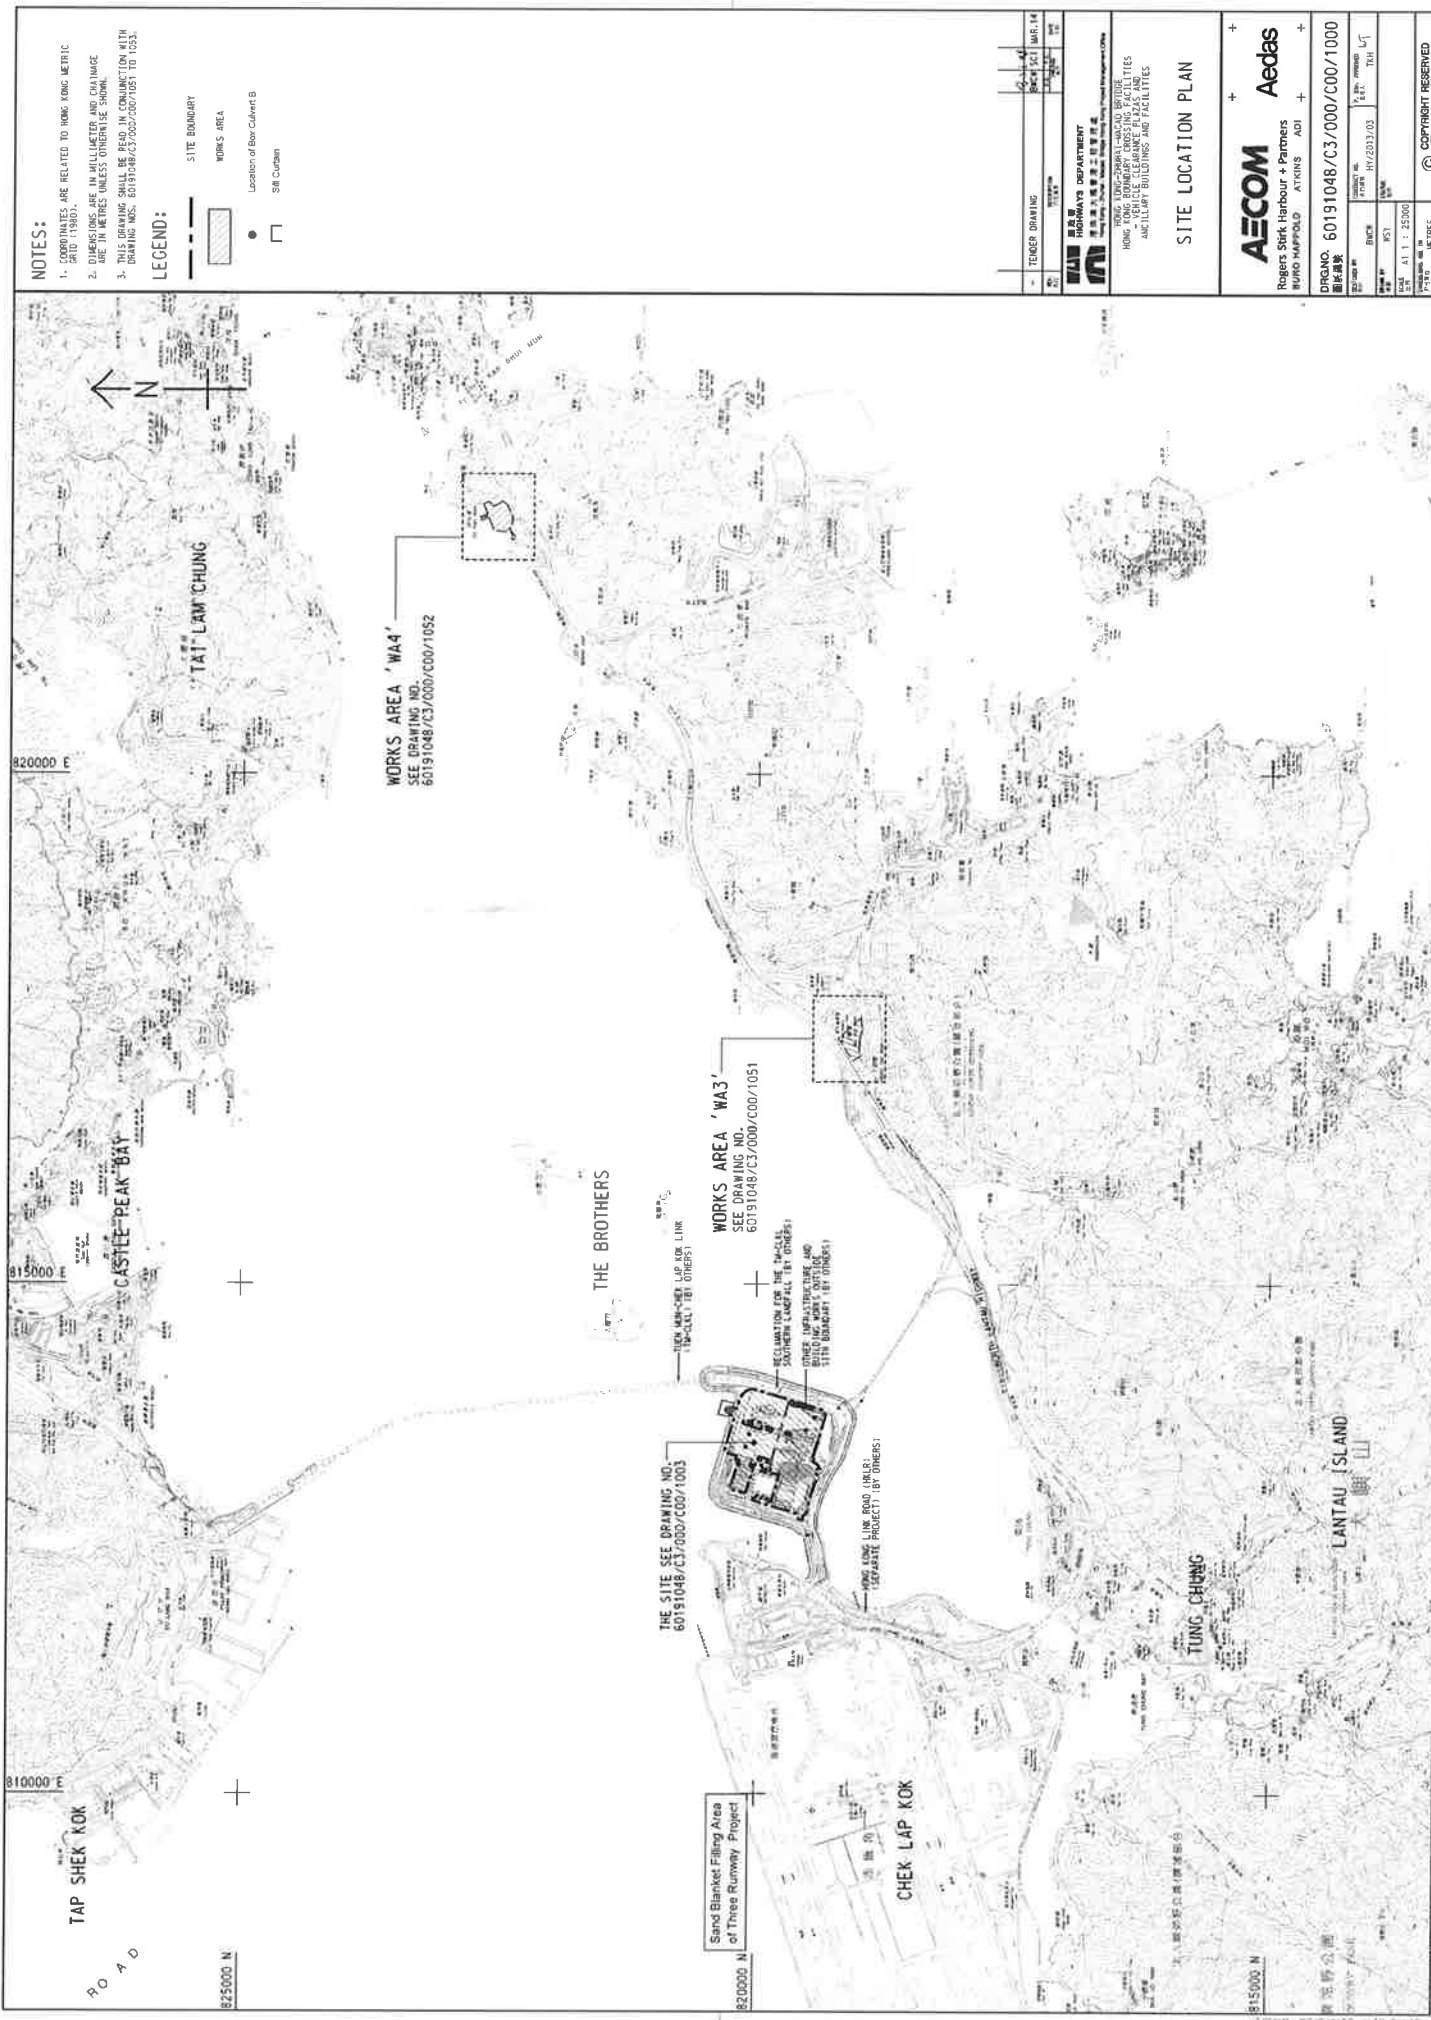
Figure 2

The Locations of Marine Transportation and Marine-based Construction Works

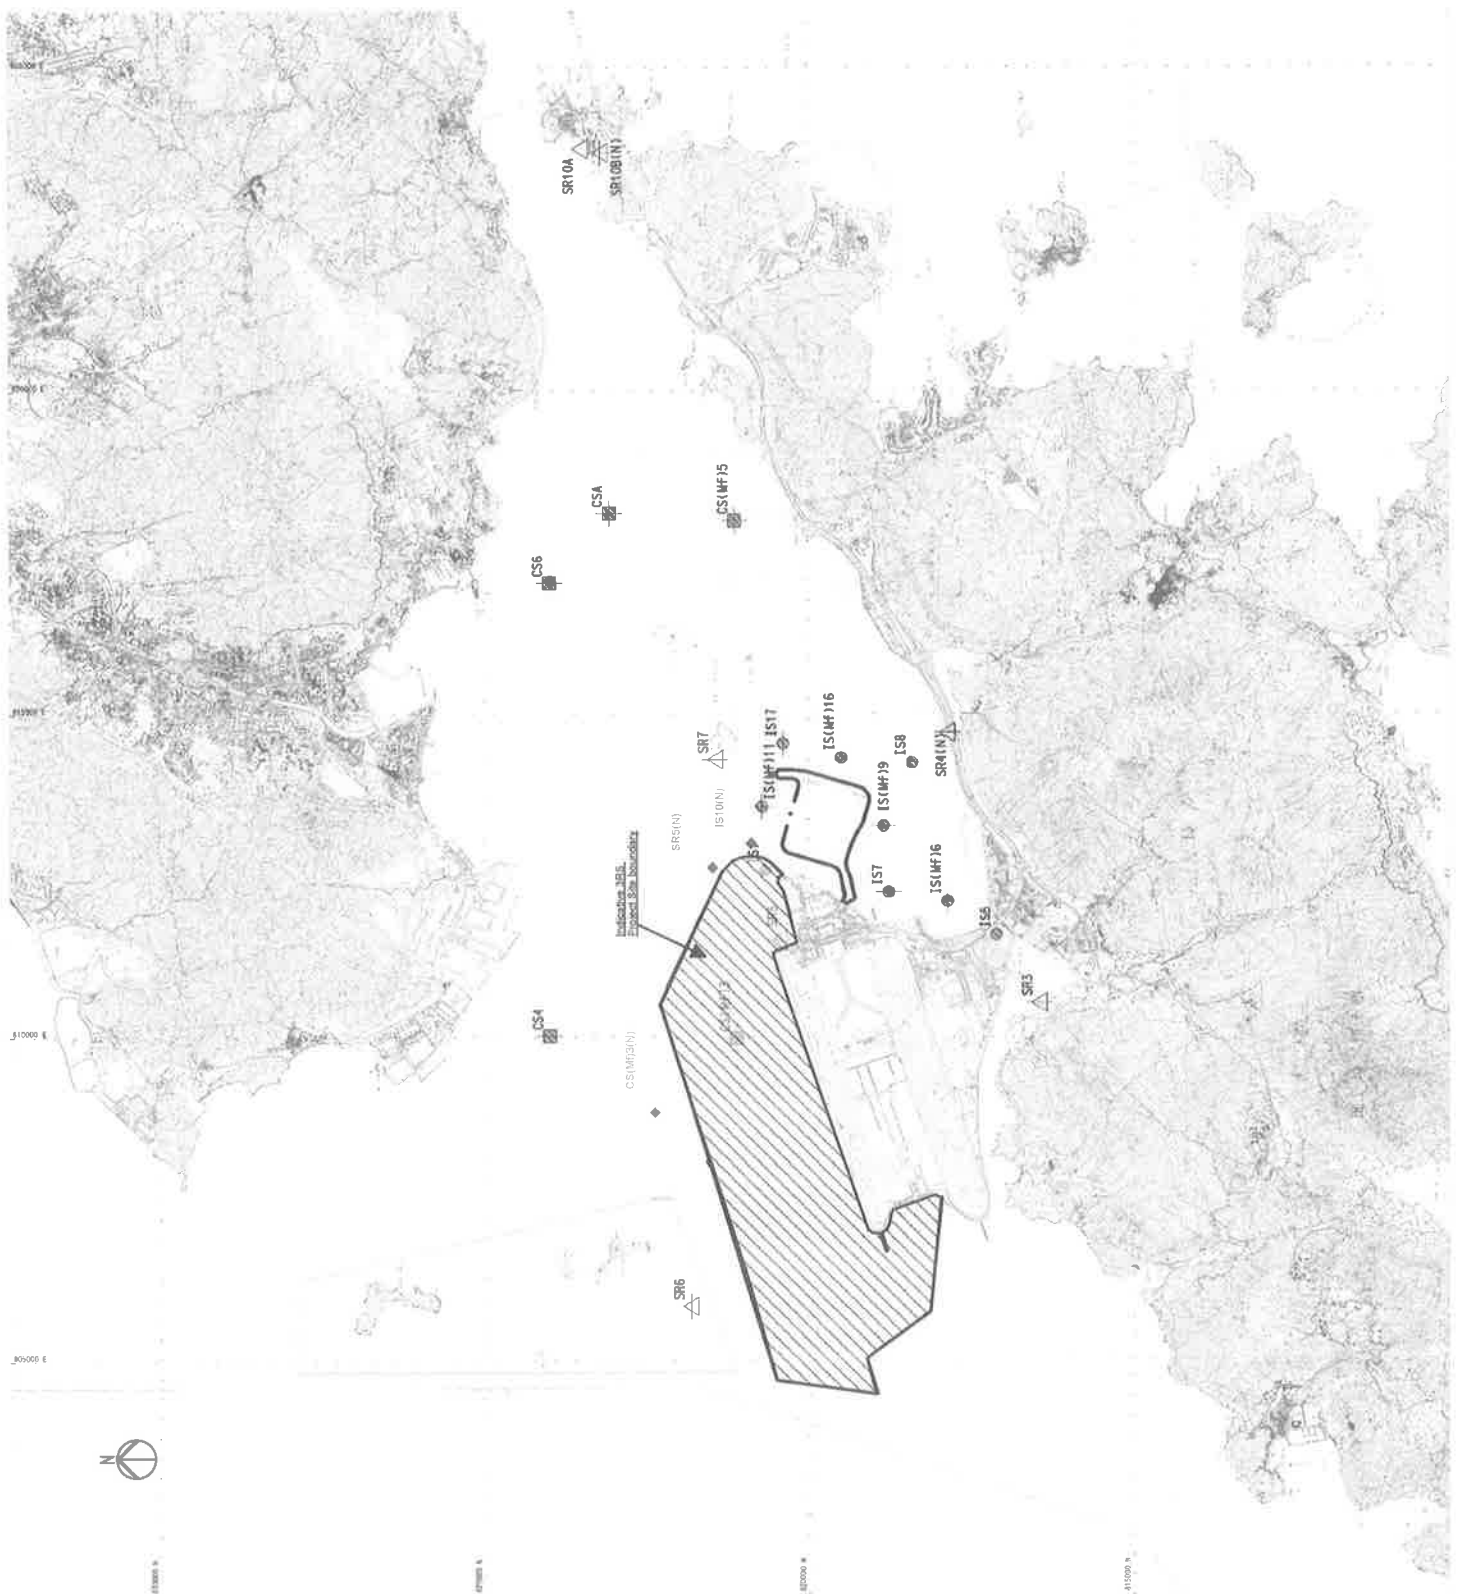
Figure 1

The Location of WQM Stations

- LEGEND**
- IS IMPACT STATIONS
 - CS CONTROL / FAR FIELD STATIONS
 - SR SENSITIVE RECEIVERS STATIONS

FIGURE 4.1 – LOCATION OF WATER QUALITY MONITORING STATIONS

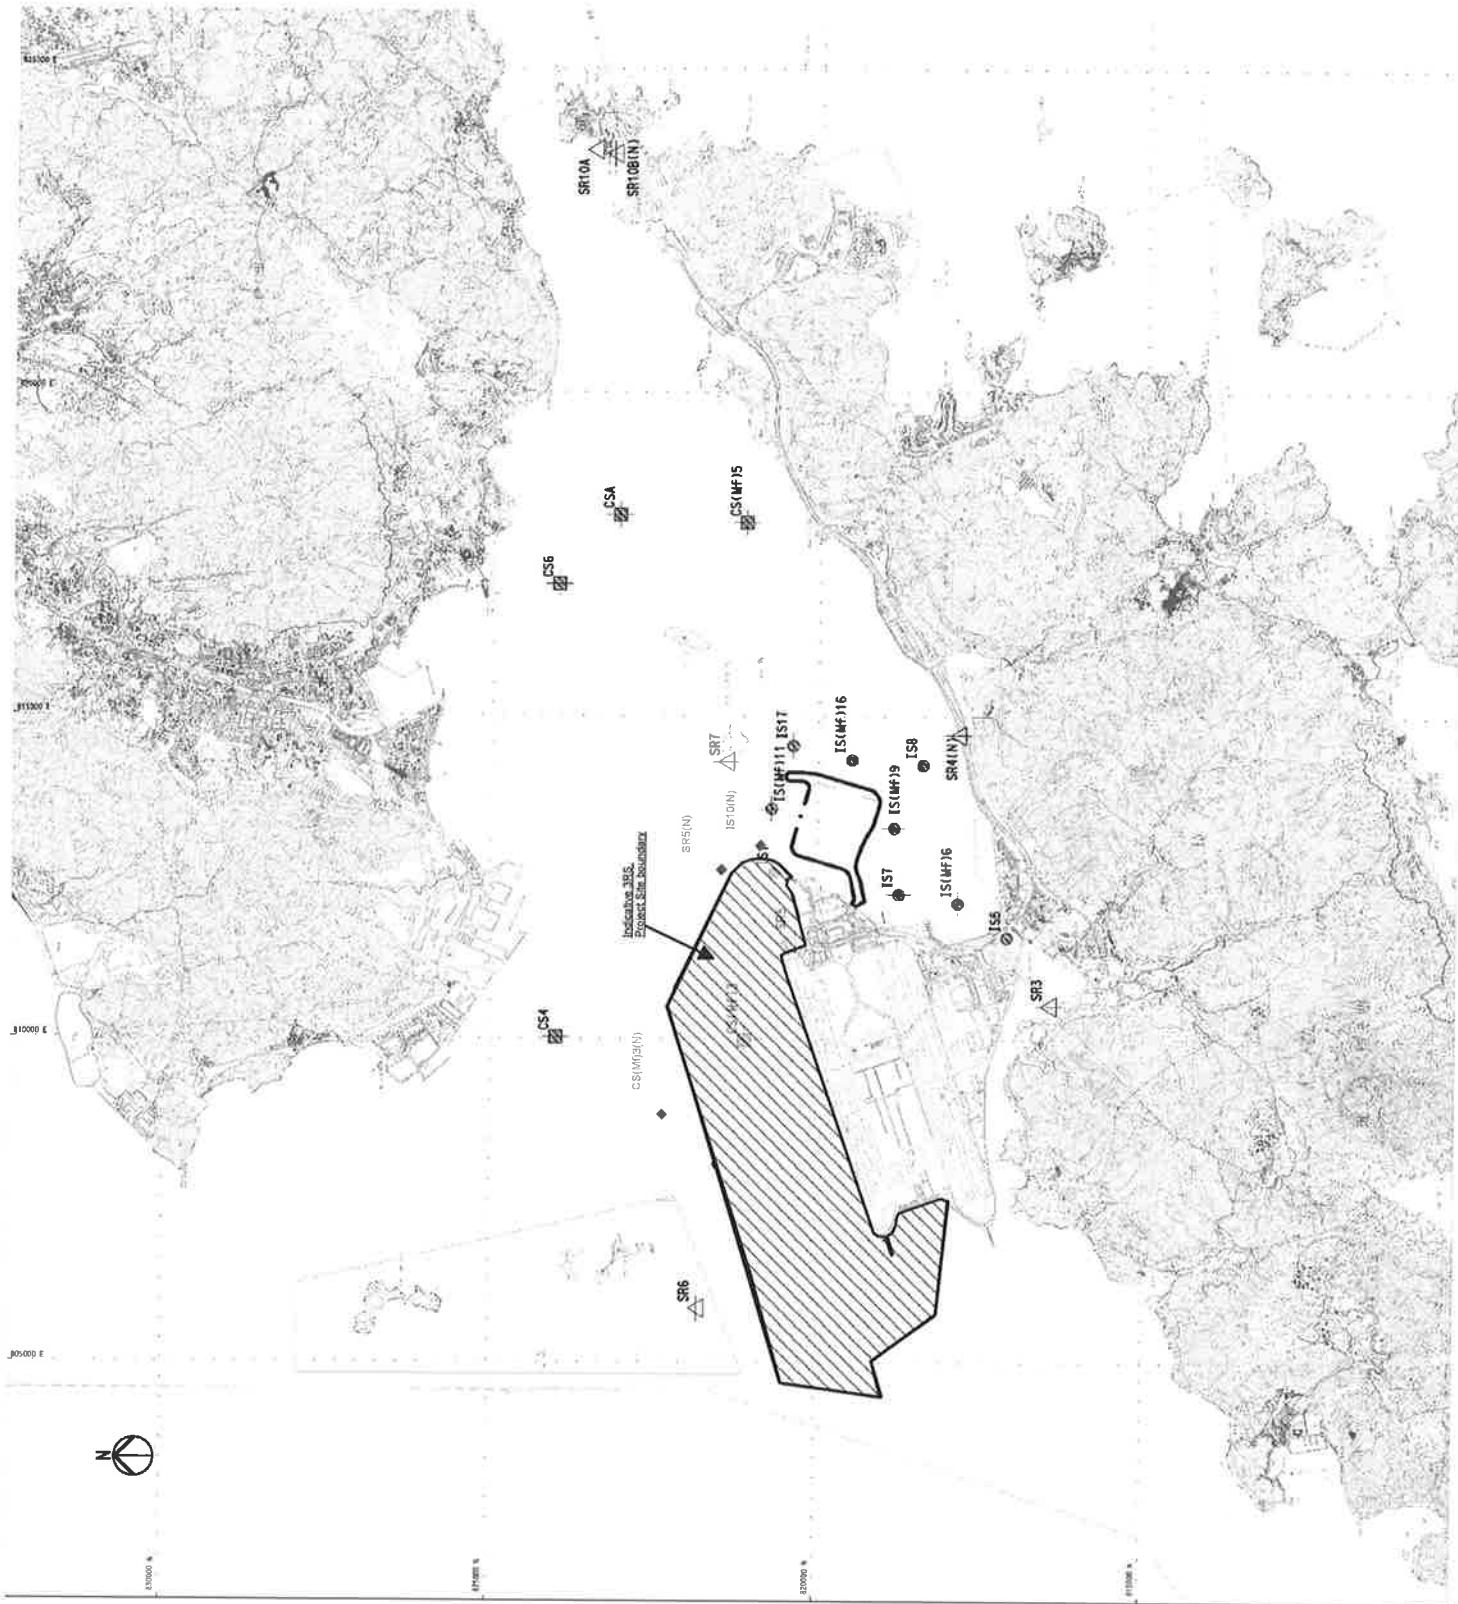
Figure 1

The Location of WQM Stations

FIGURE 4.1 – LOCATION OF WATER QUALITY MONITORING STATIONS

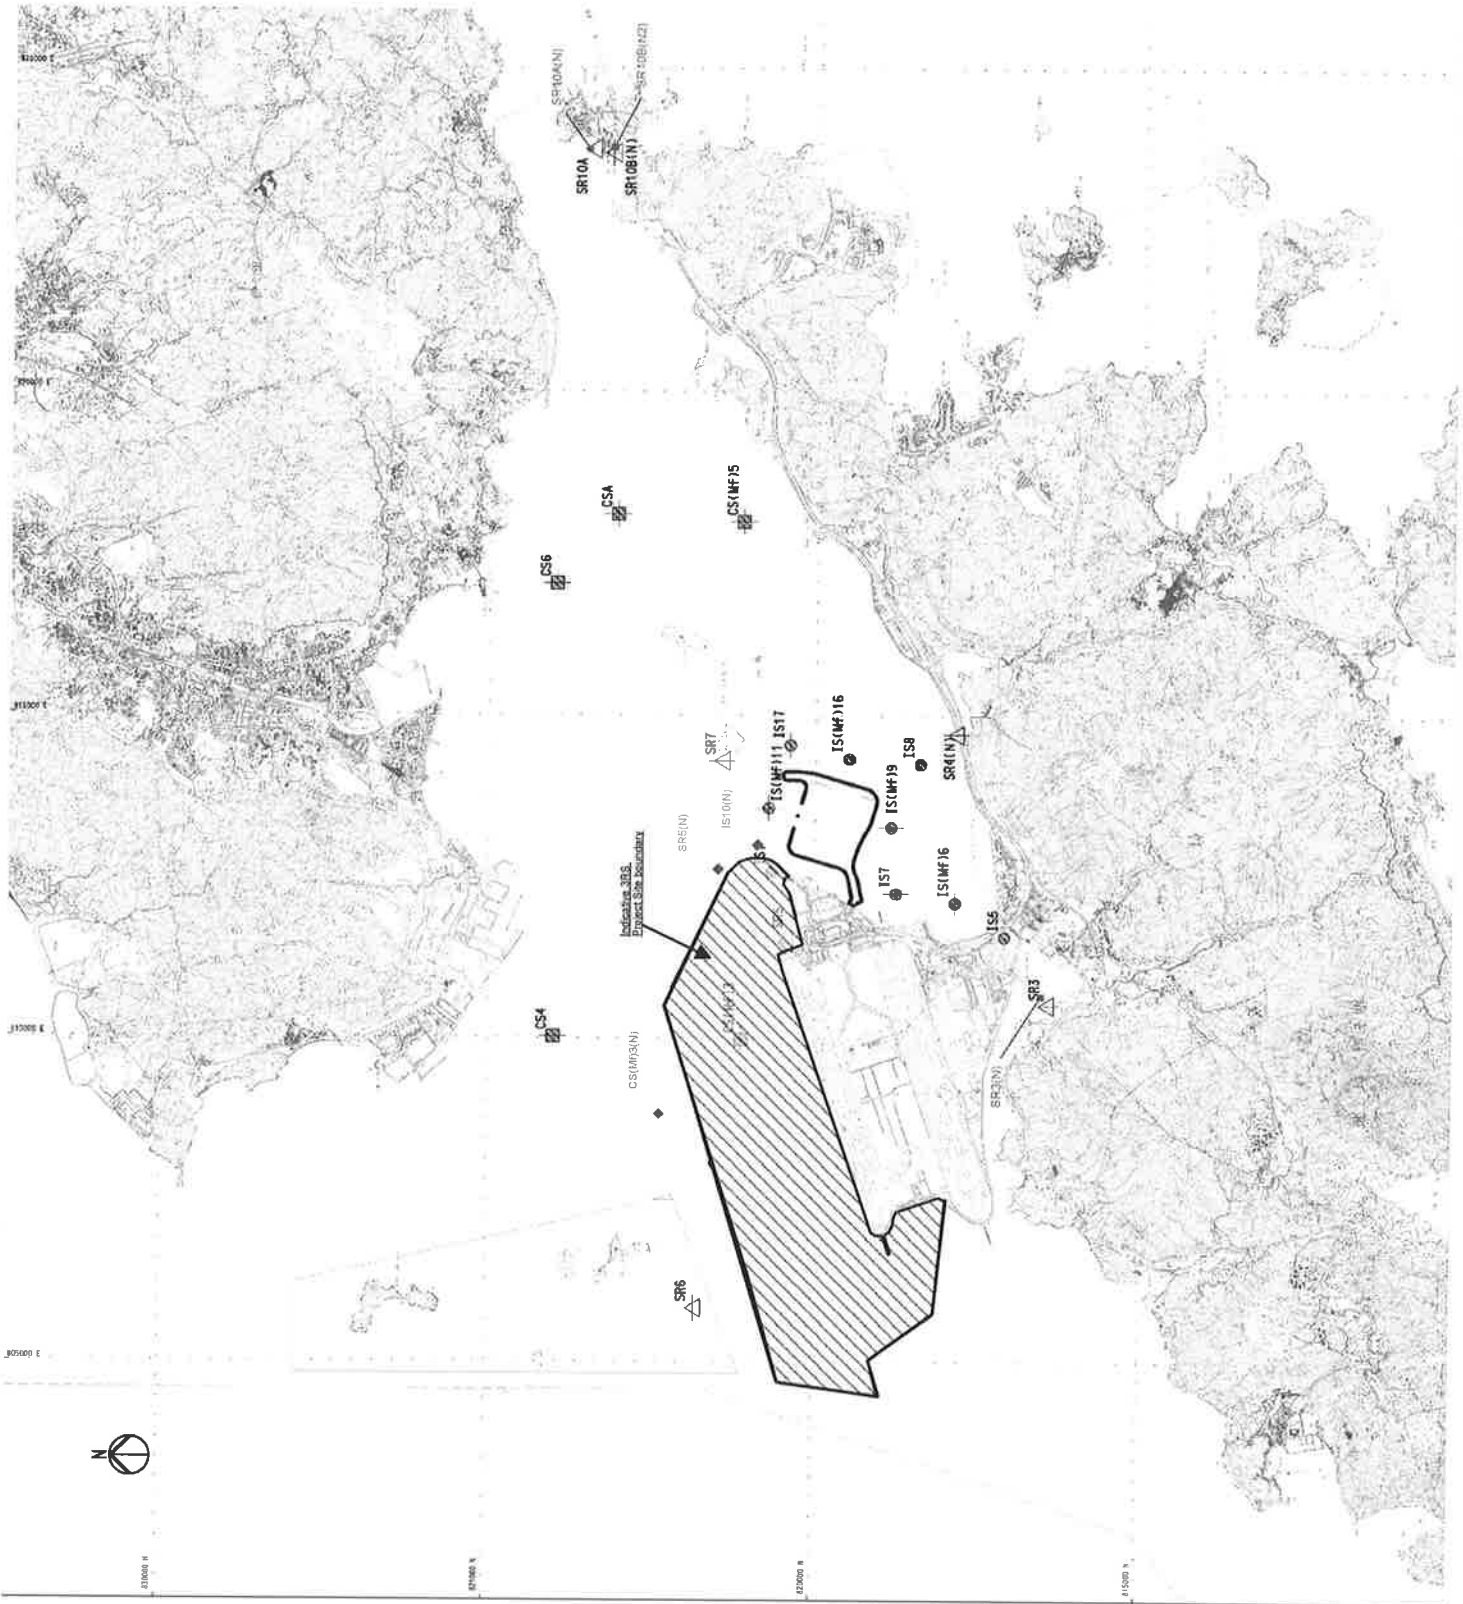
Figure 1

The Location of WQM Stations

- LEGEND**
- IS IMPACT STATIONS
 - CS CONTROL / FAR FIELD STATIONS
 - SR SENSITIVE RECEIVERS STATIONS

FIGURE 4.1 – LOCATION OF WATER QUALITY MONITORING STATIONS
