**Contract No. HK/2015/01**

**Wanchai Development Phase II and Central-Wanchai Bypass**

**Investigation Report on Breakdown of Tunnel Ventilation System at East Ventilation Building**

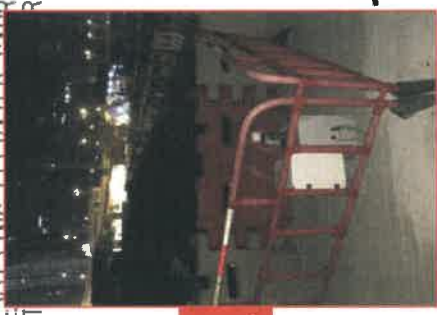
#15 MAS  
19/04/05 02:20 AM  
Site 5

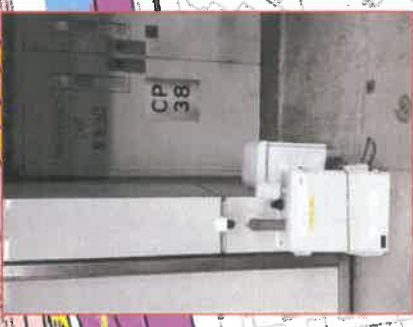
#8 MAS  
19/04/05 01:34 AM  
Site 2

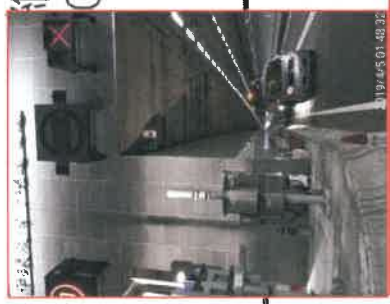
#16 MAS  
19/04/05 01:45 AM  
Site 3

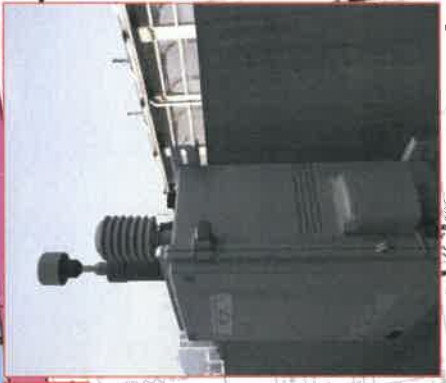
#21 MAS  
19/04/05 09:30 AM  
Site 4

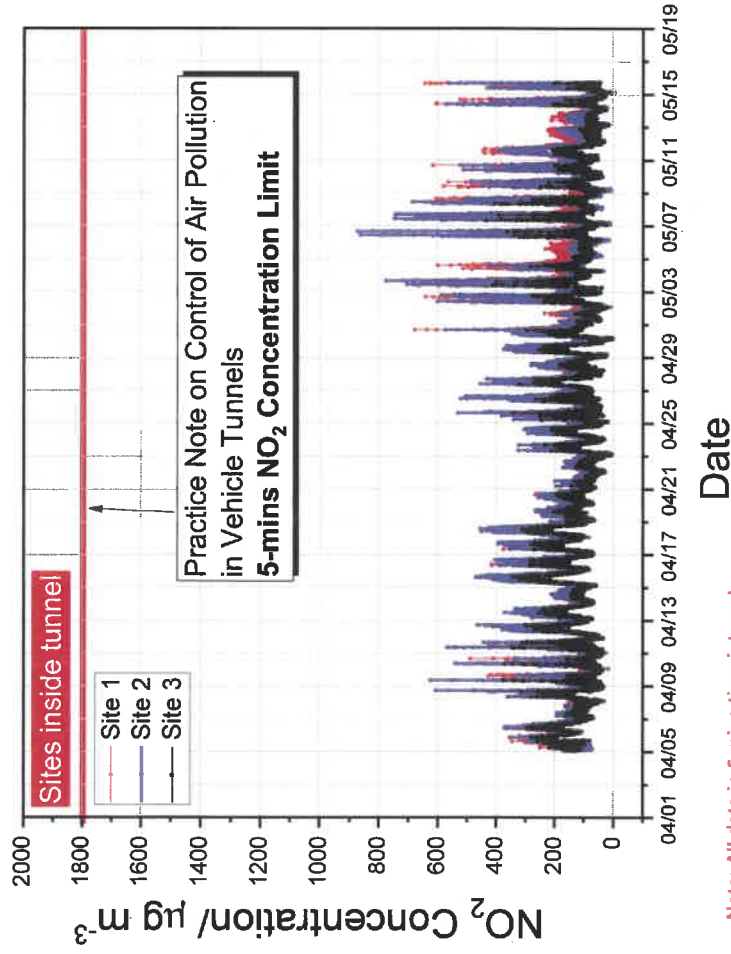
- **NO<sub>2</sub> and NO data inside the tunnel showed consistent trend by report date on May, 15.**
