擬於剩餘路段建設填海區  
Castle Peak Road Improvement between Area and Ka Loon Tsuen, Tsuen Wan - Proposed Reclamation Works for Remaining Project

JOB TITLE PWP Item No. 553TH Castle Peak Road Improvement from Sham Tseng to Ka Loon Tsuen, Tsuen Wan - Marine Ground Investigation

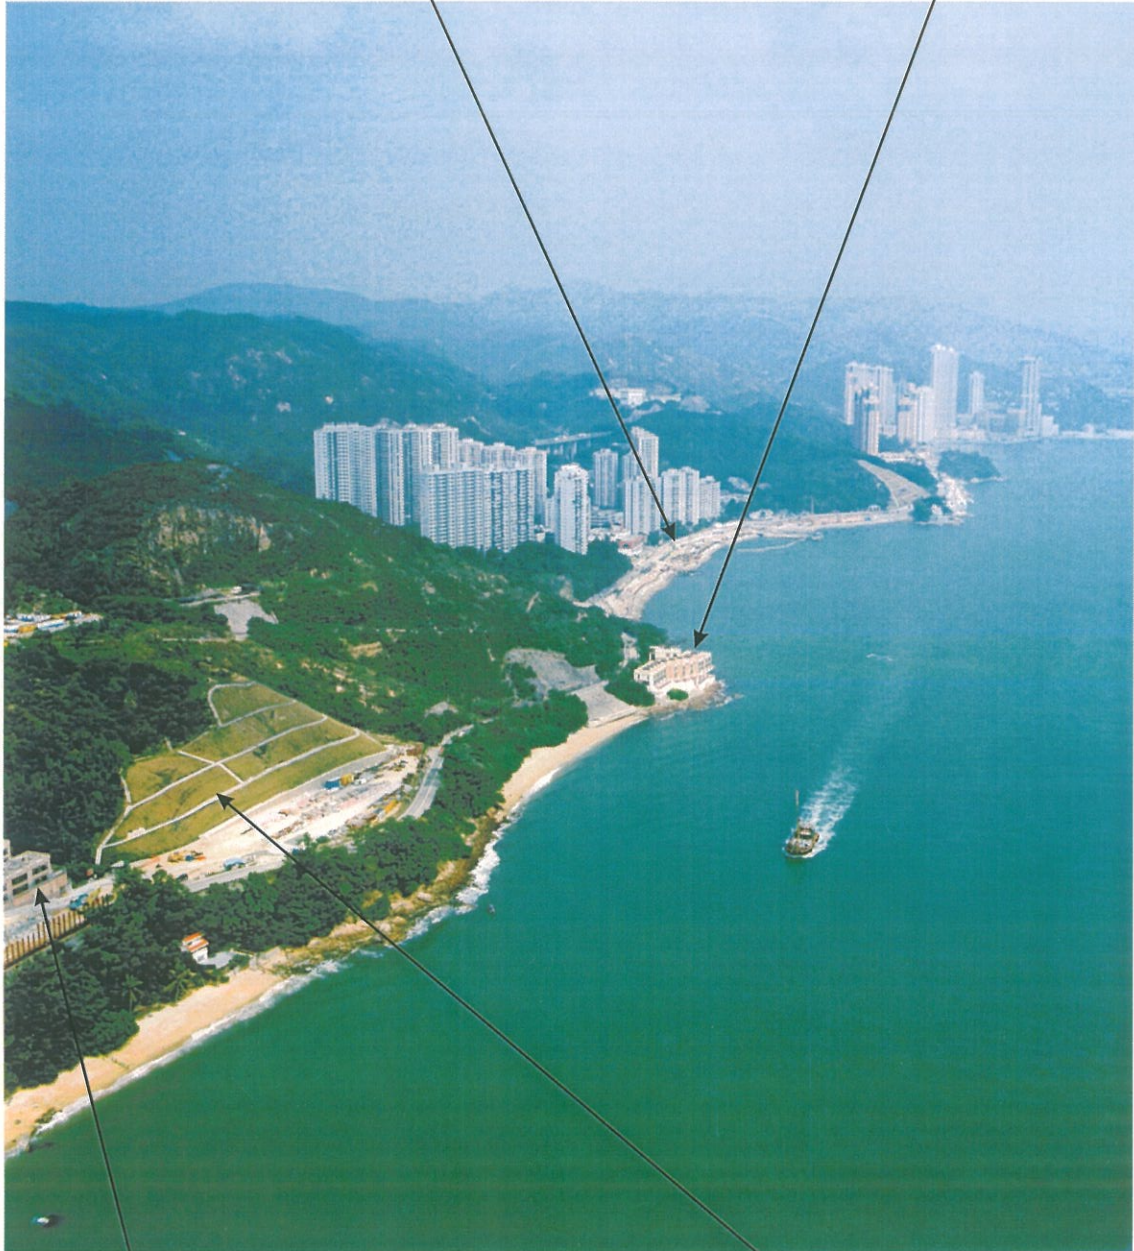
Photo No. 照片 1

Reclamation at Tsing Lung Tau constructed  
under Contract No. HY/99/18 (EP-093/2001)  
根據合約編號 HY/99/18  
興建的青龍頭填海區 (EP-093/2001)

Cut slope constructed  
under Contract No. HY/99/18  
根據合約編號 HY/99/18 興建的削土坡

Photograph of Existing Roadworks  
at West End of Remaining Project  
剩餘路段西面末端的現有道路工程

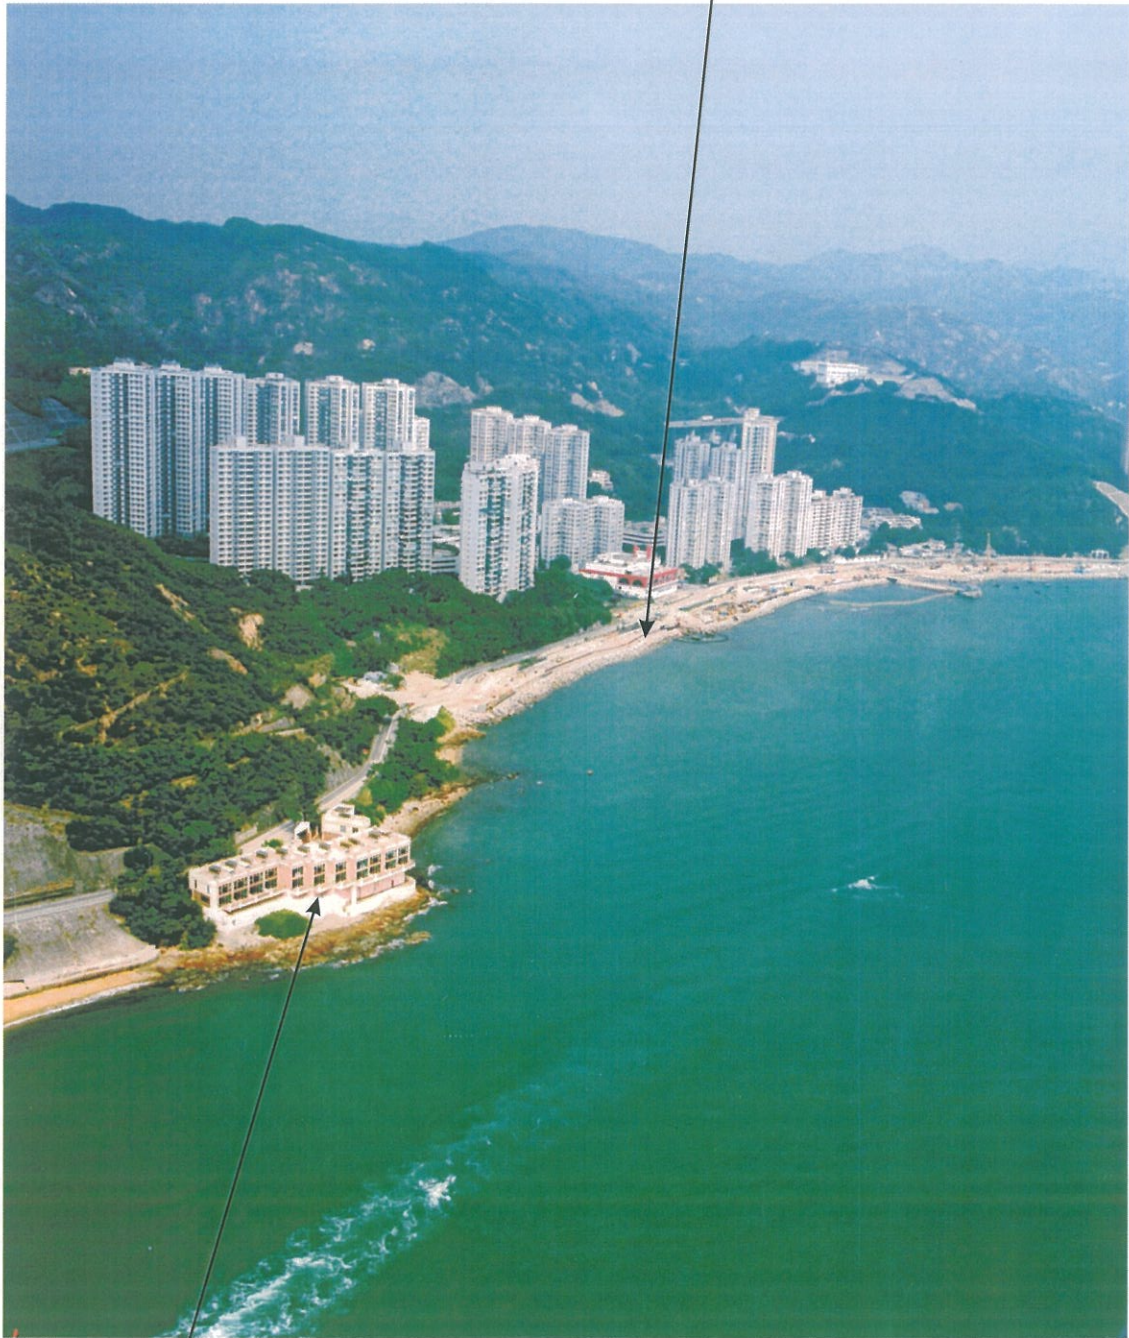
Photo No. 照片 2

Reclamation at Tsing Lung Tau constructed  
under Contract No. HY/99/18 (EP-093/2001)  
根據合約編號 HY/99/18  
興建的青龍頭填海區 (EP-093/2001)

Photograph of Existing Roadworks  
at East End of Remaining Project  
剩餘路段東面末端的現有道路工程

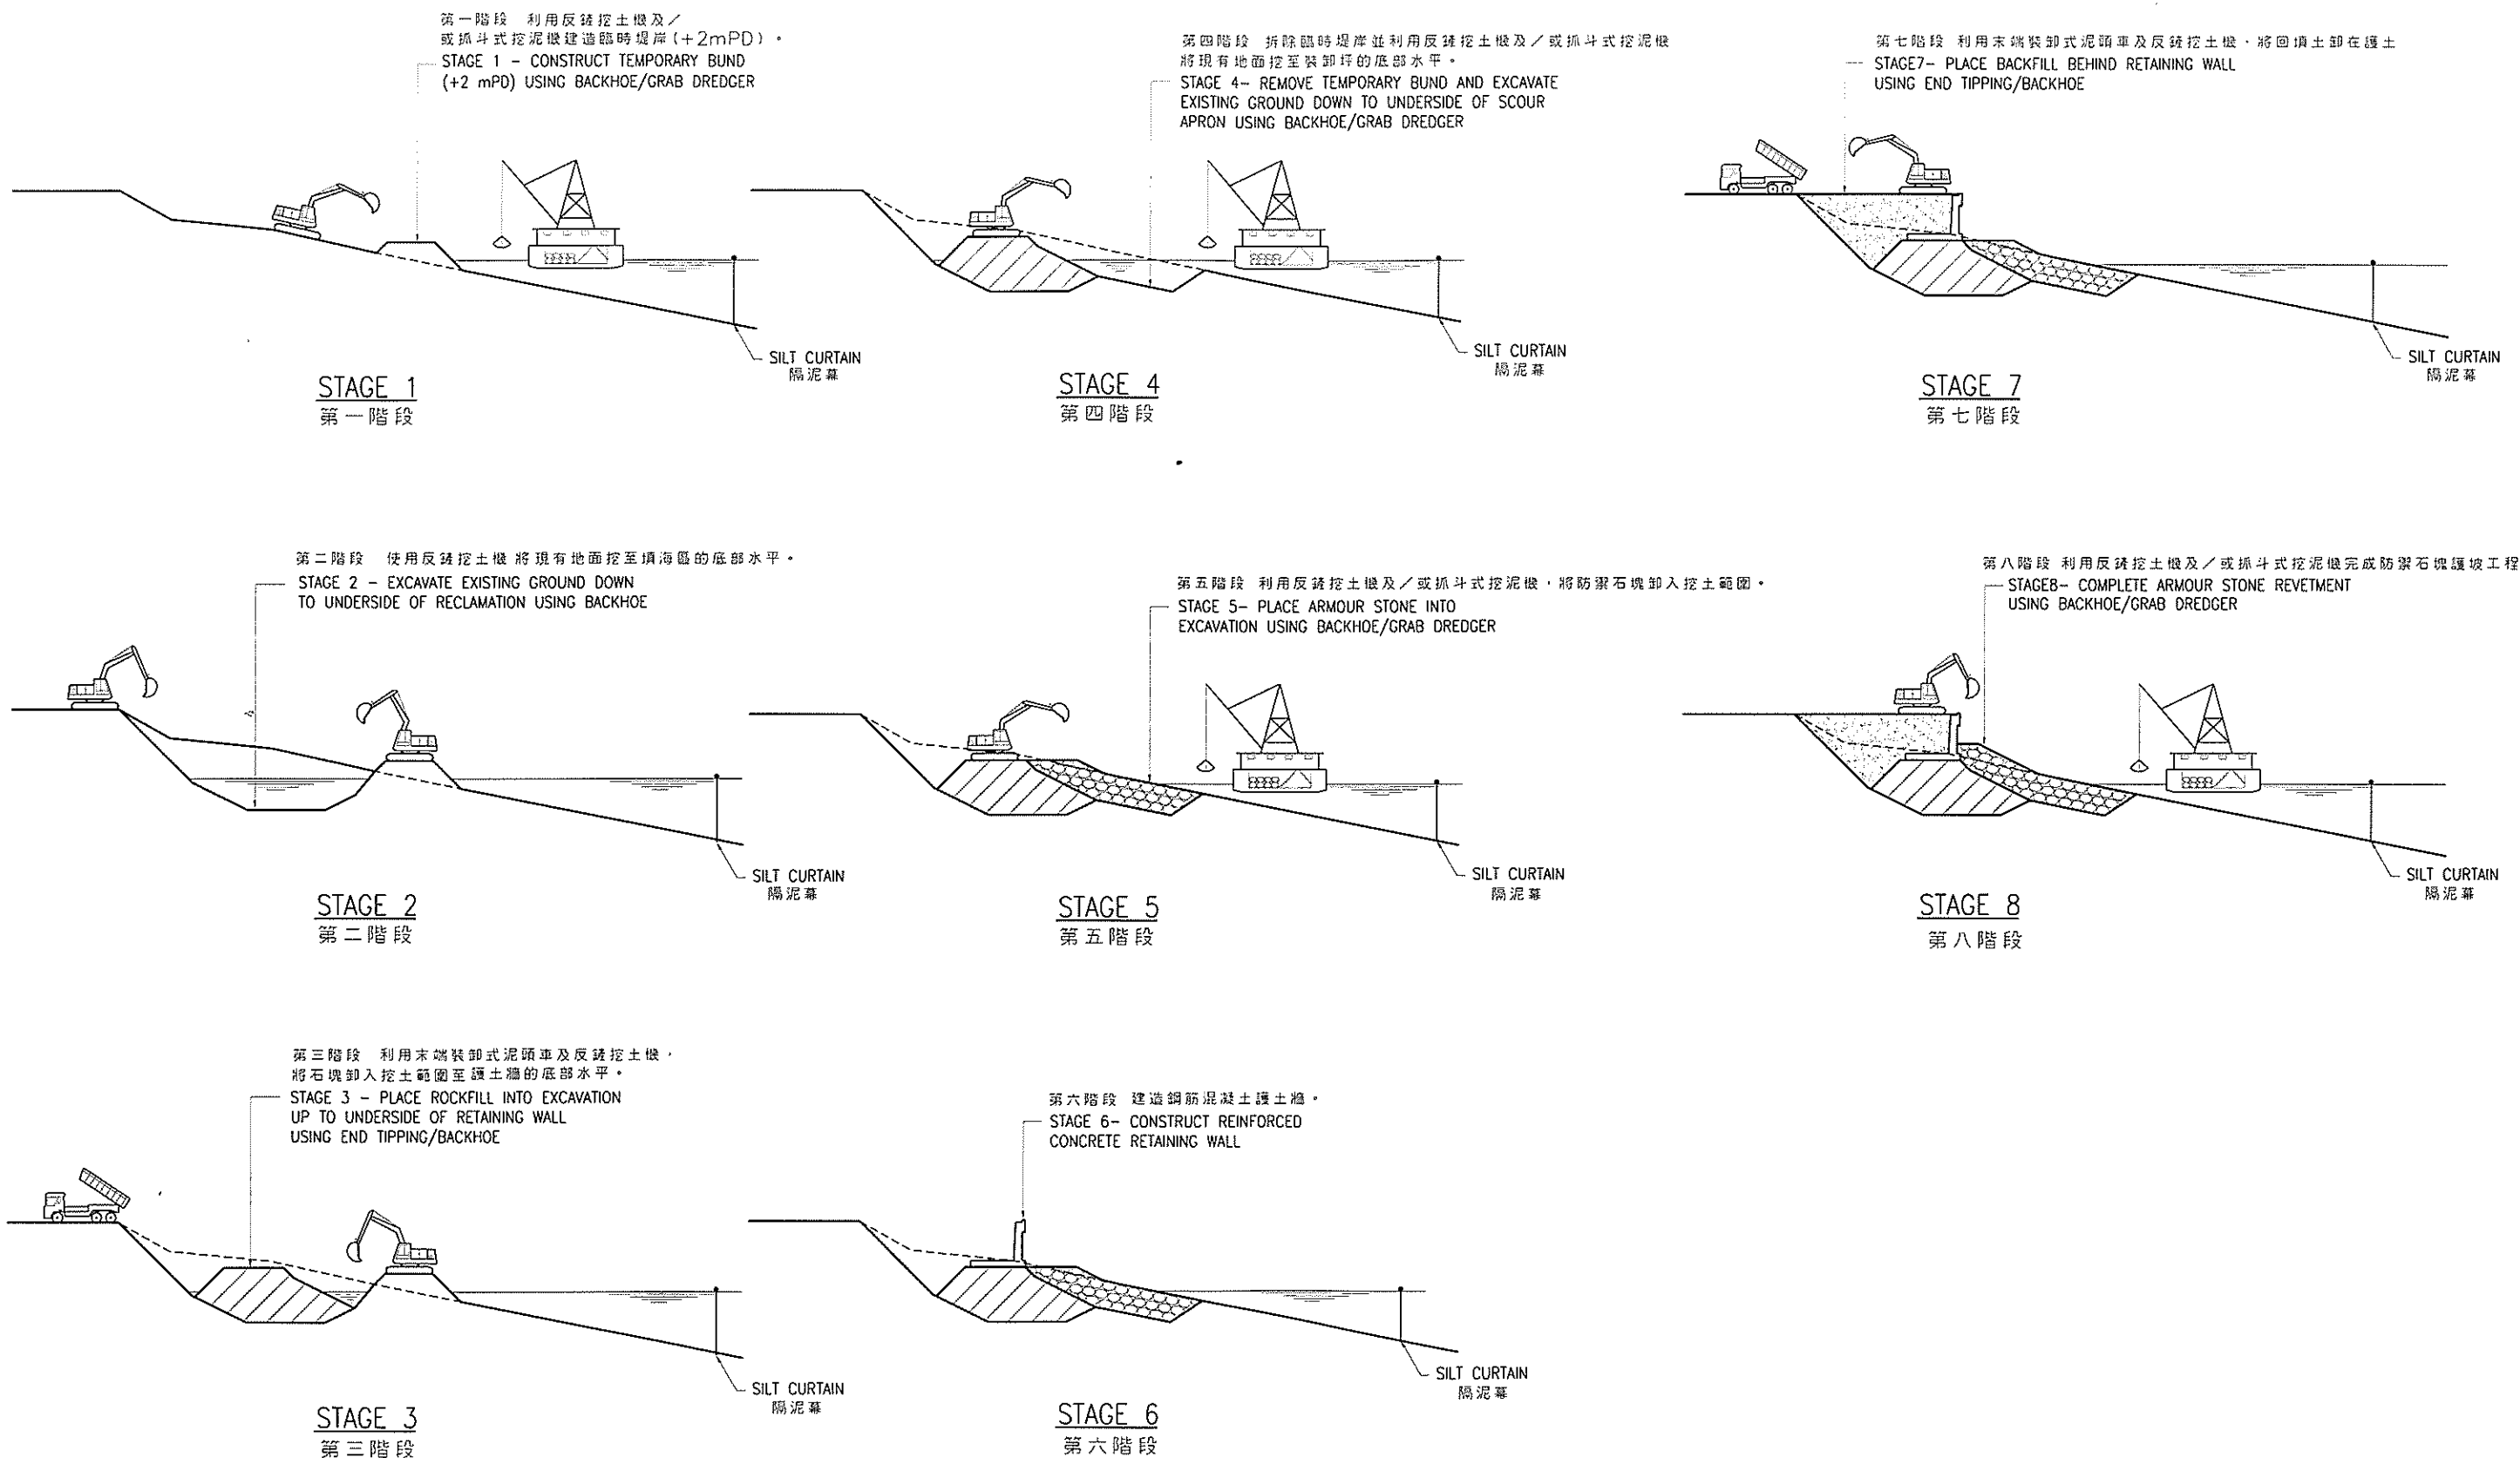
龍濤花園以東填海區的預計建設方法  
ANTICIPATED CONSTRUCTION METHOD FOR THE AREA OF RECLAMATION EAST OF GRAND BAY VILLA

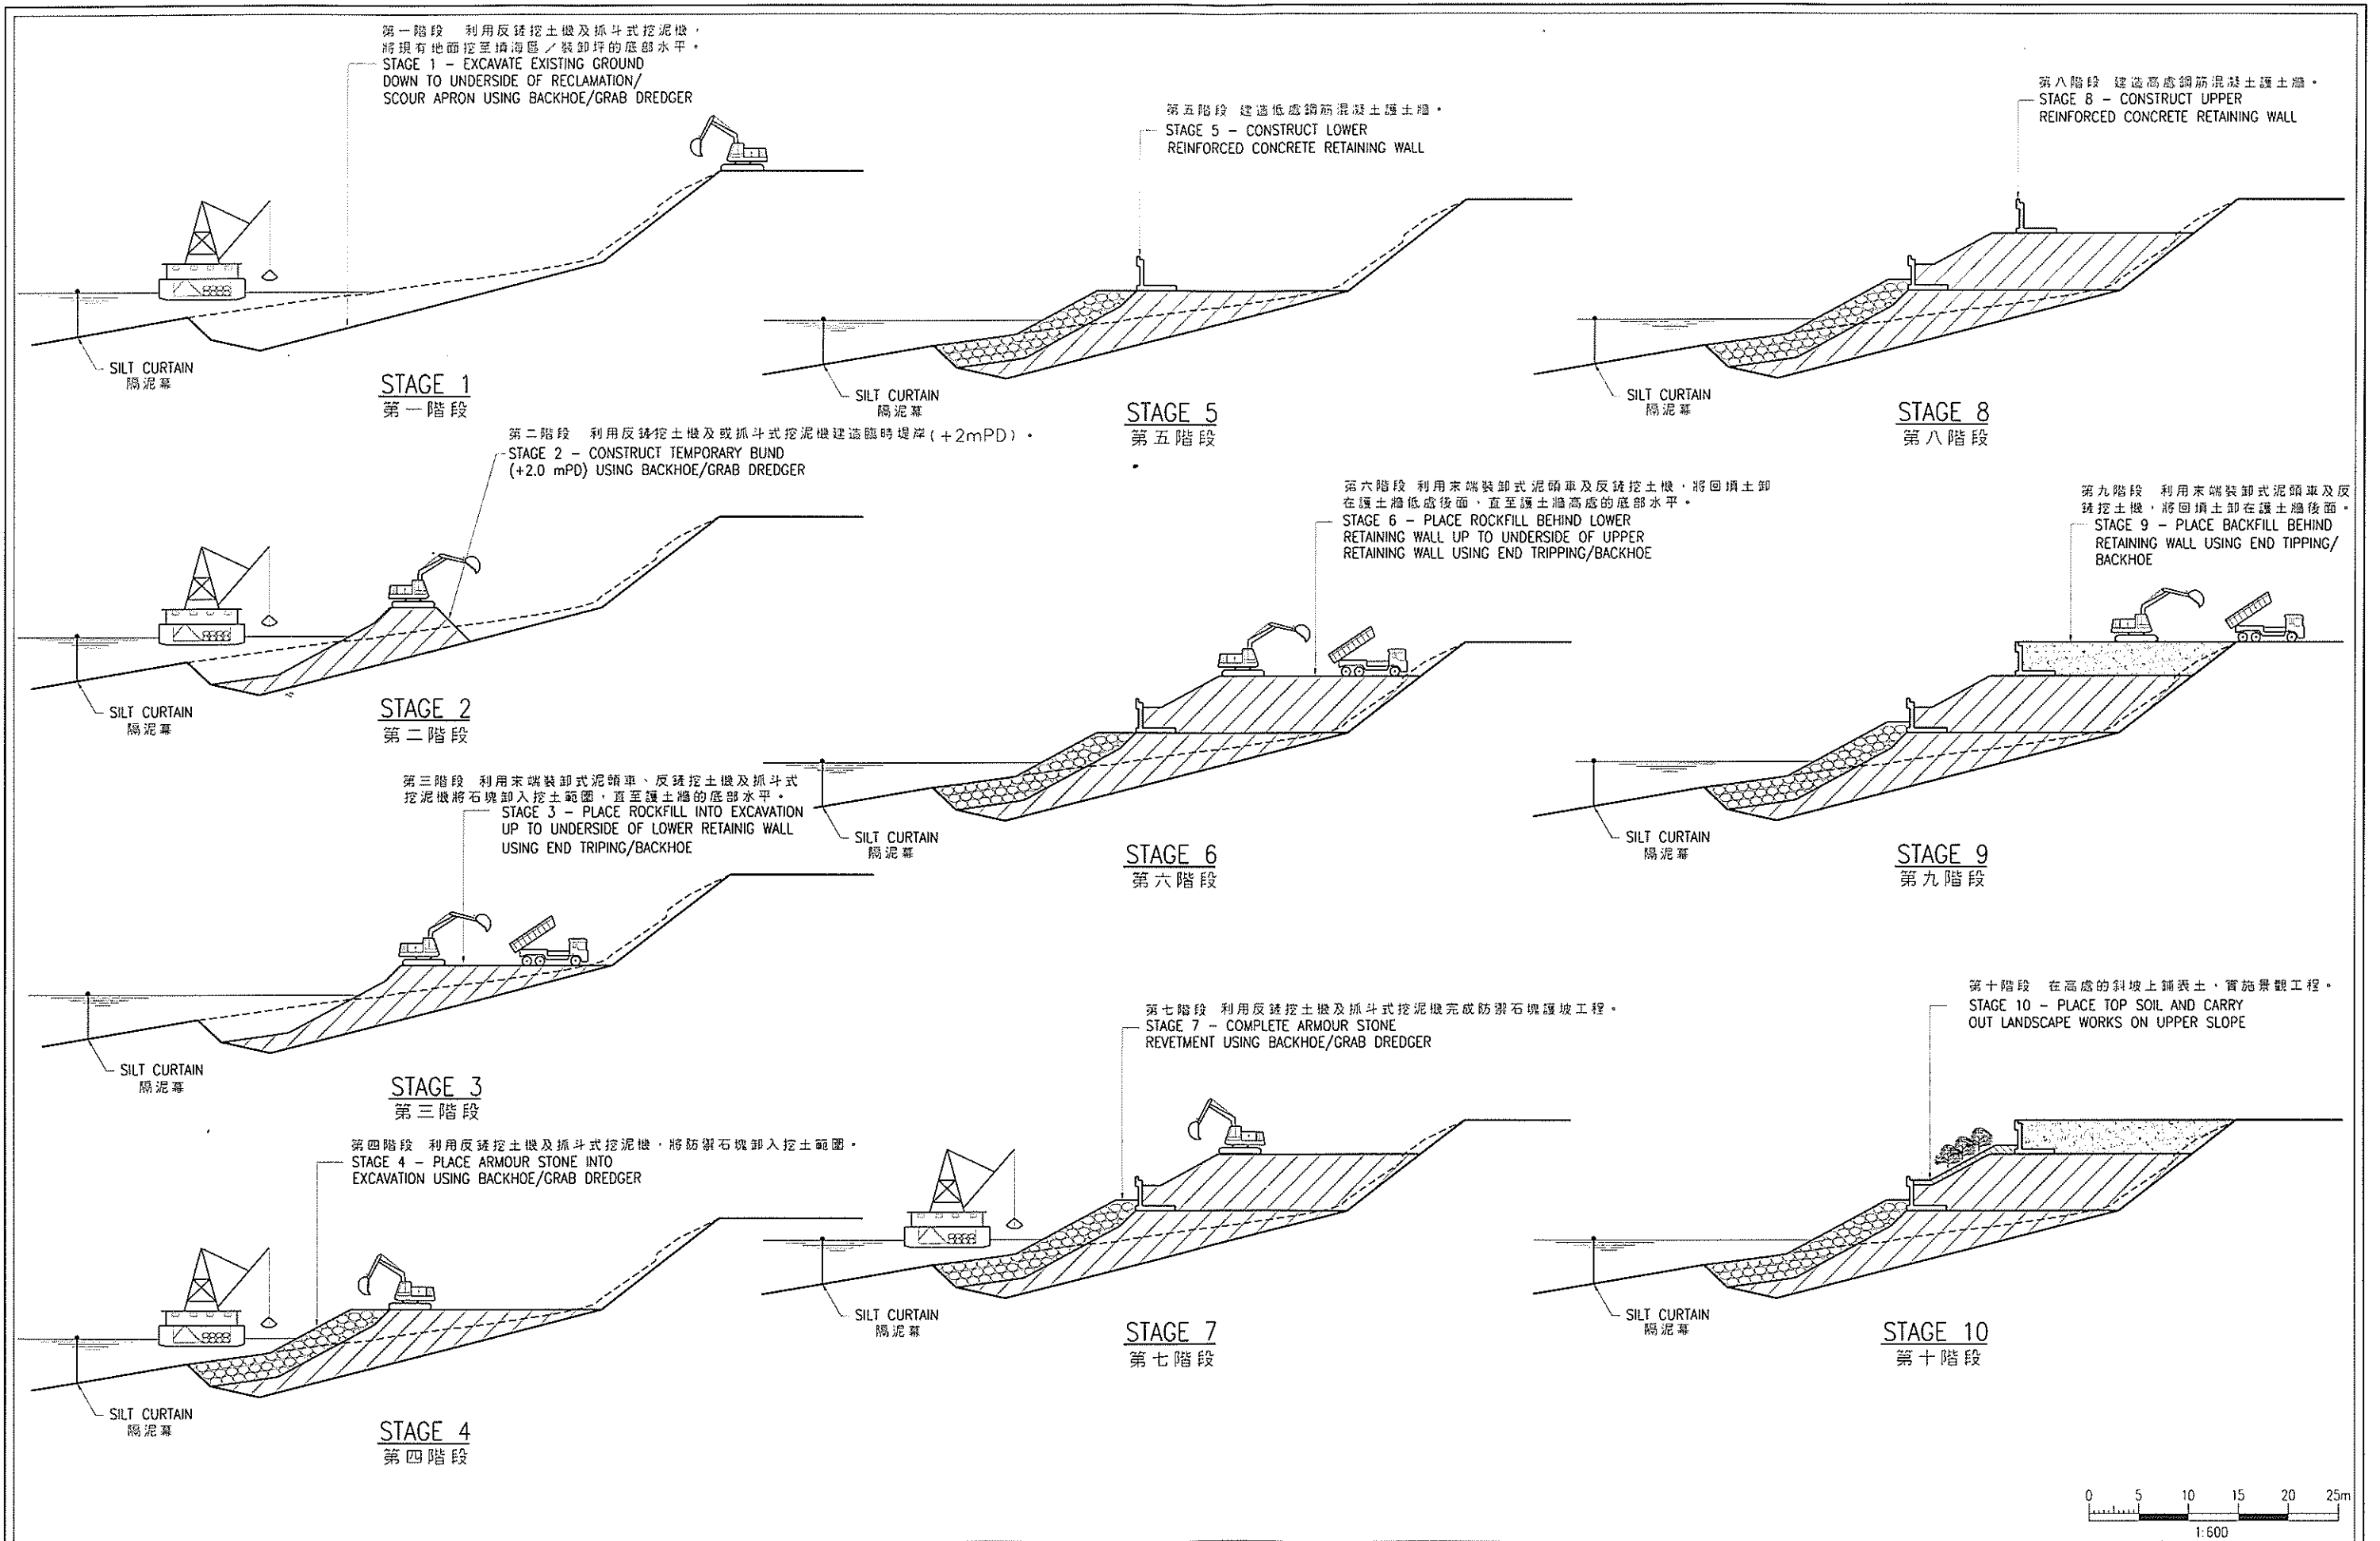
龍濤花園以西填海區的預計建設方法  
 ANTICIPATED CONSTRUCTION METHOD FOR THE AREA OF RECLAMATION WEST OF GRAND BAY VILLA

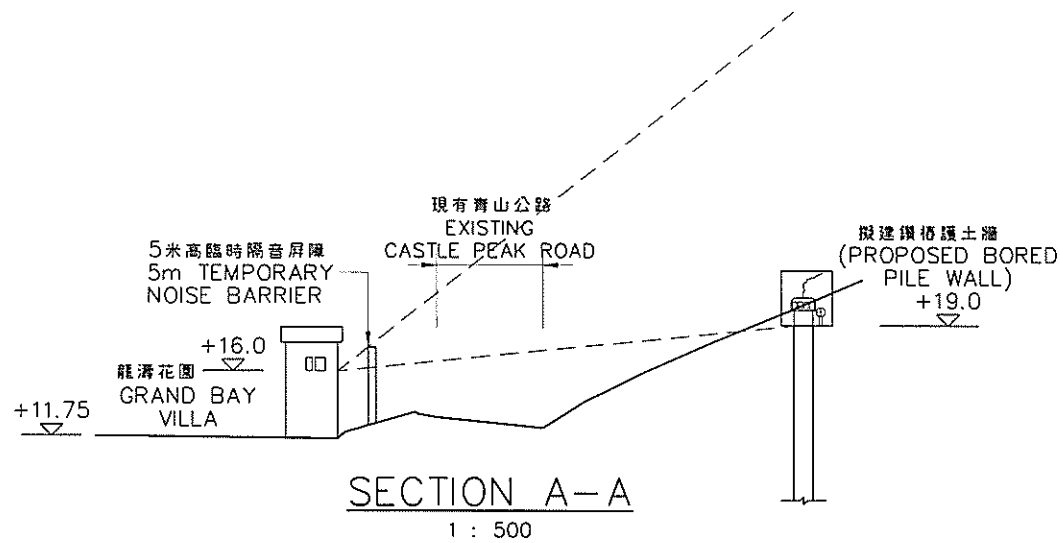
Figure. **6**

Title : 於龍灣花園擬建臨時隔音屏障  
**Proposed Temporary Noise Barrier at Grand Bay Villa (SR2)**

# NSR Exceeding 75dB(A) will require the application of Noise mitigation measure  
 The distance between NSR and construction equipment is more than 300m,  
 no significant noise impact is considered due to construction activities.  
 \* Temporary noise barrier is applied at SR2 only.

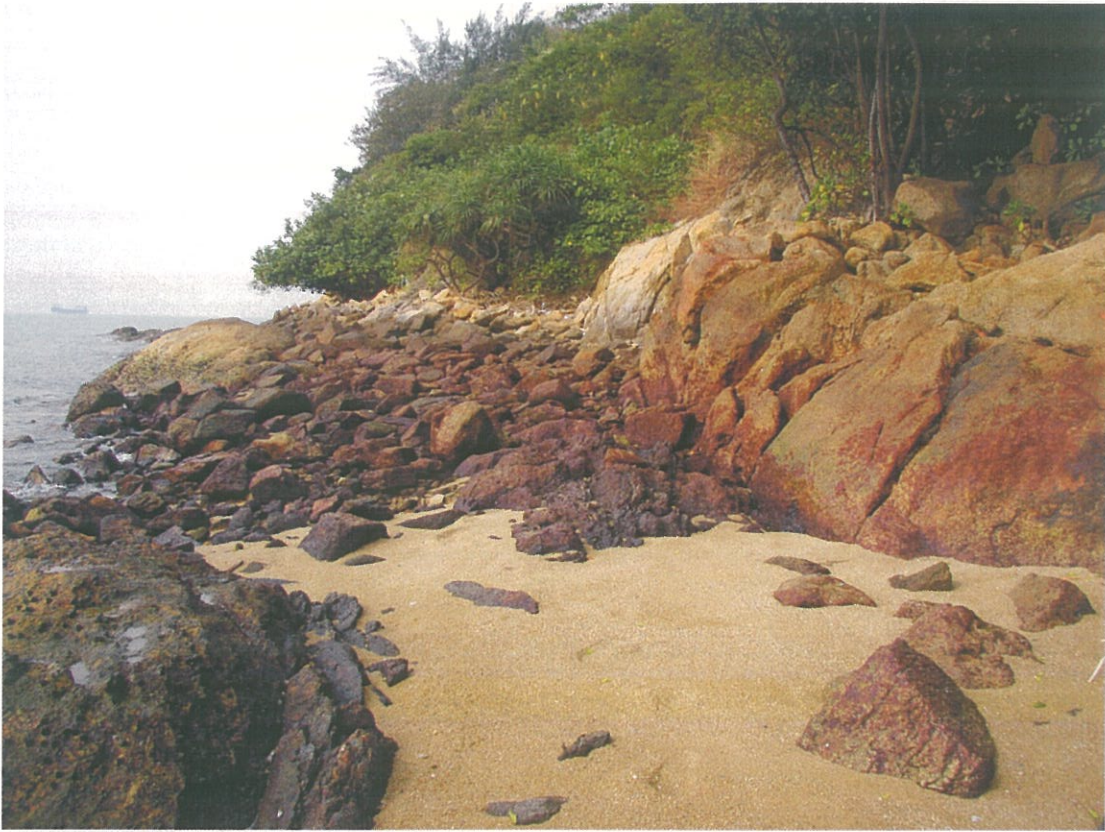
Figure 2. Boulder coastline at Subarea A.

The boulder coastline is a typical sheltered rocky shore with little exposure to strong-waves. The field survey was conducted to identify the species composition at the natural boulder coastline. In total, five 10m horizontal transects were laid in the low (0.6 mCD), mid (~1.0 mCD) and high (1.5 mCD) shores of the project area. The locations of the quantitative transect surveys were shown in *Figure 1*. Typical habitats of subareas A and B within the project area are shown in *Figures 2* and *3*, respectively. The field survey indicated that the assemblages were of sheltered shore communities with high quantities of periwinkle *Nodilittorina radiata* dominating the upper shore. The dominant fauna on the lower shore was Common Topshell *Monodonta labia* while the mid shore was dominated by Limpets *Cellana* sp. Other intertidal species recorded including Goose-neck Barnacle *Pollicipes mitella*, Shore crabs *Hemigrapsus sanguineus* and *Sphaerozium nitidus*, Hermit crab, Common Whelk *Thais* sp., Periwinkles *Littoraria articulata* and *Nodilittorina trochoides*, Turban Shell *Lunella* sp., Rock Oyster *Saccostrea cucullata*, Smooth Limpet *Notoacmoea* sp., False Limpet *Siphonaria* sp. and Sea Anemone *Haliplanella lineata*. The intertidal fauna recorded are summarised in *Table 1* below.

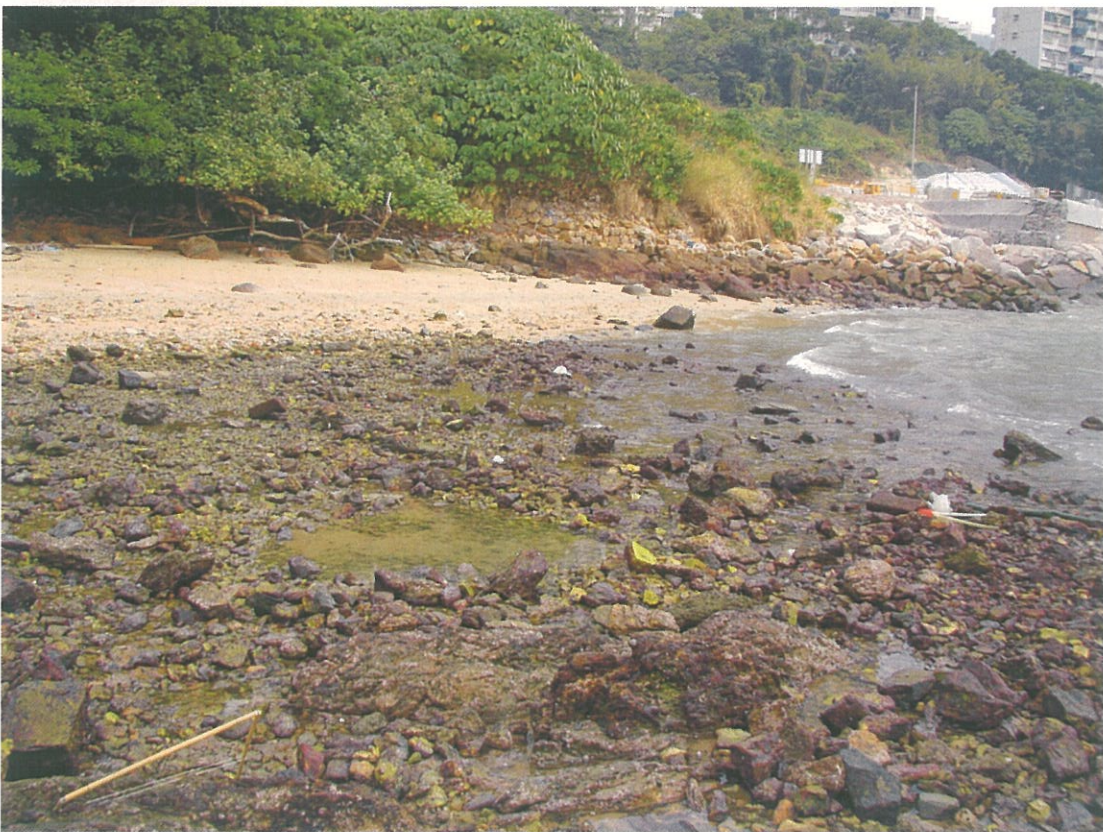
Figure 3. Boulder coastline at Subarea B.

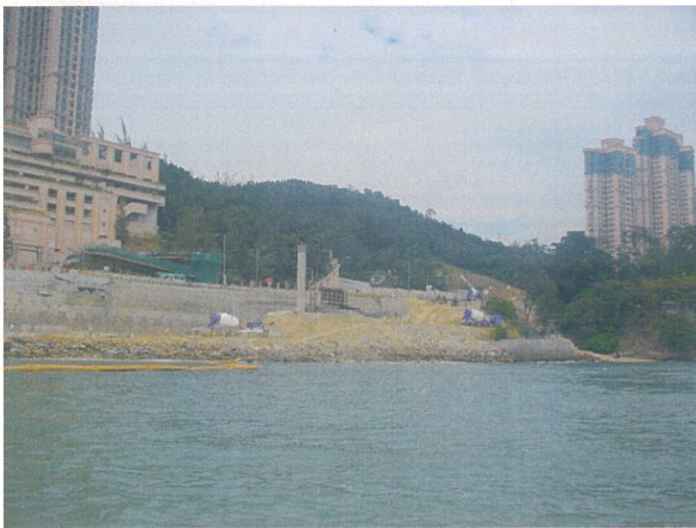
**Plate 10.** Some of the reclamation works currently going on very close to Area A.
