## **8. Hazard Assessment**

8.1.1.1 This section of the EIA presents the Hazard Assessment for the Route 16 Alternative Alignment. The Alternative Alignment passes within the Consultation Zones of Tai Po Road Water Treatment Works (WTW), Shek Lei Pui WTW and Sha Tin WTW, all of which are classified as Potentially Hazardous Installations (PHIs) due to the use of liquid chlorine in 1 tonne containers. The alignment also passes near to two bulk LPG installations at Carado Gardens, Tai Wai and the Lai Chi Kok Reception Centre.

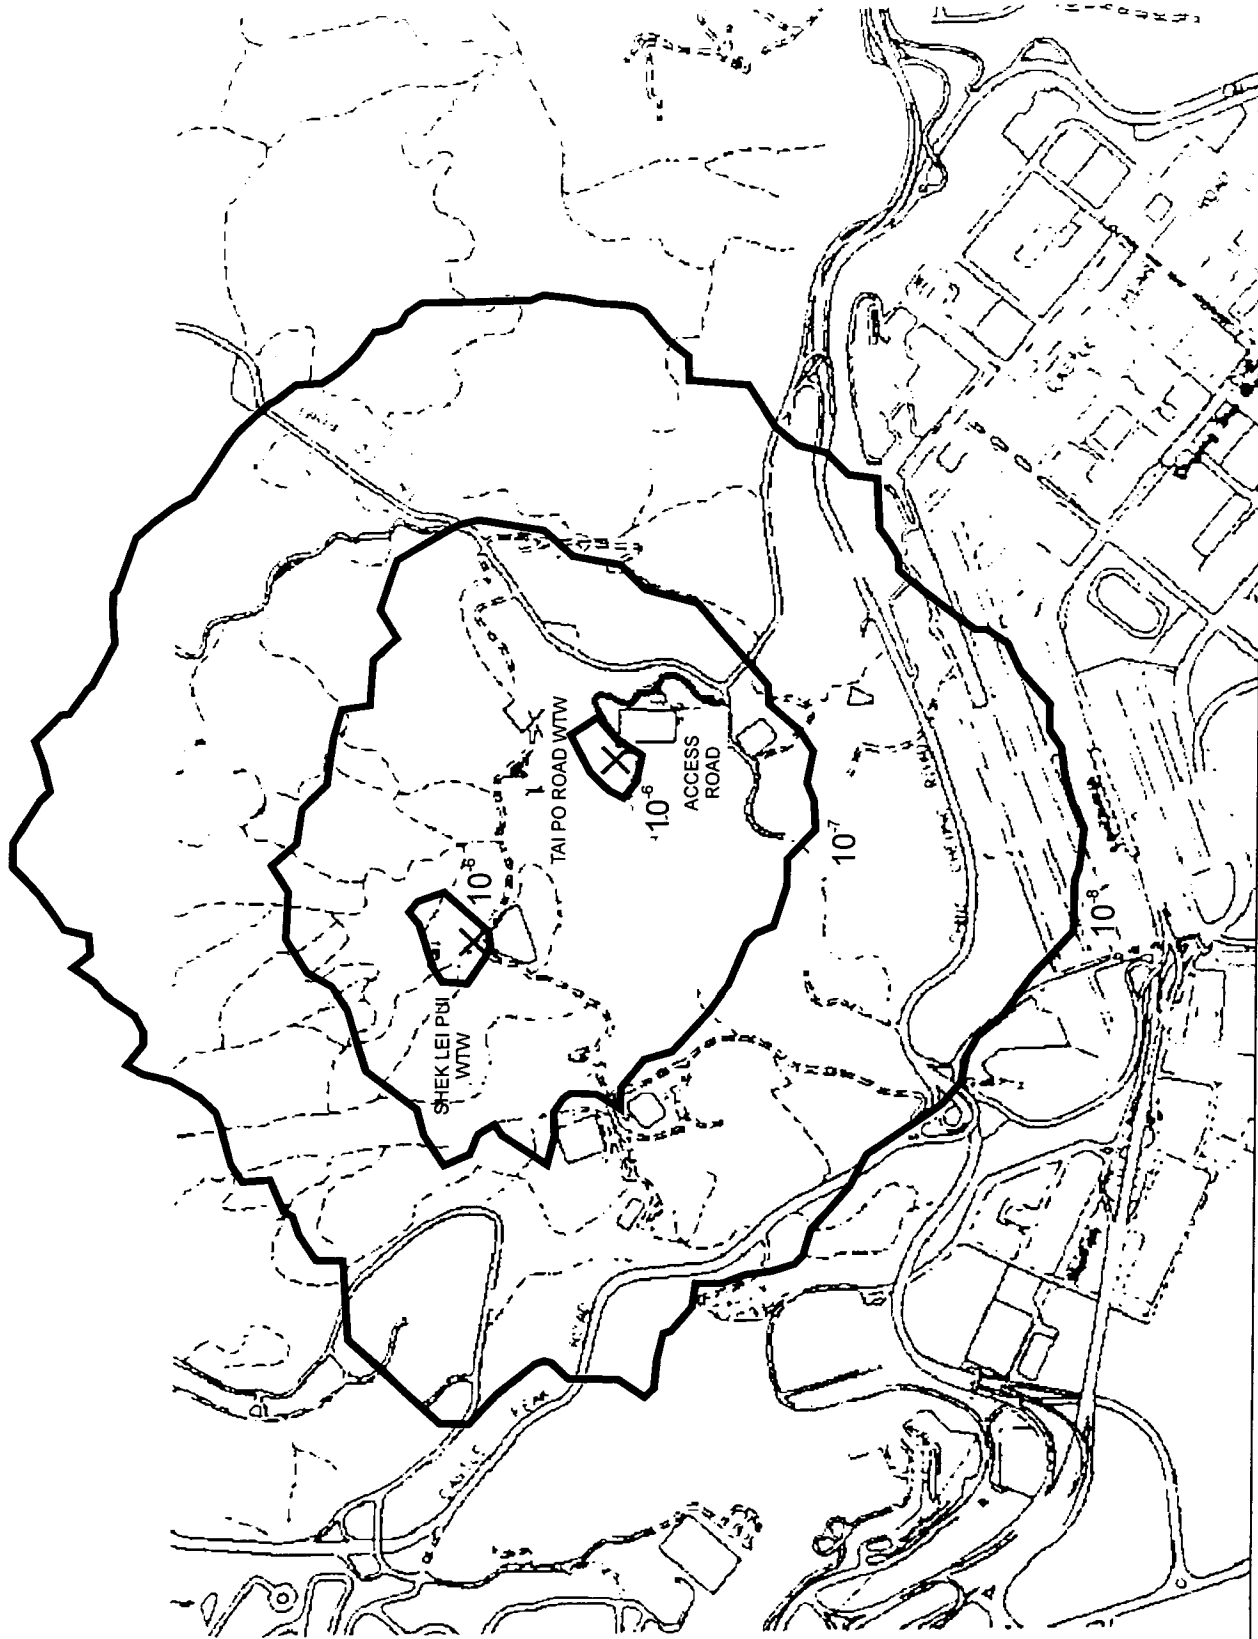
FIGURE 8.21  
INDIVIDUAL RISK CONTOURS FOR SHEK LEI PUI AND TAI PO ROAD WTW MITIGATED CASES  
(FROM 1995 HAZARD ASSESSMENT STUDY)

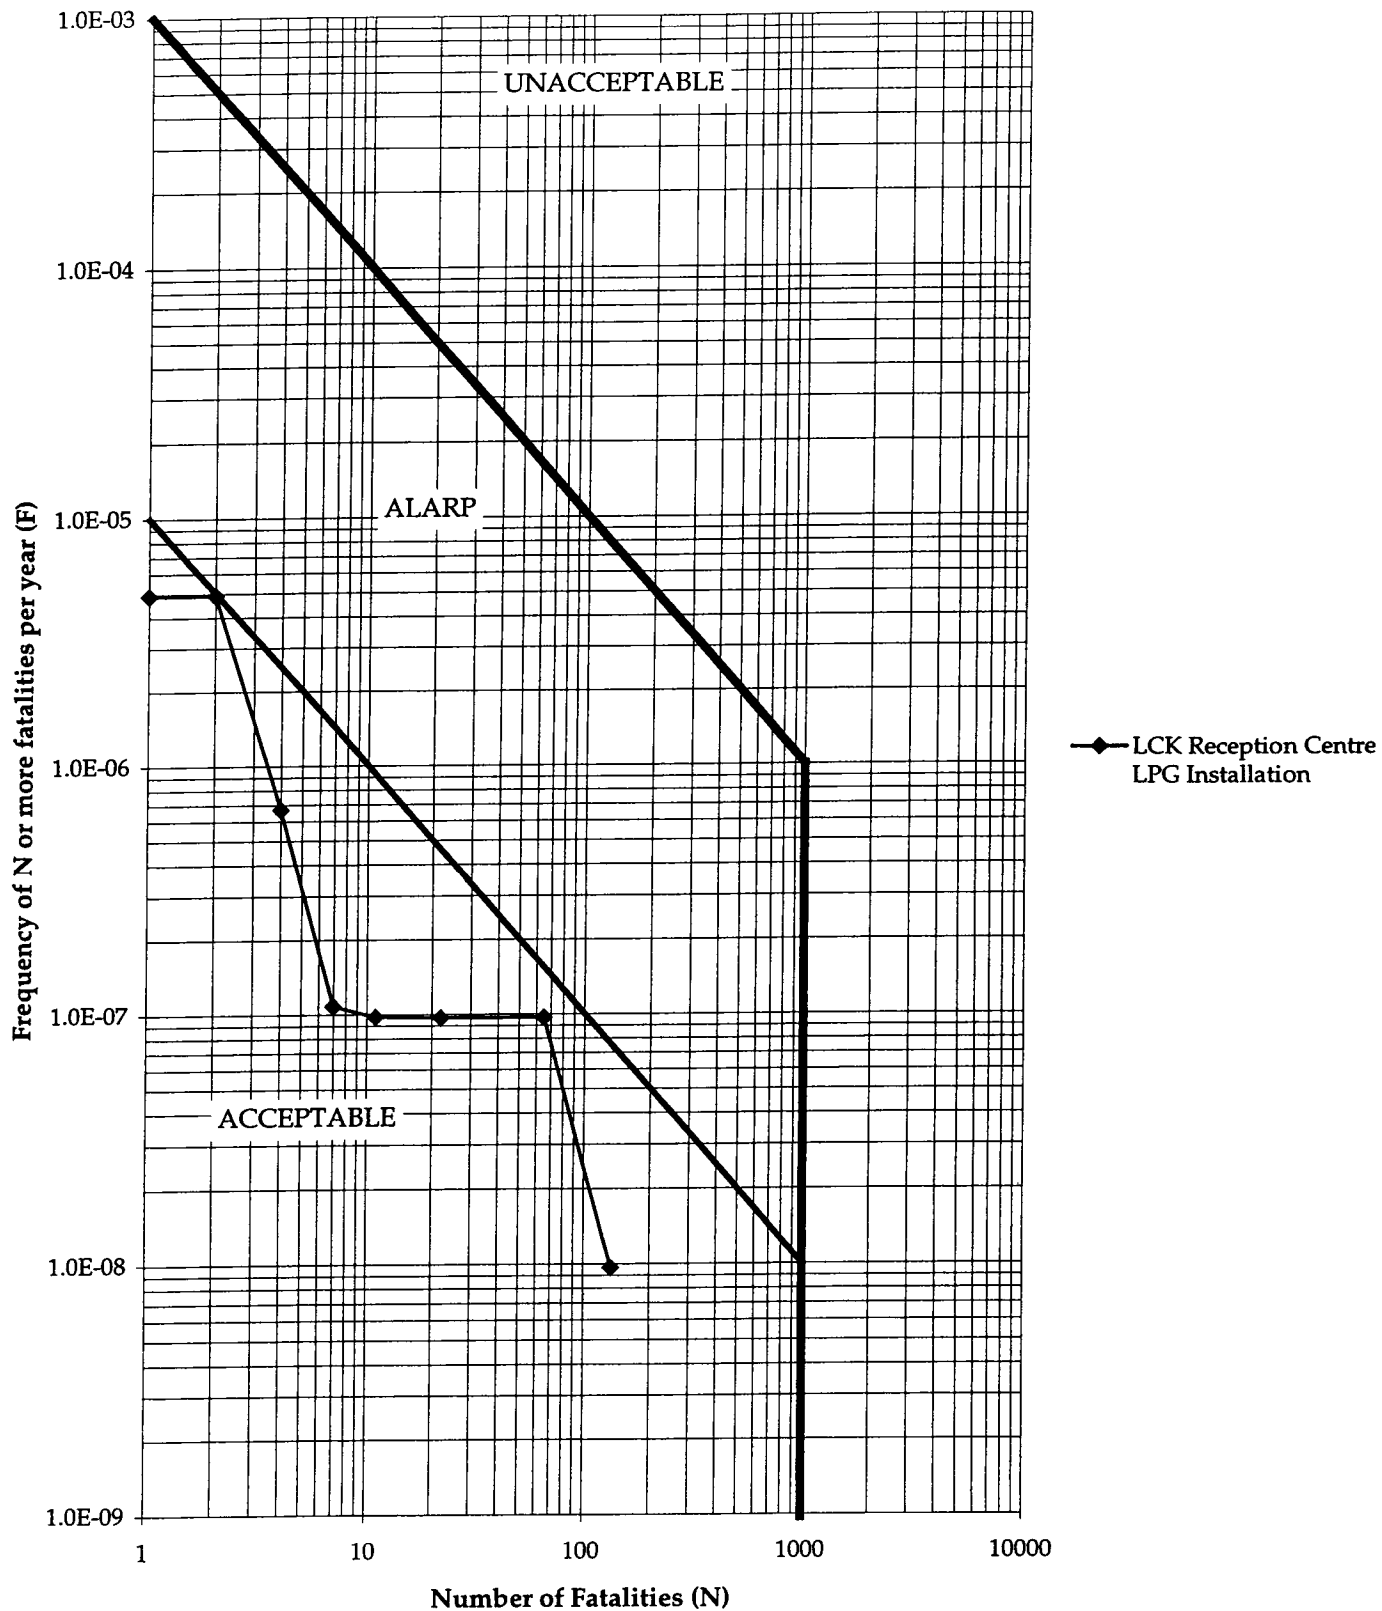
Figure 8.3a FN Curve for Risk to Route 16 due to the Lai Chi Kok Reception Centre LPG Installation

- 8.3.4.7 The data generated above for the frequency and consequences of hazardous events affecting the LCK viaduct may be used to construct an 'FN' curve. In undertaking the risk assessment it is assumed that there is a 10% chance that traffic is stationary on Route 16 at the time of the incident. A further 10% factor is applied for the flash fires scenarios to account for the probability of the wind blowing towards the nearest section of the LCK viaduct.

- 8.3.4.8 The FN curve is shown in *Figure 8.3a*. It can be seen that the FN curve lies within the acceptable region of the Risk Guidelines.
- 8.3.5 Conclusions
