6 Hazard Assessment For the Dock at Tsing Yi

6.2 Description of Relocation Project

6.2.1 The relocation of the Yiu Lian No.3 Floating Dock currently located at Yam O Wan, North East of Lantau Island to South Tsing Yi includes the following major works:

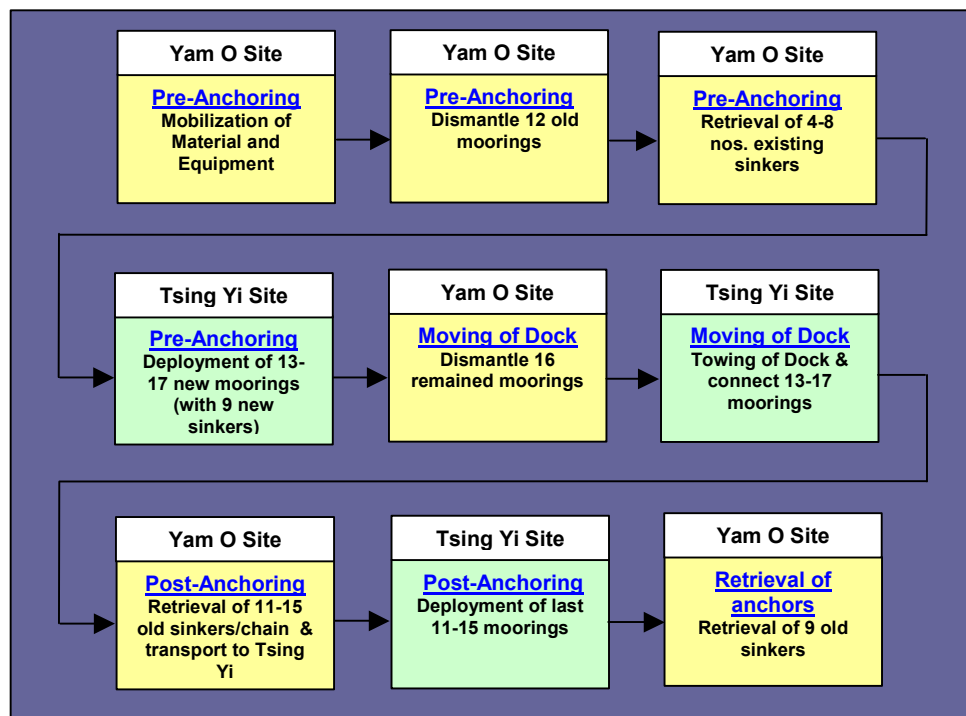
6.2.2 The prime activities during each stage of the relocation works are indicated in Figure 6-1.

Figure 6-1 Relocation Process Flow Diagrams

6.2.3 It is estimated that the relocation requires 14 weeks of work. Details of these activities and key safety issues identified are discussed in Sections 6.2.6 to 6.2.14 of this report.
