AGREEMENT NO. CE 52/2007(HY)  
 TUEN MUN - CHEK LAP KOK LINK - INVESTIGATION

VERTICAL ALIGNMENT OF PROPOSED SUBSEA TUNNEL

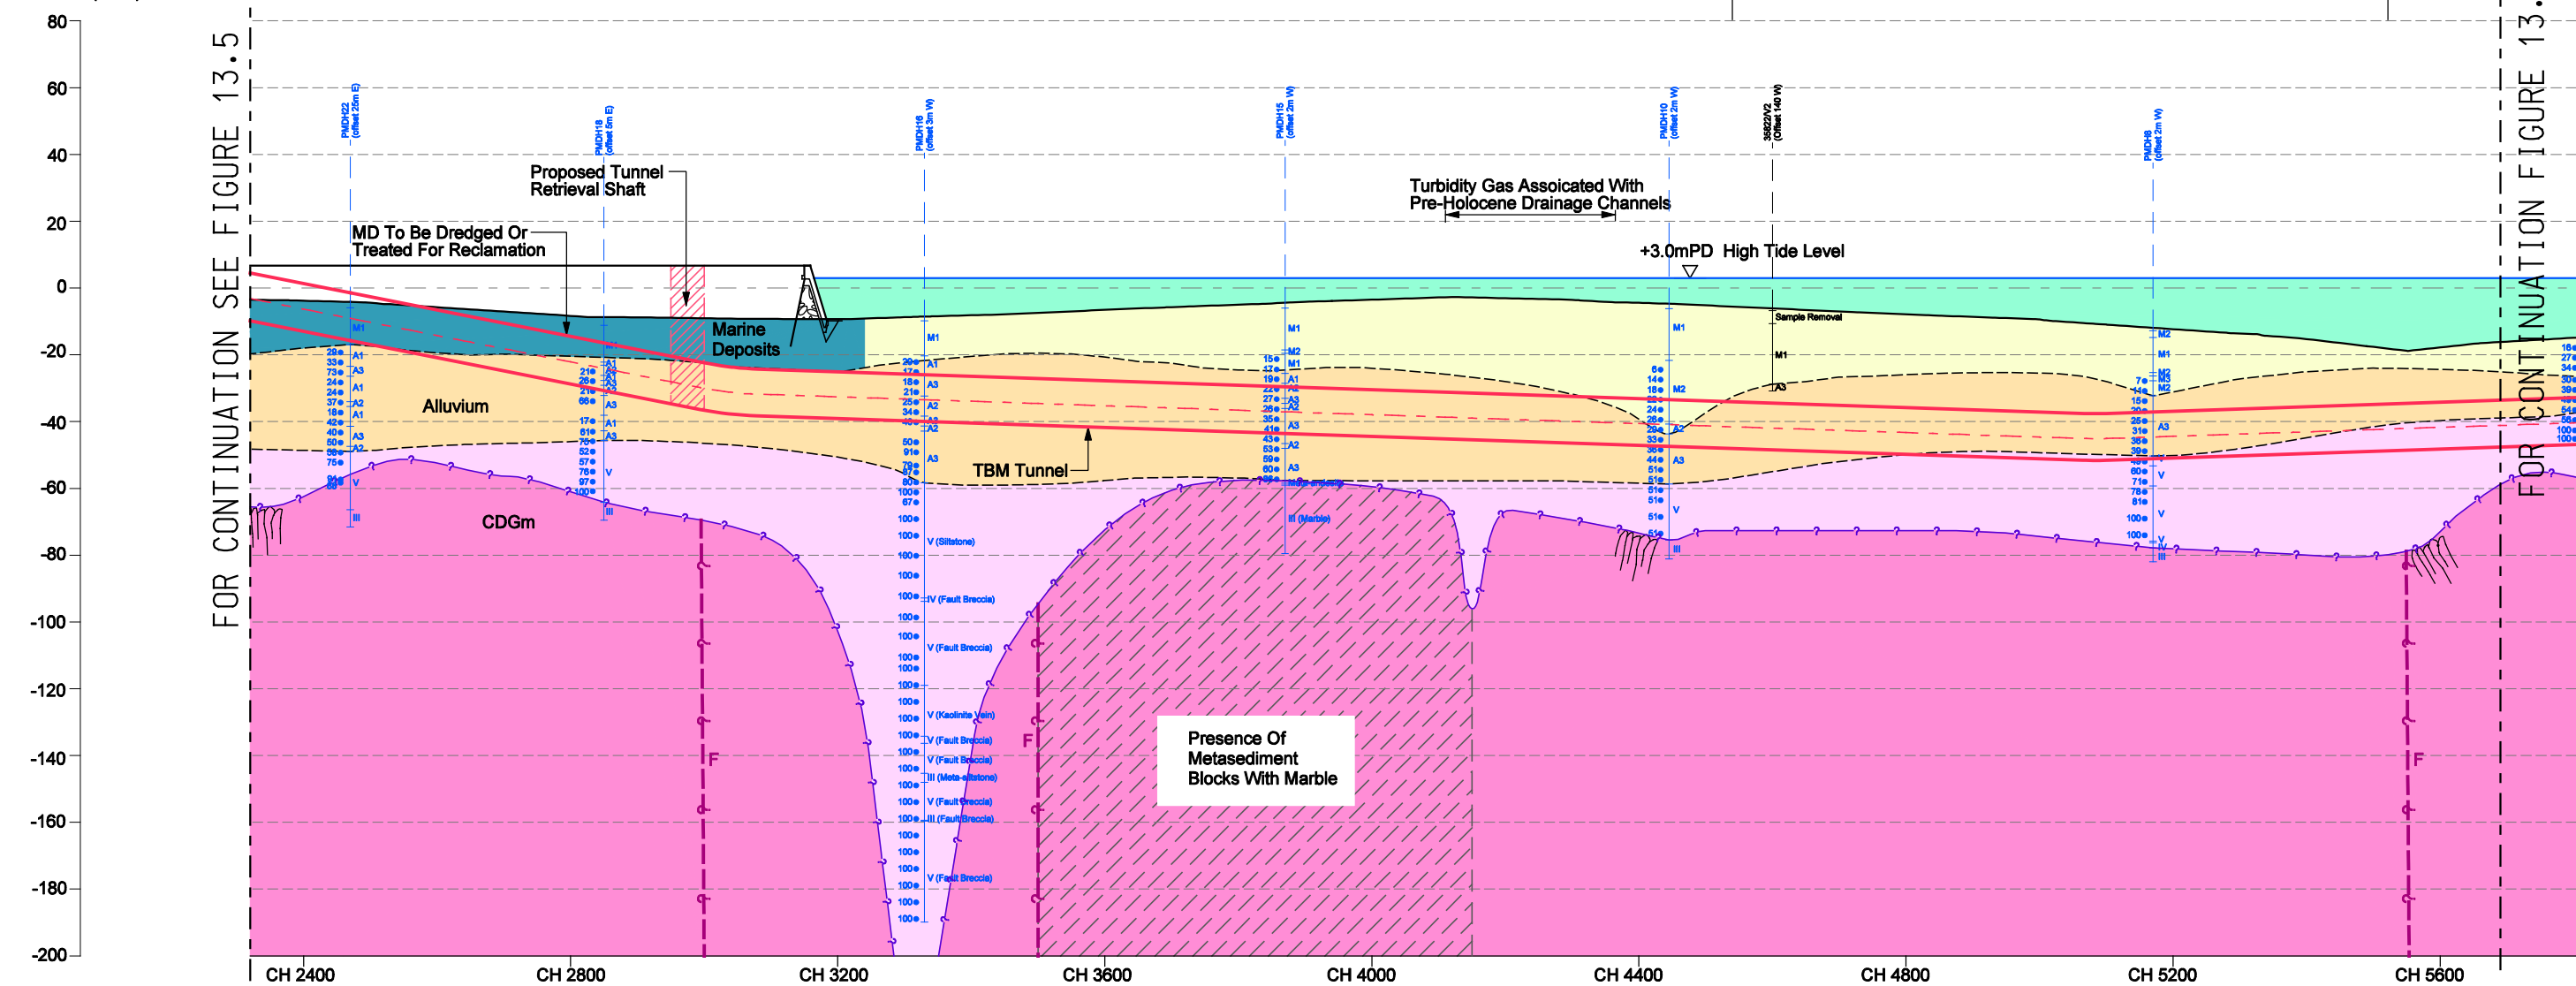
SCALE	AS SHOWN	DATE	APR. 2009
CHECK	---	DRAWN	CL
JOB No.	60044963	DRAWING No.	FIGURE 13.6
		REV	---

**Note:**  
 Rockhead Level & Material Profiles Are Referred From Adjacent Drillholes & Geophysical Survey Results

Possible Influence Zone Of Tai Lam Fault With Highly Sheared Rock Of Poor Quality Rock Mass

CHAINAGE	3000	3034	3205	4315	4527	4804	5551
GROUND CONDITION AT TUNNEL LEVEL	MD (DREDGED/TREATED)	ALL	ALL	MD	ALL	ALL	ALL
				ALL			CDG
