Appendix 7-3
Information Extracted from the Approved
EIA Reports

Information Extracted from the Approved Cycle Track EIA Report

Construction of Cycle Tracks and the Associated Supporting Facilities
From Sha Po Tsuen to Shek Sheung River, December 2008 (EIA
Application No. EIA-159/2008)

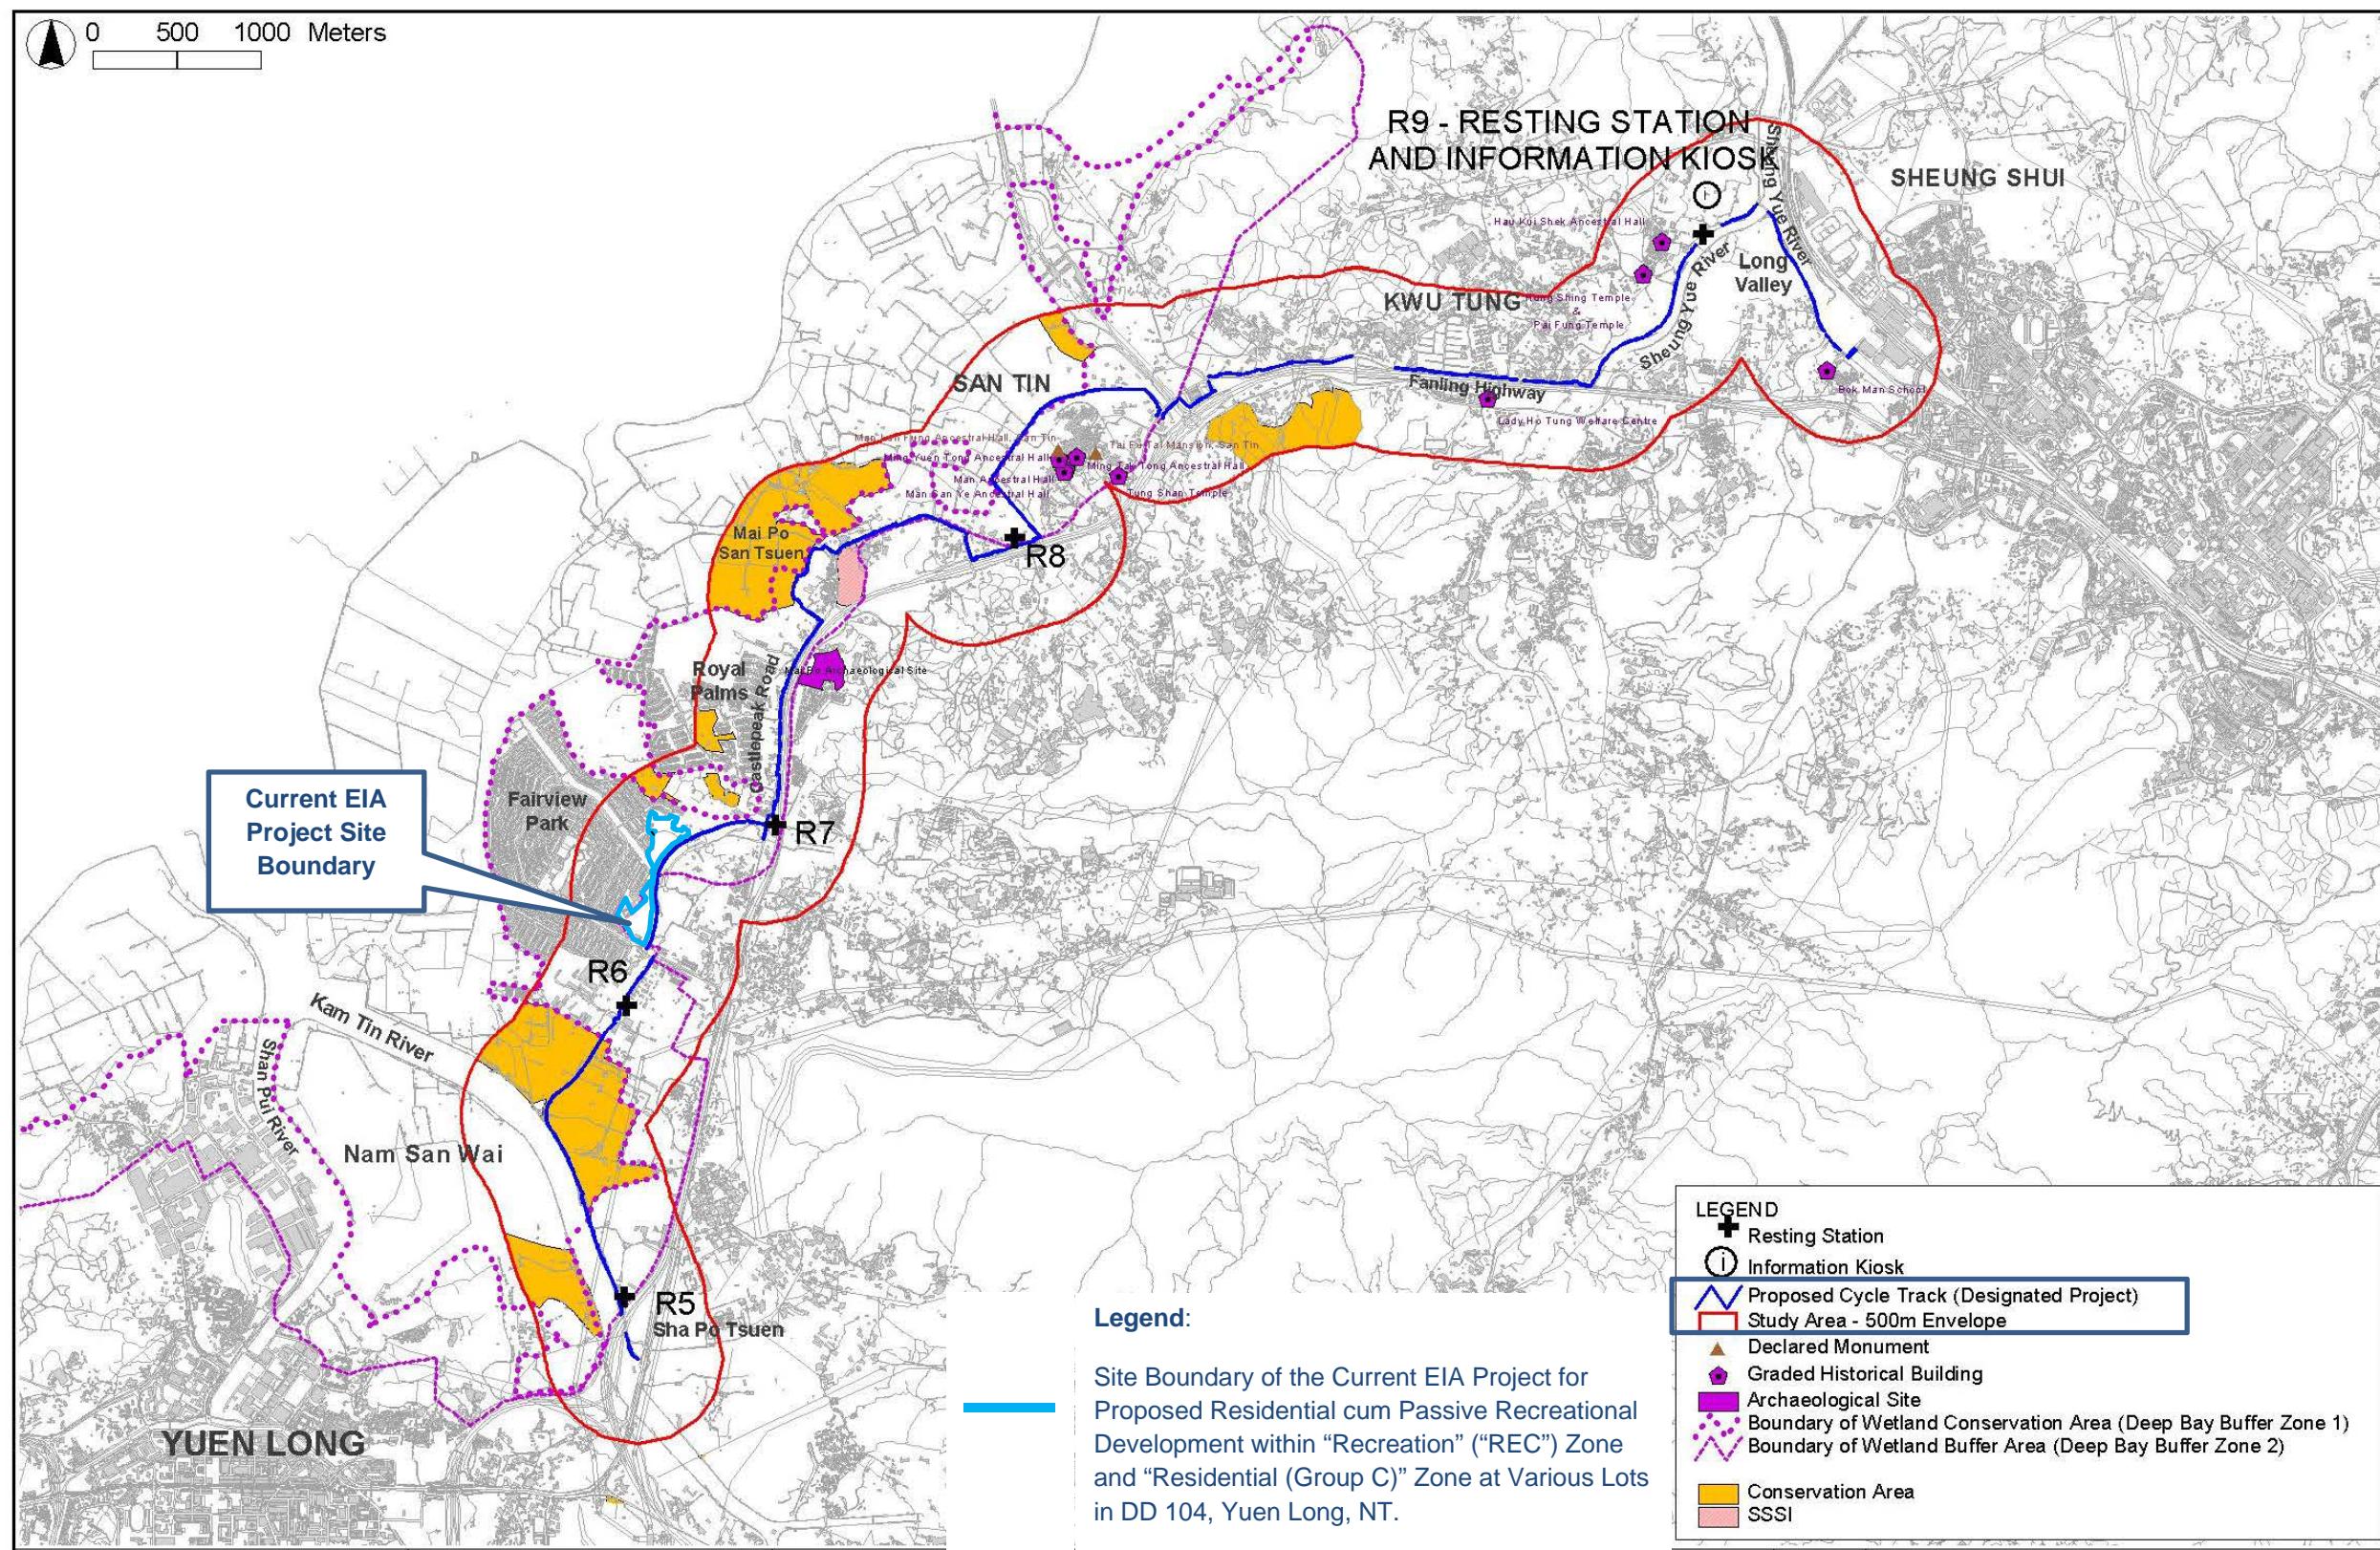
Site Boundary of the Current EIA Project (i.e. Proposed Residential cum Passive Recreational Development within "Recreation" ("REC") Zone and "Residential (Group C)" Zone at Various Lots in DD 104, Yuen Long, NT) Superimposed with the Proposed Cycle Track Project (Extracted from Figure 2-1 of the Approved EIA Report "Construction of Cycle Tracks and the Associated Supporting Facilities From Sha Po Tsuen to Shek Sheung River, December 2008" (EIA Application No. EIA-159/2008)

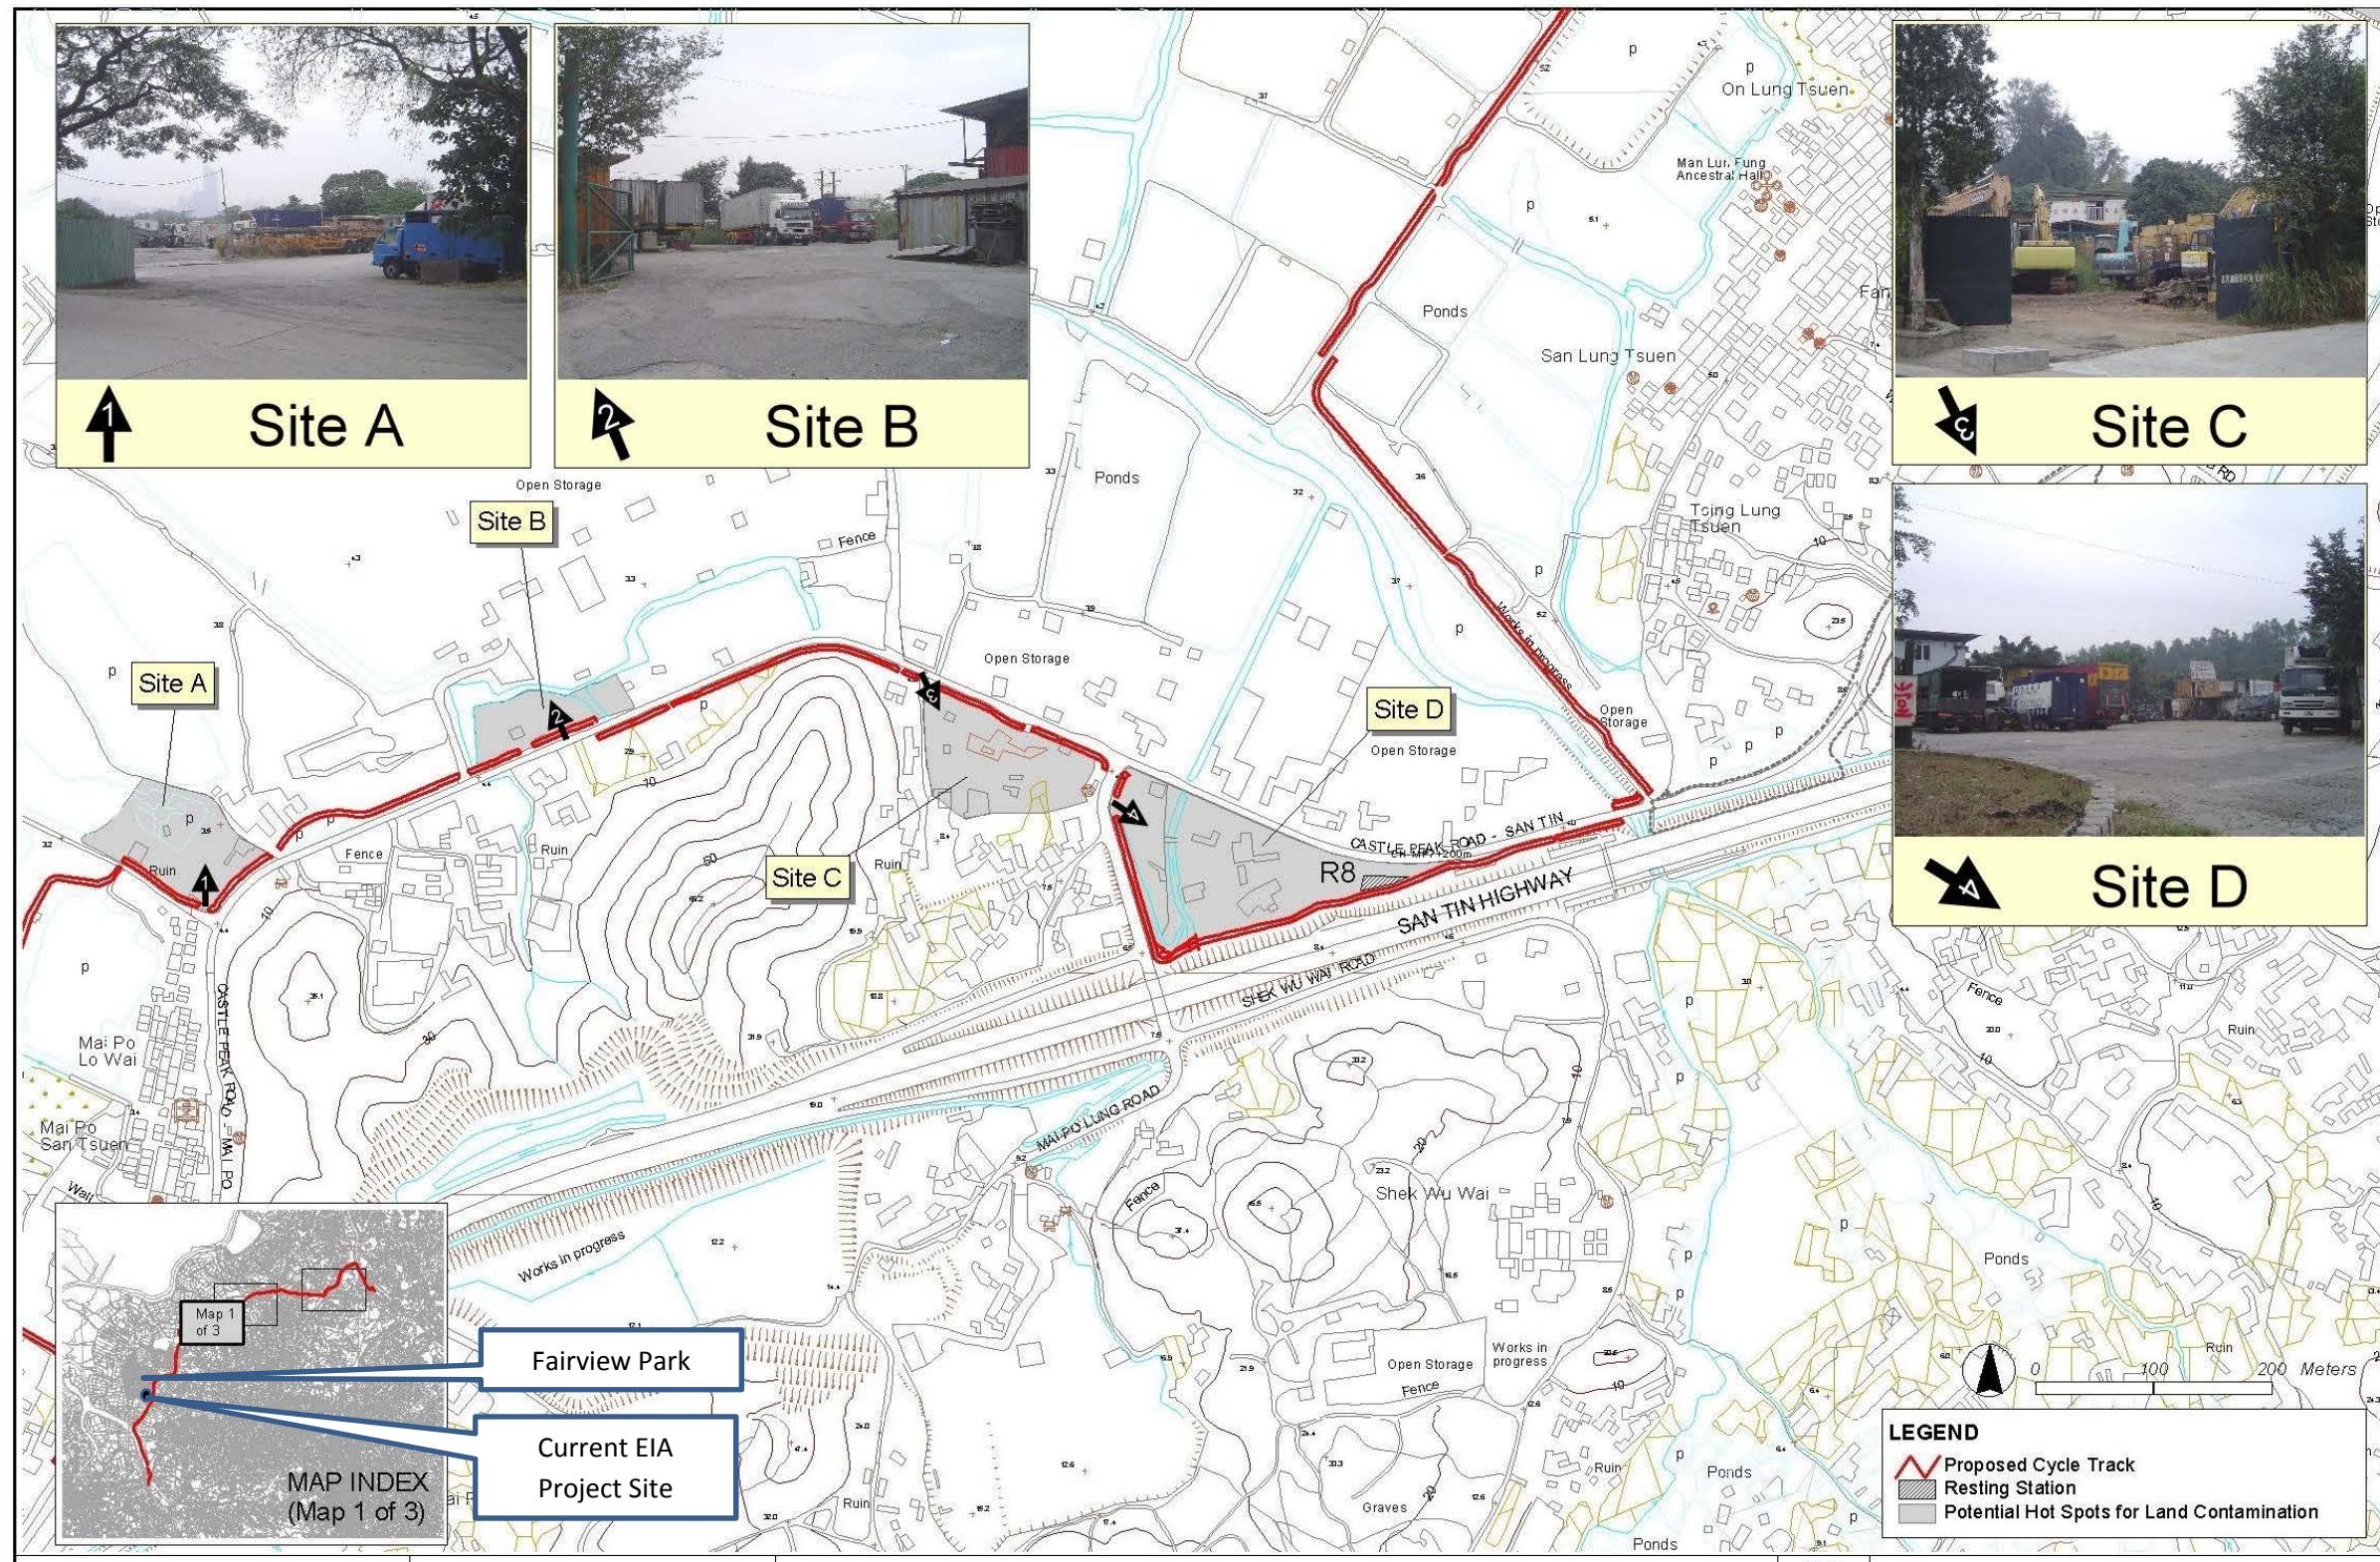
Current EIA Project (i.e. Proposed Residential cum Passive Recreational Development within “Recreation” (“REC”) Zone and “Residential (Group C)” Zone at Various Lots in DD 104, Yuen Long, NT) Superimposed with the Sites of Potential Contamination Identified in the Approved Cycle Track EIA Report (Extracted from Figure 8-1 of the Approved EIA Report “Construction of Cycle Tracks and the Associated Supporting Facilities From Sha Po Tsuen to Shek Sheung River, December 2008” (EIA Application No. EIA-159/2008)

– The Current Project Site is Outside the Identified Sites of Potential Contamination in the Approved Cycle Track Project

Potential Contaminated Site	Location	Current Land Use	Historical Land Use	Potential Contamination Impact on the Project Areas	Figure No.
Site A	At the road junction between Castle Peak Road (Mai Po) and Tam Kon Chau Road.	Long vehicle parking. A small vehicle repair workshop is operating near the roadside during the site visits.	The site was a planted area before 1997. Land use of this area changed into a car park in 1997, since then the ground floor was concrete paved. Records of large scale spillage or leakage of chemical are not known.	No specific oil stains were found on the concrete paved areas where the cycle track alignment lies. There is a potential of leakage of chemicals from vehicle repair workshop near the roadside to the project area.	8-1
Site B	On the eastbound roadside of Castle Peak Road (Mai Po).	Long vehicle parking and potential vehicle repair activities.	The site was a piece of bare ground with some vegetation in 1993. Open car park was developed since 1997. Some temporary structures were erected within the car park, which may be used for vehicle repair. Records of large scale spillage or leakage of chemical are not known.	Temporary structures which are in fairly good conditions, are not upon any works areas or proposed alignment. There is a potential of leakage of chemicals from possible vehicle repair workshop in these temporary structures to the project area.	8-1

Site C	On the westbound side of the Castle Peak Road (Mai Po) near the road junction of Castle Peak Road (Mai Po) and Mai Po Lung Road.	Vehicle parking, open storage of construction plant and potential vehicle repair activities. Site reconnaissance has identified construction plant resting on bare soil, which appeared to have been darkened.	The site appears to be a machine / construction plant storage area since 1993. Site reconnaissance found that the ground at this location was not concrete paved. The colour of surface soil was seen to be dark, which suggests that the soil may have been contaminated due to leakage from the machine / plant (e.g. leakage of hydraulic / lubrication oil) due to its land use. Records of large scale spillage or leakage of chemical are not known.	Dark colour soil suggests potential contamination.	8-1
Site D	At the junction of Castle Peak Road (San Tin) and Mai Po Lung Road.	Vehicle parking with vehicle repair workshop.	This site was partly a car parking area in 1995. The area adjacent to the Mai Po Lung Road and San Tin Highway (the western part of the site) became a car parking area in 1998. It was found during the site reconnaissance that the area was concrete paved. Review of the previous application for planning permissions by the Town Planning Board indicated that the site was granted for long-vehicle parking area and vehicle repair activities since 1999. The land use permission has been granted for another three years in September 2006. Records of large scale spillage or leakage of chemical are not known.	No specific oil stains were found on the concrete paved areas where the cycle track alignment lies. The eastern part of the site was vacant and fenced off. No specific activities were seen in this area. There is a potential of leakage of chemicals from the vehicle repair workshop within the site to the project area.	8-1

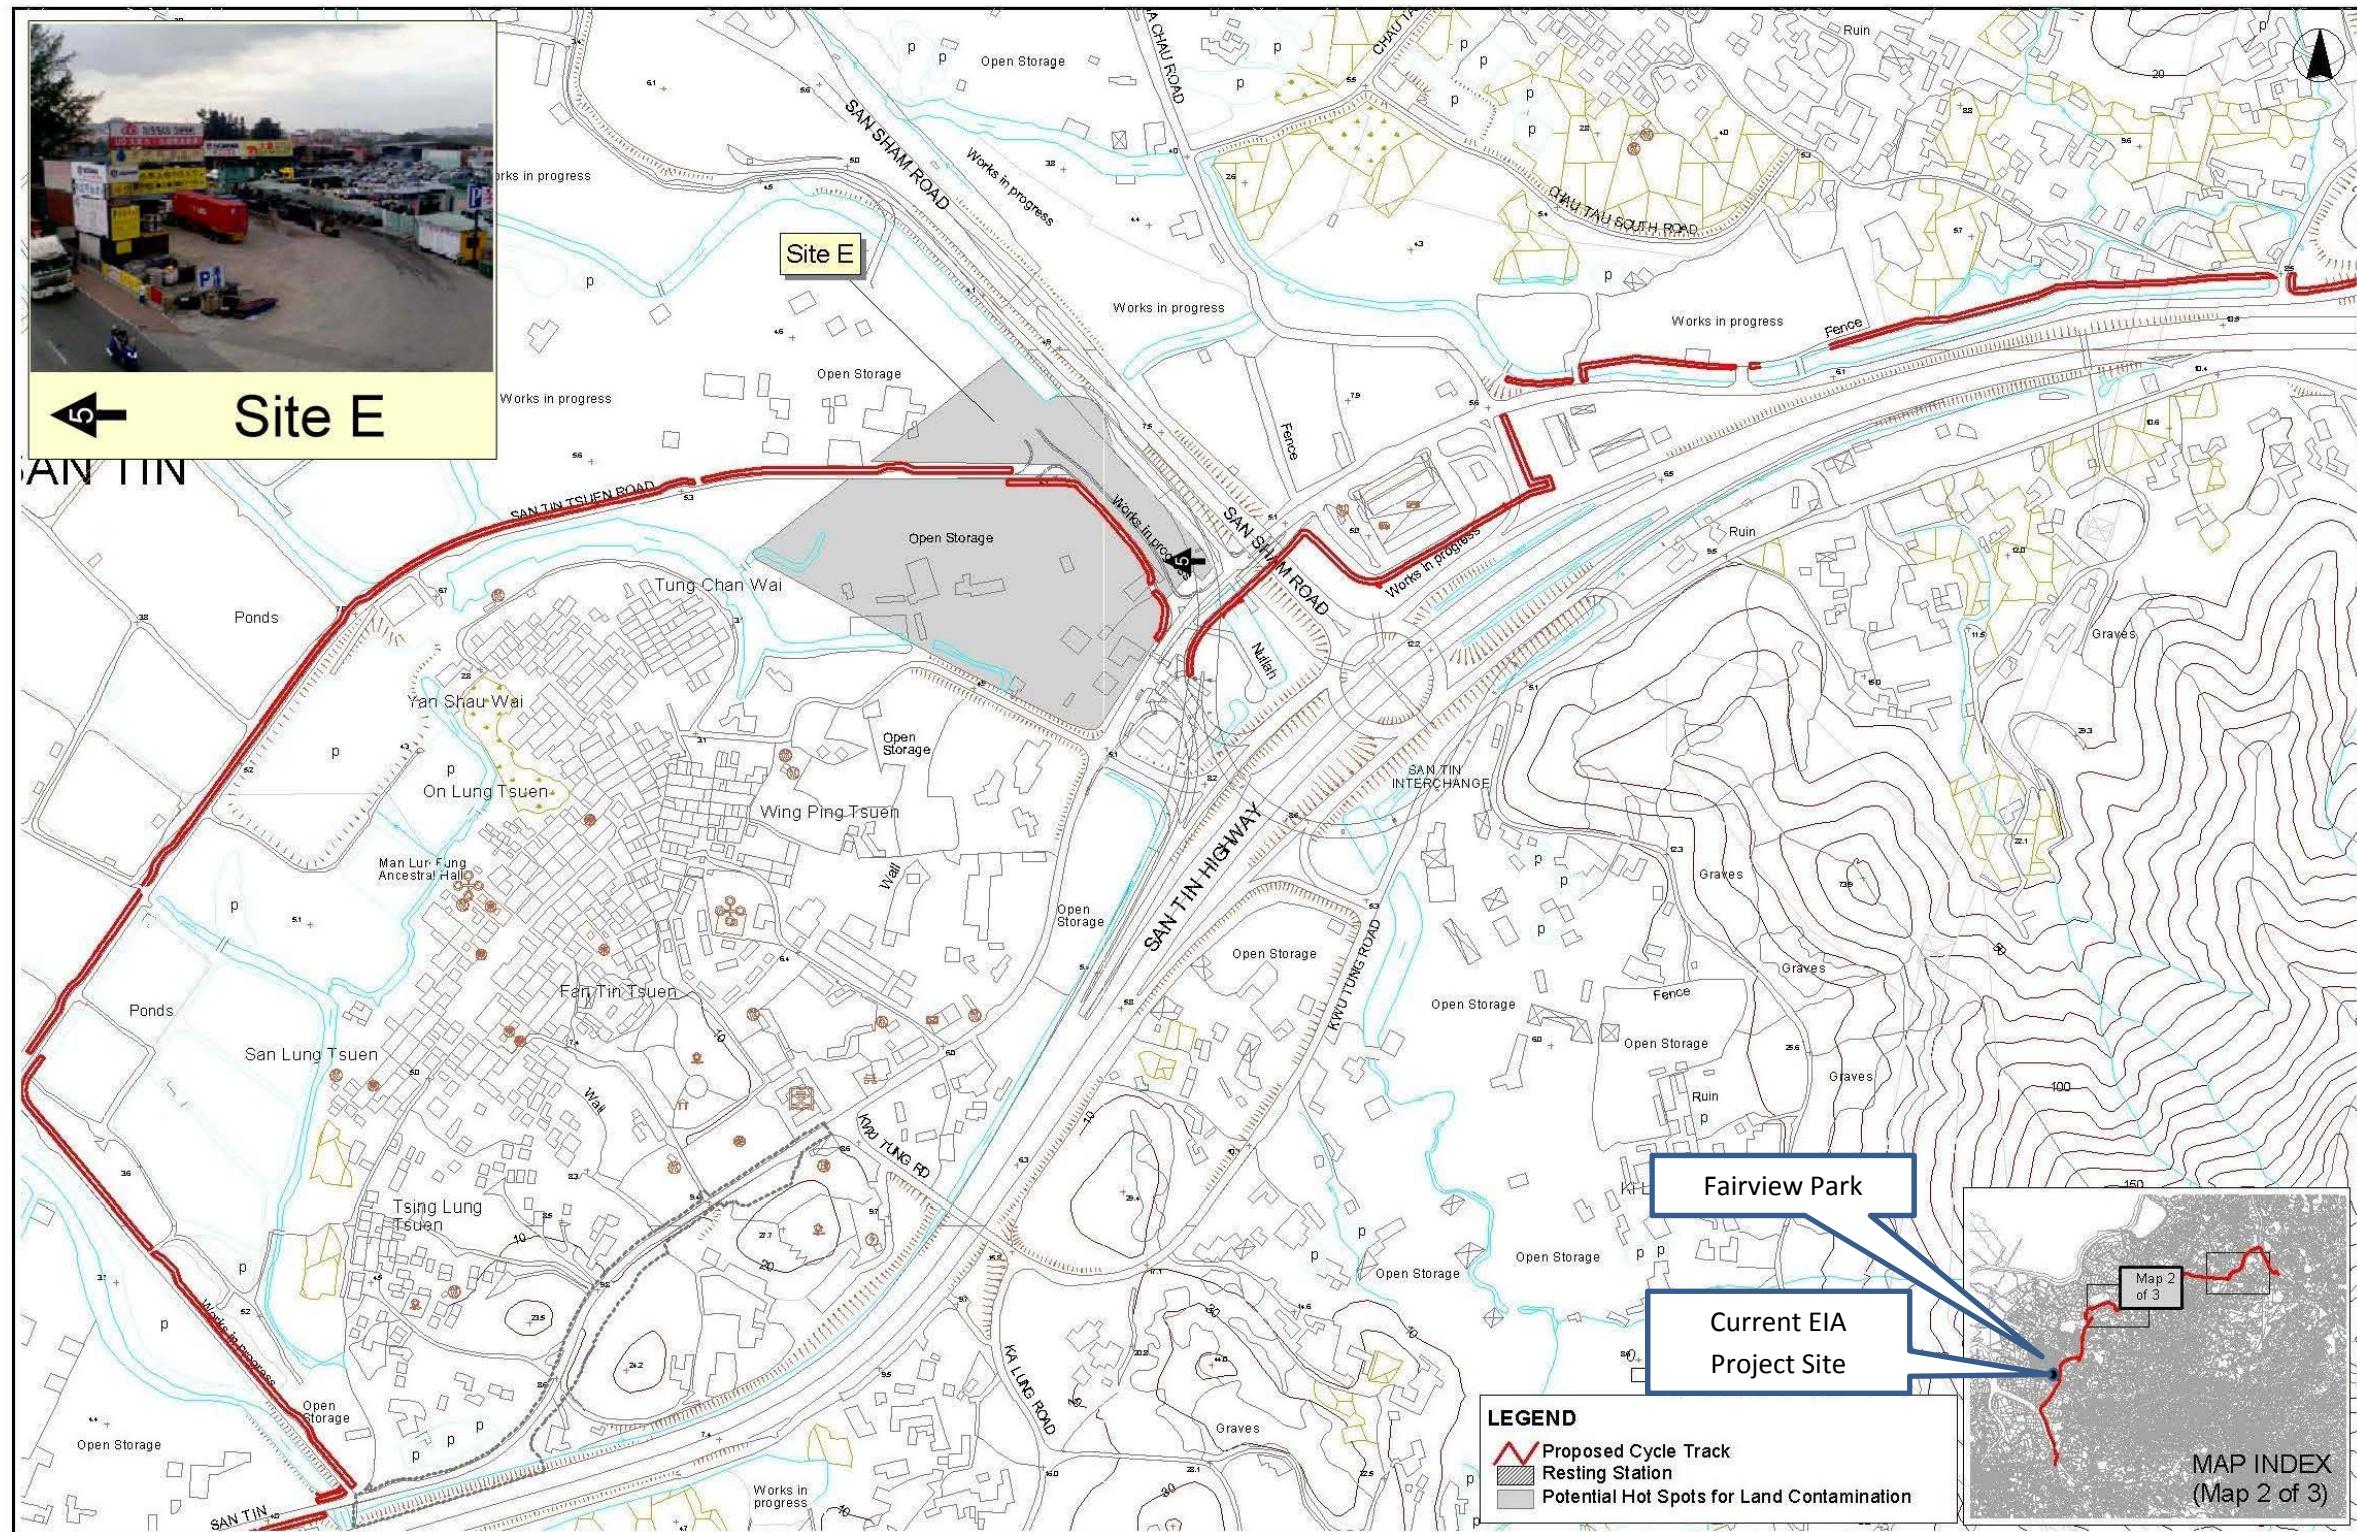
Current EIA Project (i.e. Proposed Residential cum Passive Recreational Development within “Recreation” (“REC”) Zone and “Residential (Group C)” Zone at Various Lots in DD 104, Yuen Long, NT) Superimposed with the Sites of Potential Contamination Identified in the Approved Cycle Track EIA Report (Extracted from Figure 8-2 of the Approved EIA Report for the Cycle Track Project (EIA Application No. EIA-159/2008) – The Current Project Site is Outside the Identified Sites of Potential Contamination in the Approved Cycle Track Project

Potential Contaminated Site	Location	Current Land Use	Historical Land Use	Potential Contamination Impact on the Project Areas	Figure No.
Site E	At the eastbound of Castle Peak Road (San Tin) near the San Sham Road.	Long vehicle parking and vehicle repair workshops. Site reconnaissance has found that the area abutting the Castle Peak Road is being used as vehicle repair workshops.	This site was used as open car park since 1993. Site reconnaissance found that the site was paved with concrete and there were vehicle repair activities, particularly in areas adjacent to the Castle Peak Road. A review of previous applications for planning permission by the Town Planning Board has indicated that the site was granted for cross-border traffic station and container repair since 1997. The land use permission has been granted for another three years in October 2006. Records of large scale spillage or leakage of chemical are not known.	No specific oil stains were found on the concrete paved areas where the cycle track alignment lies. Vehicle repair activities were found close to the project alignment. There is a potential of leakage of chemicals to the project area.	8-2

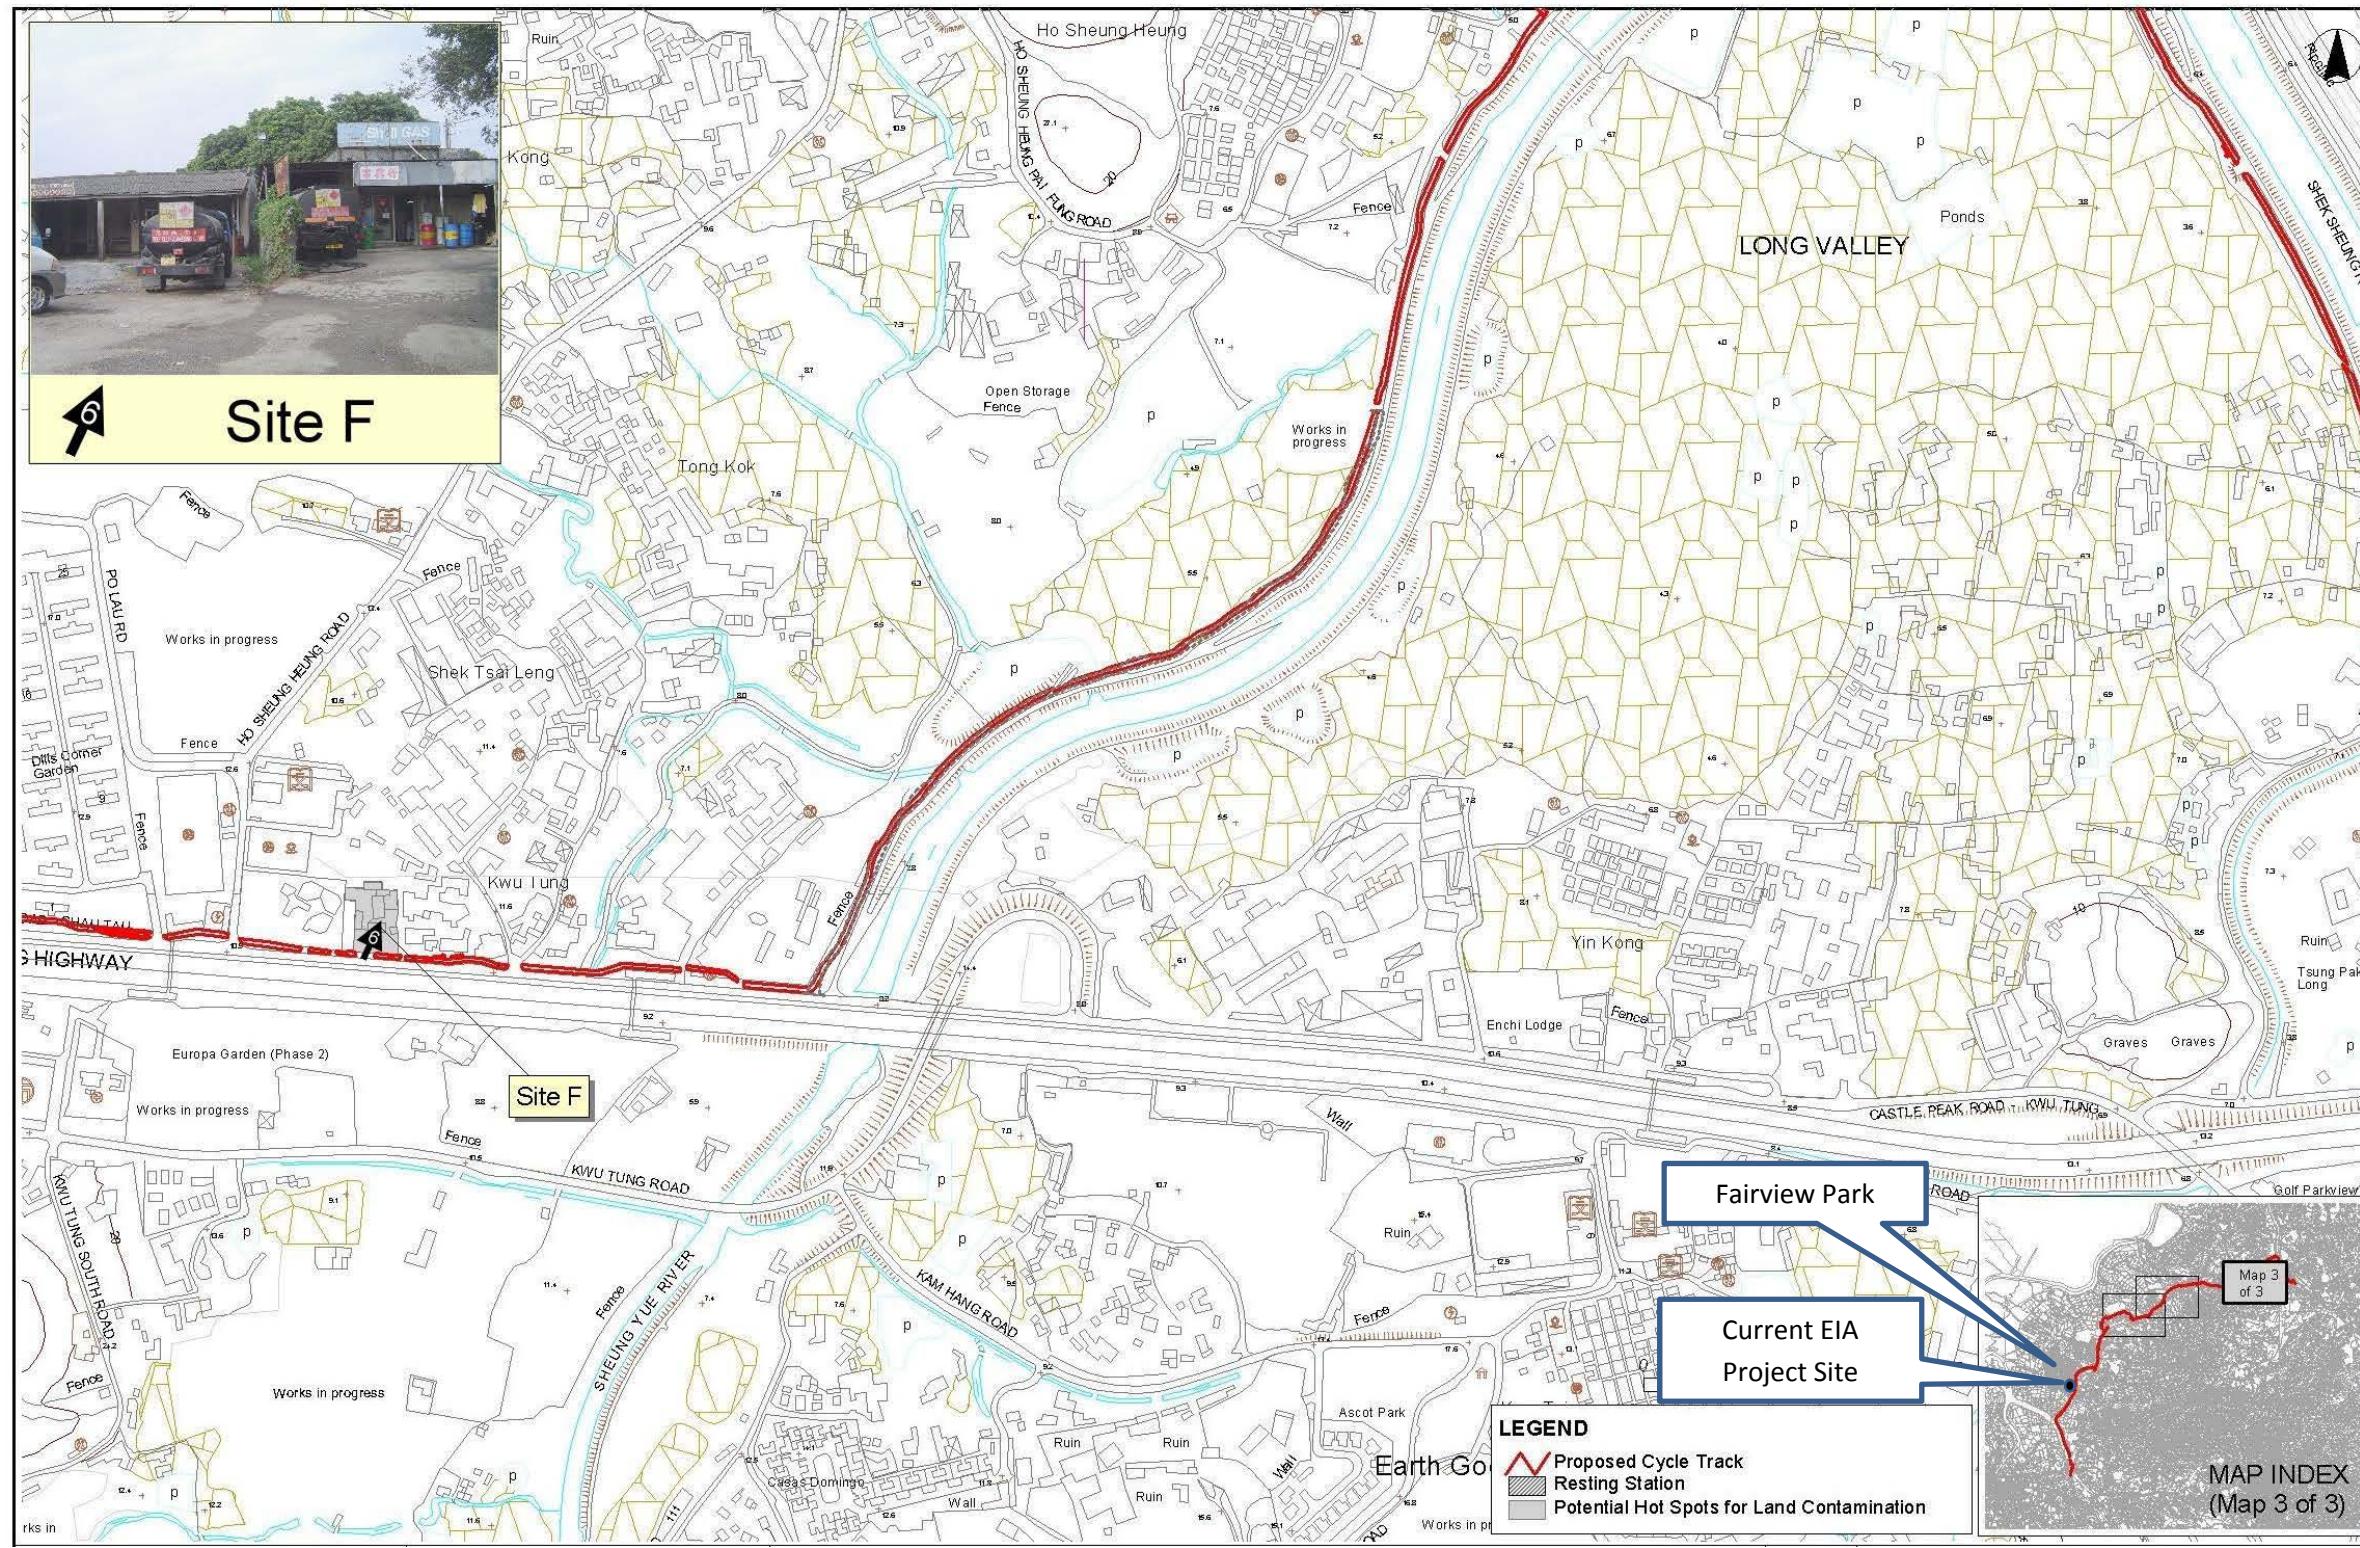
Current EIA Project (i.e. Proposed Residential cum Passive Recreational Development within “Recreation” (“REC”) Zone and “Residential (Group C)” Zone at Various Lots in DD 104, Yuen Long, NT) Superimposed with the Sites of Potential Contamination Identified in the Approved Cycle Track EIA Report (Extracted from Figure 8-3 of the Approved EIA Report for the Cycle Track Project (EIA Application No. EIA-159/2008) – The Current Project Site is Outside the Identified Sites of Potential Contamination in the Approved Cycle Track Project

Site F	At the eastbound of Castle peak Road (Kwu Tung) near Shek Tsai Leng.	Roadside fuel storage area was identified during the site reconnaissance.	This site was identified as a fuel storage area during the site reconnaissance. Two tankers were seen parked on-site. A review of the historical aerial photos have identified that the building at this location was constructed in about 1995. However, it is unclear when the site was used for fuel storage and whether the site has any underground fuel storage tanks. In addition, the ground surface was paved with concrete. Records of large scale spillage or leakage of chemical/fuel are not known.	Presence of underground fuel storage tanks is unknown. There is a potential of leakage to the project area.	8-3

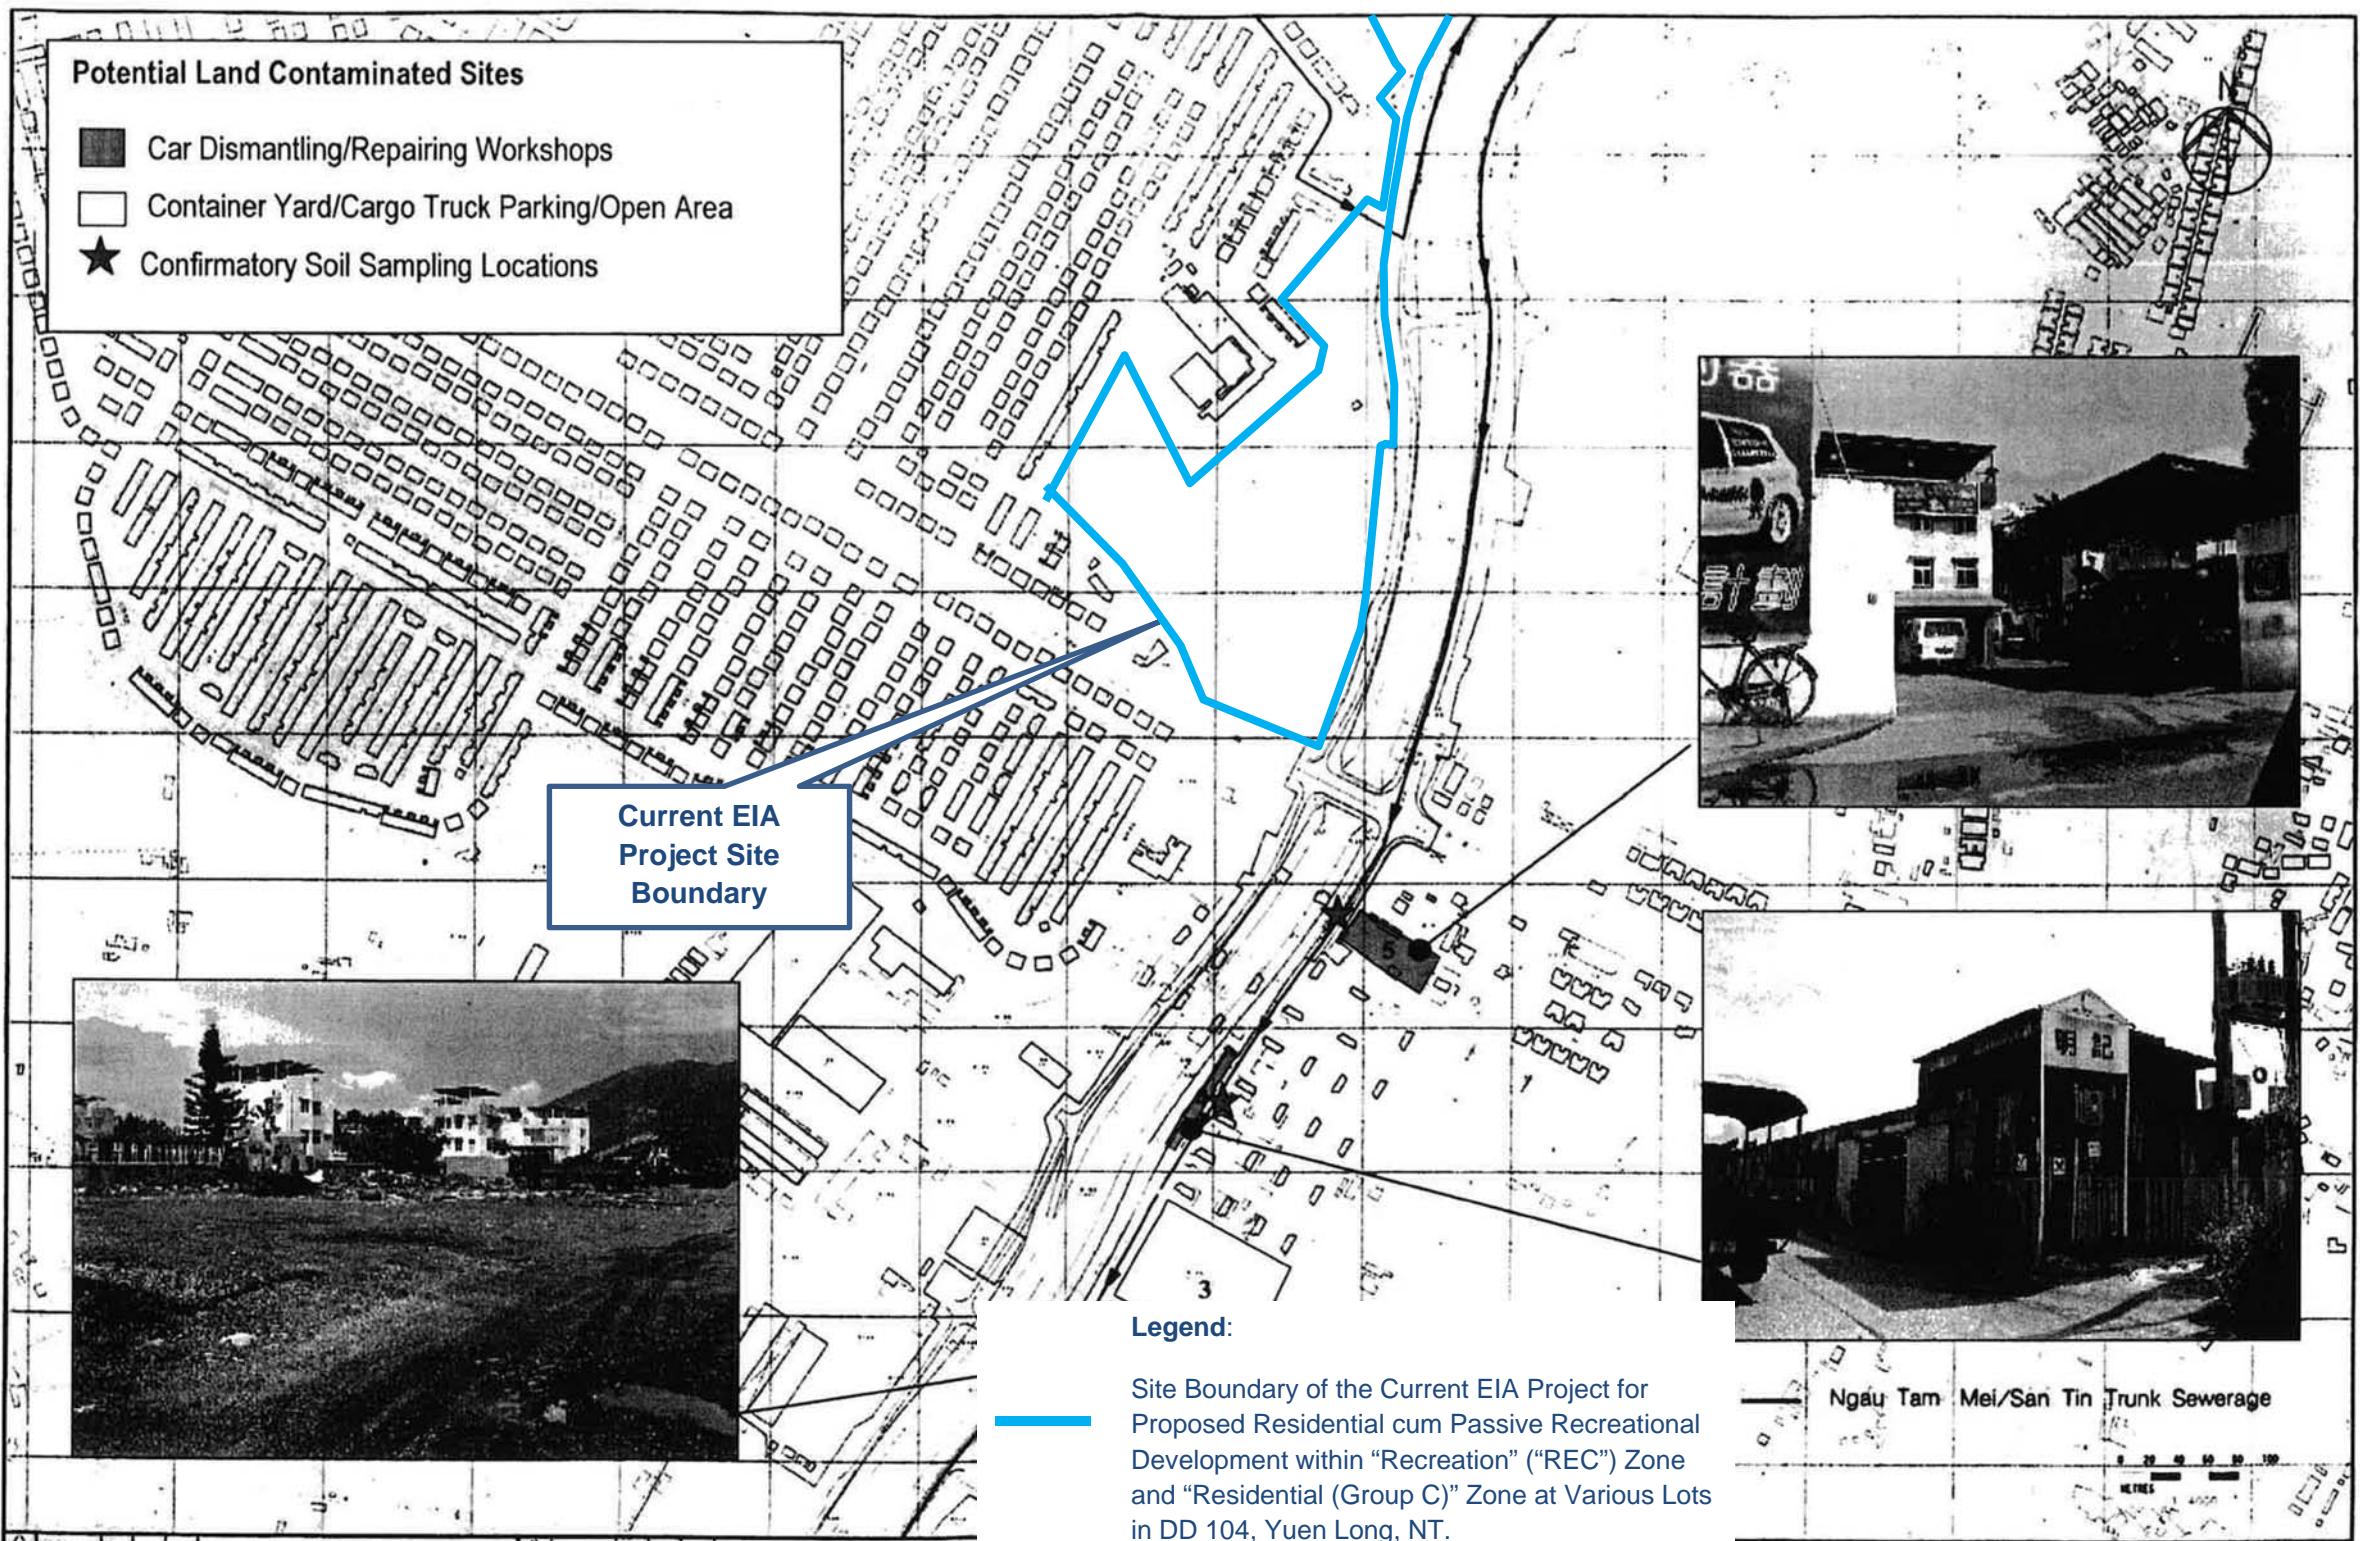
Site Boundary of the Current EIA Project (i.e. Proposed Residential cum Passive Recreational Development within "Recreation" ("REC") Zone and "Residential (Group C)" Zone at Various Lots in DD 104, Yuen Long, NT) Superimposed with the Proposed Public Sewer Project (Extracted from Figure 12.9 of the Approved EIA Report "Agreement No. CE 66/2001(EP), EIA and TIA Studies for the Stage 2 of PWP Item No. 215DS - Yuen Long and Kam Tin Sewerage and Sewage Disposal" (EIA Application No. EIA-094/2004))

-- The Project Site is Outside the Identified Potential Land Contaminated Sites near Ngau Tam Mei in the Approved Public Sewer Project in the Approved Public Sewer Project
