Appendix 7-3
Information Extracted from the Approved
EIA Reports

Information Extracted from the Approved Cycle Track EIA Report

Construction of Cycle Tracks and the Associated Supporting Facilities
From Sha Po Tsuen to Shek Sheung River, December 2008 (EIA
Application No. EIA-159/2008)

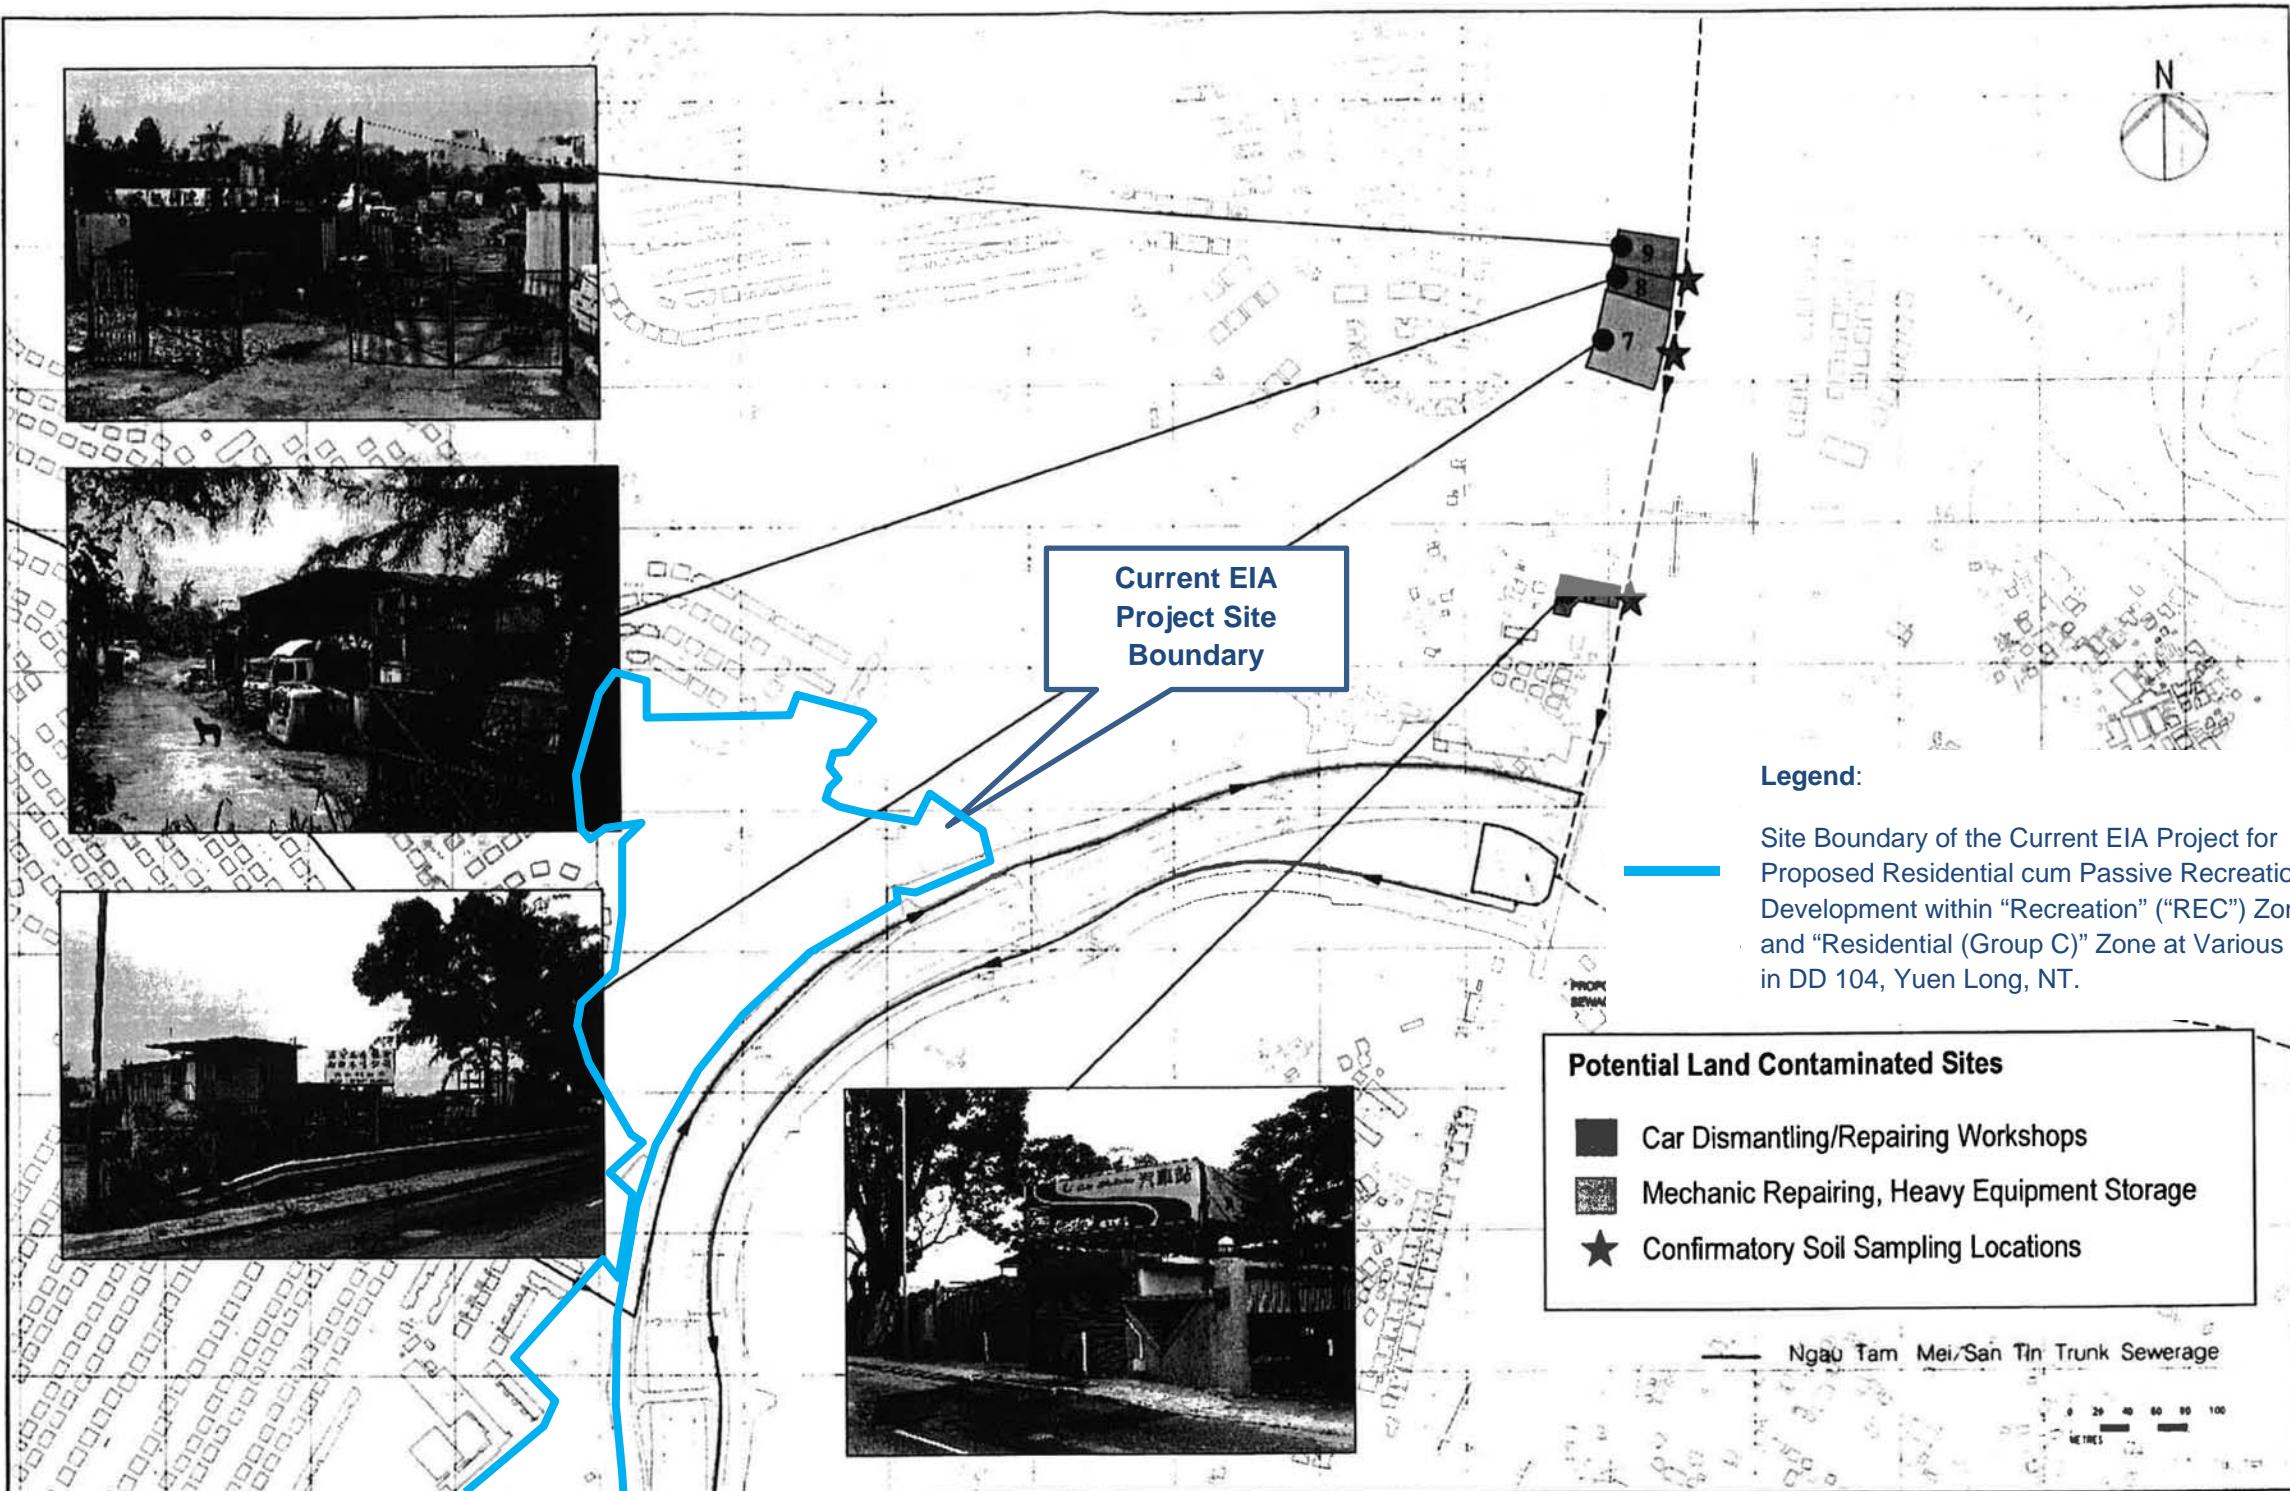
Site Boundary of the Current EIA Project (i.e. Proposed Residential cum Passive Recreational Development within "Recreation" ("REC") Zone and "Residential (Group C)" Zone at Various Lots in DD 104, Yuen Long, NT) Superimposed with the Proposed Public Sewer Project (Extracted from Figure 12.9 of the Approved EIA Report "Agreement No. CE 66/2001(EP), EIA and TIA Studies for the Stage 2 of PWP Item No. 215DS - Yuen Long and Kam Tin Sewerage and Sewage Disposal" (EIA Application No. EIA-094/2004))

-- The Project Site is Outside the Previously Identified Potential Land Contaminated Sites near Ngau Tam Mei
