**APPENDIX 7.02 HAZARD TO LIFE ASSESSMENT FOR THE USE OF EXPLOSIVES**

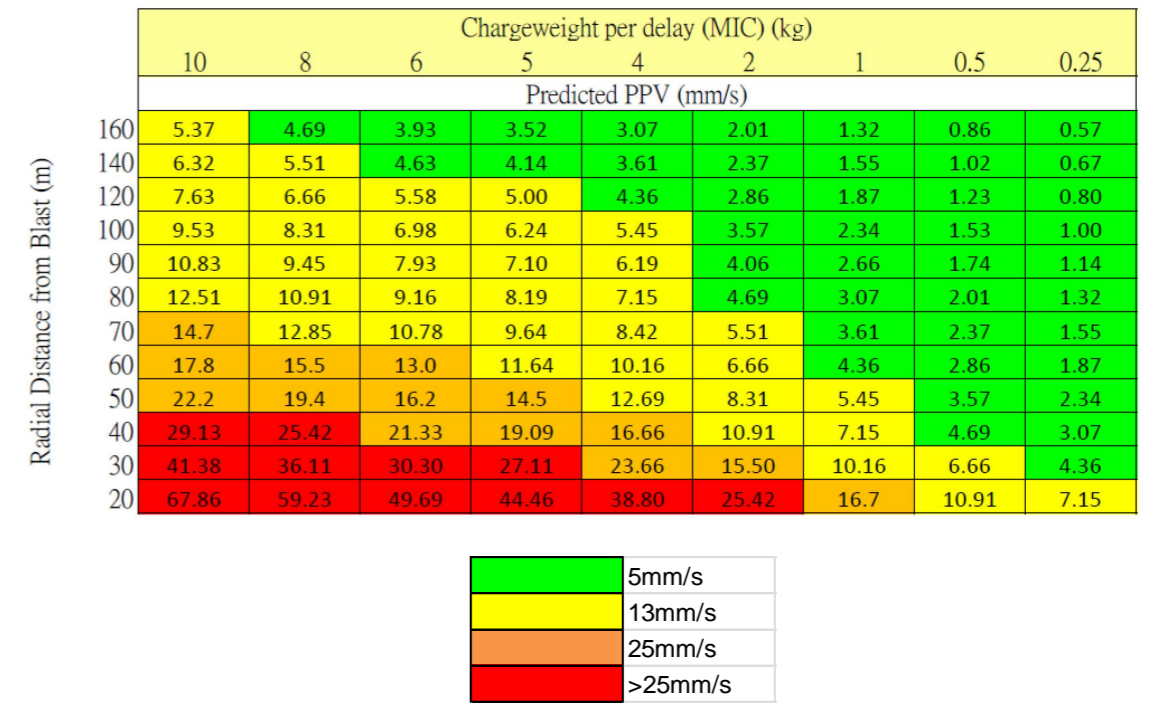
Figure 3.1 Charge weight per delay (MIC) versus Distance and PPVc

3.5.1.2 Ground vibrations induced by this stress wave have a peak velocity that is related to the instantaneous charge weight (MIC) and the distance from the blast source. **Figure 3.1** presents the typical range of charge weights and predicted vibration levels using the MD vibration constants.

3.5.1.3 For normal blasting operations, it is considered that structures in vicinity to the blasting site are unlikely to be subjected to PPV levels greater than 5mm/s.

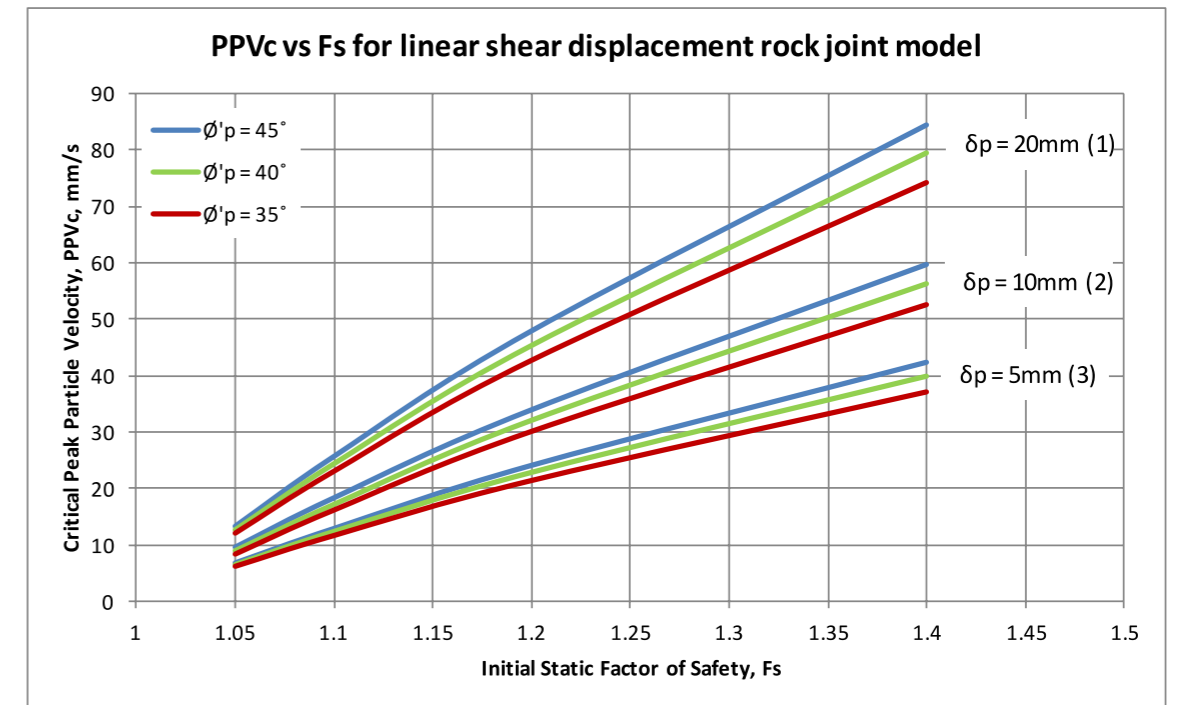
Figure 5.1 Plot of Critical Peak Particle Velocity against Initial Static Factor of Safety

5.3.3.9 GEO Report No.15 [3] provided a graphical presentation of the Critical Peak Particle Velocity, PPV<sub>c</sub>, and the initial static factor of safety for varying joint displacements at peak stress. This is shown in **Figure 5.1** below.

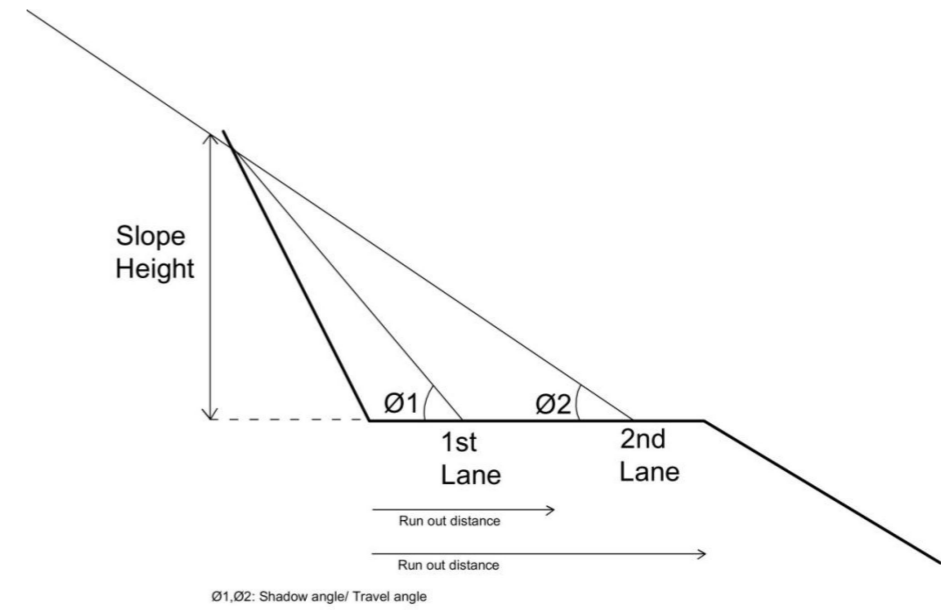
Figure 5.2 Influence zone for Slope Failures [4]

5.4.1.3 Mechanism of slope failure will affect the travel distance of landslide debris. For example, a landslide induced by rainfall is expected to travel further than one caused by blasting as the soil and rock behave in a more liquid manner. Therefore, the travel distance for rainfall induced landslides may be based on an apparent angle of friction of 15° to 30°. The apparent angle of friction or travel angle is defined as the inclination. The GEO Report No.81 [4] states that the travel angle of a typical rain induced landslide involves a landslide volume less than 2000 m<sup>3</sup> generally ranges from 30° to 40°. It is conservatively assumed that a landslide caused by detonation of explosives will result in a travel angle of 30°. The relationship of shadow/ travel angle and run out distance is shown in **Figure 5.2**.
