Land Contamination Assessment for Drainage Improvement Works in Ta Kwu Ling – Investigation, Design and Construction

Contamination Assessment Plan

24 May 2022

Project No.: 0482209

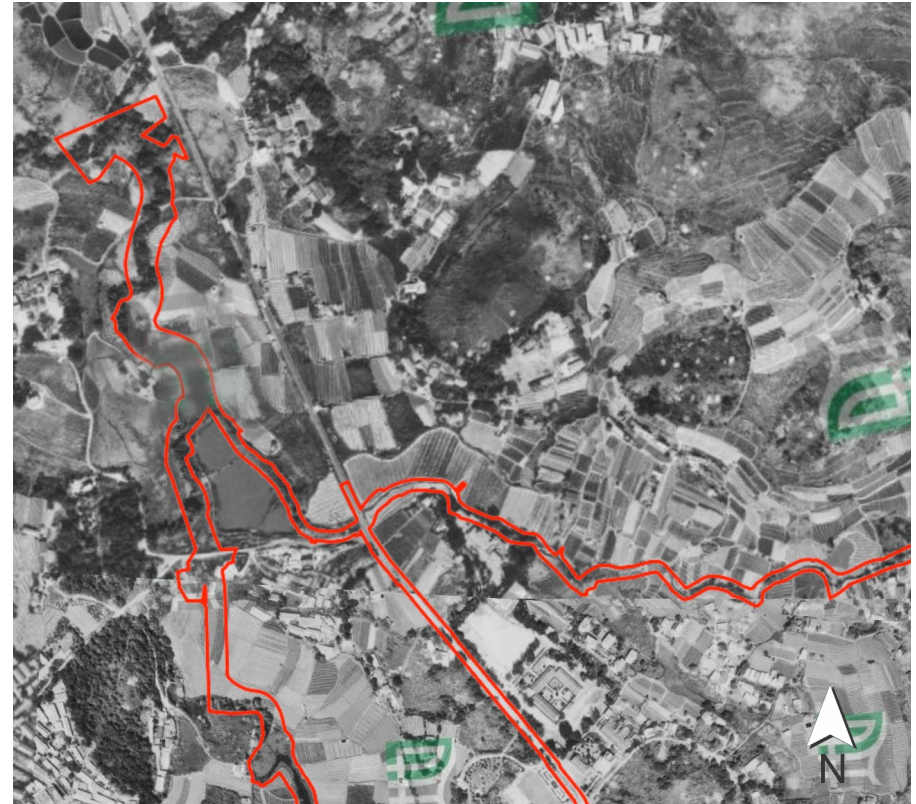
Year 1982 (Zoom-in map 1):
This section of Project Area was an undeveloped land in 1982. It mainly comprised with farmland and vegetation, also with road, drainage facilities and village houses.

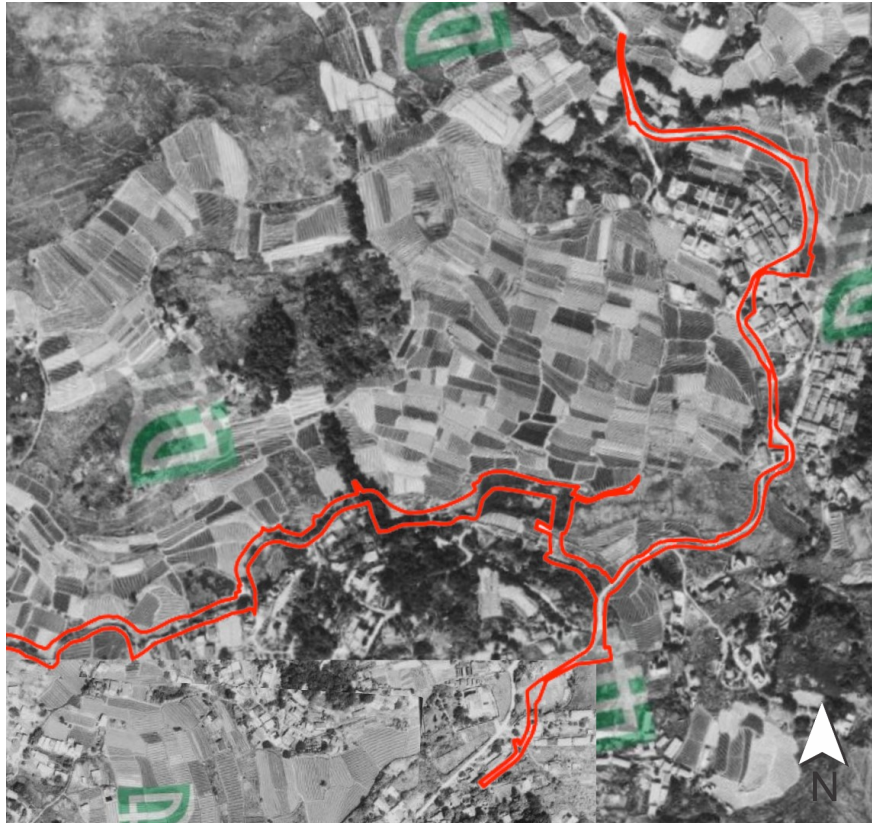
Year 1982 (Zoom-in map 2):
 This section of Project Area was an undeveloped land in 1982. Similarly, it mainly comprised with farmland and vegetation, also with drainage facilities and village houses.

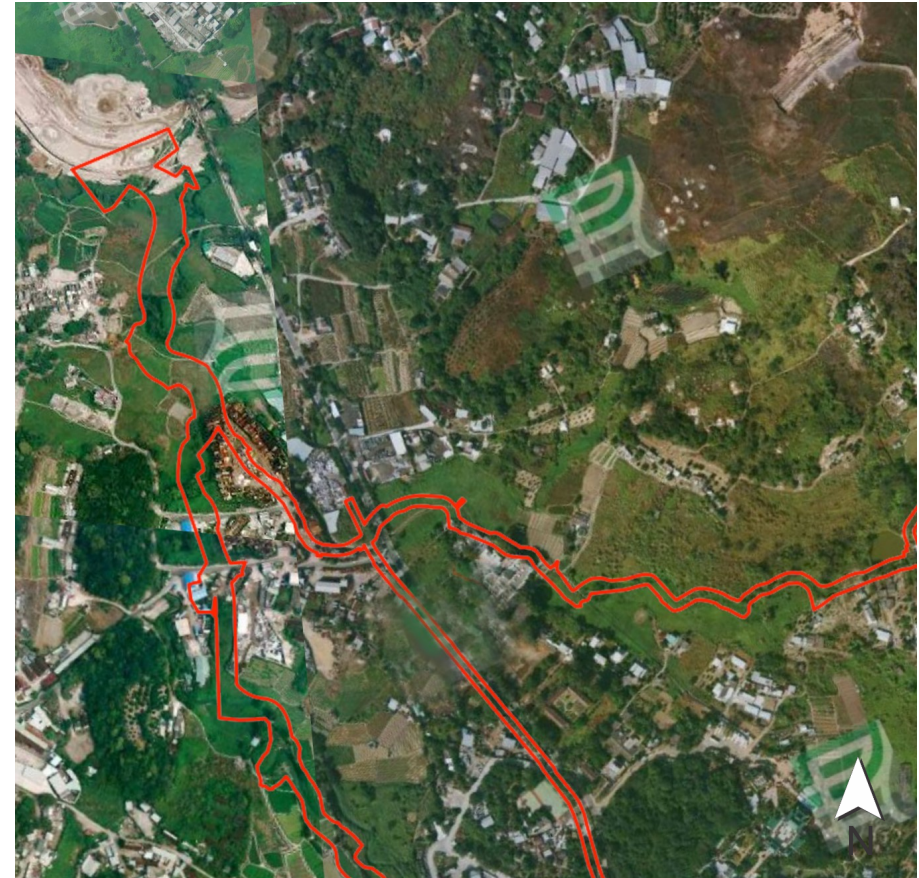
Year 2004 (Zoom-in map 1):
No significant change was observed at this section of Project Area (except the Concerned Areas). Minor site clearance works was carried out for drainage facilities in the northern corner of Project Area.

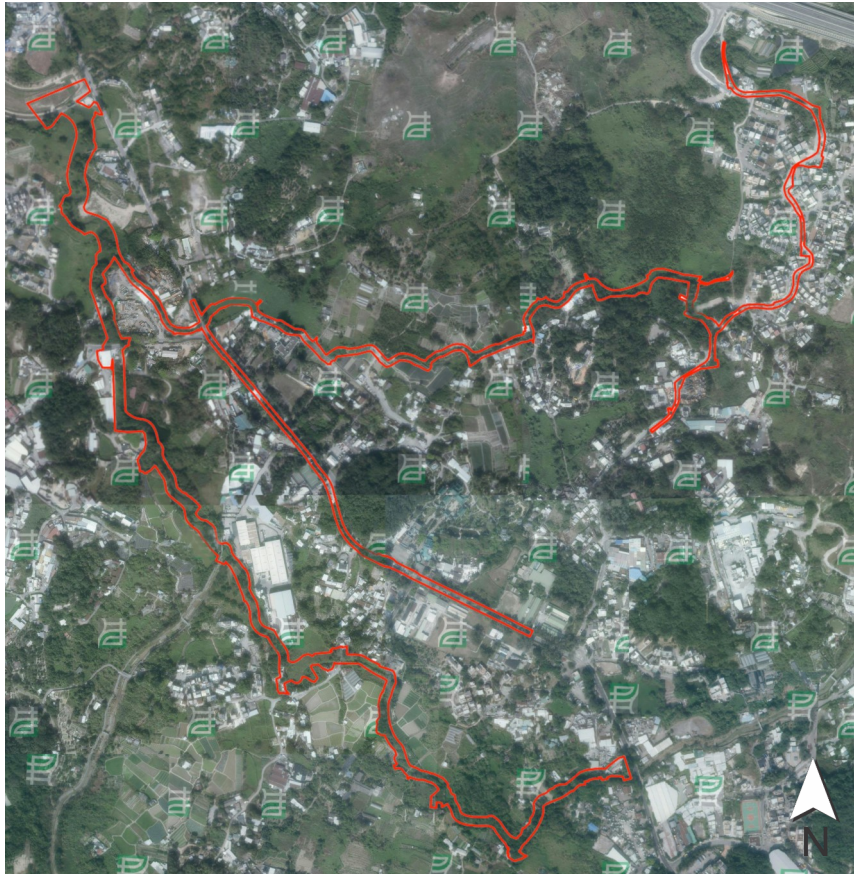
Year 2020:
No significant change was observed at the Project Area (except the Concerned Areas).

Review of aerial photo taken in 2020 showed that the boundary of Area B1 was an open storage area with small sheds along the tree canopy. According to the CWPs records from EPD, Area B1 has been occupied by a waste electric & metal products recycler namely Ping Nam Trading LTD. These electronic wastes stored onsite may possess a potential land contamination impact. SI is recommended to assess the ground condition of the electronic and metal waste storage areas.

Review of aerial photo taken in 2020 showed that the Area B2 were used as a temporary office buildings and warehouse. Based on review of historical aerial photos, there is no significant change of the land use since early 1990s. No signs of industrial activities were noted.

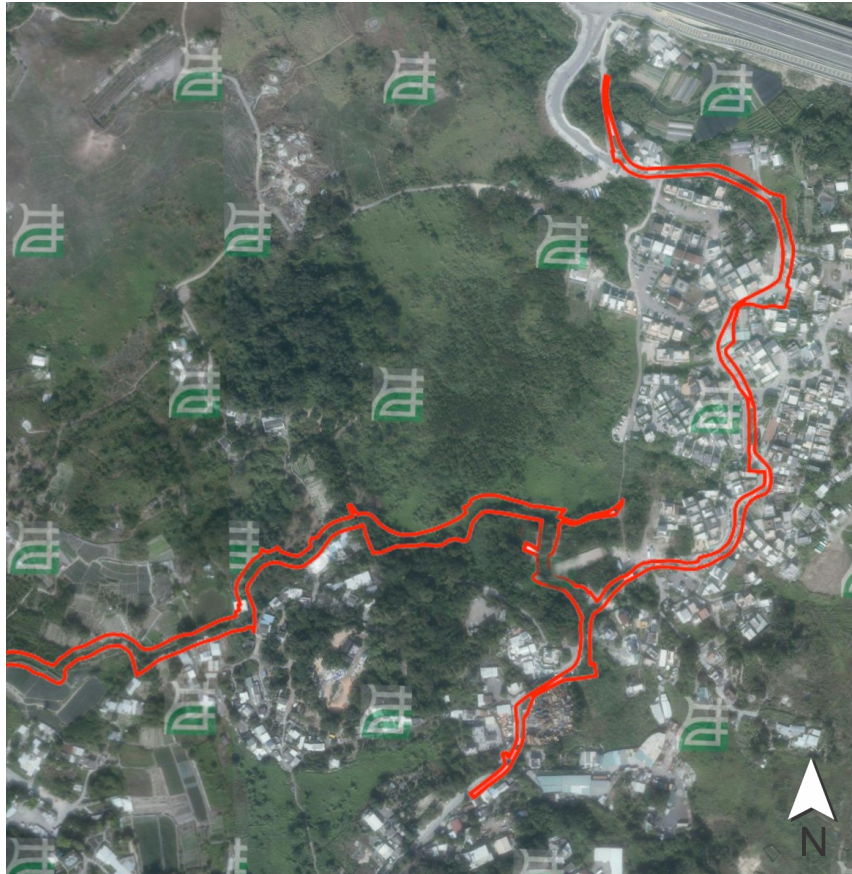
Year 2020 (Zoom-in map 2):
 No significant change was observed at this section of Project Area (except the Concerned Areas). It mainly comprised with vegetation, drainage facilities and village houses.

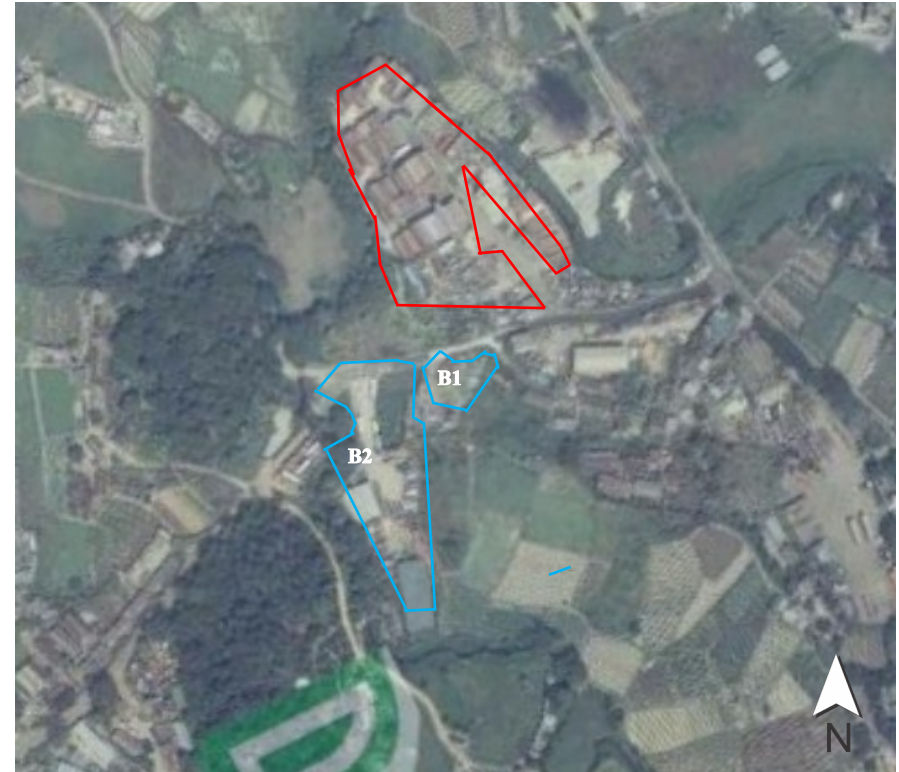
Year 1994 (Ref: CN08662)
 Concerned Area A, B1 and B2 were developed as contractor storage yard, open storage area, and temporary office buildings and warehouse structures, respectively.

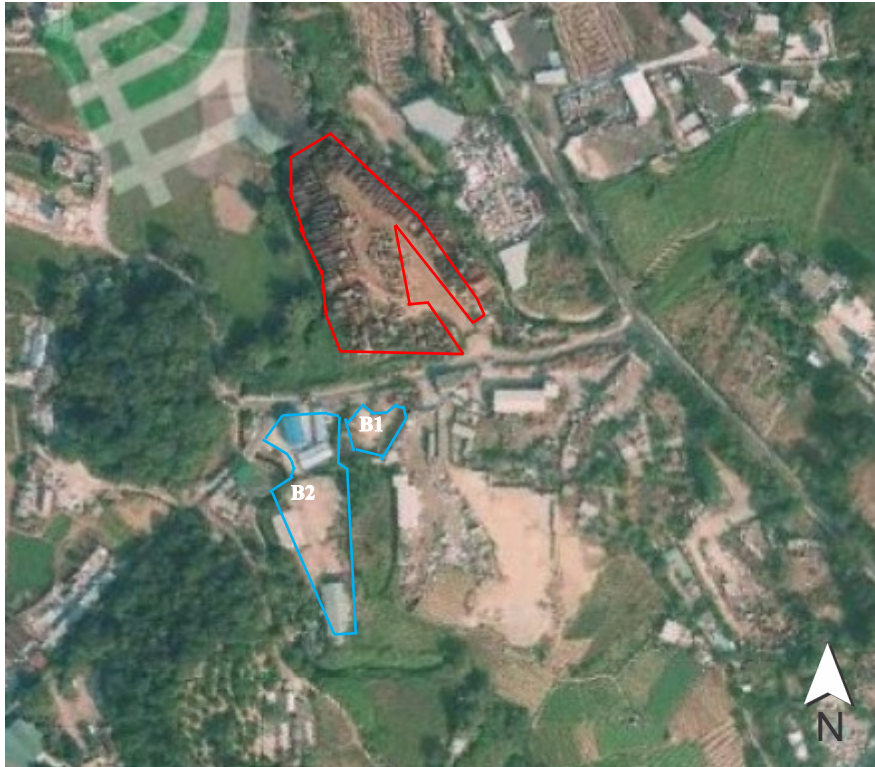
Year 2004 (Ref: CW63043)
 No significant change was observed at the Concerned Area A, B1 and B2.

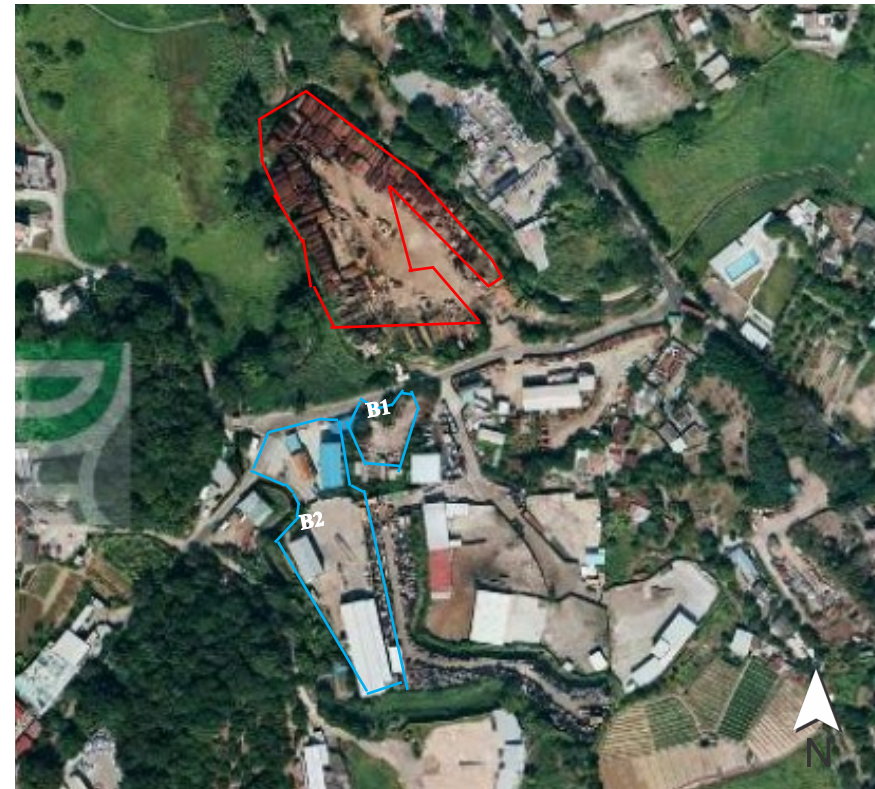
Year 2008 (Ref: CS18090):
 No significant change was observed at the Concerned Area A, B1 and B2.

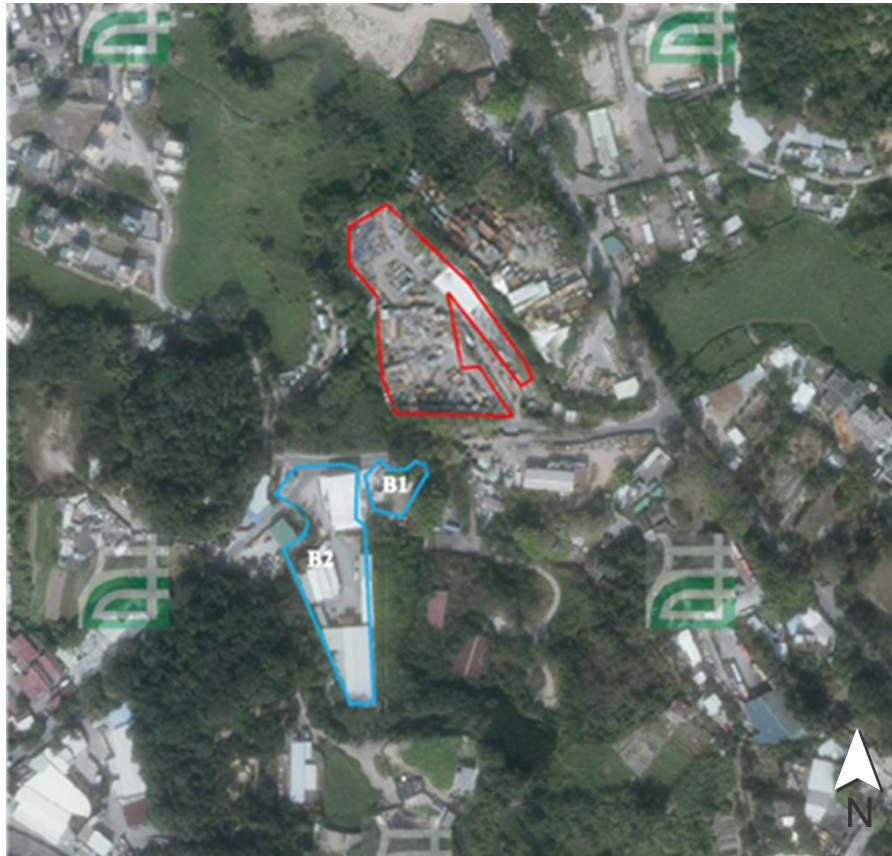
Year 2020 (Ref: E113964C):
 No significant change was observed at the Concerned Area A, B1 and B2.
