Castle Peak Road Improvement Between Sham Tseng and Ka Loon Tsuen, Tsuen Wan West Contract No. HY/99/18

Monthly Environmental Monitoring and Audit Report September 2004

Monthly Environmental Monitoring and Audit Report - September 2004

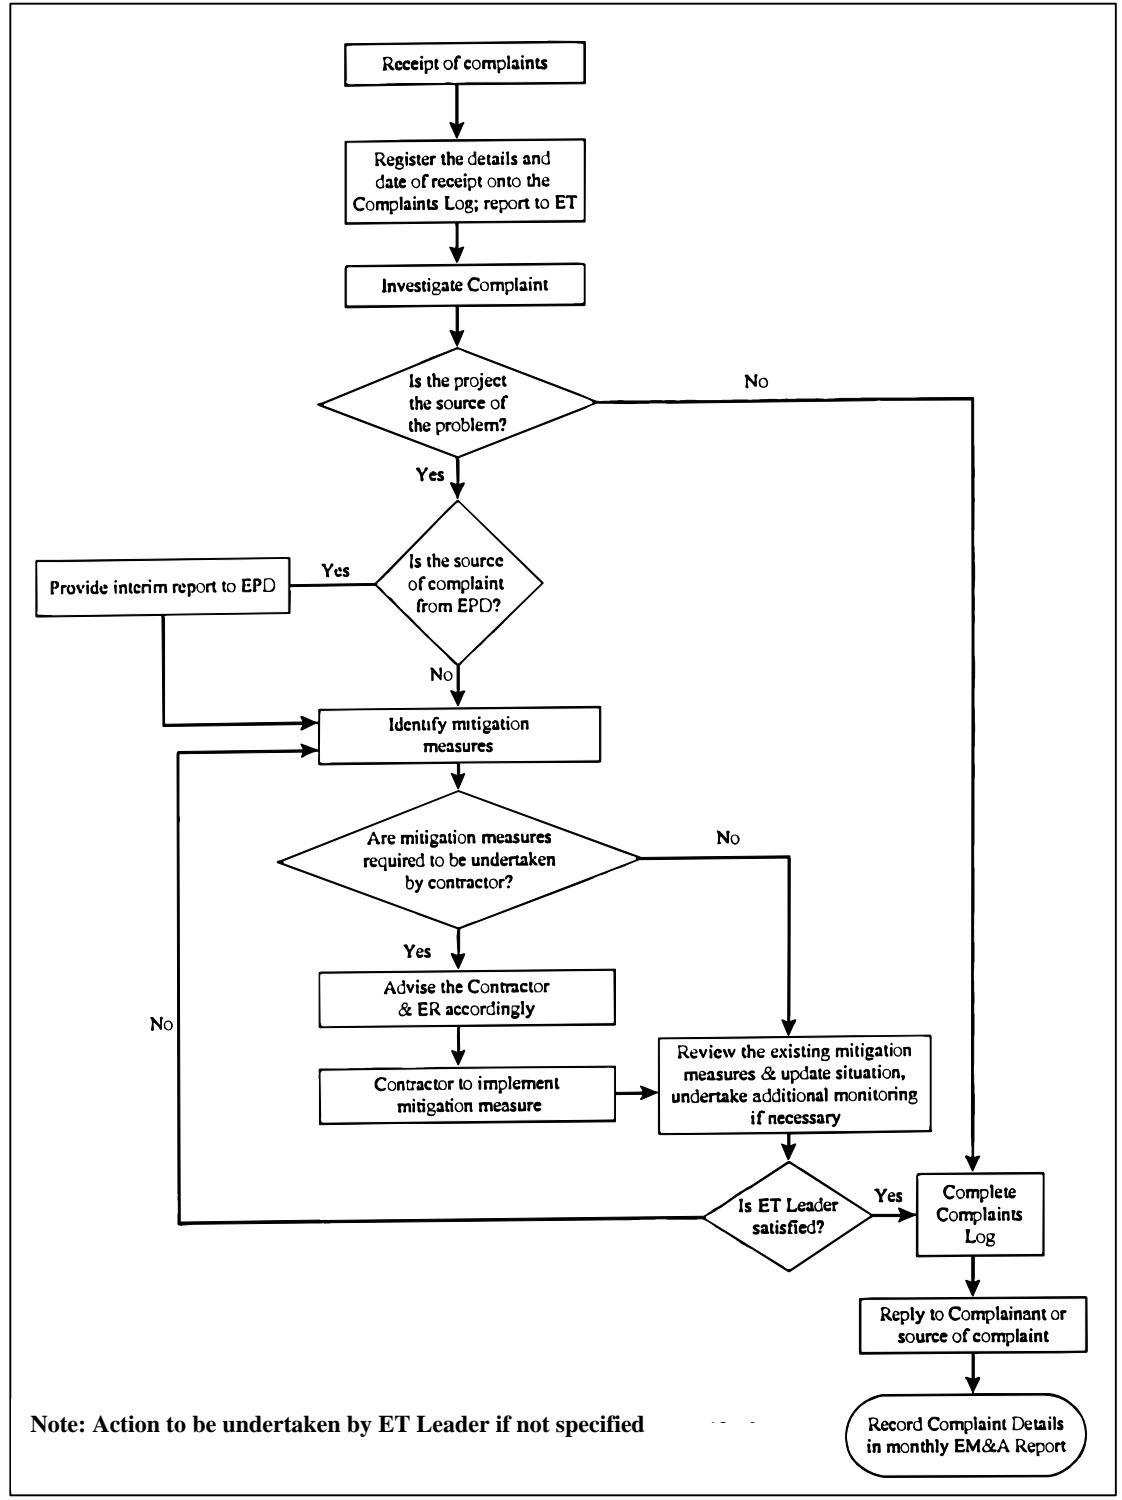
Figure 3-2 Flow chart of the complaint response procedure

A flow chart of the complaint response procedures is shown in Figure 3-2 for reference.

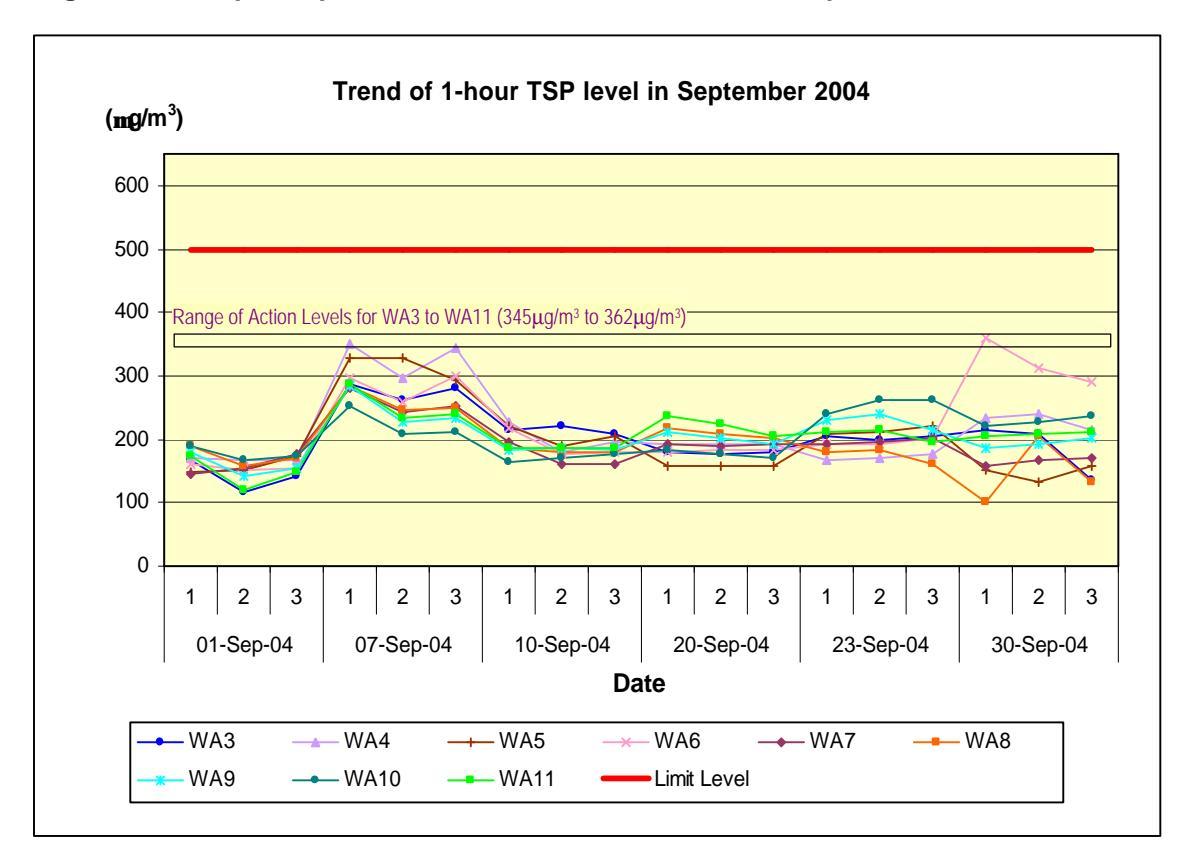
Figure 4-1 Graphical presentation of 1-hour TSP levels for September 2004

There was no exceedance of the A/L Levels during the monitoring period.

The detailed monitoring results of 1-hour TSP are given in Appendix F and the 1-hour TSP level at each monitoring location are plotted and presented in Figure 4-1.

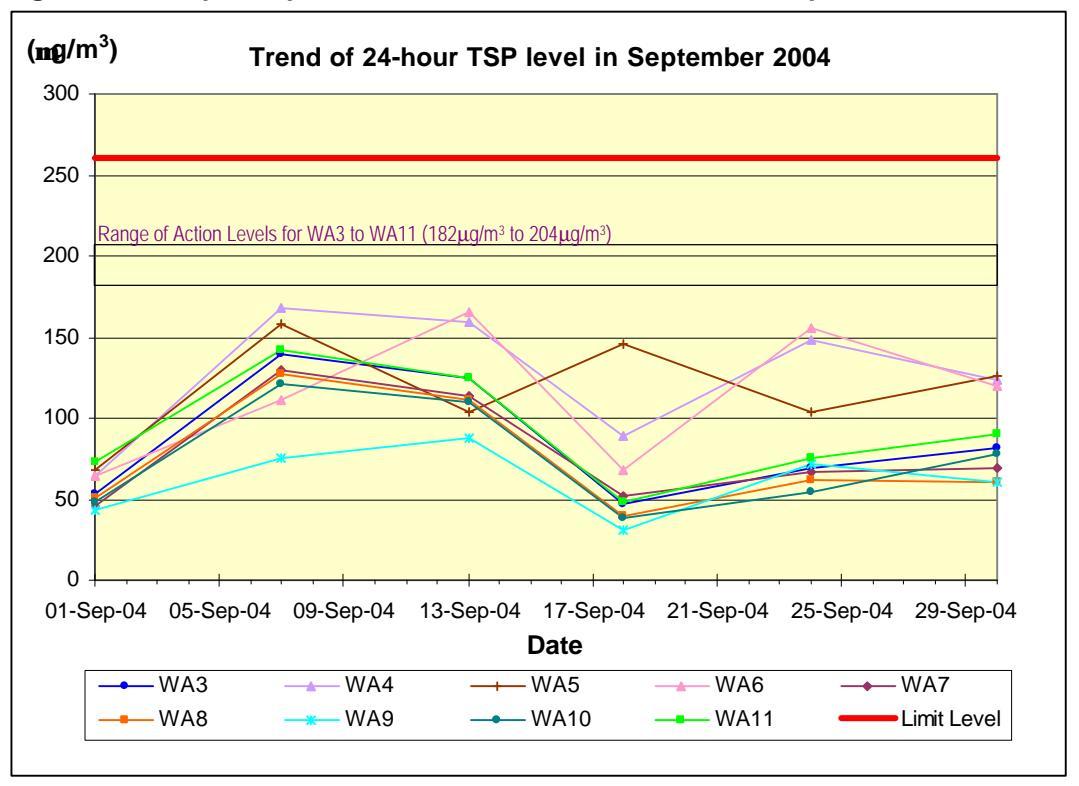
Figure 4-2 Graphical presentation of 24-hour TSP levels for September 2004

There was no exceedance of the A/L Levels during the monitoring period.

The detailed monitoring results of 24-hour TSP are given in Appendix G and the 24-hour TSP level at each monitoring location are plotted and presented in Figure 4-2.

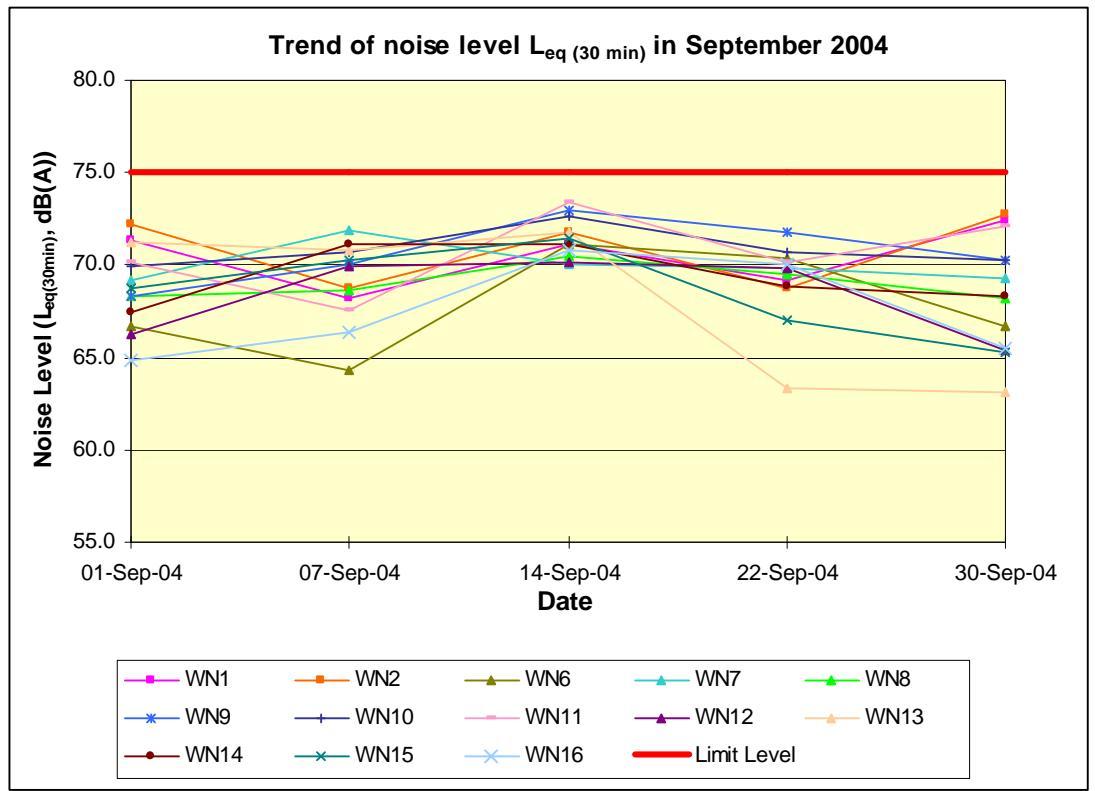
Figure 5-1 Graphical presentation of daytime noise levels for September 2004

There was no exceedance of the A/L Levels during the monitoring period.

The noise levels at each monitoring location are plotted and presented in Figure 5-1.

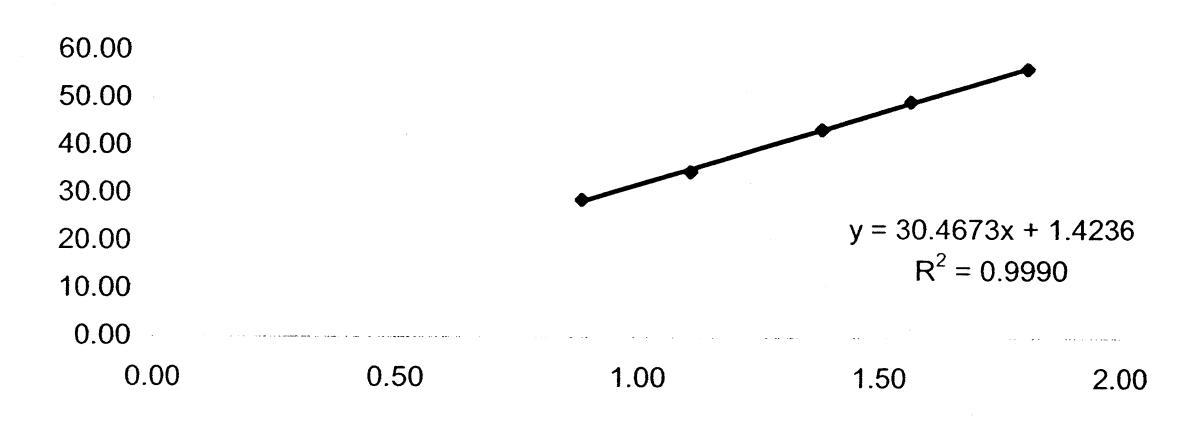
Calibration Curve

Linear RegressionSampler slope (m) :30.4673Sampler intercept (b) :1.4236Correlation coefficient (R²) :0.9990

Correlation coefficient is greater than 0.9900 and the calibration result is accepted.

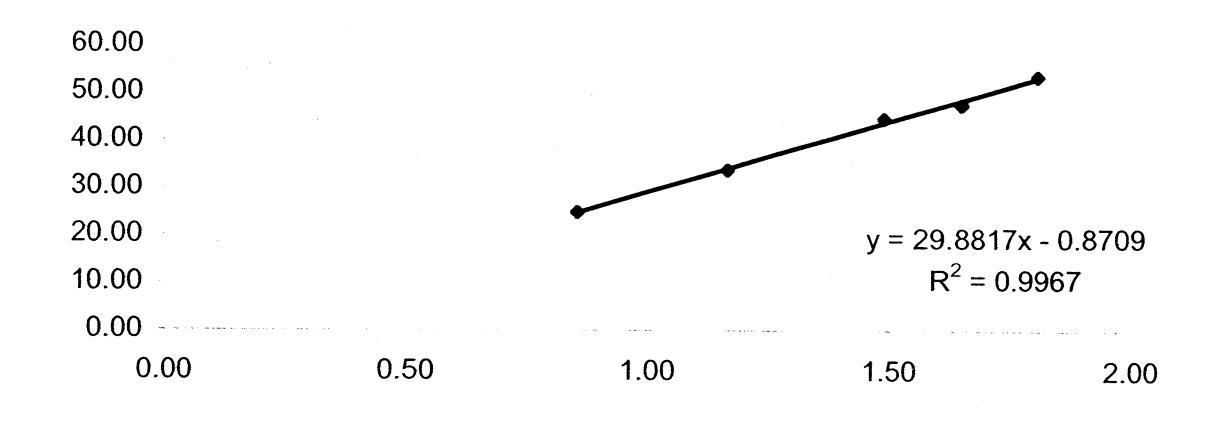
Calibration Curve

Linear Regression	
Sampler slope (m) :	29.8817
Sampler intercept (b) :	-0.8709
Correlation coefficient (R^2) :	0.9967

Correlation coefficient is greater than 0.9900 and the calibration result is accepted.
