Site Formation for Kai Tak Cruise Terminal Development -Design and Construction

Baseline Post-translocation Coral Monitoring Report

Deliverable ID: D22

July 2009

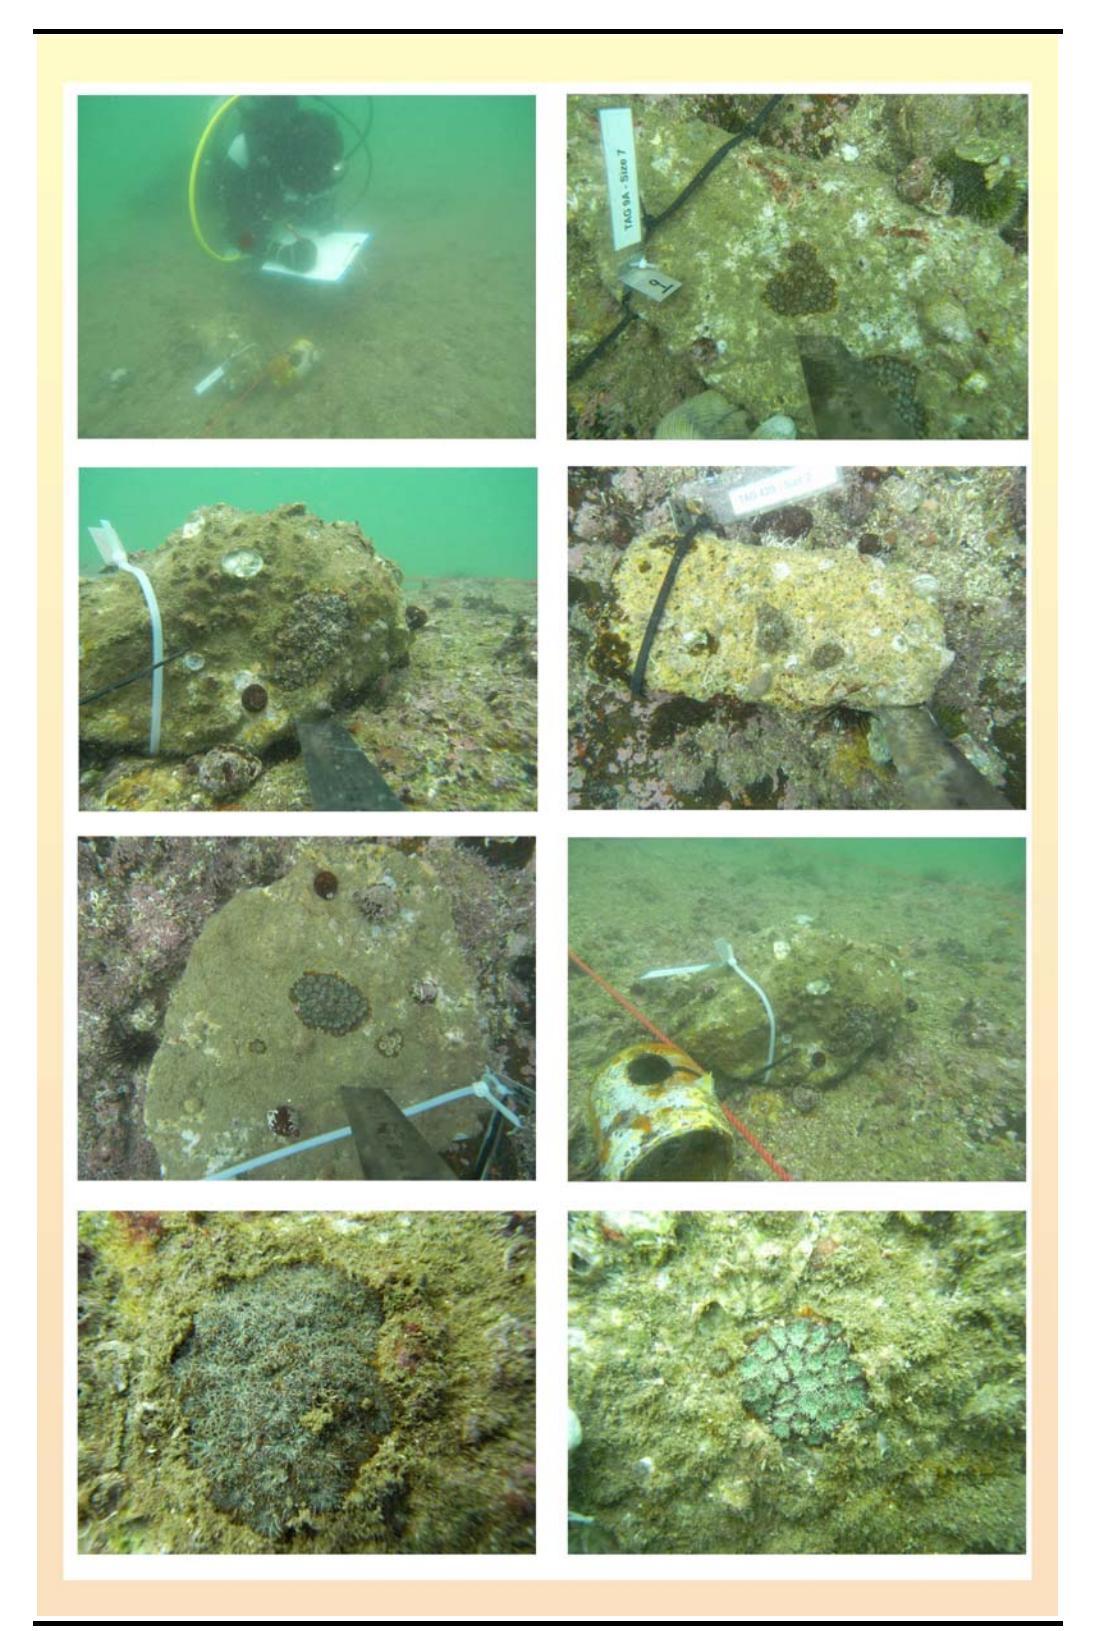
- The health condition of the translocated corals was compared to the reference corals 3.2.8 recorded within the recipient site and along the reference transect. The majority of the reference corals were in good condition exhibiting no partial mortality, bleaching or sediment cover. A total of three (13 %) of Oulastrea crispata colonies exhibited partial mortality and were represented by small areas (5 %) of freshly exposed coral skeleton (Figure 2.5). It was noted that the nature of this partial mortality was similar to that observed for a small number of translocated corals (as observed on the second day of translocation and recorded during the baseline post-translocation monitoring survey, subsection 3.2.5). Figure 2.5 presents photographs of the reference and translocated corals with the small areas of exposed skeleton. The absence of sediment cover on the living coral for both the translocated and reference corals indicates active sediment removal by coral polyps. The similar observations of small areas of partial mortality (freshly exposed skeleton) observed for both translocated and reference corals is attributed to the removal of sediment exposing dead coral areas that had not yet been overgrown with algae and does not represent recent tissue die-off and does not indicate that translocated corals exhibited stress that manifested in this type of partial mortality.

Figure 2.5Representative Photographs of the Oulastrea crispata Coral
Colonies Exhibiting small areas of Partial Mortality as
Recorded for the Translocated and Reference Corals

- 4.1.3 A small number of translocated coral colonies exhibited small areas of partial mortality (as freshly exposed skeleton), however, after comparing with reference colonies, it was found this type of partial mortality was exhibited in the *Oulastrea crispata* colonies occurring naturally within and adjacent to the recipient site at Tseung Kwan O. It is noted that the partial mortality observed for the translocated corals during the baseline post-translocation survey already existed but had not been noted in the pre-translocation survey due to sediment cover on these dead portions of the colonies.
