Ocean Park Master Redevelopment Project

Monthly Environmental Monitoring & Audit Report – April 2008

Environmental Permit No. EP-249/2006/A - Condition 3.4

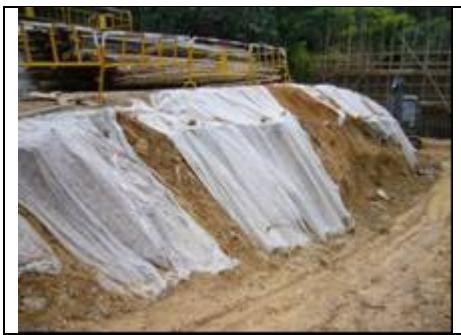
P1050829: Exposed stockpiles along the boundary of the New Panda Habitat were partly covered. The Contractor shall ensure the stockpiles are covered entirely.

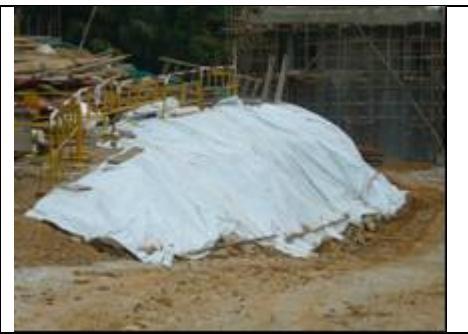
Closed - P1060180: Stockpiles along the boundary of the New Panda Habitat were covered entirely.

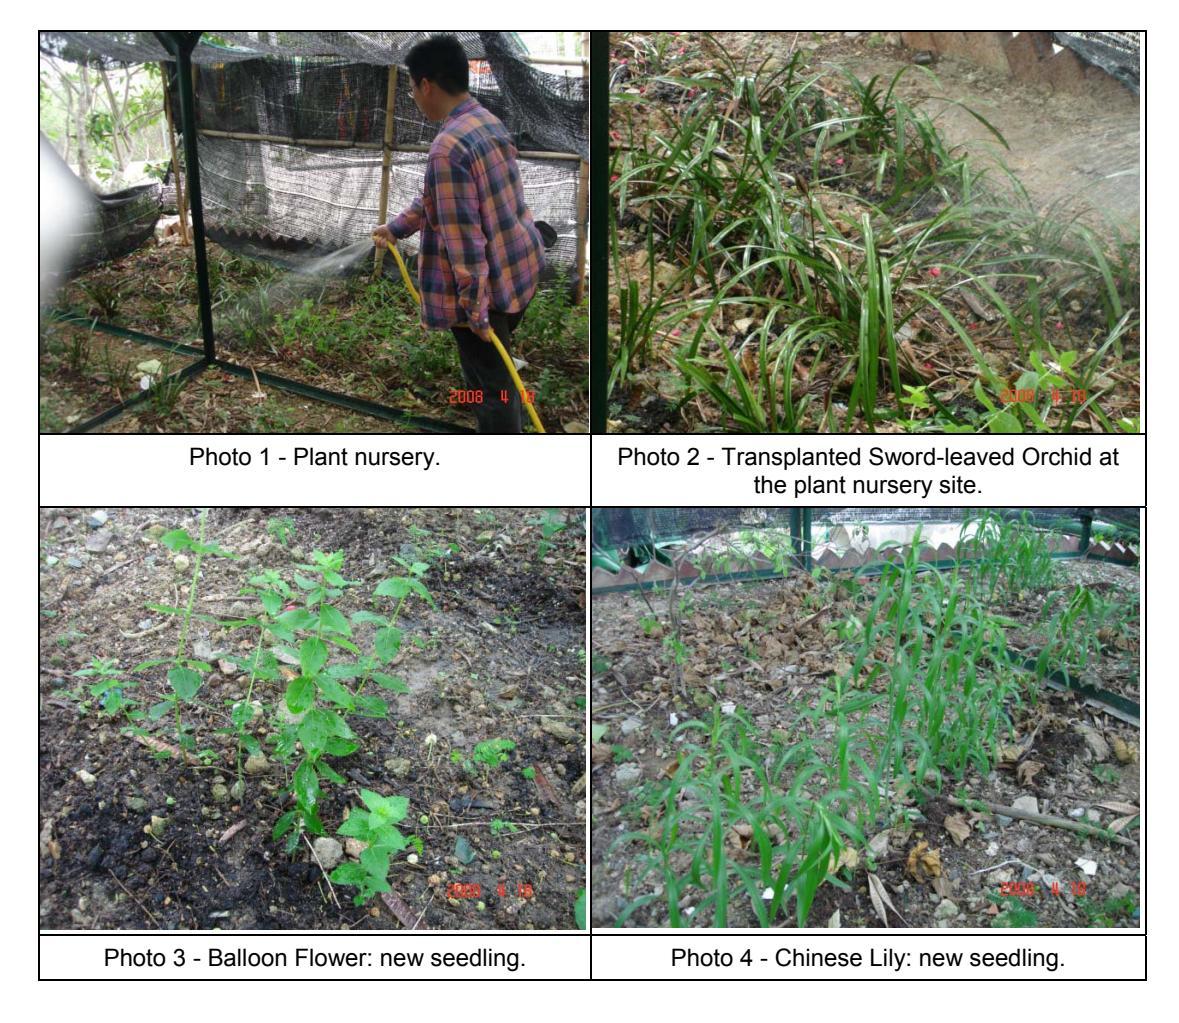
4 PHOTOS

- 3.2 The survival rate of the monitored plant Sword-leaved Orchid was still 100%. (Photo 2)
- 3.3 Most of the transplanted Balloon Flowers at the receptor site were experience seasonal shrunken and re-generated in the growing season. (Photo 3)
- 3.4 All the transplanted Chinese Lily were re-germinated in the current growing season and were identified during the monitoring in April 2008. This was concluded that the observation made in the previous reports that the Chinese Lily were became withered due to natural seasonality in the dry season while the underground roots were alive is corrected.
- 3.5 Regular maintenance including watering, weeding, apply fertilizer and pest checking to be applied continuously at the receptor site in order to achieve higher survival rate. Daily watering is recommended during the current growing season.
